Profile/Photo Observation Report

Street:	S WABASH PL	Flow Control:	Not Controlled
City:	Hobart, IN	Year Renewed:	
Location:	Yard	Tape/Media #:	
Purpose:	Routine Assessment	Dia/Height:	10"
Use:	Sanitary	Material:	VCP
Drain Area:	NA	Lining:	
Category:	NA		
Comment:	Flow direction is marked wrong.

Location Details:		Direction of Survey:	Downstream
US MH:	M-406-002	DS MH:	M-406-001
		Total Length Surveyed (ft):	68.4

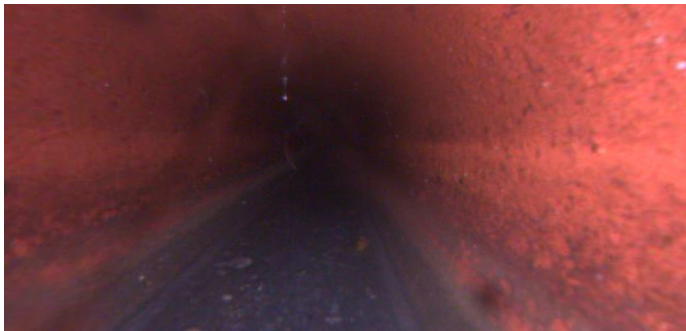
Code: **AMH**
Description: **Manhole**

Distance (ft): **.0**
Structural Grade: **0**
O&M Grade: **0**
Clock Start/From:
Clock To:
1st Value:
2nd Value:
Value Percent:
Continuous Index:
Within 8" of Joint: **NO**
Remarks: **M-406-002**

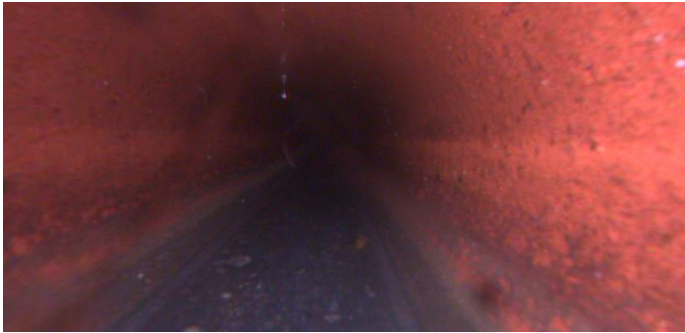
Code:	MWL
Description:	Water Level

Distance (ft):	.0
Structural Grade:	0
O&M Grade:	0
Clock Start/From:	
Clock To:	
1st Value:	
2nd Value:	
Value Percent:	10.000
Continuous Index:	
Within 8" of Joint:	NO
Remarks:

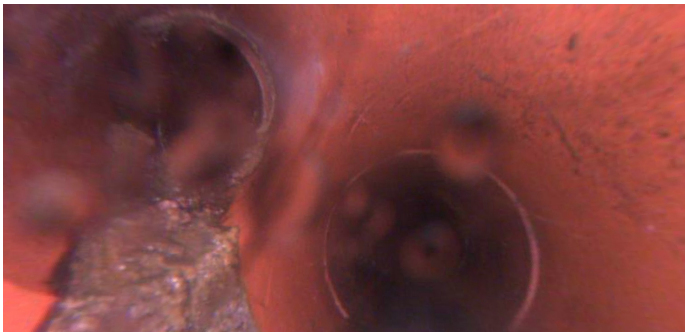
Code:	TF
Description:	Tap Factory

Distance (ft):	45.1
Structural Grade:	0
O&M Grade:	0
Clock Start/From:	10
Clock To:	
1st Value:	4.000
2nd Value:	
Value Percent:	
Continuous Index:	
Within 8" of Joint:	
Remarks:

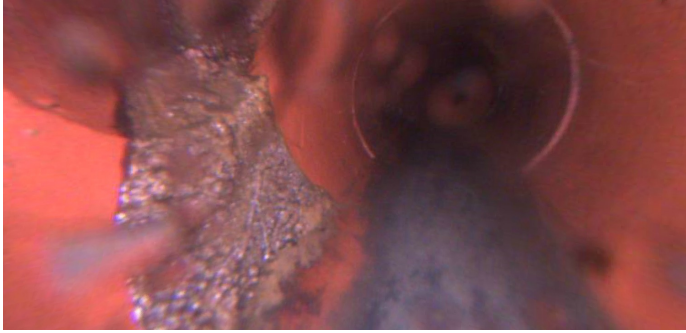
Code: **DAE**
Description: **Deposits Attached Encrustation**

Distance (ft): **45.1**
Structural Grade: **0**
O&M Grade: **2**
Clock Start/From: **7**
Clock To: **9**
1st Value:
2nd Value:
Value Percent: **5.000**
Continuous Index:
Within 8" of Joint: **NO**
Remarks:

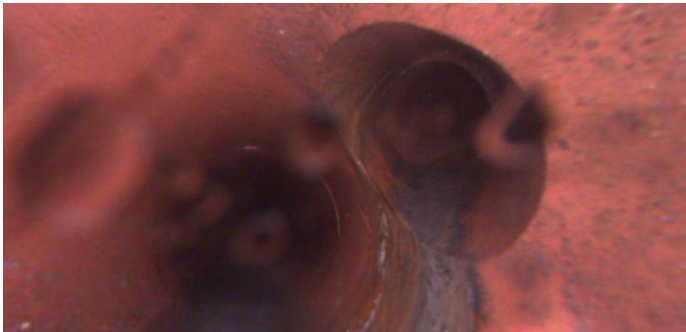
Code: **TF**
Description: **Tap Factory**

Distance (ft): **46.9**
Structural Grade: **0**
O&M Grade: **0**
Clock Start/From: **2**
Clock To:
1st Value: **4.000**
2nd Value:
Value Percent:
Continuous Index:
Within 8" of Joint:
Remarks:

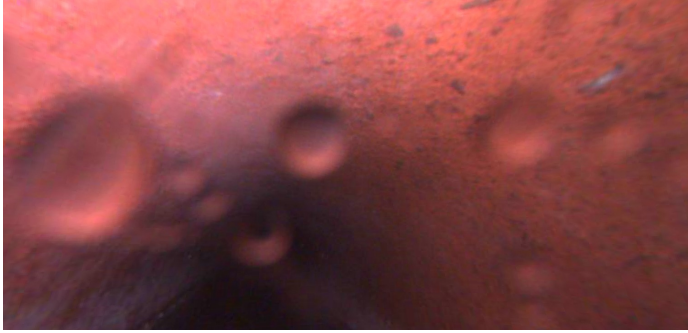
Code:	MSA
Description:	Abandoned Survey
Distance (ft):	68.4
Structural Grade:	0
O&M Grade:	0
Clock Start/From:	
Clock To:	
1st Value:	
2nd Value:	
Value Percent:	
Continuous Index:	
Within 8" of Joint:	NO
Remarks:	unknown
