Profile/Photo Observation Report

Street:	S WABASH PL	Flow Control:	Not Controlled
City:	Hobart, IN	Year Renewed:	
Location:	Yard	Tape/Media #:	
Purpose:	Routine Assessment	Dia/Height:	10"
Use:	Sanitary	Material:	VCP
Drain Area:	NA	Lining:	
Category:	NA		
Comment:

Location Details:		Direction of Survey:	Upstream
US MH:	M-406-002	DS MH:	M-406-001
		Total Length Surveyed (ft):	59.9

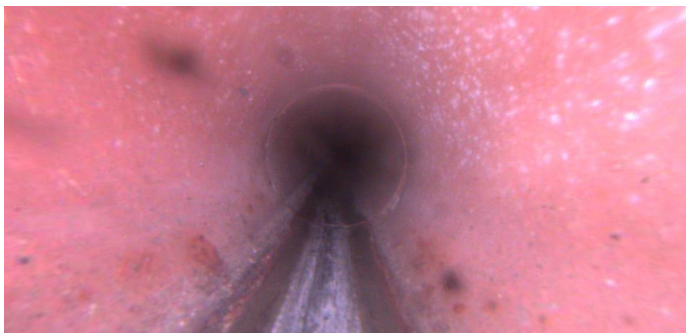
Code: **AMH**
Description: **Manhole**

Distance (ft): **.0**
Structural Grade: **0**
O&M Grade: **0**
Clock Start/From:
Clock To:
1st Value:
2nd Value:
Value Percent:
Continuous Index:
Within 8" of Joint: **NO**
Remarks: **M-406-001**

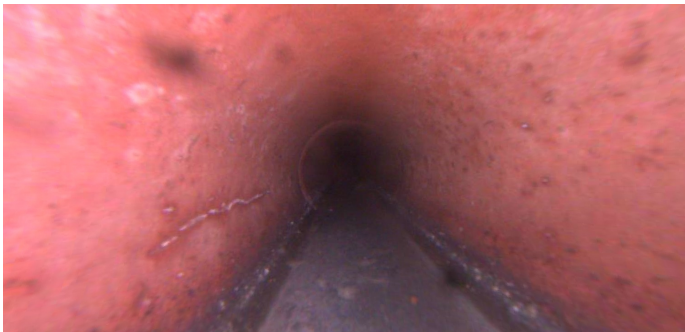
Code:	CL
Description:	Crack Longitudinal

Distance (ft):	15.6
Structural Grade:	2
O&M Grade:	0
Clock Start/From:	9
Clock To:	
1st Value:	
2nd Value:	
Value Percent:	
Continuous Index:	
Within 8" of Joint:	
Remarks:

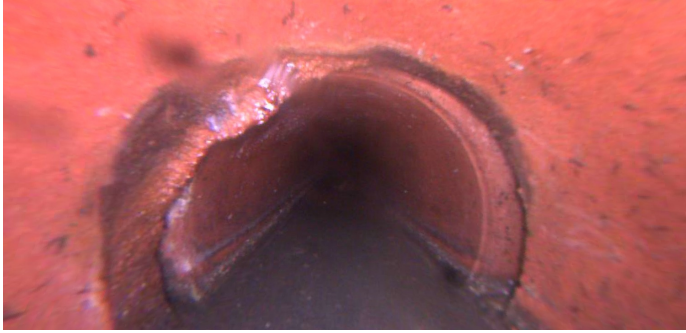
Code: **DAE**
Description: **Deposits Attached Encrustation**

Distance (ft): **31.9**
Structural Grade: **0**
O&M Grade: **2**
Clock Start/From: **8**
Clock To: **12**
1st Value:
2nd Value:
Value Percent: **5.000**
Continuous Index:
Within 8" of Joint: **YES**
Remarks:

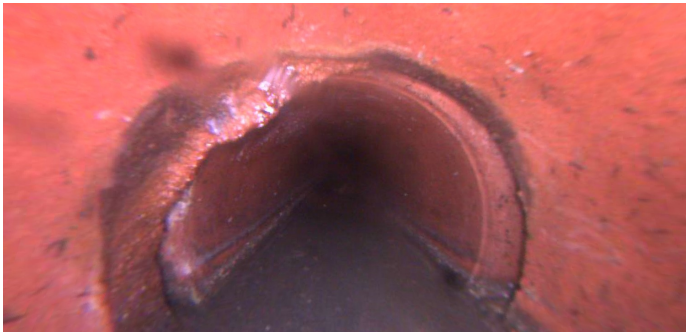
Code: **IW**
Description: **Infil Weeper**

Distance (ft): **31.9**
Structural Grade: **0**
O&M Grade: **2**
Clock Start/From: **8**
Clock To: **12**
1st Value:
2nd Value:
Value Percent:
Continuous Index:
Within 8" of Joint: **YES**
Remarks:

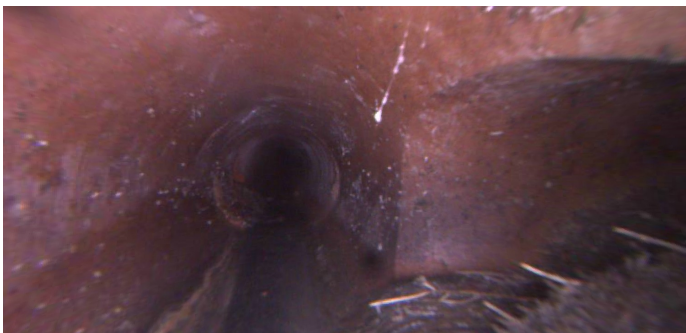
Code: **TFD**
Description: **Tap Factory Defective**

Distance (ft): **53.0**
Structural Grade: **0**
O&M Grade: **2**
Clock Start/From: **3**
Clock To:
1st Value: **4.000**
2nd Value:
Value Percent:
Continuous Index:
Within 8" of Joint:
Remarks: **rml**

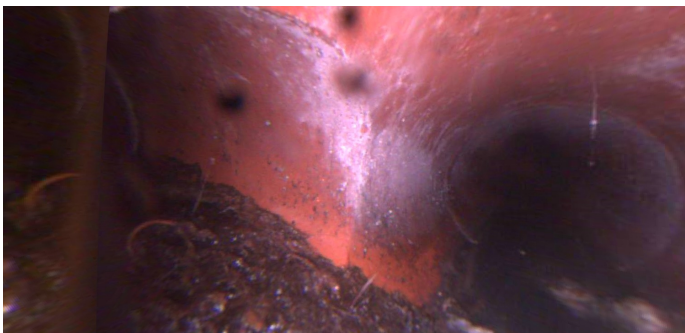
Code: **RML**
Description: **Roots Medium Lateral**

Distance (ft): **55.1**
Structural Grade: **0**
O&M Grade: **3**
Clock Start/From: **8**
Clock To: **9**
1st Value:
2nd Value:
Value Percent: **10.000**
Continuous Index:
Within 8" of Joint: **NO**
Remarks:
