## Profile/Photo Observation Report

Street:	<b>FOXCROFT STREET</b>	Flow Control:	<b>Not Controlled</b>
City:	<b>Hobart, IN</b>	Year Renewed:	
Location:	<b>Yard</b>	Tape/Media #:	
Purpose:	<b>Routine Assessment</b>	Dia/Height:	<b>10"</b>
Use:	<b>Sanitary</b>	Material:	<b>VCP</b>
Drain Area:	<b>NA</b>	Lining:	
Category:	<b>NA</b>		
Comment:

Location Details:		Direction of Survey:	<b>Upstream</b>
US MH:	<b>M-406-002</b>	DS MH:	<b>M-406-001</b>
		Total Length Surveyed (ft):	<b>59.9</b>

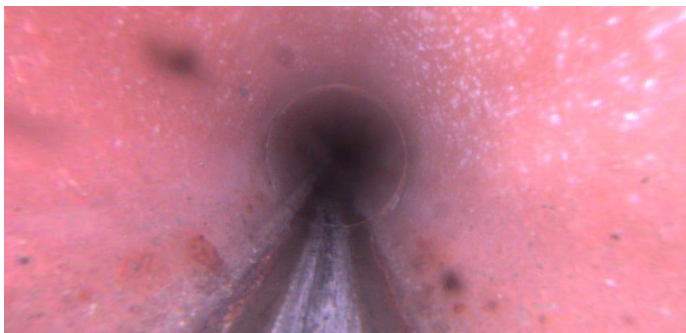
Code: **AMH**  
Description: **Manhole**

Distance (ft): **.0**  
Structural Grade: **0**  
O&M Grade: **0**  
Clock Start/From:  
Clock To:  
1st Value:  
2nd Value:  
Value Percent:  
Continuous Index:  
Within 8" of Joint: **NO**  
Remarks: **M-406-001**

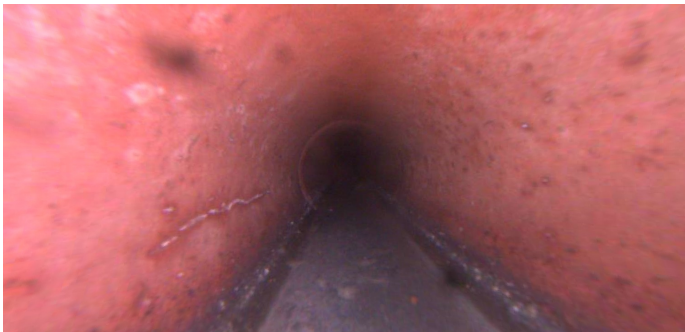
Code:	<b>CL</b>
Description:	<b>Crack Longitudinal</b>

Distance (ft):	<b>15.6</b>
Structural Grade:	<b>2</b>
O&M Grade:	<b>0</b>
Clock Start/From:	<b>9</b>
Clock To:	
1st Value:	
2nd Value:	
Value Percent:	
Continuous Index:	
Within 8" of Joint:	
Remarks:

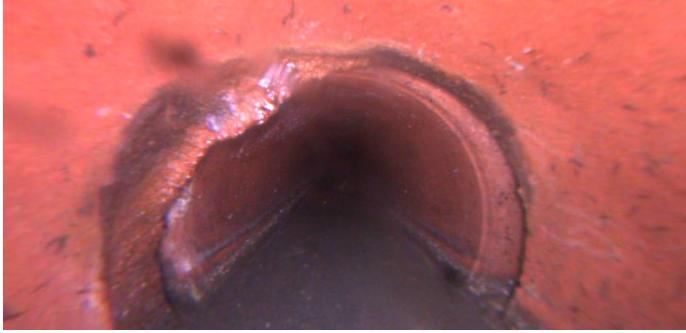
Code: **DAE**  
Description: **Deposits Attached Encrustation**

Distance (ft): **31.9**  
Structural Grade: **0**  
O&M Grade: **2**  
Clock Start/From: **8**  
Clock To: **12**  
1st Value:  
2nd Value:  
Value Percent: **5.000**  
Continuous Index:  
Within 8" of Joint: **YES**  
Remarks:

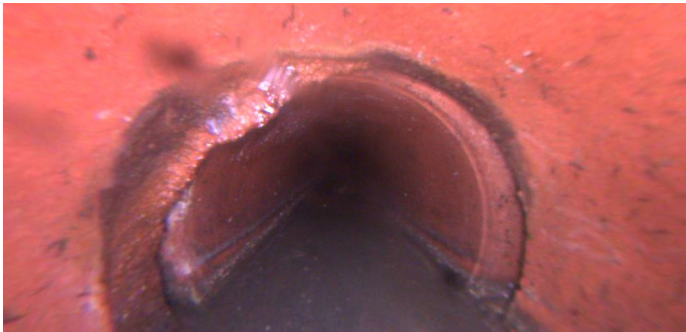
Code: **IW**  
Description: **Infil Weeper**

Distance (ft): **31.9**  
Structural Grade: **0**  
O&M Grade: **2**  
Clock Start/From: **8**  
Clock To: **12**  
1st Value:  
2nd Value:  
Value Percent:  
Continuous Index:  
Within 8" of Joint: **YES**  
Remarks:

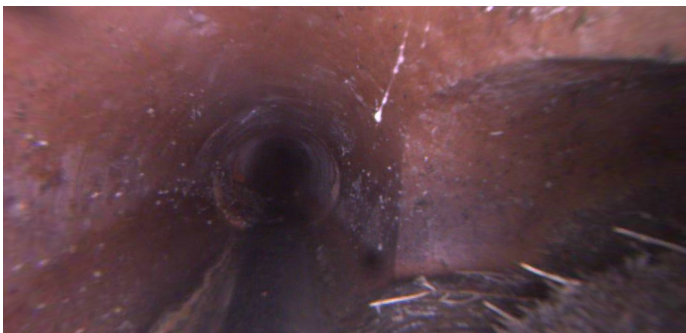
Code: **TFD**  
Description: **Tap Factory Defective**

Distance (ft): **53.0**  
Structural Grade: **0**  
O&M Grade: **2**  
Clock Start/From: **3**  
Clock To:  
1st Value: **4.000**  
2nd Value:  
Value Percent:  
Continuous Index:  
Within 8" of Joint:  
Remarks: **rml**

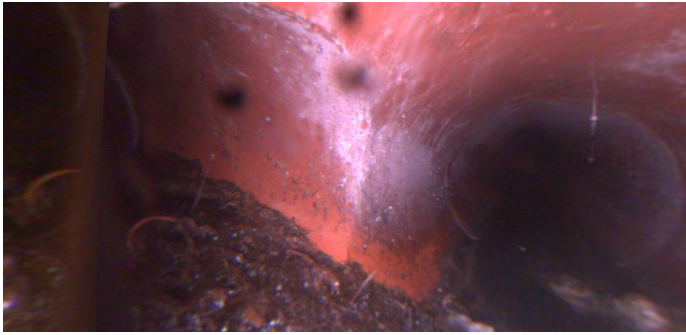
Code: **TFD**  
Description: **Tap Factory Defective**

Distance (ft): **55.1**  
Structural Grade: **0**  
O&M Grade: **2**  
Clock Start/From: **9**  
Clock To:  
1st Value: **4.000**  
2nd Value:  
Value Percent:  
Continuous Index:  
Within 8" of Joint:  
Remarks: **rml**

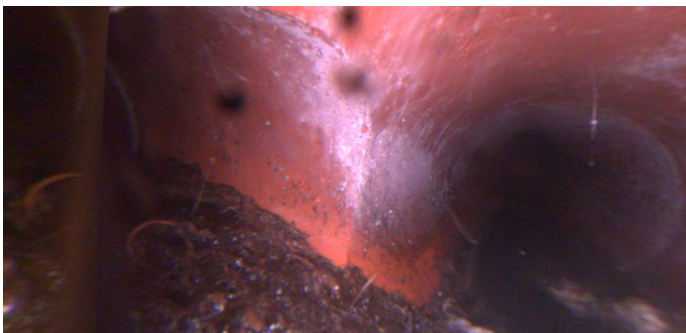
Code: **RML**  
Description: **Roots Medium Lateral**

Distance (ft): **55.1**  
Structural Grade: **0**  
O&M Grade: **3**  
Clock Start/From: **8**  
Clock To: **9**  
1st Value:  
2nd Value:  
Value Percent: **10.000**  
Continuous Index:  
Within 8" of Joint: **NO**  
Remarks:
