## Profile/Photo Observation Report

Street:	<b>LAKEVIEW DR</b>	Flow Control:	<b>Not Controlled</b>
City:	<b>Hobart, IN</b>	Year Renewed:	
Location:	<b>Yard</b>	Tape/Media #:	
Purpose:	<b>Routine Assessment</b>	Dia/Height:	<b>8"</b>
Use:	<b>Sanitary</b>	Material:	<b>PVC</b>
Drain Area:	<b>NA</b>	Lining:	
Category:	<b>NA</b>		
Comment:	<b>Flow direction is marked wrong.</b>

Location Details:		Direction of Survey:	<b>Downstream</b>
US MH:	<b>M-407-002</b>	DS MH:	<b>M-407-001</b>
		Total Length Surveyed (ft):	<b>90.3</b>

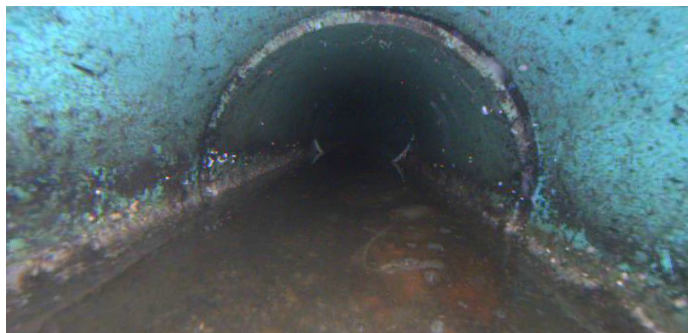
Code: **AMH**  
Description: **Manhole**

Distance (ft): **.0**  
Structural Grade: **0**  
O&M Grade: **0**  
Clock Start/From:  
Clock To:  
1st Value:  
2nd Value:  
Value Percent:  
Continuous Index:  
Within 8" of Joint: **NO**  
Remarks: **M-407-002**

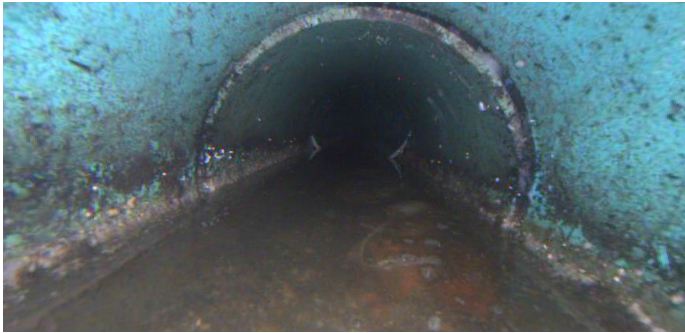
Code:	<b>MWL</b>
Description:	<b>Water Level</b>

Distance (ft):	<b>.0</b>
Structural Grade:	<b>0</b>
O&M Grade:	<b>0</b>
Clock Start/From:	
Clock To:	
1st Value:	
2nd Value:	
Value Percent:	<b>30.000</b>
Continuous Index:	
Within 8" of Joint:	<b>NO</b>
Remarks:

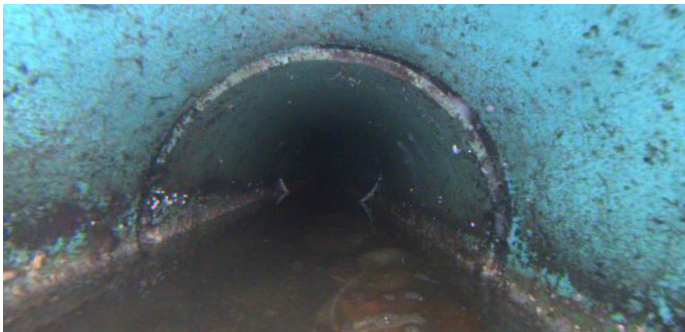
Code:	<b>JOM</b>
Description:	<b>Joint Offset Medium</b>

Distance (ft):	<b>.1</b>
Structural Grade:	<b>1</b>
O&M Grade:	<b>0</b>
Clock Start/From:	
Clock To:	
1st Value:	
2nd Value:	
Value Percent:	
Continuous Index:	
Within 8" of Joint:	<b>NO</b>
Remarks:

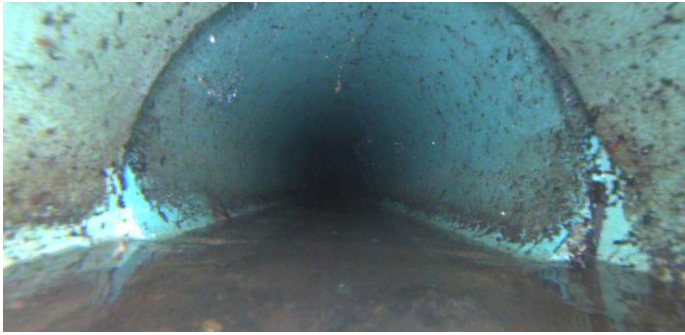
Code: **JOM**  
Description: **Joint Offset Medium**

Distance (ft): **2.8**  
Structural Grade: **1**  
O&M Grade: **0**  
Clock Start/From:  
Clock To:  
1st Value:  
2nd Value:  
Value Percent:  
Continuous Index:  
Within 8" of Joint: **NO**  
Remarks:

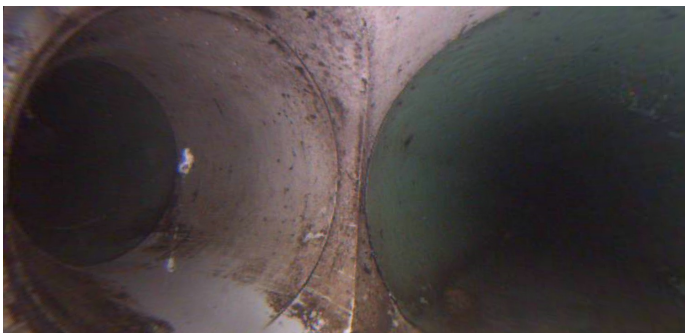
Code: **TF**  
Description: **Tap Factory**

Distance (ft): **8.3**  
Structural Grade: **0**  
O&M Grade: **0**  
Clock Start/From: **9**  
Clock To:  
1st Value: **4.000**  
2nd Value:  
Value Percent:  
Continuous Index:  
Within 8" of Joint:  
Remarks:

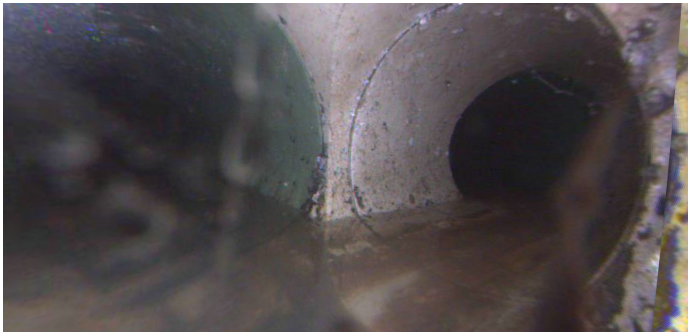
Code: **TFA**  
Description: **Tap Factory Active**

Distance (ft): **85.9**  
Structural Grade: **0**  
O&M Grade: **0**  
Clock Start/From: **3**  
Clock To:  
1st Value: **4.000**  
2nd Value:  
Value Percent:  
Continuous Index:  
Within 8" of Joint:  
Remarks:
