Profile/Photo Observation Report

Date:	04/12/2018	Weather:		Coding:	PACP 6.0
Pipe Length (ft):	244.9	Owner:	NA	Pre Clean:	No Pre-Cleaning
P.O.#:		Surveyor:	Jen Costello	PSR:	P-407-003-004
Customer:		Clean Date:	01/01/1900	Shape:	C

Street:	FOXCROFT STREET	Flow Control:	Not Controlled
City:	Hobart, IN	Year Renewed:	
Location:	Yard	Tape/Media #:	
Purpose:	Routine Assessment	Dia/Height:	10"
Use:	Sanitary	Material:	PVC
Drain Area:	NA	Lining:	
Category:	NA		
Comment:			
Location Details:		Direction of Survey:	Upstream
US MH:	M-407-003	DS MH:	M-407-004
		Total Length Surveyed (ft):	31.5

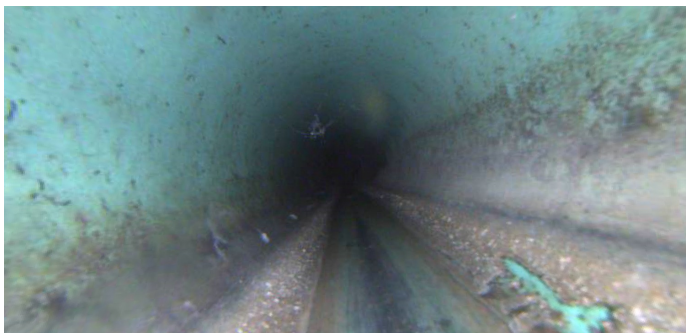
Code: **AMH**
Description: **Manhole**

Distance (ft): **.0**
Structural Grade: **0**
O&M Grade: **0**
Clock Start/From:
Clock To:
1st Value:
2nd Value:
Value Percent:
Continuous Index:
Within 8" of Joint: **NO**
Remarks: **M-407-004**

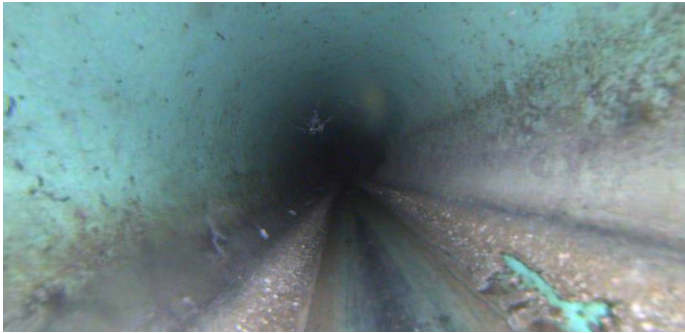
Code:	MWL
Description:	Water Level

Distance (ft):	.0
Structural Grade:	0
O&M Grade:	0
Clock Start/From:	
Clock To:	
1st Value:	
2nd Value:	
Value Percent:	5.000
Continuous Index:	
Within 8" of Joint:	NO
Remarks:

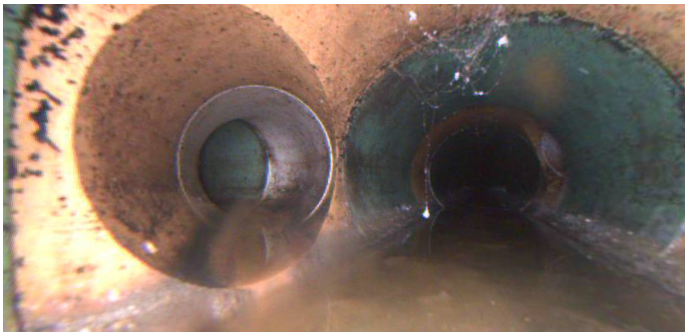
Code:	TFA
Description:	Tap Factory Active

Distance (ft):	28.3
Structural Grade:	0
O&M Grade:	0
Clock Start/From:	9
Clock To:	
1st Value:	4.000
2nd Value:	
Value Percent:	
Continuous Index:	
Within 8" of Joint:	
Remarks:

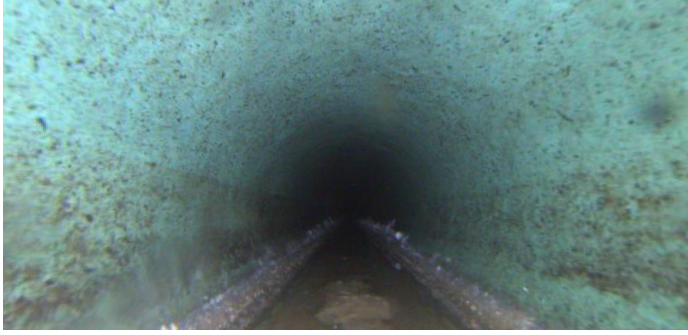
Code:	MSA
Description:	Abandoned Survey
Distance (ft):	31.5
Structural Grade:	0
O&M Grade:	0
Clock Start/From:	
Clock To:	
1st Value:	
2nd Value:	
Value Percent:	
Continuous Index:	
Within 8" of Joint:	NO
Remarks:	DEBRIS UNDER WATER
