Profile/Photo Observation Report

Date:	04/12/2018	Weather:		Coding:	PACP 6.0
Pipe Length (ft):	238.7	Owner:	NA	Pre Clean:	No Pre-Cleaning
P.O.#:		Surveyor:	Jen Costello	PSR:	P-407-004-005
Customer:		Clean Date:	01/01/1900	Shape:	C

Street:	LAKEVIEW DR	Flow Control:	Not Controlled
City:	Hobart, IN	Year Renewed:	
Location:	Yard	Tape/Media #:	
Purpose:	Routine Assessment	Dia/Height:	10"
Use:	Sanitary	Material:	PVC
Drain Area:	NA	Lining:	
Category:	NA		
Comment:			
Location Details:		Direction of Survey:	Downstream
US MH:	M-407-004	DS MH:	M-407-005
		Total Length Surveyed (ft):	217.6

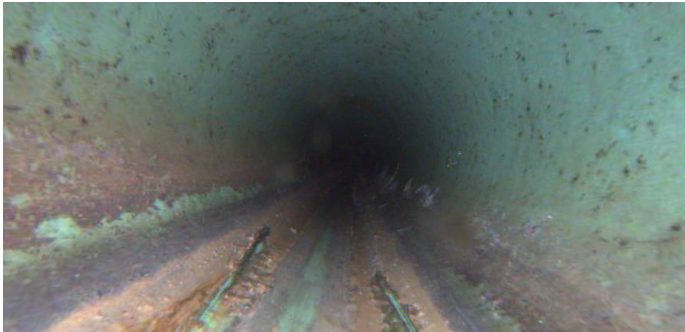
Code:	AMH
Description:	Manhole

Distance (ft):	.0
Structural Grade:	0
O&M Grade:	0
Clock Start/From:	
Clock To:	
1st Value:	
2nd Value:	
Value Percent:	
Continuous Index:	
Within 8" of Joint:	NO
Remarks:	M-407-004

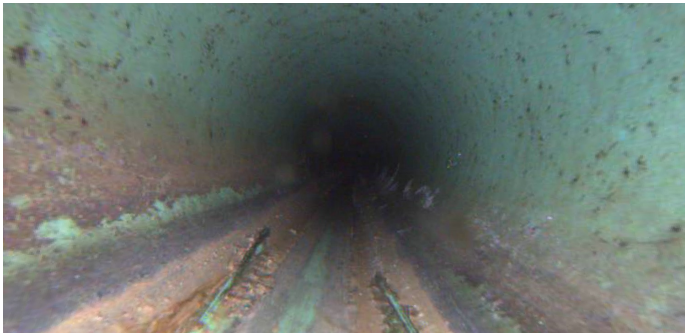
Code:	DAGS
Description:	Deposits Attached Grease

Distance (ft):	.0
Structural Grade:	0
O&M Grade:	2
Clock Start/From:	3
Clock To:	9
1st Value:	
2nd Value:	
Value Percent:	5.000
Continuous Index:	S01
Within 8" of Joint:	NO
Remarks:

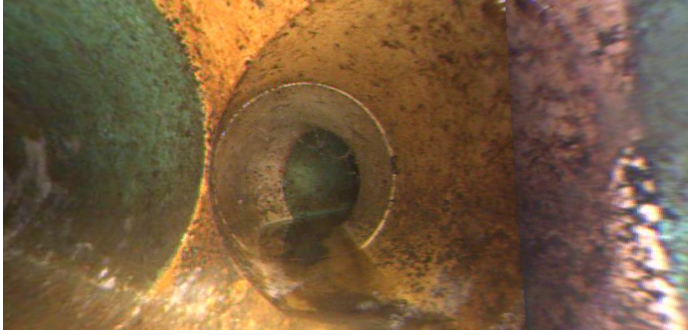
Code: **TFA**
Description: **Tap Factory Active**

Distance (ft): **7.1**
Structural Grade: **0**
O&M Grade: **0**
Clock Start/From: **9**
Clock To:
1st Value: **4.000**
2nd Value:
Value Percent:
Continuous Index:
Within 8" of Joint:
Remarks:

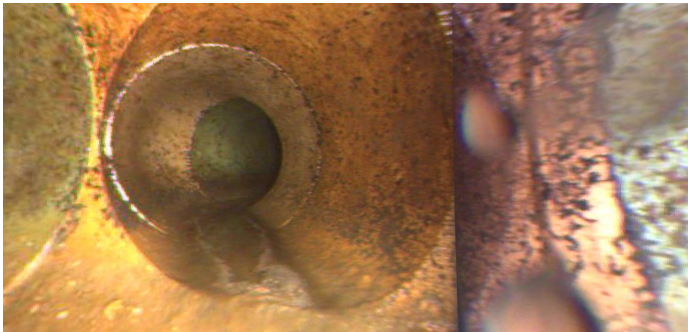
Code: **TFA**
Description: **Tap Factory Active**

Distance (ft): **112.0**
Structural Grade: **0**
O&M Grade: **0**
Clock Start/From: **9**
Clock To:
1st Value: **4.000**
2nd Value:
Value Percent:
Continuous Index:
Within 8" of Joint:
Remarks:

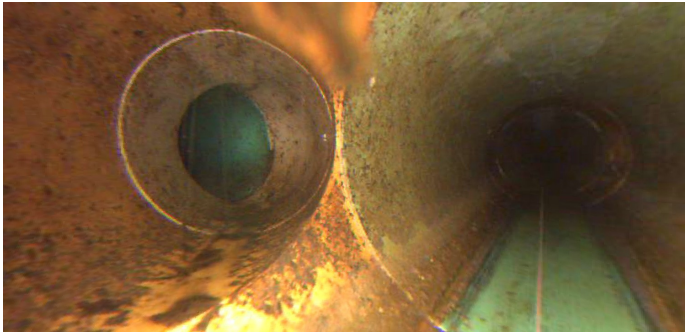
Code: **TF**
Description: **Tap Factory**

Distance (ft): **114.8**
Structural Grade: **0**
O&M Grade: **0**
Clock Start/From: **3**
Clock To:
1st Value: **4.000**
2nd Value:
Value Percent:
Continuous Index:
Within 8" of Joint:
Remarks:

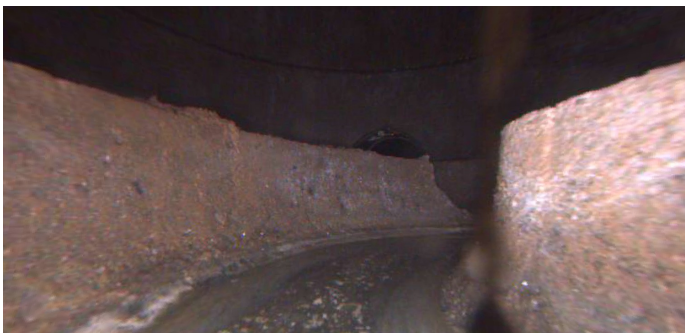
Code: **DAGS**
Description: **Deposits Attached Grease**

Distance (ft): **216.2**
Structural Grade: **0**
O&M Grade: **2**
Clock Start/From: **3**
Clock To: **9**
1st Value:
2nd Value:
Value Percent: **5.000**
Continuous Index: **F01**
Within 8" of Joint: **NO**
Remarks:

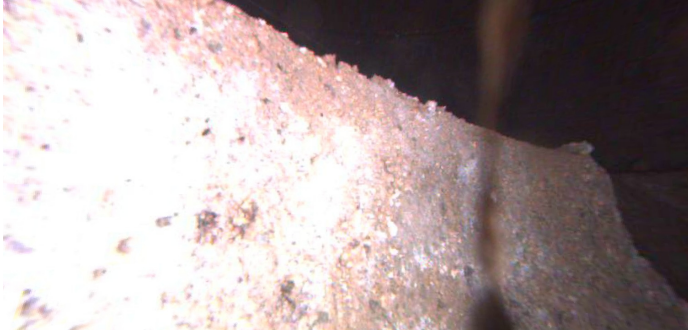
Code:	AMH
Description:	Manhole
Distance (ft):	217.6
Structural Grade:	0
O&M Grade:	0
Clock Start/From:	
Clock To:	
1st Value:	
2nd Value:	
Value Percent:	
Continuous Index:	
Within 8" of Joint:	NO
Remarks:	M-407-005
