## Profile/Photo Observation Report

Street:	<b>FOXCROFT STREET</b>	Flow Control:	<b>Not Controlled</b>
City:	<b>Hobart, IN</b>	Year Renewed:	
Location:	<b>Yard</b>	Tape/Media #:	
Purpose:	<b>Routine Assessment</b>	Dia/Height:	<b>10"</b>
Use:	<b>Sanitary</b>	Material:	<b>PVC</b>
Drain Area:	<b>NA</b>	Lining:	
Category:	<b>NA</b>		
Comment:	<b>Flow direction is marked wrong.</b>

Location Details:		Direction of Survey:	<b>Upstream</b>
US MH:	<b>M-407-006</b>	DS MH:	<b>M-407-005</b>
		Total Length Surveyed (ft):	<b>135.3</b>

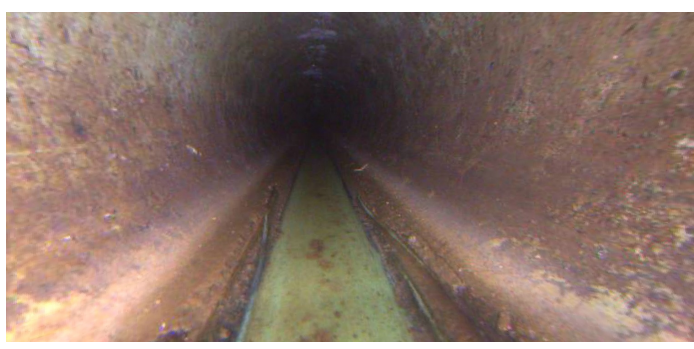
Code: **AMH**  
Description: **Manhole**

Distance (ft): **.0**  
Structural Grade: **0**  
O&M Grade: **0**  
Clock Start/From:  
Clock To:  
1st Value:  
2nd Value:  
Value Percent:  
Continuous Index:  
Within 8" of Joint: **NO**  
Remarks: **M-407-005**

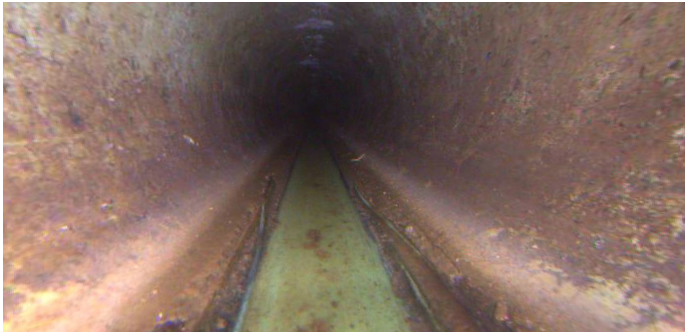
Code: **MWL**  
Description: **Water Level**

Distance (ft): **.0**  
Structural Grade: **0**  
O&M Grade: **0**  
Clock Start/From:  
Clock To:  
1st Value:  
2nd Value:  
Value Percent: **5.000**  
Continuous Index:  
Within 8" of Joint: **NO**  
Remarks:

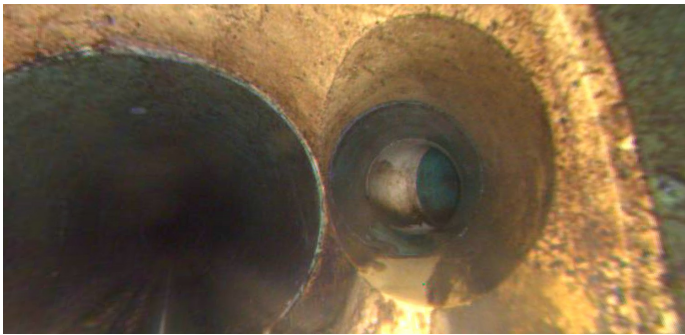
Code: **TF**  
Description: **Tap Factory**

Distance (ft): **75.9**  
Structural Grade: **0**  
O&M Grade: **0**  
Clock Start/From: **9**  
Clock To:  
1st Value: **4.000**  
2nd Value:  
Value Percent:  
Continuous Index:  
Within 8" of Joint:  
Remarks:

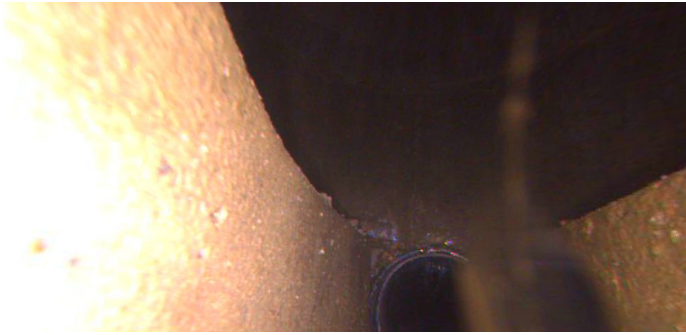
Code: **AMH**  
Description: **Manhole**

Distance (ft): **135.1**  
Structural Grade: **0**  
O&M Grade: **0**  
Clock Start/From:  
Clock To:  
1st Value:  
2nd Value:  
Value Percent:  
Continuous Index:  
Within 8" of Joint: **NO**  
Remarks: **M-407-006**
