Profile/Photo Observation Report

Date:	04/12/2018	Weather:		Coding:	PACP 6.0
Pipe Length (ft):	143.5	Owner:	NA	Pre Clean:	No Pre-Cleaning
P.O.#:		Surveyor:	Jen Costello	PSR:	P-407-006-007
Customer:		Clean Date:	01/01/1900	Shape:	C

Street:	LAKESIDE DR	Flow Control:	Not Controlled
City:	Hobart, IN	Year Renewed:	
Location:	Yard	Tape/Media #:	
Purpose:	Routine Assessment	Dia/Height:	10"
Use:	Sanitary	Material:	PVC
Drain Area:	NA	Lining:	
Category:	NA		
Comment:			
Location Details:		Direction of Survey:	Downstream
US MH:	M-407-007	DS MH:	M-407-006
		Total Length Surveyed (ft):	145.0

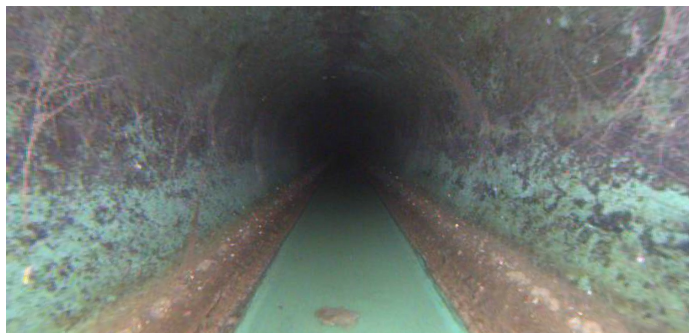
Code: **AMH**
Description: **Manhole**

Distance (ft): **.0**
Structural Grade: **0**
O&M Grade: **0**
Clock Start/From:
Clock To:
1st Value:
2nd Value:
Value Percent:
Continuous Index:
Within 8" of Joint: **NO**
Remarks: **M-407-007**

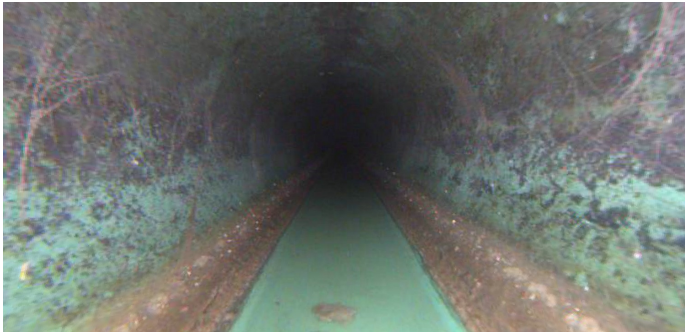
Code:	MWL
Description:	Water Level

Distance (ft):	.0
Structural Grade:	0
O&M Grade:	0
Clock Start/From:	
Clock To:	
1st Value:	
2nd Value:	
Value Percent:	5.000
Continuous Index:	
Within 8" of Joint:	NO
Remarks:

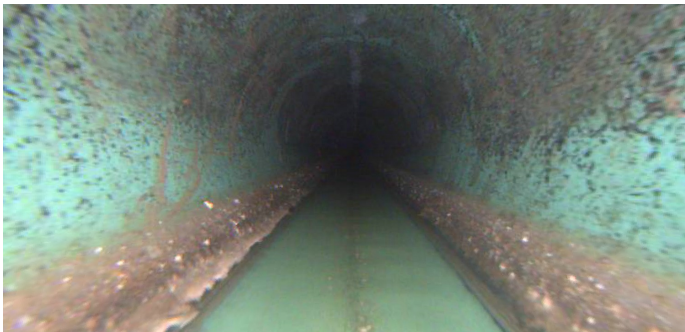
Code:	DAGS
Description:	Deposits Attached Grease

Distance (ft):	5.9
Structural Grade:	0
O&M Grade:	2
Clock Start/From:	7
Clock To:	5
1st Value:	
2nd Value:	
Value Percent:	5.000
Continuous Index:	S01
Within 8" of Joint:	NO
Remarks:

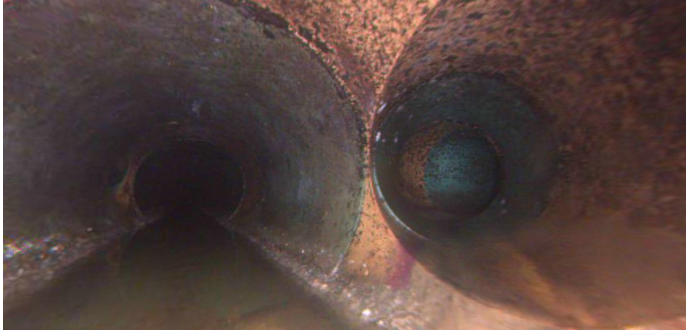
Code: **TFA**
Description: **Tap Factory Active**

Distance (ft): **24.9**
Structural Grade: **0**
O&M Grade: **0**
Clock Start/From: **3**
Clock To:
1st Value: **4.000**
2nd Value:
Value Percent:
Continuous Index:
Within 8" of Joint:
Remarks:

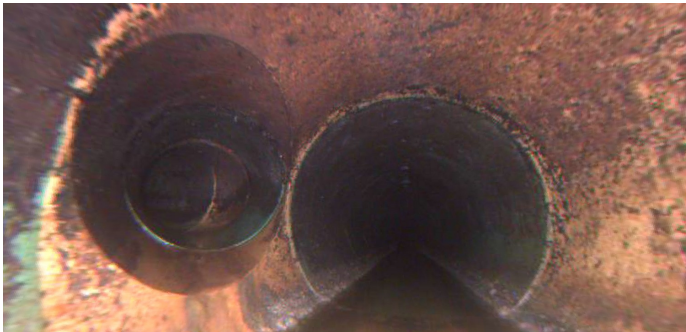
Code: **TF**
Description: **Tap Factory**

Distance (ft): **26.8**
Structural Grade: **0**
O&M Grade: **0**
Clock Start/From: **9**
Clock To:
1st Value: **4.000**
2nd Value:
Value Percent:
Continuous Index:
Within 8" of Joint:
Remarks:

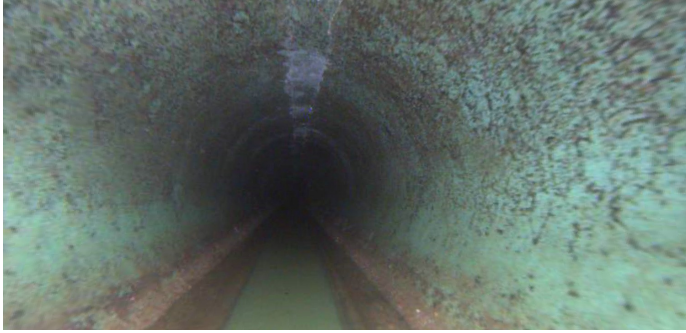
Code: **DAGS**
Description: **Deposits Attached Grease**

Distance (ft): **45.0**
Structural Grade: **0**
O&M Grade: **2**
Clock Start/From: **7**
Clock To: **5**
1st Value:
2nd Value:
Value Percent: **5.000**
Continuous Index: **F01**
Within 8" of Joint: **NO**
Remarks:

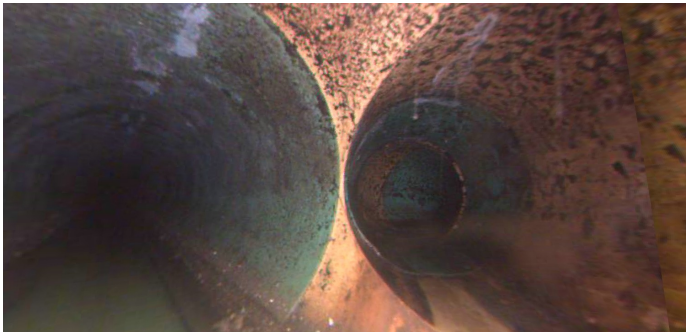
Code: **TFA**
Description: **Tap Factory Active**

Distance (ft): **66.0**
Structural Grade: **0**
O&M Grade: **0**
Clock Start/From: **3**
Clock To:
1st Value: **4.000**
2nd Value:
Value Percent:
Continuous Index:
Within 8" of Joint:
Remarks:

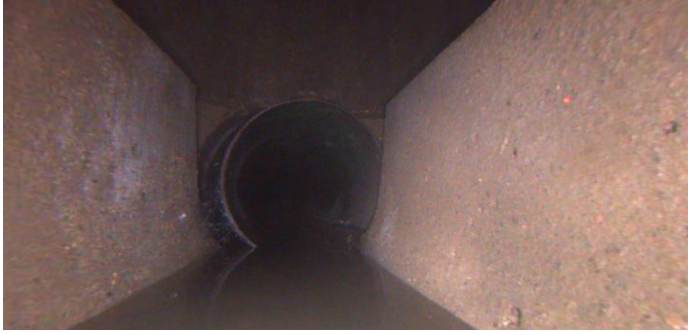
Code:	AMH
Description:	Manhole
Distance (ft):	145.0
Structural Grade:	0
O&M Grade:	0
Clock Start/From:	
Clock To:	
1st Value:	
2nd Value:	
Value Percent:	
Continuous Index:	
Within 8" of Joint:	NO
Remarks:	M-407-006
