Profile/Photo Observation Report

Street:	FOXCROFT STREET	Flow Control:	Not Controlled
City:	Hobart, IN	Year Renewed:	
Location:	Yard	Tape/Media #:	
Purpose:	Routine Assessment	Dia/Height:	10"
Use:	Sanitary	Material:	PVC
Drain Area:	NA	Lining:	
Category:	NA		
Comment:

Location Details:		Direction of Survey:	Downstream
US MH:	M-407-007	DS MH:	M-407-006
		Total Length Surveyed (ft):	145.0

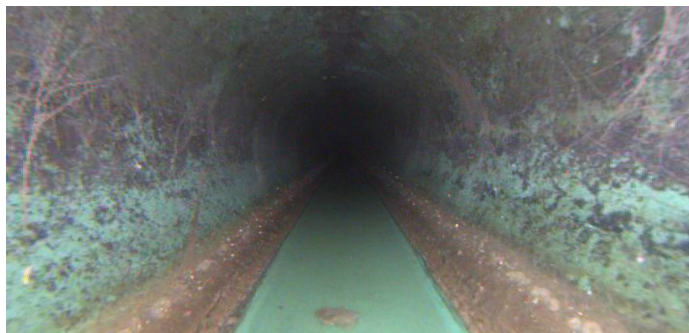
Code: **AMH**
Description: **Manhole**

Distance (ft): **.0**
Structural Grade: **0**
O&M Grade: **0**
Clock Start/From:
Clock To:
1st Value:
2nd Value:
Value Percent:
Continuous Index:
Within 8" of Joint: **NO**
Remarks: **M-407-007**

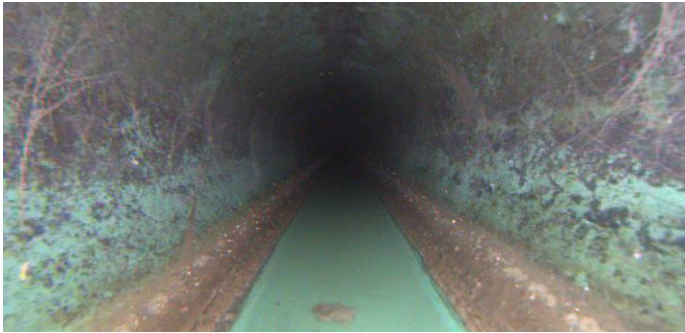
Code:	MWL
Description:	Water Level

Distance (ft):	.0
Structural Grade:	0
O&M Grade:	0
Clock Start/From:	
Clock To:	
1st Value:	
2nd Value:	
Value Percent:	5.000
Continuous Index:	
Within 8" of Joint:	NO
Remarks:

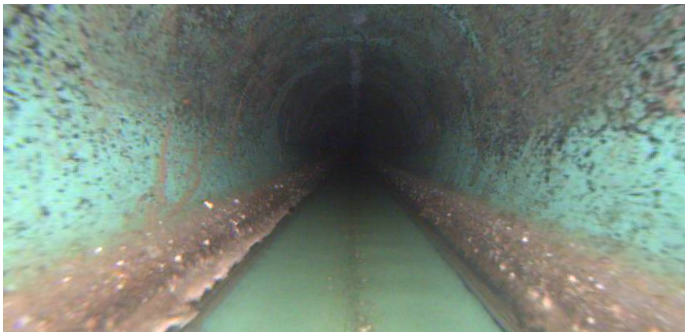
Code:	DAGS
Description:	Deposits Attached Grease

Distance (ft):	5.9
Structural Grade:	0
O&M Grade:	2
Clock Start/From:	7
Clock To:	5
1st Value:	
2nd Value:	
Value Percent:	5.000
Continuous Index:	S01
Within 8" of Joint:	NO
Remarks:

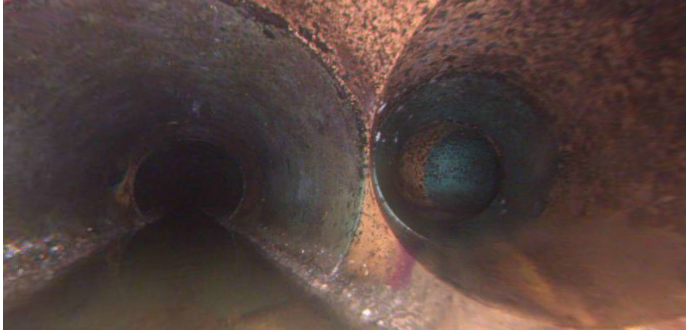
Code: **TFA**
Description: **Tap Factory Active**

Distance (ft): **24.9**
Structural Grade: **0**
O&M Grade: **0**
Clock Start/From: **3**
Clock To:
1st Value: **4.000**
2nd Value:
Value Percent:
Continuous Index:
Within 8" of Joint:
Remarks:

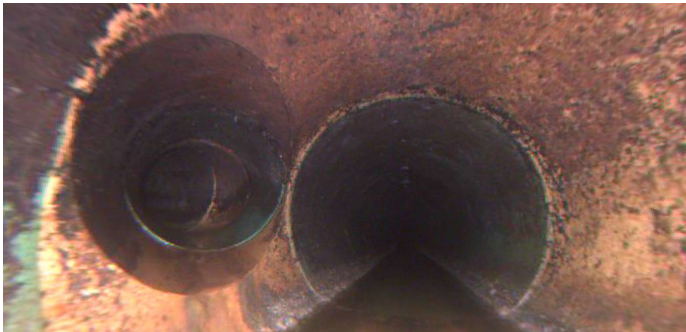
Code: **TF**
Description: **Tap Factory**

Distance (ft): **26.8**
Structural Grade: **0**
O&M Grade: **0**
Clock Start/From: **9**
Clock To:
1st Value: **4.000**
2nd Value:
Value Percent:
Continuous Index:
Within 8" of Joint:
Remarks:

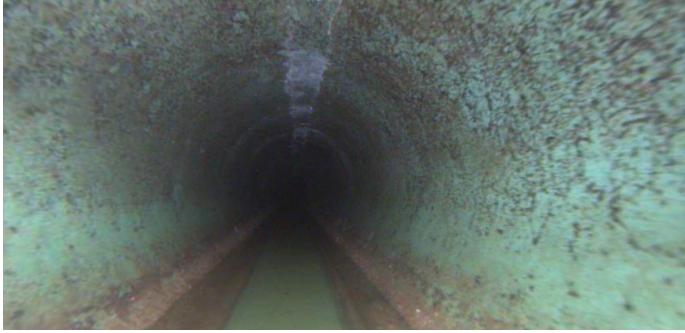
Code: **DAGS**
Description: **Deposits Attached Grease**

Distance (ft): **45.0**
Structural Grade: **0**
O&M Grade: **2**
Clock Start/From: **7**
Clock To: **5**
1st Value:
2nd Value:
Value Percent: **5.000**
Continuous Index: **F01**
Within 8" of Joint: **NO**
Remarks:

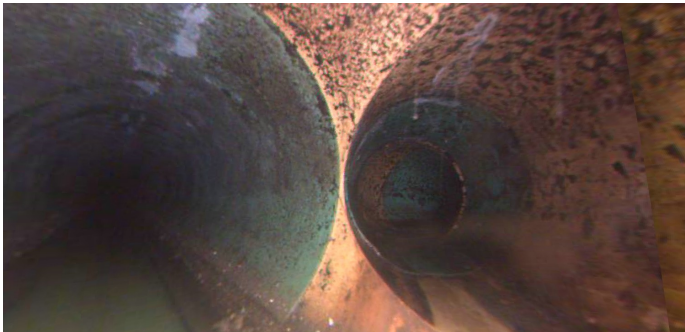
Code: **TFA**
Description: **Tap Factory Active**

Distance (ft): **66.0**
Structural Grade: **0**
O&M Grade: **0**
Clock Start/From: **3**
Clock To:
1st Value: **4.000**
2nd Value:
Value Percent:
Continuous Index:
Within 8" of Joint:
Remarks:

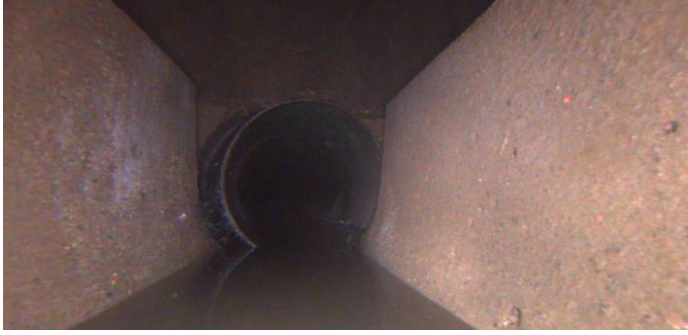
Code:	AMH
Description:	Manhole
Distance (ft):	145.0
Structural Grade:	0
O&M Grade:	0
Clock Start/From:	
Clock To:	
1st Value:	
2nd Value:	
Value Percent:	
Continuous Index:	
Within 8" of Joint:	NO
Remarks:	M-407-006
