Profile/Photo Observation Report

Date:	04/12/2018	Weather:		Coding:	PACP 6.0
Pipe Length (ft):	280.6	Owner:	NA	Pre Clean:	No Pre-Cleaning
P.O.#:		Surveyor:	Jen Costello	PSR:	P-407-007-008
Customer:		Clean Date:	01/01/1900	Shape:	C

Street:	FOXCROFT STREET	Flow Control:	Not Controlled
City:	Hobart, IN	Year Renewed:	
Location:	Yard	Tape/Media #:	
Purpose:	Routine Assessment	Dia/Height:	10"
Use:	Sanitary	Material:	PVC
Drain Area:	NA	Lining:	
Category:	NA		
Comment:	Flow direction is marked wrong.		
Location Details:		Direction of Survey:	Upstream
US MH:	M-407-008	DS MH:	M-407-007
		Total Length Surveyed (ft):	271.5

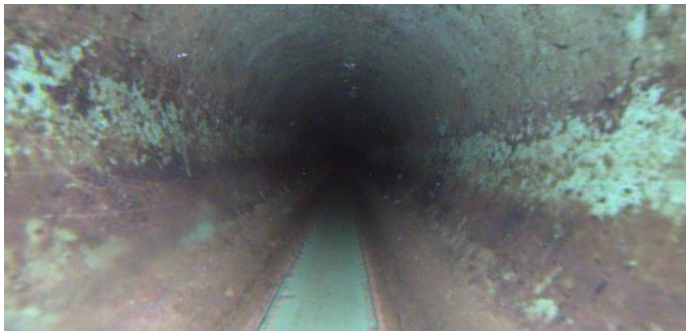
Code: **AMH**
Description: **Manhole**

Distance (ft): **.0**
Structural Grade: **0**
O&M Grade: **0**
Clock Start/From:
Clock To:
1st Value:
2nd Value:
Value Percent:
Continuous Index:
Within 8" of Joint: **NO**
Remarks: **M-407-007**

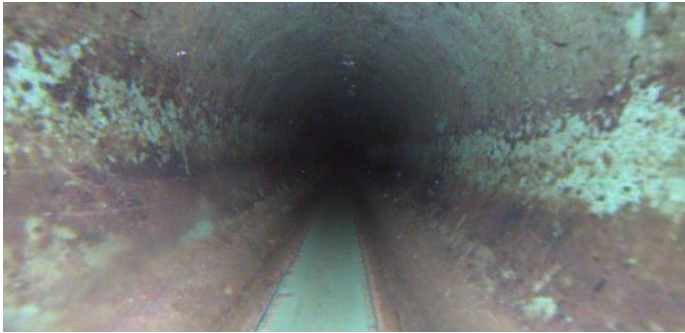
Code:	MWL
Description:	Water Level

Distance (ft):	.0
Structural Grade:	0
O&M Grade:	0
Clock Start/From:	
Clock To:	
1st Value:	
2nd Value:	
Value Percent:	5.000
Continuous Index:	
Within 8" of Joint:	NO
Remarks:

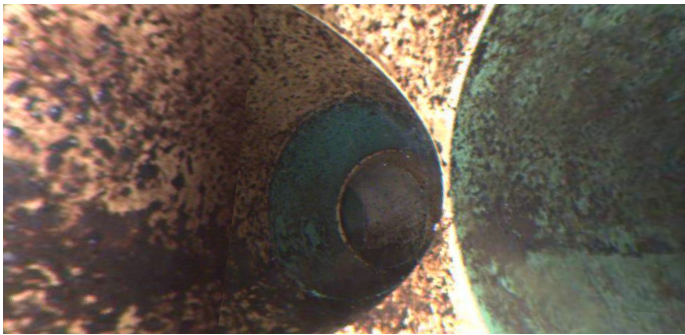
Code:	TF
Description:	Tap Factory

Distance (ft):	49.5
Structural Grade:	0
O&M Grade:	0
Clock Start/From:	3
Clock To:	
1st Value:	4.000
2nd Value:	
Value Percent:	
Continuous Index:	
Within 8" of Joint:	
Remarks:

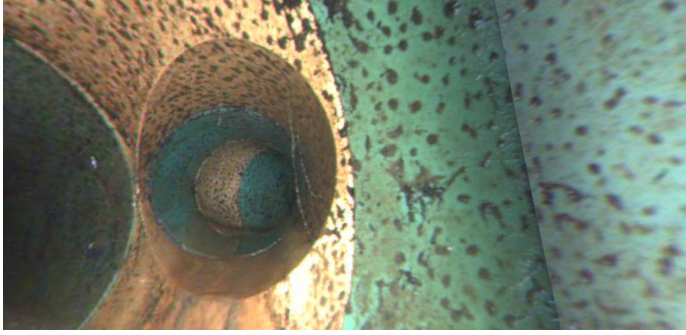
Code: **TF**
Description: **Tap Factory**

Distance (ft): **52.1**
Structural Grade: **0**
O&M Grade: **0**
Clock Start/From: **9**
Clock To:
1st Value: **4.000**
2nd Value:
Value Percent:
Continuous Index:
Within 8" of Joint:
Remarks:

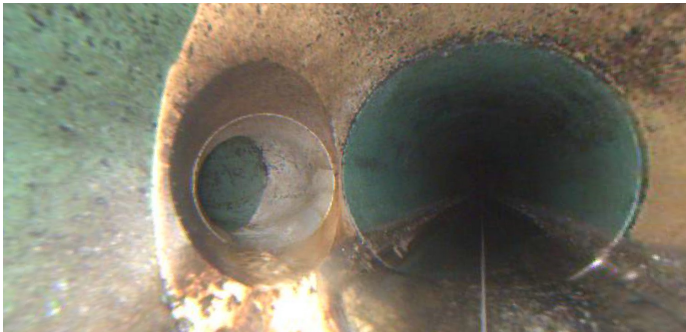
Code: **TF**
Description: **Tap Factory**

Distance (ft): **137.8**
Structural Grade: **0**
O&M Grade: **0**
Clock Start/From: **3**
Clock To:
1st Value: **4.000**
2nd Value:
Value Percent:
Continuous Index:
Within 8" of Joint:
Remarks:

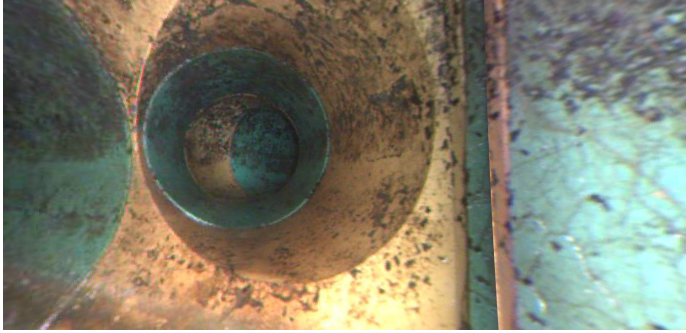
Code: **TF**
Description: **Tap Factory**

Distance (ft): **139.6**
Structural Grade: **0**
O&M Grade: **0**
Clock Start/From: **9**
Clock To:
1st Value: **4.000**
2nd Value:
Value Percent:
Continuous Index:
Within 8" of Joint:
Remarks:

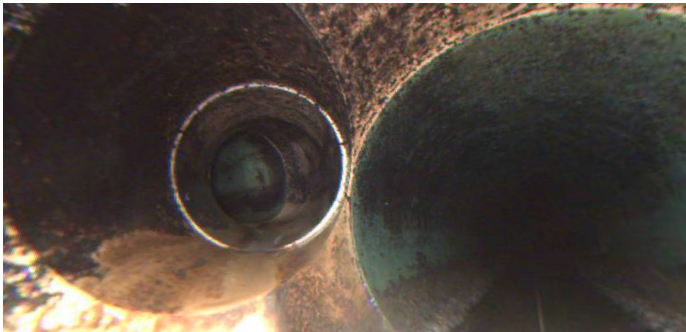
Code: **TF**
Description: **Tap Factory**

Distance (ft): **203.0**
Structural Grade: **0**
O&M Grade: **0**
Clock Start/From: **9**
Clock To:
1st Value: **4.000**
2nd Value:
Value Percent:
Continuous Index:
Within 8" of Joint:
Remarks:

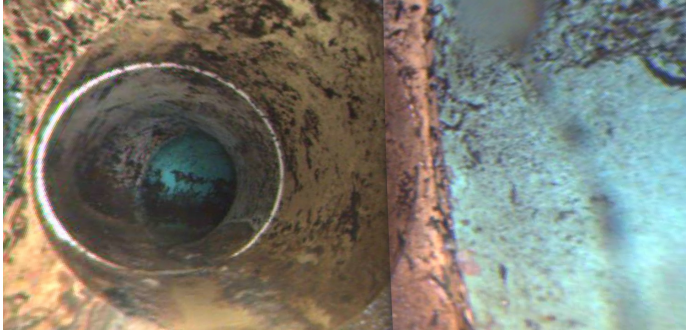
Code: **TF**
Description: **Tap Factory**

Distance (ft): **205.7**
Structural Grade: **0**
O&M Grade: **0**
Clock Start/From: **9**
Clock To:
1st Value: **4.000**
2nd Value:
Value Percent:
Continuous Index:
Within 8" of Joint:
Remarks:

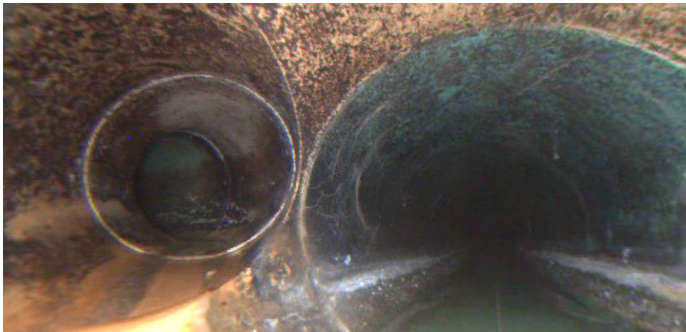
Code: **TF**
Description: **Tap Factory**

Distance (ft): **264.1**
Structural Grade: **0**
O&M Grade: **0**
Clock Start/From: **3**
Clock To:
1st Value: **4.000**
2nd Value:
Value Percent:
Continuous Index:
Within 8" of Joint:
Remarks:

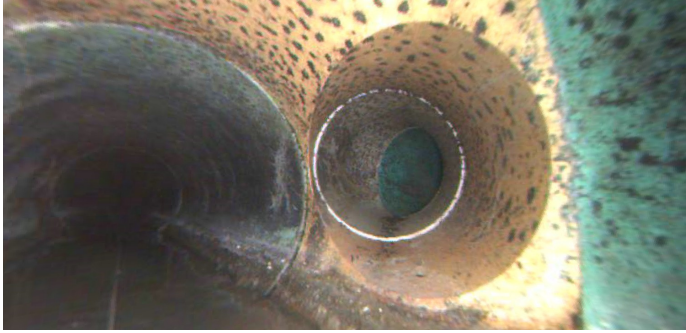
Code: **TF**
Description: **Tap Factory**

Distance (ft): **266.6**
Structural Grade: **0**
O&M Grade: **0**
Clock Start/From: **9**
Clock To:
1st Value: **4.000**
2nd Value:
Value Percent:
Continuous Index:
Within 8" of Joint:
Remarks:

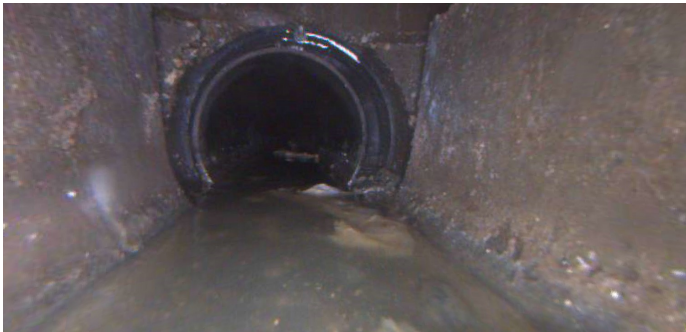
Code: **AMH**
Description: **Manhole**

Distance (ft): **271.5**
Structural Grade: **0**
O&M Grade: **0**
Clock Start/From:
Clock To:
1st Value:
2nd Value:
Value Percent:
Continuous Index:
Within 8" of Joint: **NO**
Remarks: **M-407-008**
