# Profile/Photo Observation Report

Date:	<b>10/08/2018</b>	Weather:		Coding:	<b>PACP 6.0</b>
Pipe Length (ft):	<b>134.0</b>	Owner:	<b>NA</b>	Pre Clean:	<b>Not Known</b>
P.O.#:		Surveyor:	<b>Selasie Honu</b>	PSR:	<b>P-407-009-010</b>
Customer:		Clean Date:	<b>01/01/1900</b>	Shape:	<b>C</b>

Street:	<b>11th. Pl.</b>	Flow Control:	<b>Not Controlled</b>
City:	<b>Hobart, IN</b>	Year Renewed:	
Location:	<b>Light Highway</b>	Tape/Media #:	
Purpose:	<b>Routine Assessment</b>	Dia/Height:	<b>10"</b>
Use:	<b>Sanitary</b>	Material:	<b>PVC</b>
Drain Area:	<b>NA</b>	Lining:	
Category:	<b>NA</b>		
Comment:			
Location Details:		Direction of Survey:	<b>Downstream</b>
US MH:	<b>M-407-010</b>	DS MH:	<b>M-407-009</b>
		Total Length Surveyed (ft):	<b>123.9</b>

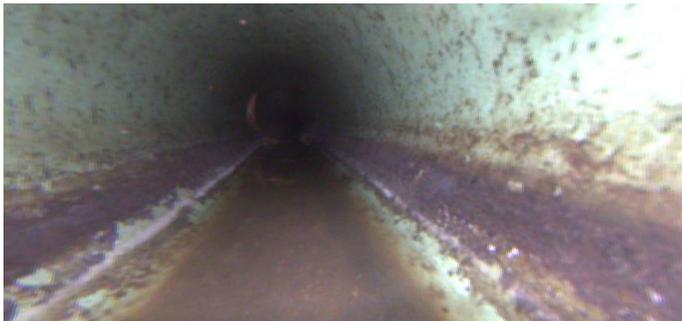
Code: **AMH**  
Description: **Manhole**

Distance (ft): **.0**  
Structural Grade: **0**  
O&M Grade: **0**  
Clock Start/From:  
Clock To:  
1st Value:  
2nd Value:  
Value Percent:  
Continuous Index:  
Within 8" of Joint: **NO**  
Remarks: **M-407-010**

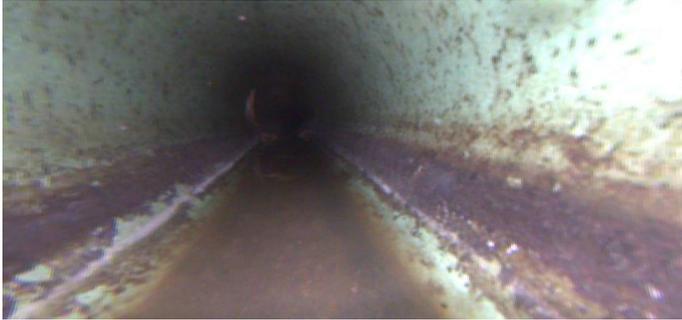
Code: **MWL**  
Description: **Water Level**

Distance (ft): **.0**  
Structural Grade: **0**  
O&M Grade: **0**  
Clock Start/From:  
Clock To:  
1st Value:  
2nd Value:  
Value Percent: **5.000**  
Continuous Index:  
Within 8" of Joint: **NO**  
Remarks:

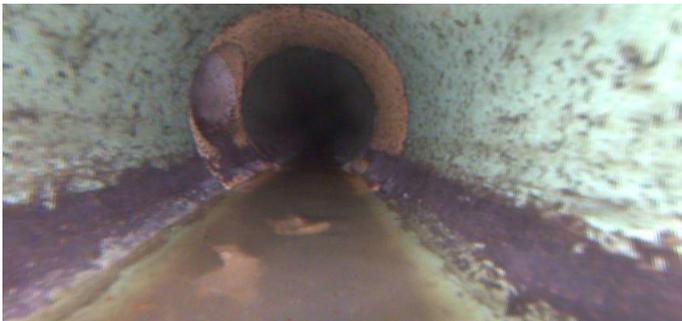
Code: **TF**  
Description: **Tap Factory**

Distance (ft): **3.5**  
Structural Grade: **0**  
O&M Grade: **0**  
Clock Start/From: **9**  
Clock To:  
1st Value: **4.000**  
2nd Value:  
Value Percent:  
Continuous Index:  
Within 8" of Joint:  
Remarks:

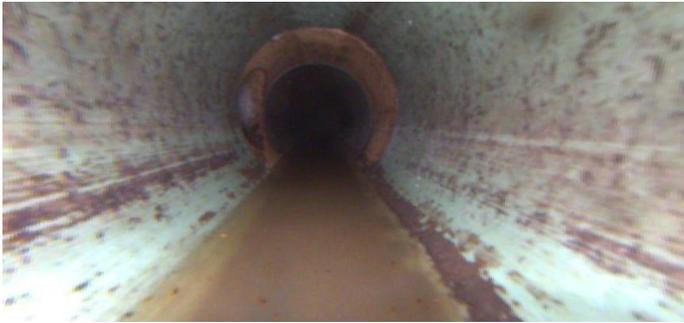
Code: **TF**  
Description: **Tap Factory**

Distance (ft): **61.8**  
Structural Grade: **0**  
O&M Grade: **0**  
Clock Start/From: **9**  
Clock To:  
1st Value: **4.000**  
2nd Value:  
Value Percent:  
Continuous Index:  
Within 8" of Joint:  
Remarks:

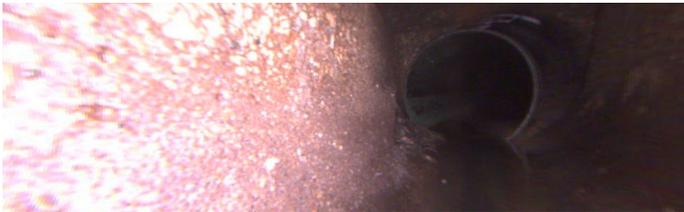
Code: **AMH**  
Description: **Manhole**

Distance (ft): **123.9**  
Structural Grade: **0**  
O&M Grade: **0**  
Clock Start/From:  
Clock To:  
1st Value:  
2nd Value:  
Value Percent:  
Continuous Index:  
Within 8" of Joint: **NO**  
Remarks: **M-407-009**
