Profile/Photo Observation Report

Date:	03/28/2018	Weather:		Coding:	PACP 6.0
Pipe Length (ft):	341.1	Owner:	NA	Pre Clean:	No Pre-Cleaning
P.O.#:		Surveyor:	Selasie Honu	PSR:	P-407-011-012
Customer:		Clean Date:	01/01/1900	Shape:	C

Street:	W 11TH PL	Flow Control:	Not Controlled
City:	Hobart, IN	Year Renewed:	
Location:	Light Highway	Tape/Media #:	
Purpose:	Routine Assessment	Dia/Height:	10"
Use:	Sanitary	Material:	PVC
Drain Area:	NA	Lining:	
Category:	NA		
Comment:	Flow direction wrong

Location Details:		Direction of Survey:	Upstream
US MH:	M-407-012	DS MH:	M-4074-011
		Total Length Surveyed (ft):	338.8

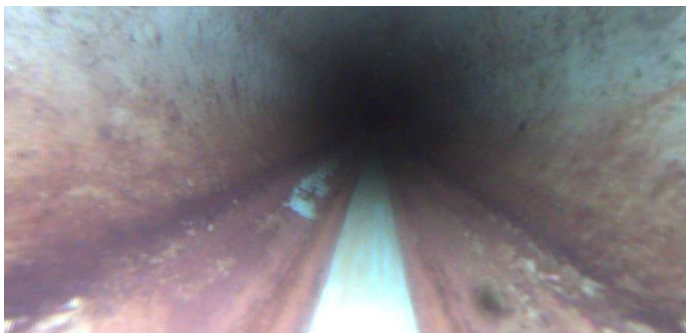
Code: **AMH**
Description: **Manhole**

Distance (ft): **.0**
Structural Grade: **0**
O&M Grade: **0**
Clock Start/From:
Clock To:
1st Value:
2nd Value:
Value Percent:
Continuous Index:
Within 8" of Joint: **NO**
Remarks: **M-4074-011**

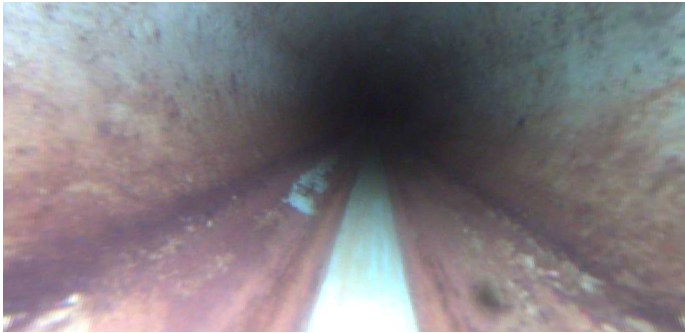
Code:	MWL
Description:	Water Level

Distance (ft):	.0
Structural Grade:	0
O&M Grade:	0
Clock Start/From:	
Clock To:	
1st Value:	
2nd Value:	
Value Percent:	5.000
Continuous Index:	
Within 8" of Joint:	NO
Remarks:

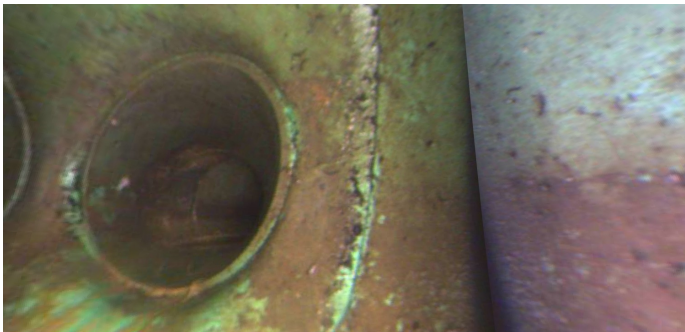
Code:	TF
Description:	Tap Factory

Distance (ft):	58.3
Structural Grade:	0
O&M Grade:	0
Clock Start/From:	9
Clock To:	
1st Value:	4.000
2nd Value:	
Value Percent:	
Continuous Index:	
Within 8" of Joint:	
Remarks:

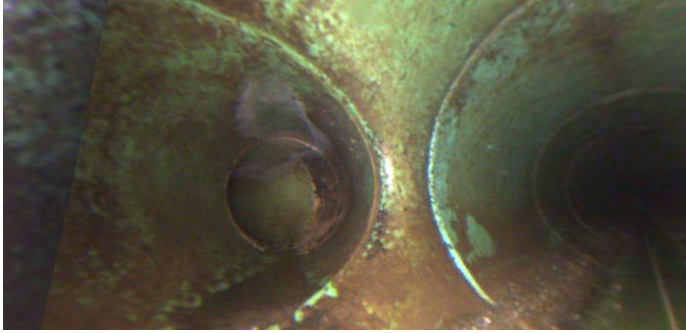
Code: **TF**
Description: **Tap Factory**

Distance (ft): **60.1**
Structural Grade: **0**
O&M Grade: **0**
Clock Start/From: **3**
Clock To:
1st Value: **4.000**
2nd Value:
Value Percent:
Continuous Index:
Within 8" of Joint:
Remarks:

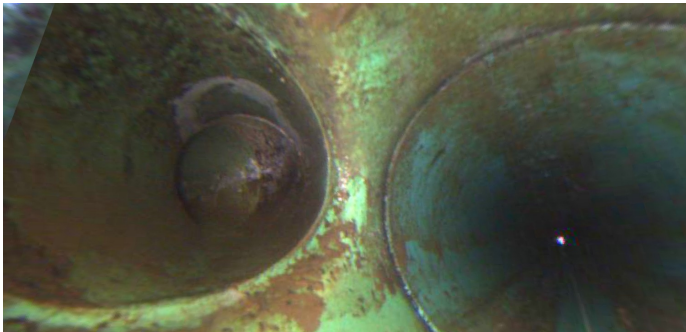
Code: **TF**
Description: **Tap Factory**

Distance (ft): **152.9**
Structural Grade: **0**
O&M Grade: **0**
Clock Start/From: **3**
Clock To:
1st Value: **4.000**
2nd Value:
Value Percent:
Continuous Index:
Within 8" of Joint:
Remarks:

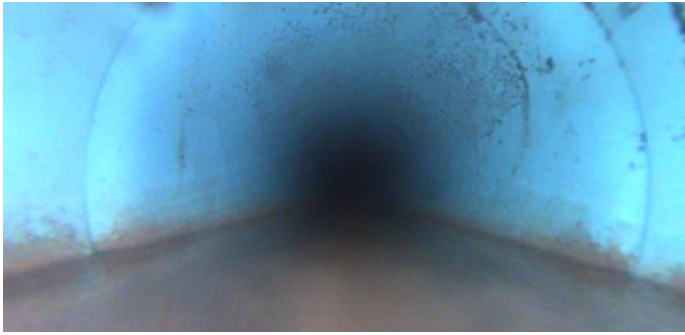
Code: **MWL**
Description: **Water Level**

Distance (ft): **187.2**
Structural Grade: **0**
O&M Grade: **0**
Clock Start/From:
Clock To:
1st Value:
2nd Value:
Value Percent: **40.000**
Continuous Index:
Within 8" of Joint: **NO**
Remarks:

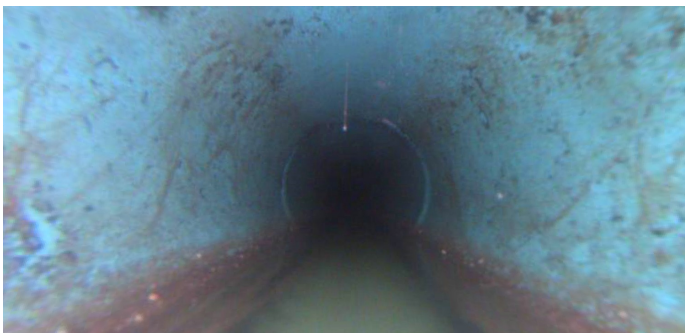
Code: **MWL**
Description: **Water Level**

Distance (ft): **224.4**
Structural Grade: **0**
O&M Grade: **0**
Clock Start/From:
Clock To:
1st Value:
2nd Value:
Value Percent: **5.000**
Continuous Index:
Within 8" of Joint: **NO**
Remarks:

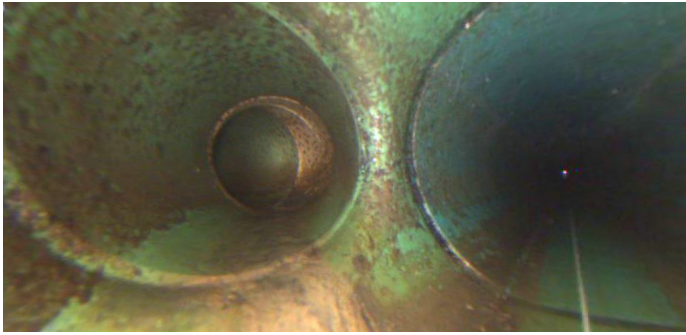
Code: **TF**
Description: **Tap Factory**

Distance (ft): **239.7**
Structural Grade: **0**
O&M Grade: **0**
Clock Start/From: **3**
Clock To:
1st Value: **4.000**
2nd Value:
Value Percent:
Continuous Index:
Within 8" of Joint:
Remarks:

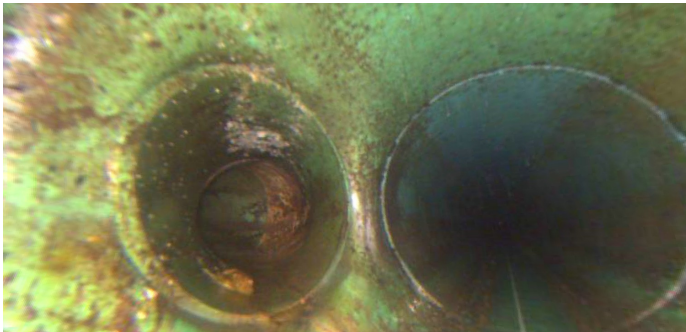
Code: **TF**
Description: **Tap Factory**

Distance (ft): **279.2**
Structural Grade: **0**
O&M Grade: **0**
Clock Start/From: **3**
Clock To:
1st Value: **4.000**
2nd Value:
Value Percent:
Continuous Index:
Within 8" of Joint:
Remarks:

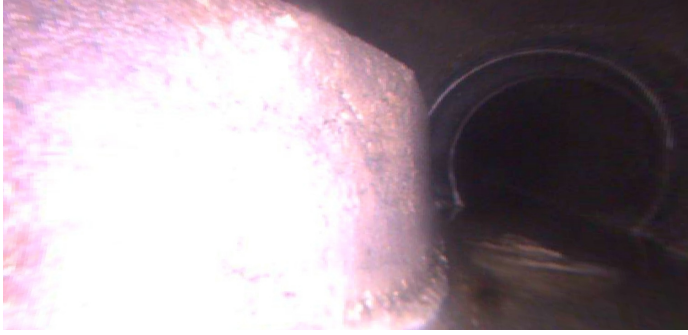
Code:	AMH
Description:	Manhole
Distance (ft):	338.8
Structural Grade:	0
O&M Grade:	0
Clock Start/From:	
Clock To:	
1st Value:	
2nd Value:	
Value Percent:	
Continuous Index:	
Within 8" of Joint:	NO
Remarks:	M-407-012
