## Profile/Photo Observation Report

Street:	<b>FOXCROFT STREET</b>	Flow Control:	<b>Not Controlled</b>
City:	<b>Hobart, IN</b>	Year Renewed:	
Location:	<b>Light Highway</b>	Tape/Media #:	
Purpose:	<b>Routine Assessment</b>	Dia/Height:	<b>10"</b>
Use:	<b>Sanitary</b>	Material:	<b>PVC</b>
Drain Area:	<b>NA</b>	Lining:	
Category:	<b>NA</b>		
Comment:	<b>Flow direction wrong</b>

Location Details:		Direction of Survey:	<b>Upstream</b>
US MH:	<b>M-407-012</b>	DS MH:	<b>M-4074-011</b>
		Total Length Surveyed (ft):	<b>338.8</b>

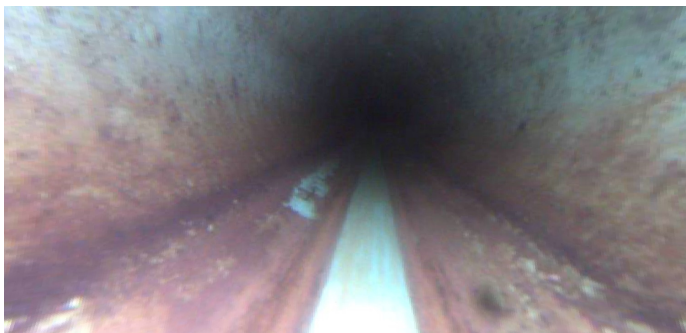
Code: **AMH**  
Description: **Manhole**

Distance (ft): **.0**  
Structural Grade: **0**  
O&M Grade: **0**  
Clock Start/From:  
Clock To:  
1st Value:  
2nd Value:  
Value Percent:  
Continuous Index:  
Within 8" of Joint: **NO**  
Remarks: **M-4074-011**

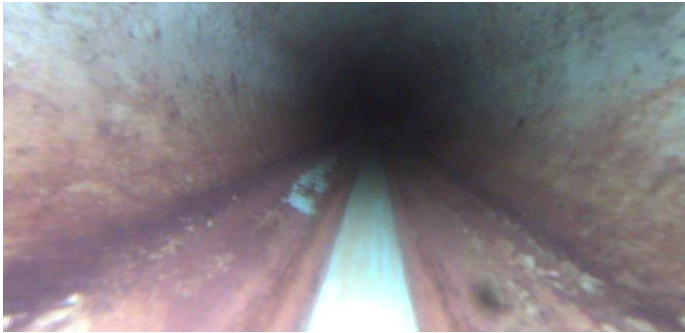
Code:	<b>MWL</b>
Description:	<b>Water Level</b>

Distance (ft):	<b>.0</b>
Structural Grade:	<b>0</b>
O&M Grade:	<b>0</b>
Clock Start/From:	
Clock To:	
1st Value:	
2nd Value:	
Value Percent:	<b>5.000</b>
Continuous Index:	
Within 8" of Joint:	<b>NO</b>
Remarks:

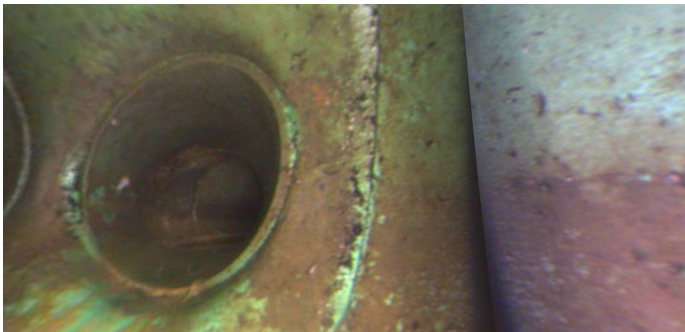
Code:	<b>TF</b>
Description:	<b>Tap Factory</b>

Distance (ft):	<b>58.3</b>
Structural Grade:	<b>0</b>
O&M Grade:	<b>0</b>
Clock Start/From:	<b>9</b>
Clock To:	
1st Value:	<b>4.000</b>
2nd Value:	
Value Percent:	
Continuous Index:	
Within 8" of Joint:	
Remarks:

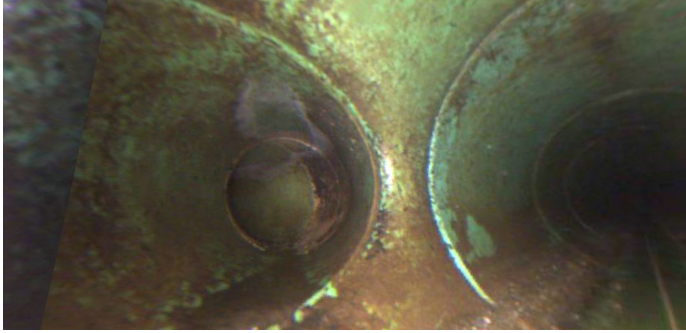
Code: **TF**  
Description: **Tap Factory**

Distance (ft): **60.1**  
Structural Grade: **0**  
O&M Grade: **0**  
Clock Start/From: **3**  
Clock To:  
1st Value: **4.000**  
2nd Value:  
Value Percent:  
Continuous Index:  
Within 8" of Joint:  
Remarks:

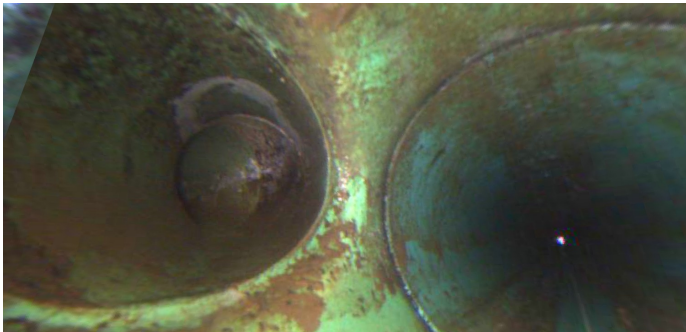
Code: **TF**  
Description: **Tap Factory**

Distance (ft): **152.9**  
Structural Grade: **0**  
O&M Grade: **0**  
Clock Start/From: **3**  
Clock To:  
1st Value: **4.000**  
2nd Value:  
Value Percent:  
Continuous Index:  
Within 8" of Joint:  
Remarks:

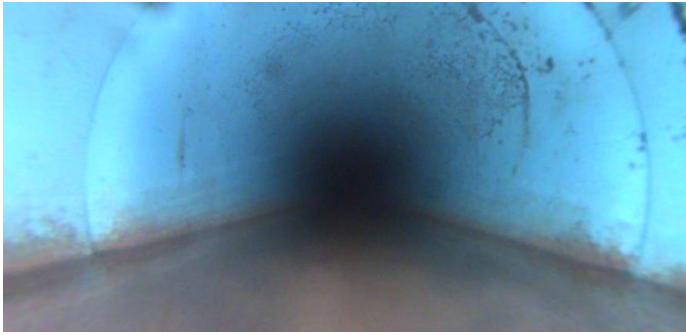
Code: **MWL**  
Description: **Water Level**

Distance (ft): **187.2**  
Structural Grade: **0**  
O&M Grade: **0**  
Clock Start/From:  
Clock To:  
1st Value:  
2nd Value:  
Value Percent: **40.000**  
Continuous Index:  
Within 8" of Joint: **NO**  
Remarks:

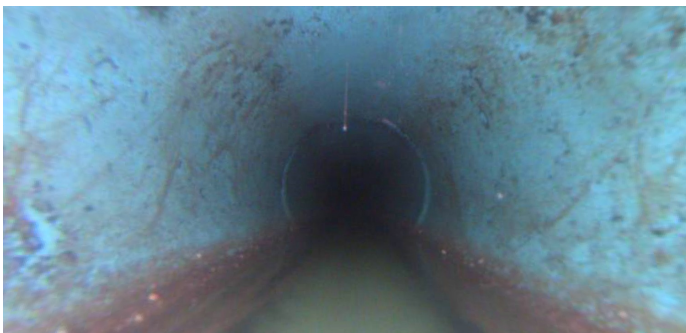
Code: **MWL**  
Description: **Water Level**

Distance (ft): **224.4**  
Structural Grade: **0**  
O&M Grade: **0**  
Clock Start/From:  
Clock To:  
1st Value:  
2nd Value:  
Value Percent: **5.000**  
Continuous Index:  
Within 8" of Joint: **NO**  
Remarks:

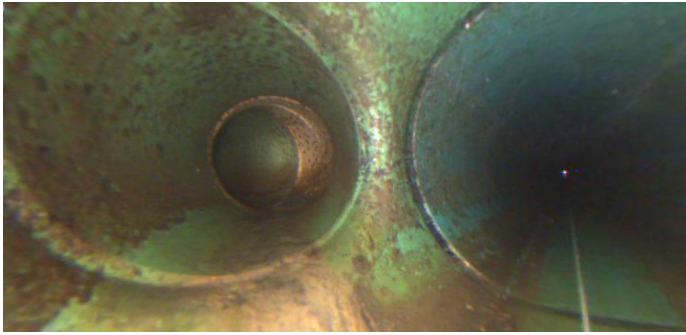
Code: **TF**  
Description: **Tap Factory**

Distance (ft): **239.7**  
Structural Grade: **0**  
O&M Grade: **0**  
Clock Start/From: **3**  
Clock To:  
1st Value: **4.000**  
2nd Value:  
Value Percent:  
Continuous Index:  
Within 8" of Joint:  
Remarks:

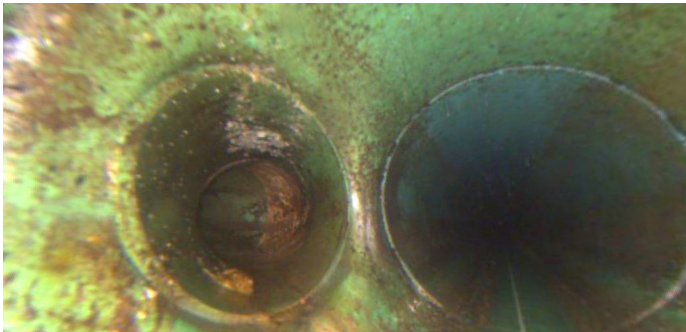
Code: **TF**  
Description: **Tap Factory**

Distance (ft): **279.2**  
Structural Grade: **0**  
O&M Grade: **0**  
Clock Start/From: **3**  
Clock To:  
1st Value: **4.000**  
2nd Value:  
Value Percent:  
Continuous Index:  
Within 8" of Joint:  
Remarks:

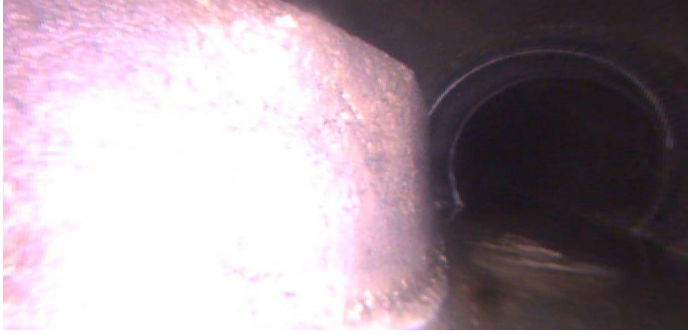
Code:	<b>AMH</b>
Description:	<b>Manhole</b>
Distance (ft):	<b>338.8</b>
Structural Grade:	<b>0</b>
O&M Grade:	<b>0</b>
Clock Start/From:	
Clock To:	
1st Value:	
2nd Value:	
Value Percent:	
Continuous Index:	
Within 8" of Joint:	<b>NO</b>
Remarks:	<b>M-407-012</b>
