Profile/Photo Observation Report

Street:	W 11TH PL	Flow Control:	Not Controlled
City:	Hobart, IN	Year Renewed:	
Location:	Light Highway	Tape/Media #:	
Purpose:	Routine Assessment	Dia/Height:	10"
Use:	Sanitary	Material:	PVC
Drain Area:	NA	Lining:	
Category:	NA		
Comment:	Flow direction wrong

Location Details:		Direction of Survey:	Upstream
US MH:	M-407-013	DS MH:	M-407-012
		Total Length Surveyed (ft):	175.1

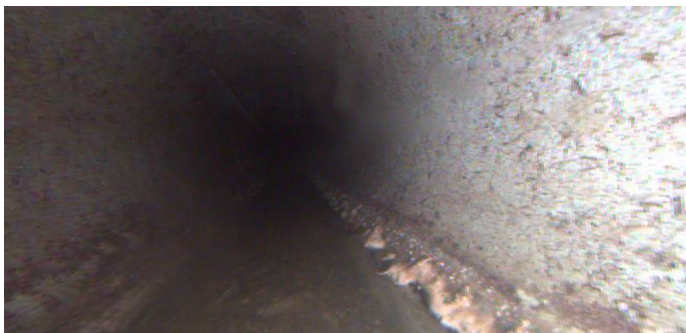
Code: **AMH**
Description: **Manhole**

Distance (ft): **.0**
Structural Grade: **0**
O&M Grade: **0**
Clock Start/From:
Clock To:
1st Value:
2nd Value:
Value Percent:
Continuous Index:
Within 8" of Joint: **NO**
Remarks: **M-407-012**

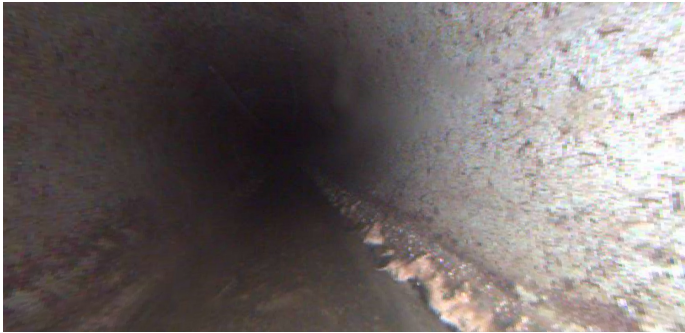
Code:	MWL
Description:	Water Level

Distance (ft):	.0
Structural Grade:	0
O&M Grade:	0
Clock Start/From:	
Clock To:	
1st Value:	
2nd Value:	
Value Percent:	5.000
Continuous Index:	
Within 8" of Joint:	NO
Remarks:

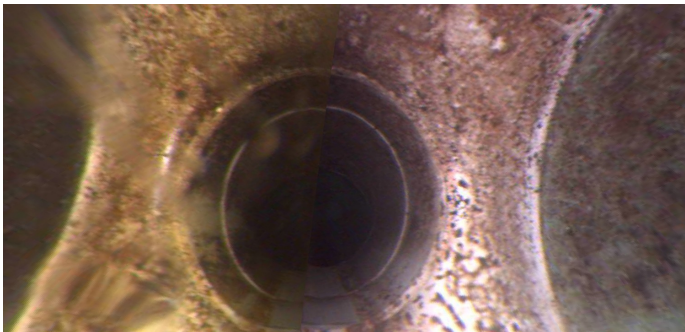
Code:	TF
Description:	Tap Factory

Distance (ft):	75.2
Structural Grade:	0
O&M Grade:	0
Clock Start/From:	10
Clock To:	
1st Value:	4.000
2nd Value:	
Value Percent:	
Continuous Index:	
Within 8" of Joint:	
Remarks:

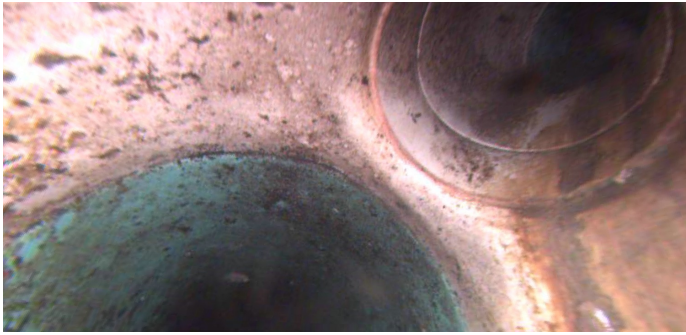
Code: **TF**
Description: **Tap Factory**

Distance (ft): **77.3**
Structural Grade: **0**
O&M Grade: **0**
Clock Start/From: **1**
Clock To:
1st Value: **4.000**
2nd Value:
Value Percent:
Continuous Index:
Within 8" of Joint:
Remarks:

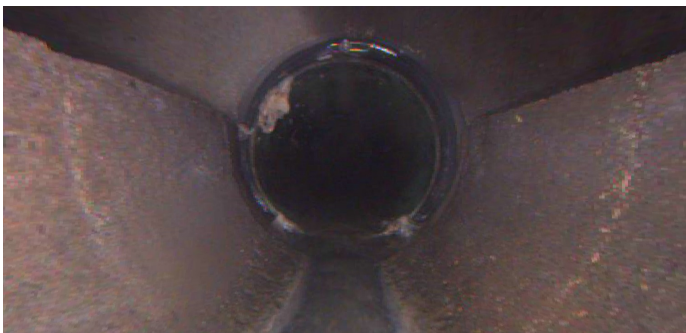
Code: **AMH**
Description: **Manhole**

Distance (ft): **175.1**
Structural Grade: **0**
O&M Grade: **0**
Clock Start/From:
Clock To:
1st Value:
2nd Value:
Value Percent:
Continuous Index:
Within 8" of Joint: **NO**
Remarks: **M-407-013**
