## Profile/Photo Observation Report

Date:	<b>03/28/2018</b>	Weather:		Coding:	<b>PACP 6.0</b>
Pipe Length (ft):	<b>179.2</b>	Owner:	<b>NA</b>	Pre Clean:	<b>No Pre-Cleaning</b>
P.O.#:		Surveyor:	<b>Selasie Honu</b>	PSR:	<b>P-407-012-013</b>
Customer:		Clean Date:	<b>01/01/1900</b>	Shape:	<b>C</b>

Street:	<b>FOXCROFT STREET</b>	Flow Control:	<b>Not Controlled</b>
City:	<b>Hobart, IN</b>	Year Renewed:	
Location:	<b>Light Highway</b>	Tape/Media #:	
Purpose:	<b>Routine Assessment</b>	Dia/Height:	<b>10"</b>
Use:	<b>Sanitary</b>	Material:	<b>PVC</b>
Drain Area:	<b>NA</b>	Lining:	
Category:	<b>NA</b>		
Comment:	<b>Flow direction wrong</b>

Location Details:		Direction of Survey:	<b>Upstream</b>
US MH:	<b>M-407-013</b>	DS MH:	<b>M-407-012</b>
		Total Length Surveyed (ft):	<b>175.1</b>

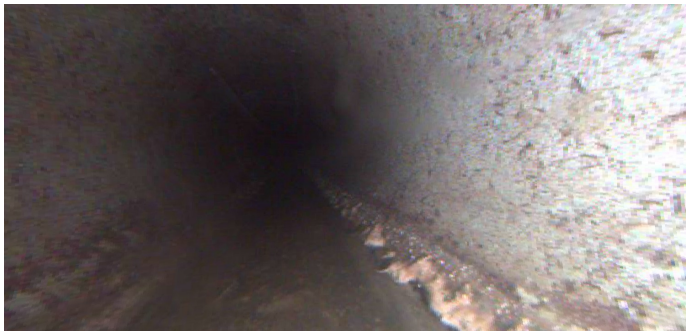
Code: **AMH**  
Description: **Manhole**

Distance (ft): **.0**  
Structural Grade: **0**  
O&M Grade: **0**  
Clock Start/From:  
Clock To:  
1st Value:  
2nd Value:  
Value Percent:  
Continuous Index:  
Within 8" of Joint: **NO**  
Remarks: **M-407-012**

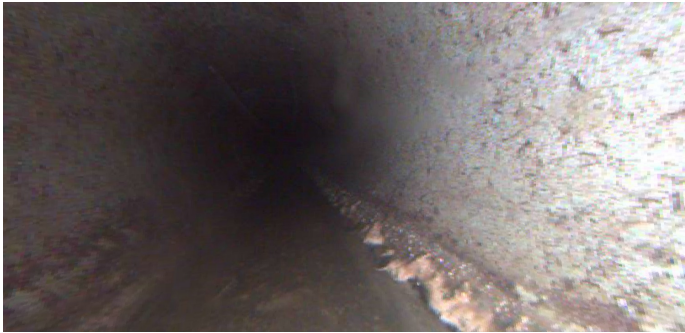
Code:	<b>MWL</b>
Description:	<b>Water Level</b>

Distance (ft):	<b>.0</b>
Structural Grade:	<b>0</b>
O&M Grade:	<b>0</b>
Clock Start/From:	
Clock To:	
1st Value:	
2nd Value:	
Value Percent:	<b>5.000</b>
Continuous Index:	
Within 8" of Joint:	<b>NO</b>
Remarks:

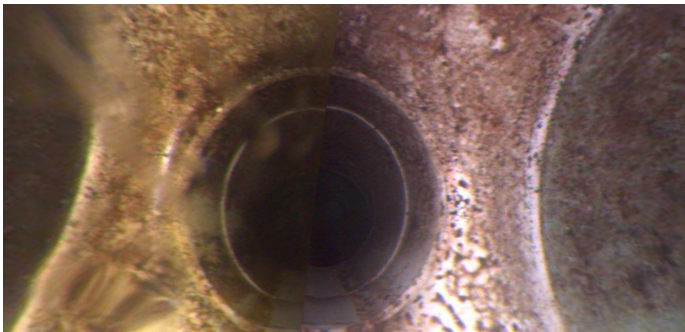
Code:	<b>TF</b>
Description:	<b>Tap Factory</b>

Distance (ft):	<b>75.2</b>
Structural Grade:	<b>0</b>
O&M Grade:	<b>0</b>
Clock Start/From:	<b>10</b>
Clock To:	
1st Value:	<b>4.000</b>
2nd Value:	
Value Percent:	
Continuous Index:	
Within 8" of Joint:	
Remarks:

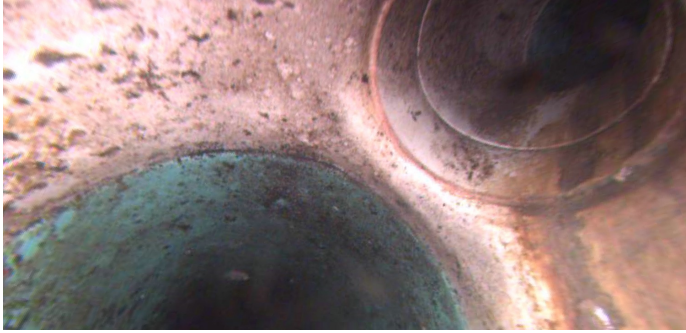
Code: **TF**  
Description: **Tap Factory**

Distance (ft): **77.3**  
Structural Grade: **0**  
O&M Grade: **0**  
Clock Start/From: **1**  
Clock To:  
1st Value: **4.000**  
2nd Value:  
Value Percent:  
Continuous Index:  
Within 8" of Joint:  
Remarks:

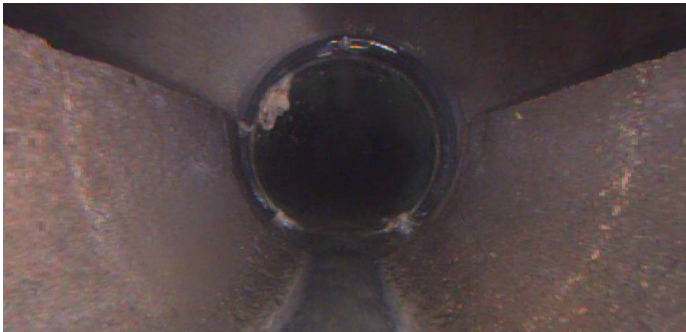
Code: **AMH**  
Description: **Manhole**

Distance (ft): **175.1**  
Structural Grade: **0**  
O&M Grade: **0**  
Clock Start/From:  
Clock To:  
1st Value:  
2nd Value:  
Value Percent:  
Continuous Index:  
Within 8" of Joint: **NO**  
Remarks: **M-407-013**
