Profile/Photo Observation Report

Date:	10/08/2018	Weather:		Coding:	PACP 6.0
Pipe Length (ft):	331.8	Owner:	NA	Pre Clean:	Not Known
P.O.#:		Surveyor:	Selasie Honu	PSR:	P-407-010-011
Customer:		Clean Date:	01/01/1900	Shape:	C

Street:	W 11TH PL	Flow Control:	Not Controlled
City:	Hobart, IN	Year Renewed:	
Location:	Light Highway	Tape/Media #:	
Purpose:	Routine Assessment	Dia/Height:	10"
Use:	Sanitary	Material:	PVC
Drain Area:	NA	Lining:	
Category:	NA		
Comment:

Location Details:		Direction of Survey:	Upstream
US MH:	M-4074-011	DS MH:	M-407-010
		Total Length Surveyed (ft):	341.8

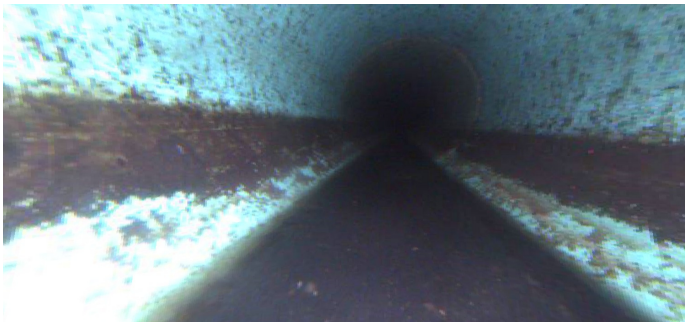
Code: **AMH**
Description: **Manhole**

Distance (ft): **.0**
Structural Grade: **0**
O&M Grade: **0**
Clock Start/From:
Clock To:
1st Value:
2nd Value:
Value Percent:
Continuous Index:
Within 8" of Joint: **NO**
Remarks: **M-407-010**

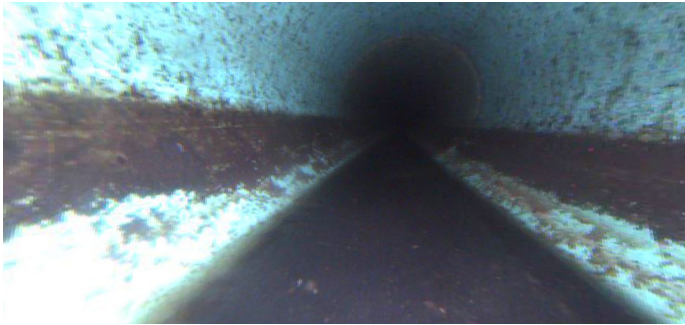
Code:	MWL
Description:	Water Level

Distance (ft):	.0
Structural Grade:	0
O&M Grade:	0
Clock Start/From:	
Clock To:	
1st Value:	
2nd Value:	
Value Percent:	5.000
Continuous Index:	
Within 8" of Joint:	NO
Remarks:

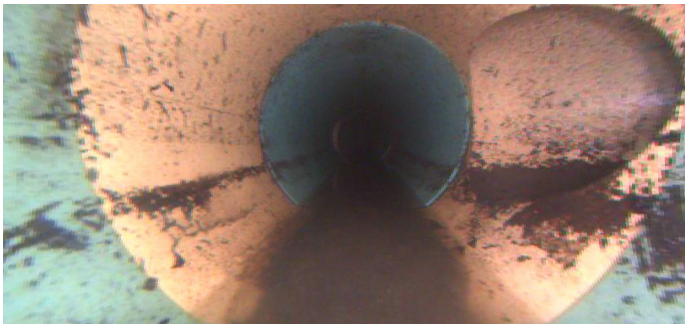
Code:	TF
Description:	Tap Factory

Distance (ft):	94.6
Structural Grade:	0
O&M Grade:	0
Clock Start/From:	3
Clock To:	
1st Value:	4.000
2nd Value:	
Value Percent:	
Continuous Index:	
Within 8" of Joint:	
Remarks:

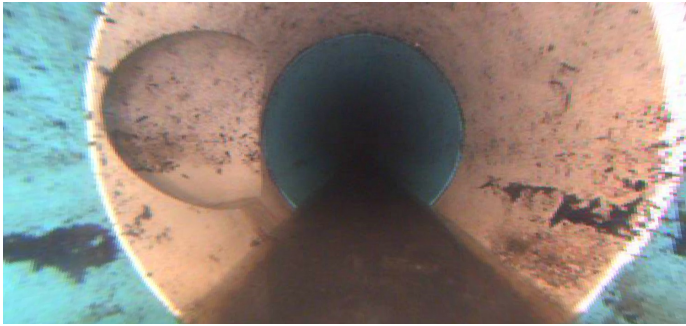
Code: **TF**
Description: **Tap Factory**

Distance (ft): **97.8**
Structural Grade: **0**
O&M Grade: **0**
Clock Start/From: **9**
Clock To:
1st Value: **4.000**
2nd Value:
Value Percent:
Continuous Index:
Within 8" of Joint:
Remarks:

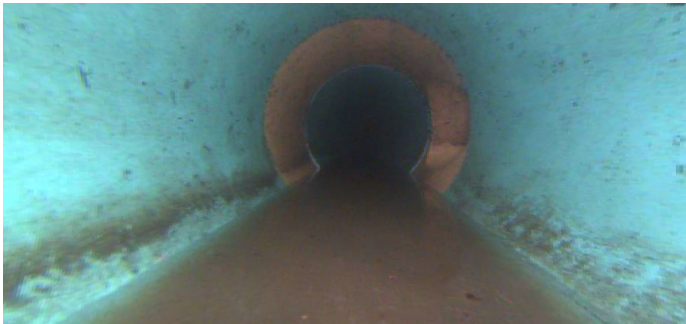
Code: **TF**
Description: **Tap Factory**

Distance (ft): **150.0**
Structural Grade: **0**
O&M Grade: **0**
Clock Start/From: **3**
Clock To:
1st Value: **4.000**
2nd Value:
Value Percent:
Continuous Index:
Within 8" of Joint:
Remarks:

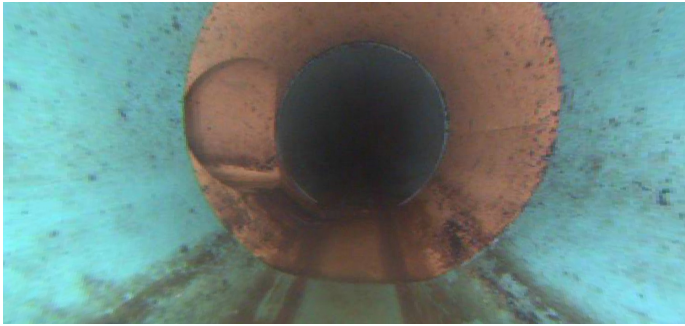
Code: **TF**
Description: **Tap Factory**

Distance (ft): **158.6**
Structural Grade: **0**
O&M Grade: **0**
Clock Start/From: **9**
Clock To:
1st Value: **4.000**
2nd Value:
Value Percent:
Continuous Index:
Within 8" of Joint:
Remarks:

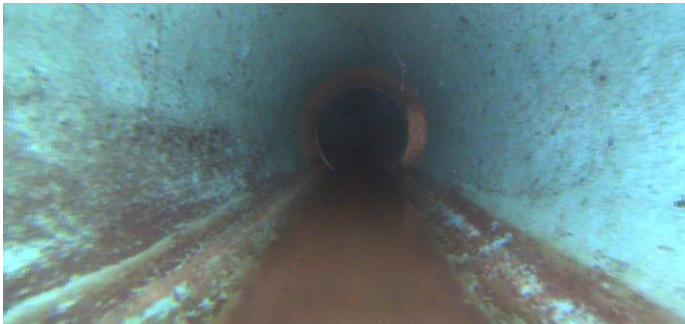
Code: **TF**
Description: **Tap Factory**

Distance (ft): **249.2**
Structural Grade: **0**
O&M Grade: **0**
Clock Start/From: **3**
Clock To:
1st Value: **4.000**
2nd Value:
Value Percent:
Continuous Index:
Within 8" of Joint:
Remarks:

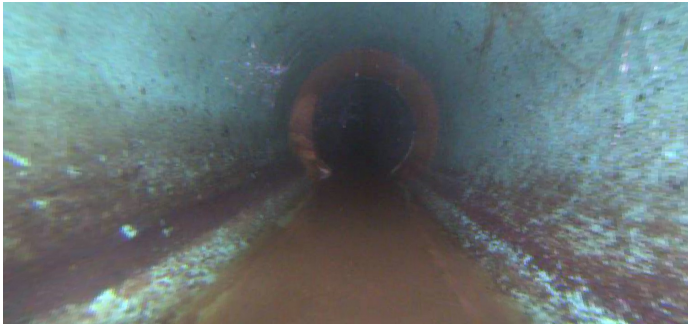
Code: **TF**
Description: **Tap Factory**

Distance (ft): **253.1**
Structural Grade: **0**
O&M Grade: **0**
Clock Start/From: **9**
Clock To:
1st Value: **4.000**
2nd Value:
Value Percent:
Continuous Index:
Within 8" of Joint:
Remarks:

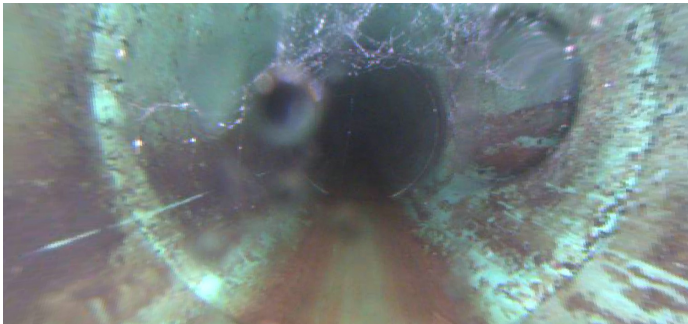
Code: **TF**
Description: **Tap Factory**

Distance (ft): **302.7**
Structural Grade: **0**
O&M Grade: **0**
Clock Start/From: **3**
Clock To:
1st Value: **4.000**
2nd Value:
Value Percent:
Continuous Index:
Within 8" of Joint:
Remarks:

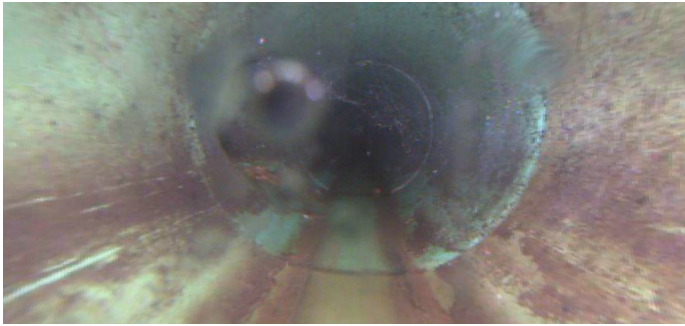
Code: **TF**
Description: **Tap Factory**

Distance (ft): **308.2**
Structural Grade: **0**
O&M Grade: **0**
Clock Start/From: **9**
Clock To:
1st Value: **4.000**
2nd Value:
Value Percent:
Continuous Index:
Within 8" of Joint:
Remarks:

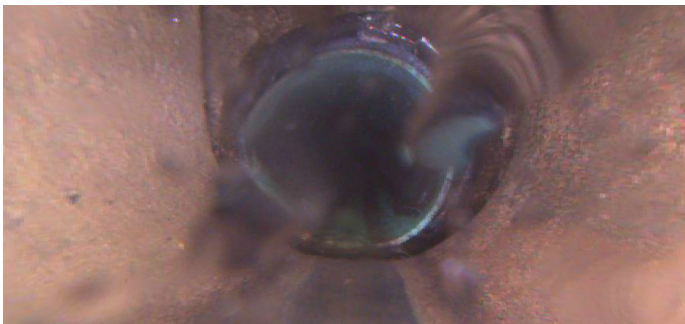
Code: **AMH**
Description: **Manhole**

Distance (ft): **341.8**
Structural Grade: **0**
O&M Grade: **0**
Clock Start/From:
Clock To:
1st Value:
2nd Value:
Value Percent:
Continuous Index:
Within 8" of Joint: **NO**
Remarks: **M-4074-011**
