Profile/Photo Observation Report

Date:	10/08/2018	Weather:		Coding:	PACP 6.0
Pipe Length (ft):	331.8	Owner:	NA	Pre Clean:	Not Known
P.O.#:		Surveyor:	Selasie Honu	PSR:	P-407-010-011
Customer:		Clean Date:	01/01/1900	Shape:	C

Street:	11th. Pl.	Flow Control:	Not Controlled
City:	Hobart, IN	Year Renewed:	
Location:	Light Highway	Tape/Media #:	
Purpose:	Routine Assessment	Dia/Height:	10"
Use:	Sanitary	Material:	PVC
Drain Area:	NA	Lining:	
Category:	NA		
Comment:

Location Details:		Direction of Survey:	Upstream
US MH:	M-4074-011	DS MH:	M-407-010
		Total Length Surveyed (ft):	341.8

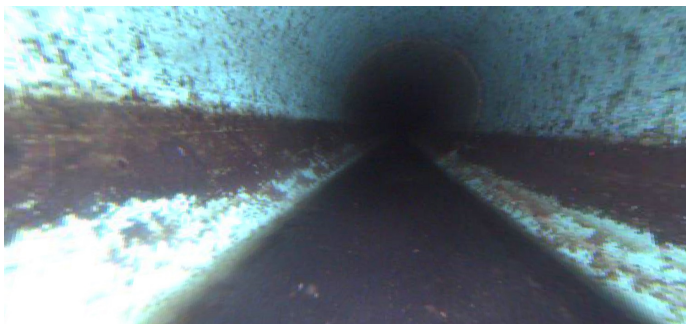
Code: **AMH**
Description: **Manhole**

Distance (ft): **.0**
Structural Grade: **0**
O&M Grade: **0**
Clock Start/From:
Clock To:
1st Value:
2nd Value:
Value Percent:
Continuous Index:
Within 8" of Joint: **NO**
Remarks: **M-407-010**

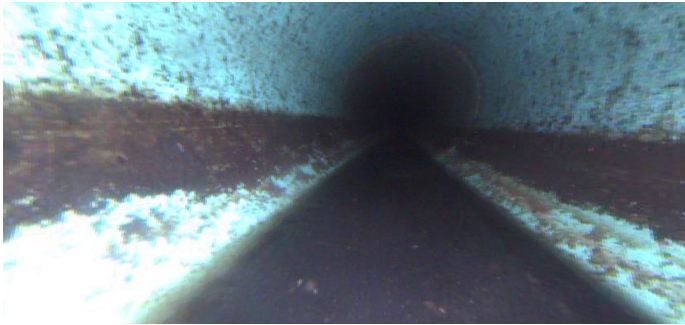
Code:	MWL
Description:	Water Level

Distance (ft):	.0
Structural Grade:	0
O&M Grade:	0
Clock Start/From:	
Clock To:	
1st Value:	
2nd Value:	
Value Percent:	5.000
Continuous Index:	
Within 8" of Joint:	NO
Remarks:

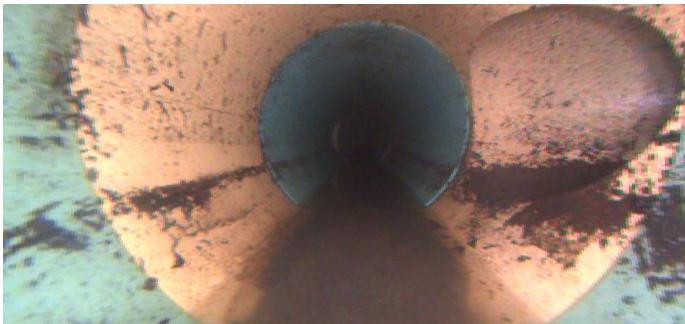
Code:	TF
Description:	Tap Factory

Distance (ft):	94.6
Structural Grade:	0
O&M Grade:	0
Clock Start/From:	3
Clock To:	
1st Value:	4.000
2nd Value:	
Value Percent:	
Continuous Index:	
Within 8" of Joint:	
Remarks:

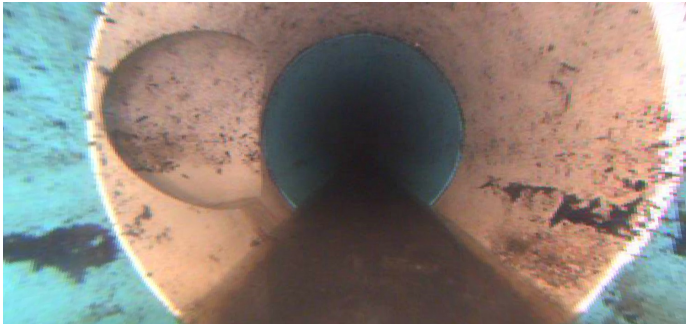
Code: **TF**
Description: **Tap Factory**

Distance (ft): **97.8**
Structural Grade: **0**
O&M Grade: **0**
Clock Start/From: **9**
Clock To:
1st Value: **4.000**
2nd Value:
Value Percent:
Continuous Index:
Within 8" of Joint:
Remarks:

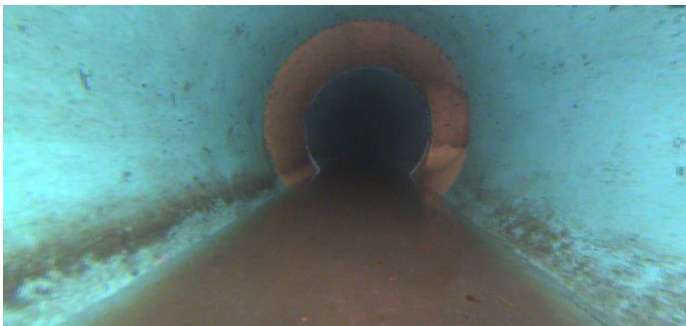
Code: **TF**
Description: **Tap Factory**

Distance (ft): **150.0**
Structural Grade: **0**
O&M Grade: **0**
Clock Start/From: **3**
Clock To:
1st Value: **4.000**
2nd Value:
Value Percent:
Continuous Index:
Within 8" of Joint:
Remarks:

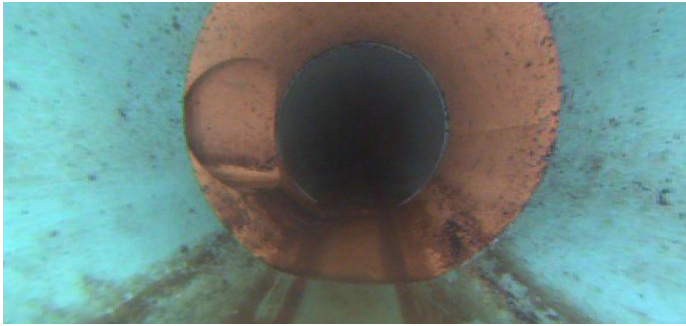
Code: **TF**
Description: **Tap Factory**

Distance (ft): **158.6**
Structural Grade: **0**
O&M Grade: **0**
Clock Start/From: **9**
Clock To:
1st Value: **4.000**
2nd Value:
Value Percent:
Continuous Index:
Within 8" of Joint:
Remarks:

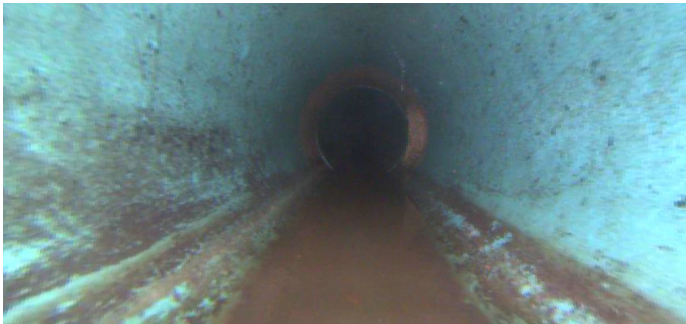
Code: **TF**
Description: **Tap Factory**

Distance (ft): **249.2**
Structural Grade: **0**
O&M Grade: **0**
Clock Start/From: **3**
Clock To:
1st Value: **4.000**
2nd Value:
Value Percent:
Continuous Index:
Within 8" of Joint:
Remarks:

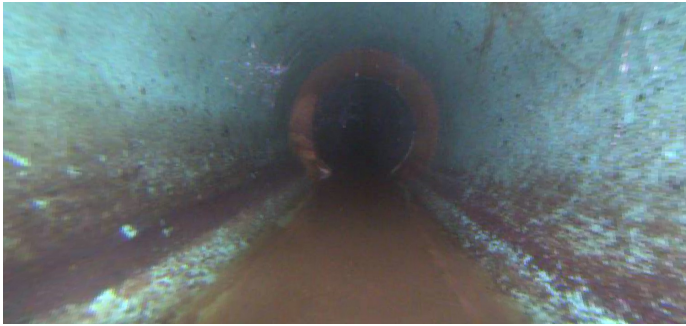
Code: **TF**
Description: **Tap Factory**

Distance (ft): **253.1**
Structural Grade: **0**
O&M Grade: **0**
Clock Start/From: **9**
Clock To:
1st Value: **4.000**
2nd Value:
Value Percent:
Continuous Index:
Within 8" of Joint:
Remarks:

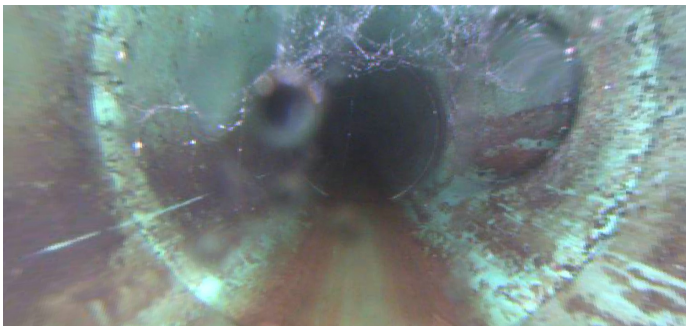
Code: **TF**
Description: **Tap Factory**

Distance (ft): **302.7**
Structural Grade: **0**
O&M Grade: **0**
Clock Start/From: **3**
Clock To:
1st Value: **4.000**
2nd Value:
Value Percent:
Continuous Index:
Within 8" of Joint:
Remarks:

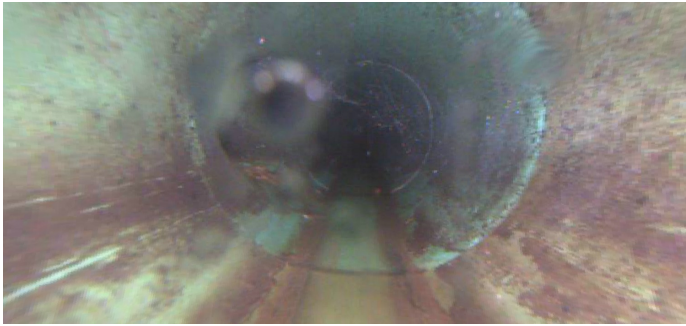
Code: **TF**
Description: **Tap Factory**

Distance (ft): **308.2**
Structural Grade: **0**
O&M Grade: **0**
Clock Start/From: **9**
Clock To:
1st Value: **4.000**
2nd Value:
Value Percent:
Continuous Index:
Within 8" of Joint:
Remarks:

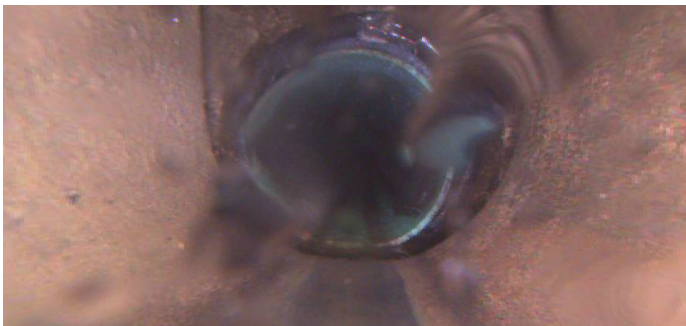
Code: **AMH**
Description: **Manhole**

Distance (ft): **341.8**
Structural Grade: **0**
O&M Grade: **0**
Clock Start/From:
Clock To:
1st Value:
2nd Value:
Value Percent:
Continuous Index:
Within 8" of Joint: **NO**
Remarks: **M-4074-011**
