Profile/Photo Observation Report

Street:	Off Wisconsin Street	Flow Control:	
City:	Hobart, IN	Year Renewed:	
Location:	Alley	Tape/Media #:	882
Purpose:	Routine Assessment	Dia/Height:	10"
Use:	Sanitary	Material:	VCP
Drain Area:		Lining:

US MH: **M-503-4** DS MH: **M-503-5** Total Length Surveyed (ft): **1.0**

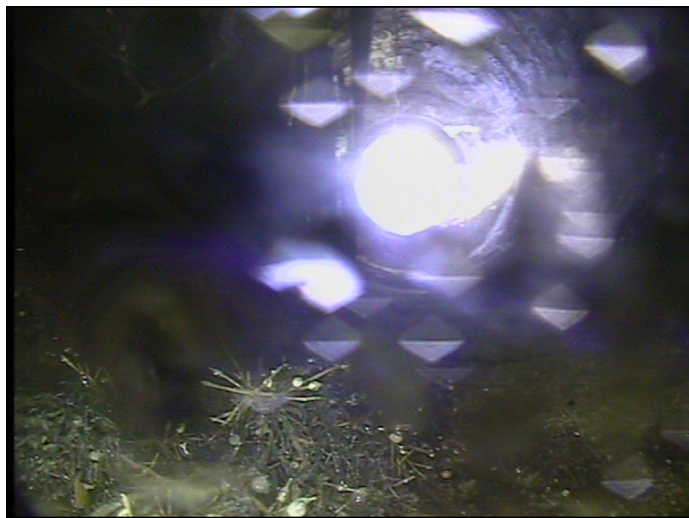
Code: **AMH**
Description: **Manhole**

Distance (ft): **.0**
Structural Grade: **0**
O&M Grade: **0**
Clock Start/From:
Clock To:
1st Value:
2nd Value:
Value Percent:
Continuous Index:
Within 8" of Joint: **NO**
Remarks: **M-503-5**

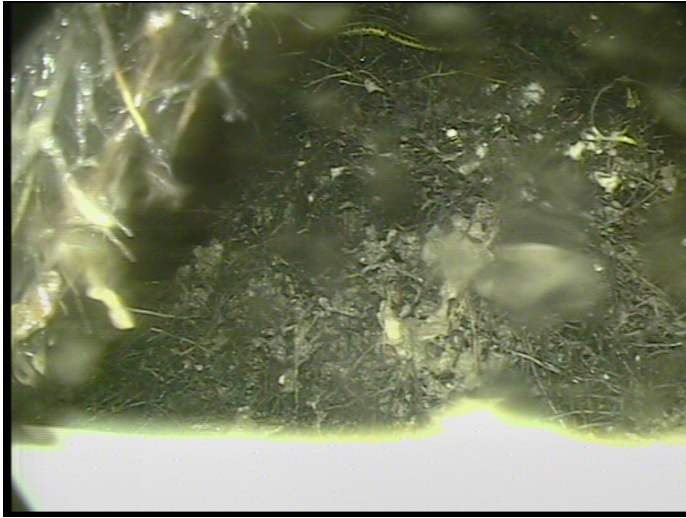
Code: **MWL**
Description: **Water Level**

Distance (ft): **.0**
Structural Grade: **0**
O&M Grade: **0**
Clock Start/From:
Clock To:
1st Value:
2nd Value:
Value Percent: **20.000**
Continuous Index:
Within 8" of Joint: **NO**
Remarks:

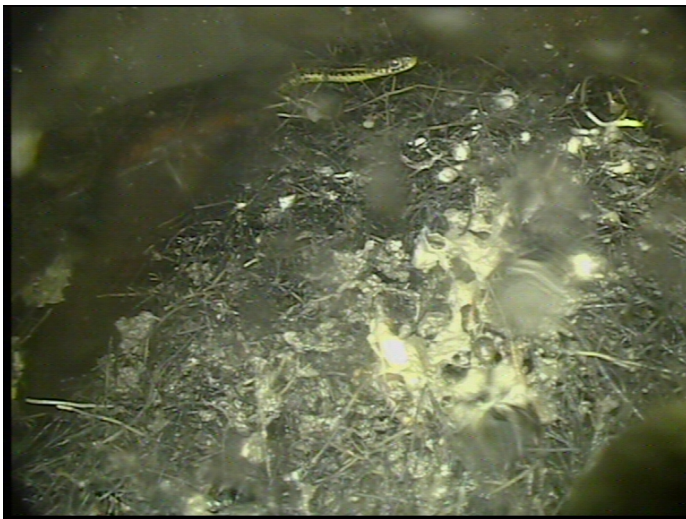
Code: **RBJ**
Description: **Roots Ball Joint**

Distance (ft): **1.0**
Structural Grade: **0**
O&M Grade: **4**
Clock Start/From: **8**
Clock To: **4**
1st Value:
2nd Value:
Value Percent: **55.000**
Continuous Index:
Within 8" of Joint: **YES**
Remarks:

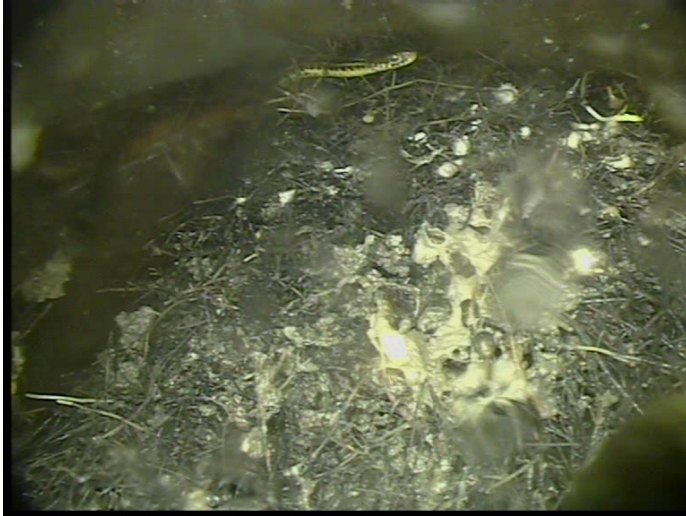
Code: **VZ**
Description: **Vermin Other**

Distance (ft): **1.0**
Structural Grade: **0**
O&M Grade: **1**
Clock Start/From:
Clock To:
1st Value: **1.000**
2nd Value:
Value Percent:
Continuous Index:
Within 8" of Joint: **NO**
Remarks: **Snake**

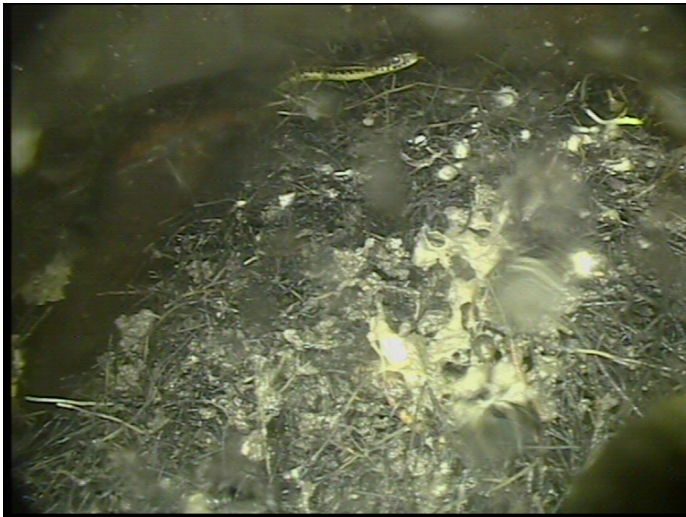
Code: **MSA**
Description: **Abandoned Survey**

Distance (ft): **1.0**
Structural Grade: **0**
O&M Grade: **0**
Clock Start/From:
Clock To:
1st Value:
2nd Value:
Value Percent:
Continuous Index:
Within 8" of Joint: **NO**
Remarks: **Large root ball**
