Profile/Photo Observation Report

Date:	10/22/2021	Weather:		Coding:	PACP 7.0
Pipe Length (ft):	146.9	Owner:	City of Hobart	Pre Clean:	Heavy Cleaning
P.O.#:	YES502259	Surveyor:	S. Bucklin	PSR:	P-503-005-004
Customer:	City of Hobart	Clean Date:	10/21/2021	Shape:	C

Street:	West 40th Place	Flow Control:	Not Controlled
City:	Hobart, IN	Year Renewed:	
Location:	Alley	Tape/Media #:	
Purpose:	Routine Assessment	Dia/Height:	12"
Use:	Sanitary Sewage Pipe	Material:	VCP
Drain Area:		Lining:	None
Category:	NA

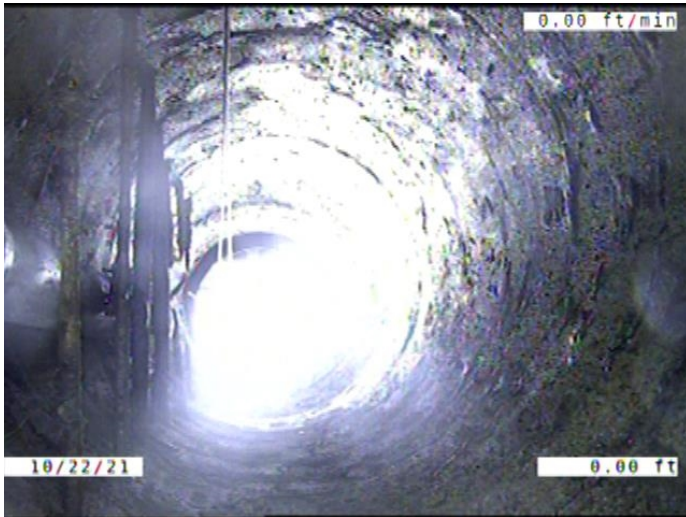
Code: **AMH**
 Description: **Manhole**

Distance (ft): **.0**
 Structural Grade: **0**
 O&M Grade: **0**
 Clock Start/From:
 Clock To:
 1st Value:
 2nd Value:
 Value Percent:
 Continuous Index:
 Within 8" of Joint: **NO**
 Remarks: **M-503-005**

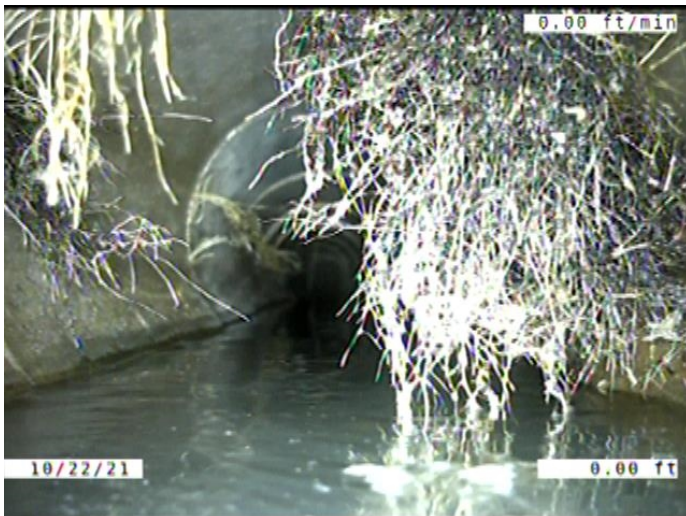
Code: **MWL**
 Description: **Miscellaneous Water Level**

Distance (ft): **.0**
 Structural Grade: **0**
 O&M Grade: **0**
 Clock Start/From:
 Clock To:
 1st Value:
 2nd Value:
 Value Percent: **10.000**
 Continuous Index:
 Within 8" of Joint: **NO**
 Remarks:

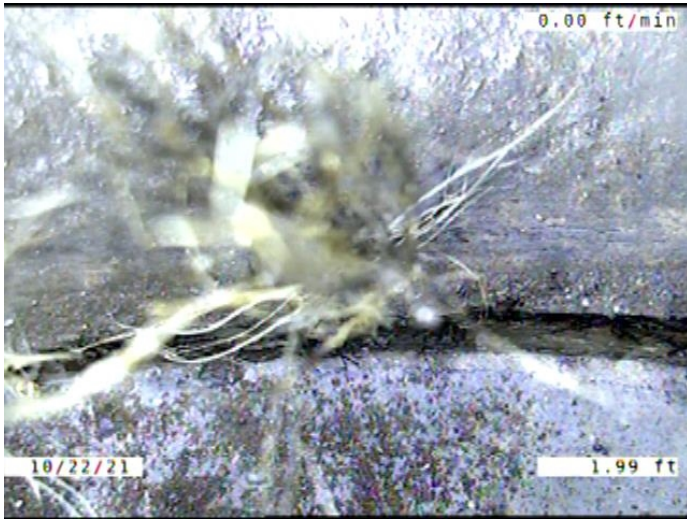
Code: **RFJ**
 Description: **Roots Fine Joint**

Distance (ft): **2.0**
 Structural Grade: **0**
 O&M Grade: **1**
 Clock Start/From: **8**
 Clock To: **4**
 1st Value:
 2nd Value:
 Value Percent:
 Continuous Index: **S01**
 Within 8" of Joint: **YES**
 Remarks:

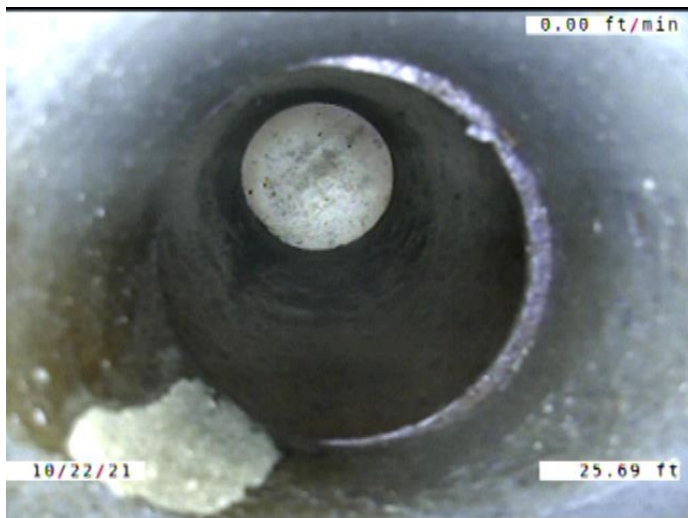
Code: **TFC**
Description: **Tap Factory Capped**

Distance (ft): **25.7**
Structural Grade: **0**
O&M Grade: **0**
Clock Start/From: **11**
Clock To:
1st Value: **4.000**
2nd Value:
Value Percent:
Continuous Index:
Within 8" of Joint: **YES**
Remarks:

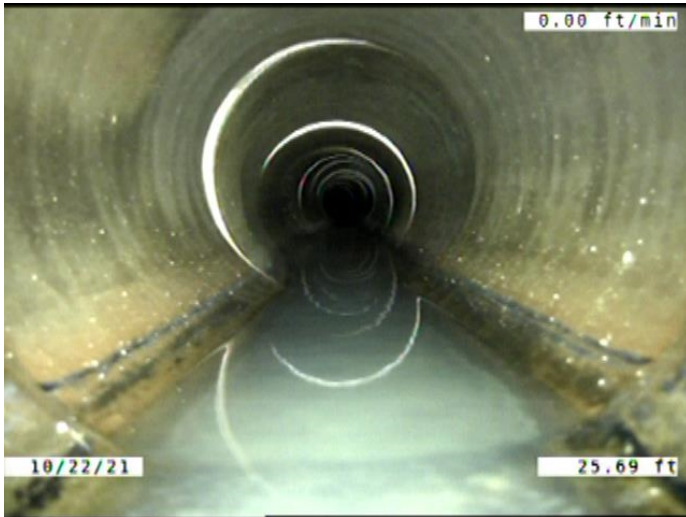
Code: **RFJ**
 Description: **Roots Fine Joint**

Distance (ft): **25.7**
 Structural Grade: **0**
 O&M Grade: **1**
 Clock Start/From: **8**
 Clock To: **4**
 1st Value:
 2nd Value:
 Value Percent:
 Continuous Index: **F01**
 Within 8" of Joint: **YES**
 Remarks:

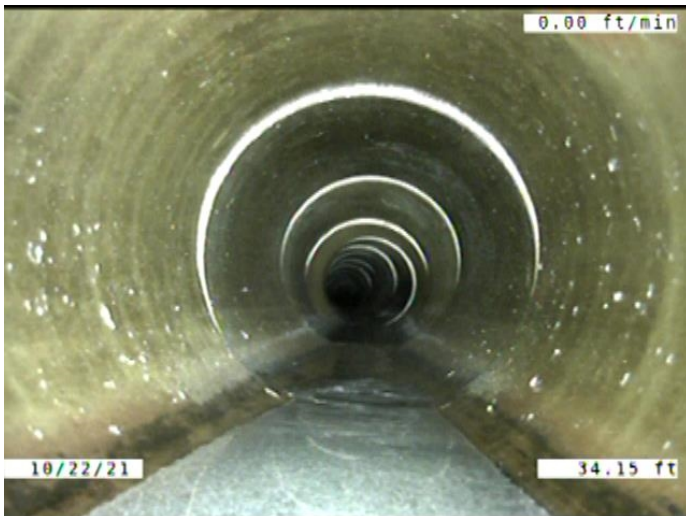
Code: **MWLS**
 Description: **Miscellaneous Water Level Sag**

Distance (ft): **34.2**
 Structural Grade: **2**
 O&M Grade: **0**
 Clock Start/From:
 Clock To:
 1st Value:
 2nd Value:
 Value Percent: **5.000**
 Continuous Index:
 Within 8" of Joint: **NO**
 Remarks:

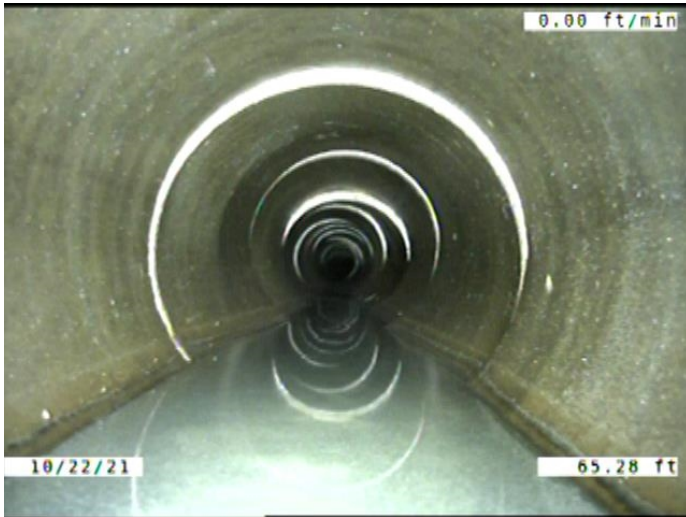
Code: **MWLS**
 Description: **Miscellaneous Water Level Sag**

Distance (ft): **65.3**
 Structural Grade: **2**
 O&M Grade: **0**
 Clock Start/From:
 Clock To:
 1st Value:
 2nd Value:
 Value Percent: **10.000**
 Continuous Index: **S02**
 Within 8" of Joint: **NO**
 Remarks:

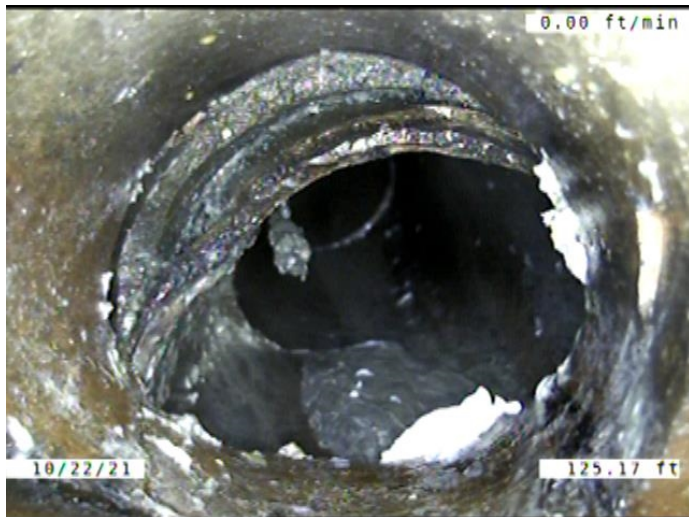
Code: **TFD**
 Description: **Tap Factory Defective**

Distance (ft): **125.2**
 Structural Grade: **0**
 O&M Grade: **3**
 Clock Start/From: **1**
 Clock To:
 1st Value: **4.000**
 2nd Value:
 Value Percent:
 Continuous Index:
 Within 8" of Joint: **YES**
 Remarks: **LARGE OFFSET FIRST JOINT BACK. SOIL VISIBLE**

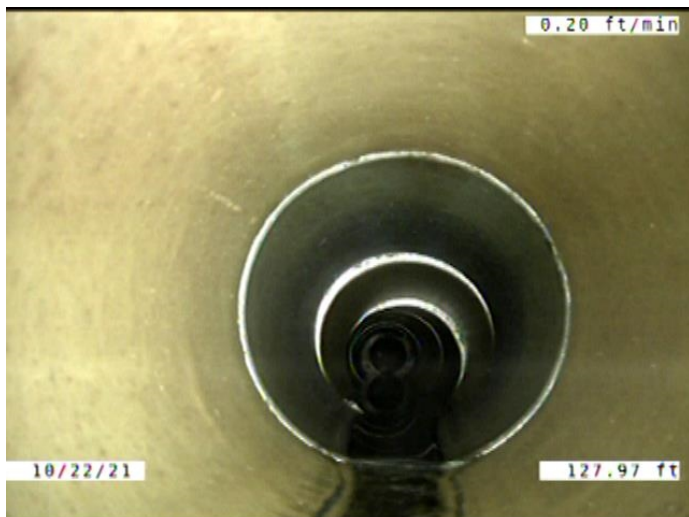
Code: **MWLS**
Description: **Miscellaneous Water Level Sag**

Distance (ft): **128.0**
Structural Grade: **2**
O&M Grade: **0**
Clock Start/From:
Clock To:
1st Value:
2nd Value:
Value Percent: **5.000**
Continuous Index: **F03**
Within 8" of Joint: **NO**
Remarks:

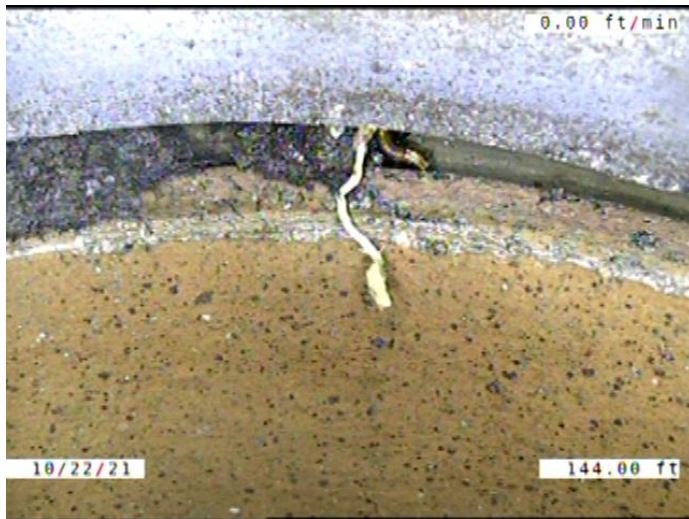
Code: **RFJ**
 Description: **Roots Fine Joint**

Distance (ft): **144.0**
 Structural Grade: **0**
 O&M Grade: **1**
 Clock Start/From: **2**
 Clock To:
 1st Value:
 2nd Value:
 Value Percent:
 Continuous Index:
 Within 8" of Joint: **YES**
 Remarks:

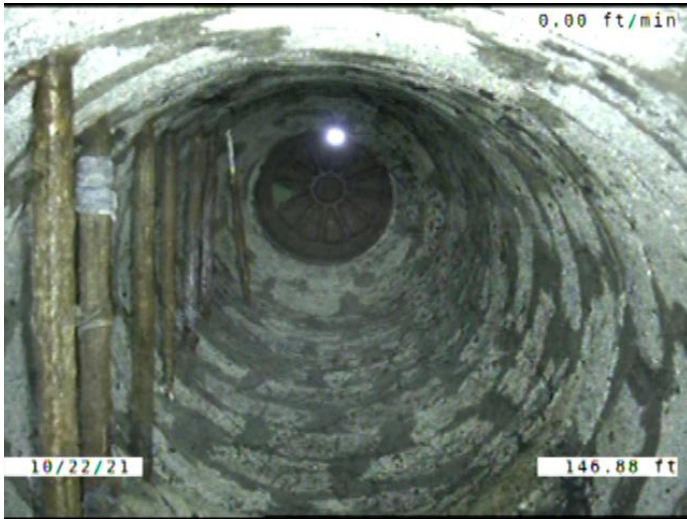
Code:	AMH
Description:	Manhole
Distance (ft):	146.9
Structural Grade:	0
O&M Grade:	0
Clock Start/From:	
Clock To:	
1st Value:	
2nd Value:	
Value Percent:	
Continuous Index:	
Within 8" of Joint:	NO
Remarks:	M-503-004
