## Profile/Photo Observation Report

Street:	<b>W 40TH AVE</b>	Flow Control:	<b>Not Controlled</b>
City:	<b>Hobart, IN</b>	Year Renewed:	
Location:	<b>Other</b>	Tape/Media #:	
Purpose:	<b>Not Known</b>	Dia/Height:	<b>12"</b>
Use:	<b>Sanitary</b>	Material:	<b>VCP</b>
Drain Area:	<b>NA</b>	Lining:	
Category:	<b>NA</b>		
Comment:

Location Details:		Direction of Survey:	<b>Downstream</b>
US MH:	<b>M-503-008</b>	DS MH:	<b>M-503-009</b>
		Total Length Surveyed (ft):	<b>203.9</b>

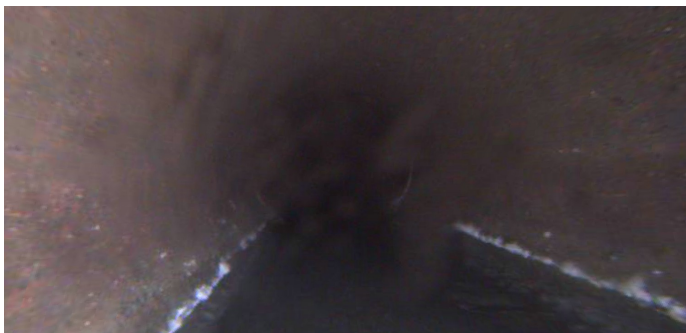
Code: **AMH**  
Description: **Manhole**

Distance (ft): **.0**  
Structural Grade: **0**  
O&M Grade: **0**  
Clock Start/From:  
Clock To:  
1st Value:  
2nd Value:  
Value Percent:  
Continuous Index:  
Within 8" of Joint: **NO**  
Remarks: **M-503-008**

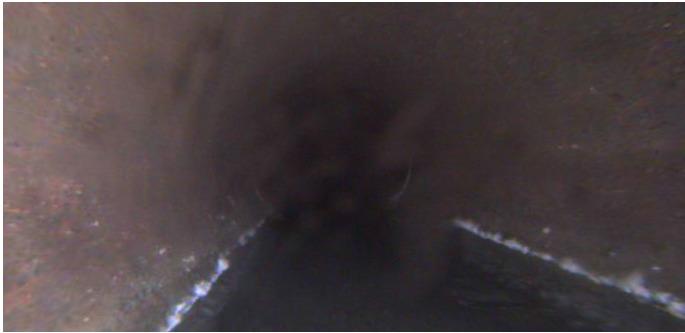
Code:	<b>MWL</b>
Description:	<b>Water Level</b>

Distance (ft):	<b>.0</b>
Structural Grade:	<b>0</b>
O&M Grade:	<b>0</b>
Clock Start/From:	
Clock To:	
1st Value:	
2nd Value:	
Value Percent:	<b>5.000</b>
Continuous Index:	
Within 8" of Joint:	<b>NO</b>
Remarks:

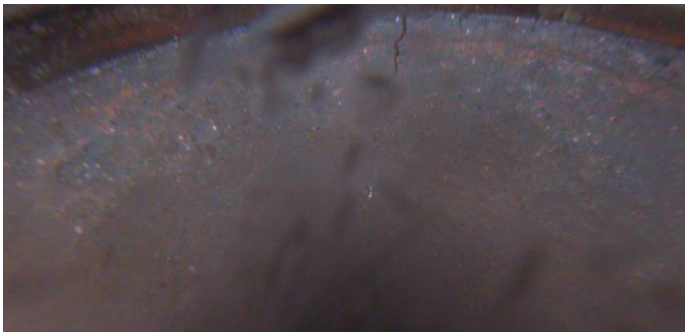
Code:	<b>FL</b>
Description:	<b>Fracture Longitudinal</b>

Distance (ft):	<b>4.8</b>
Structural Grade:	<b>3</b>
O&M Grade:	<b>0</b>
Clock Start/From:	<b>12</b>
Clock To:	
1st Value:	
2nd Value:	
Value Percent:	
Continuous Index:	
Within 8" of Joint:	<b>YES</b>
Remarks:

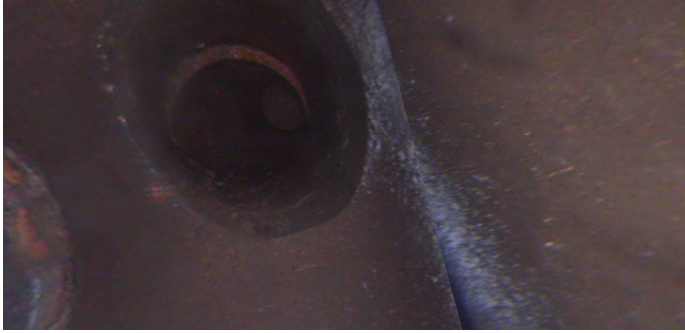
Code: **TF**  
Description: **Tap Factory**

Distance (ft): **9.9**  
Structural Grade: **0**  
O&M Grade: **0**  
Clock Start/From: **10**  
Clock To:  
1st Value: **4.000**  
2nd Value:  
Value Percent:  
Continuous Index:  
Within 8" of Joint:  
Remarks:

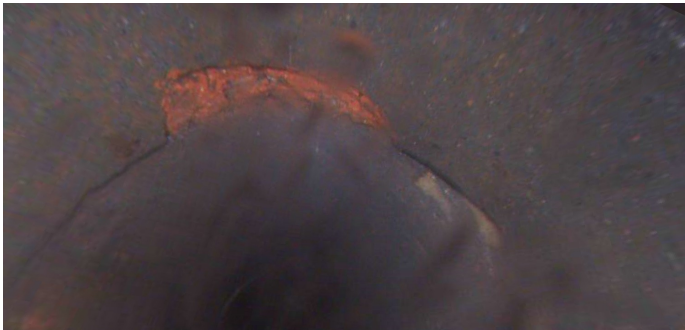
Code: **SSS**  
Description: **Surface Spalling**

Distance (ft): **12.3**  
Structural Grade: **2**  
O&M Grade: **0**  
Clock Start/From: **11**  
Clock To: **1**  
1st Value:  
2nd Value:  
Value Percent:  
Continuous Index:  
Within 8" of Joint: **YES**  
Remarks:

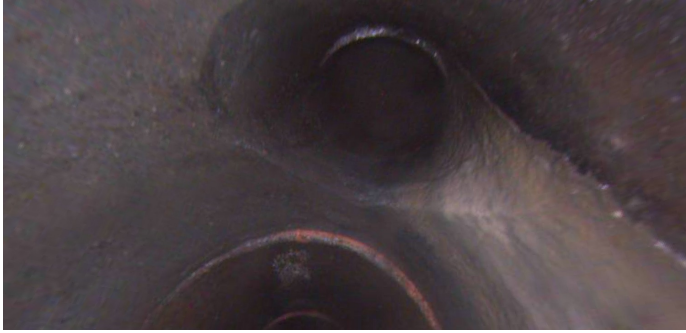
Code: **TF**  
Description: **Tap Factory**

Distance (ft): **26.2**  
Structural Grade: **0**  
O&M Grade: **0**  
Clock Start/From: **11**  
Clock To:  
1st Value: **4.000**  
2nd Value:  
Value Percent:  
Continuous Index:  
Within 8" of Joint:  
Remarks:

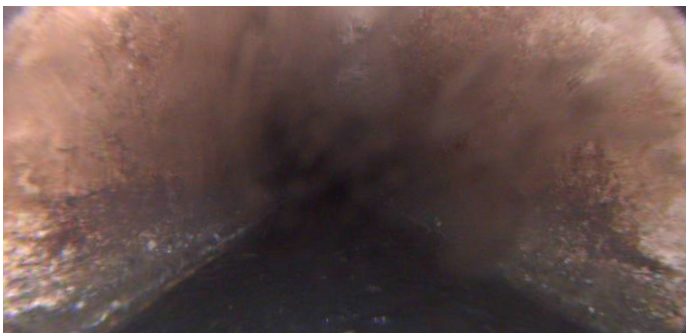
Code: **MMC**  
Description: **Material Change**

Distance (ft): **47.1**  
Structural Grade: **0**  
O&M Grade: **0**  
Clock Start/From:  
Clock To:  
1st Value:  
2nd Value:  
Value Percent:  
Continuous Index:  
Within 8" of Joint: **NO**  
Remarks: **PVC**

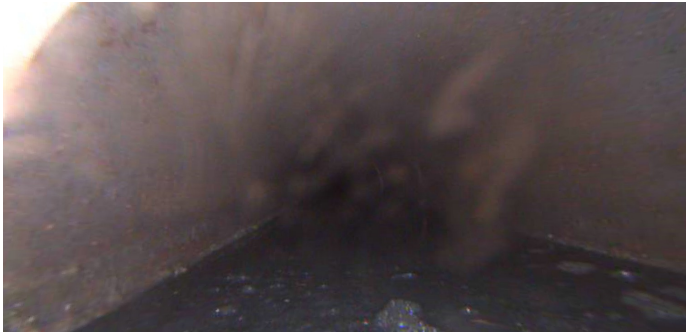
Code:	<b>MMC</b>
Description:	<b>Material Change</b>
Distance (ft):	<b>57.6</b>
Structural Grade:	<b>0</b>
O&M Grade:	<b>0</b>
Clock Start/From:	
Clock To:	
1st Value:	
2nd Value:	
Value Percent:	
Continuous Index:	
Within 8" of Joint:	<b>NO</b>
Remarks:	<b>vcp</b>

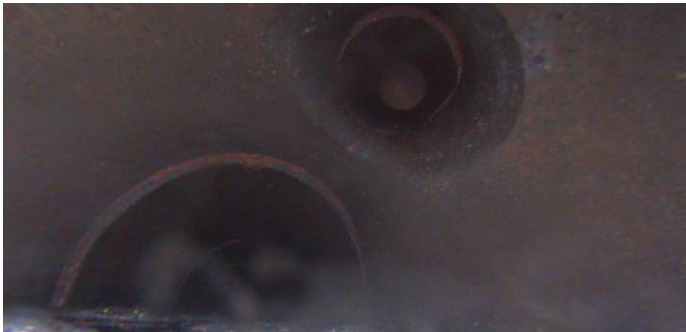
Code:	<b>TF</b>
Description:	<b>Tap Factory</b>
Distance (ft):	<b>71.1</b>
Structural Grade:	<b>0</b>
O&M Grade:	<b>0</b>
Clock Start/From:	<b>11</b>
Clock To:	
1st Value:	<b>4.000</b>
2nd Value:	
Value Percent:	
Continuous Index:	
Within 8" of Joint:	
Remarks:

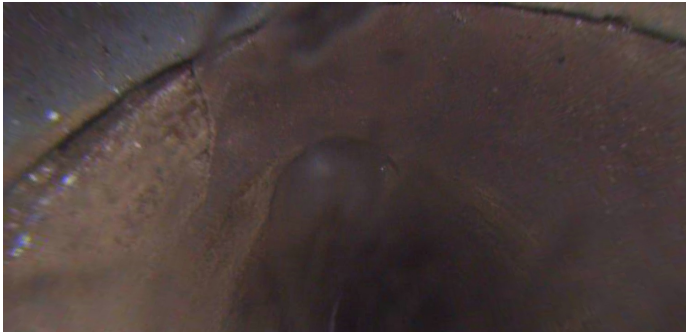
Code: **FS**  
Description: **Fracture Spiral**

Distance (ft): **94.0**  
Structural Grade: **3**  
O&M Grade: **0**  
Clock Start/From: **10**  
Clock To: **11**  
1st Value:  
2nd Value:  
Value Percent:  
Continuous Index:  
Within 8" of Joint: **YES**  
Remarks:

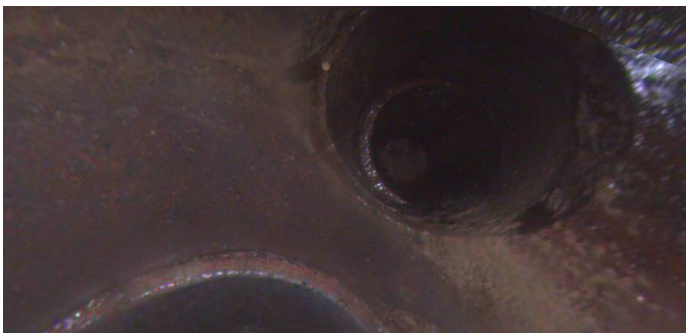
Code: **TF**  
Description: **Tap Factory**

Distance (ft): **95.3**  
Structural Grade: **0**  
O&M Grade: **0**  
Clock Start/From: **11**  
Clock To:  
1st Value: **4.000**  
2nd Value:  
Value Percent:  
Continuous Index:  
Within 8" of Joint:  
Remarks:

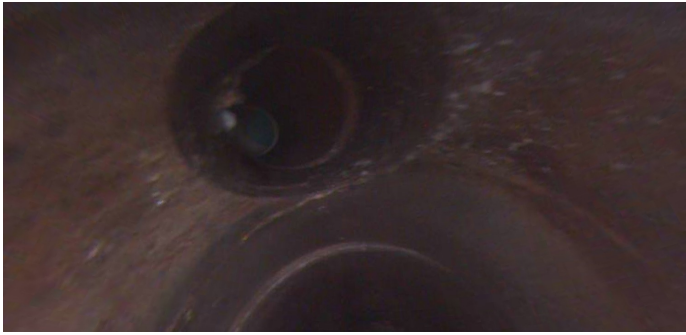
Code: **TF**  
Description: **Tap Factory**

Distance (ft): **97.5**  
Structural Grade: **0**  
O&M Grade: **0**  
Clock Start/From: **1**  
Clock To:  
1st Value: **4.000**  
2nd Value:  
Value Percent:  
Continuous Index:  
Within 8" of Joint:  
Remarks:

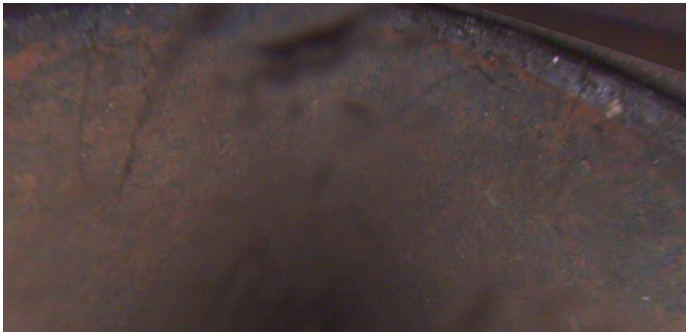
Code: **RFJ**  
Description: **Roots Fine Joint**

Distance (ft): **124.9**  
Structural Grade: **0**  
O&M Grade: **1**  
Clock Start/From: **11**  
Clock To: **1**  
1st Value:  
2nd Value:  
Value Percent:  
Continuous Index:  
Within 8" of Joint: **YES**  
Remarks:

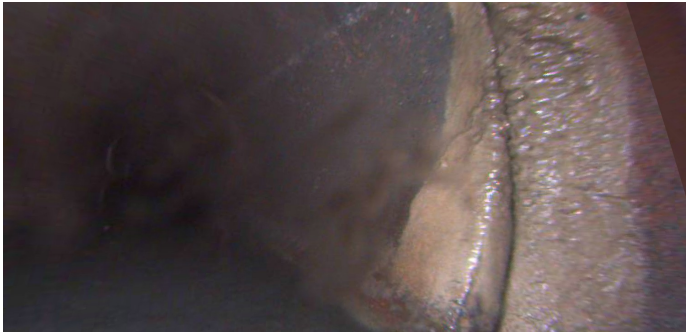
Code: **IW**  
Description: **Infil Weeper**

Distance (ft): **139.1**  
Structural Grade: **0**  
O&M Grade: **2**  
Clock Start/From: **1**  
Clock To: **4**  
1st Value:  
2nd Value:  
Value Percent:  
Continuous Index:  
Within 8" of Joint: **YES**  
Remarks:

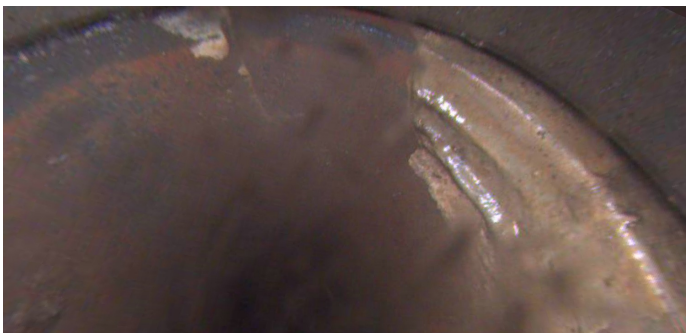
Code: **FM**  
Description: **Fracture Multiple**

Distance (ft): **152.8**  
Structural Grade: **4**  
O&M Grade: **0**  
Clock Start/From: **11**  
Clock To: **1**  
1st Value:  
2nd Value:  
Value Percent:  
Continuous Index:  
Within 8" of Joint: **YES**  
Remarks:

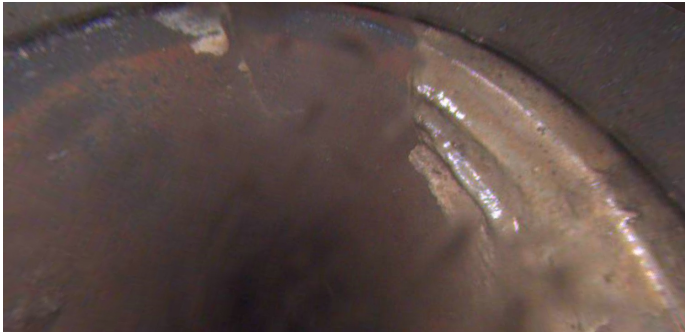
Code: **IW**  
Description: **Infil Weeper**

Distance (ft): **152.8**  
Structural Grade: **0**  
O&M Grade: **2**  
Clock Start/From: **1**  
Clock To: **4**  
1st Value:  
2nd Value:  
Value Percent:  
Continuous Index:  
Within 8" of Joint: **YES**  
Remarks:

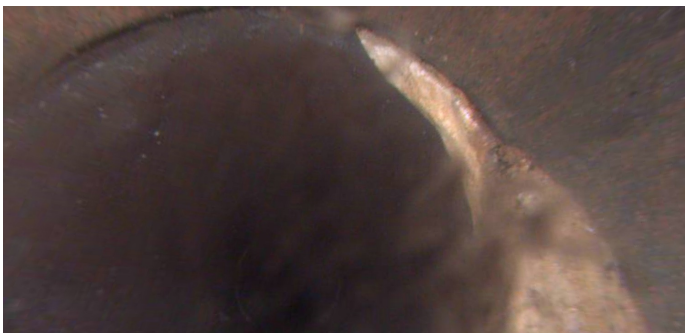
Code: **DAE**  
Description: **Deposits Attached Encrustation**

Distance (ft): **155.2**  
Structural Grade: **0**  
O&M Grade: **2**  
Clock Start/From: **1**  
Clock To: **4**  
1st Value:  
2nd Value:  
Value Percent: **5.000**  
Continuous Index:  
Within 8" of Joint: **YES**  
Remarks:

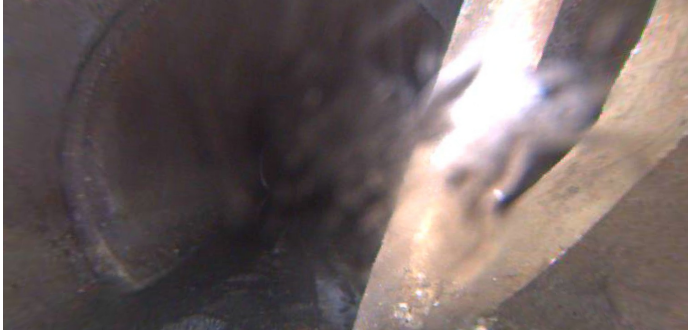
Code:	AMH
Description:	Manhole
Distance (ft):	203.9
Structural Grade:	0
O&M Grade:	0
Clock Start/From:	
Clock To:	
1st Value:	
2nd Value:	
Value Percent:	
Continuous Index:	
Within 8" of Joint:	NO
Remarks:	M-503-009
