RedZone  
ROBOTICS

US MH: **M-503-009**      DS MH: **M-503-010**      Total Length Surveyed (ft): **95.7**

Overall Index: **2.82** Overall Quick: **534A** Overall Rating: **107.00**

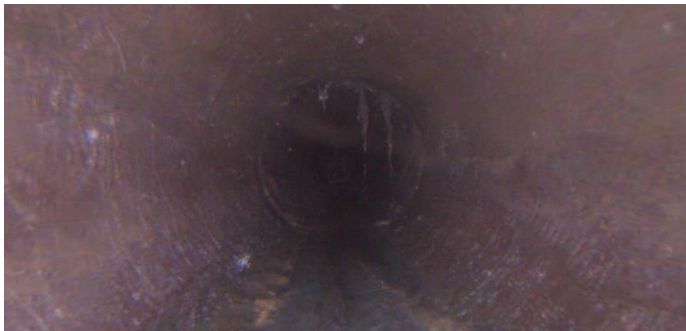
Code: **AMH**  
Description: **Manhole**

Distance (ft): **.0**  
Structural Grade: **0**  
O&M Grade: **0**  
Clock Start/From:  
Clock To:  
1st Value:  
2nd Value:  
Value Percent:  
Continuous Index:  
Within 8" of Joint: **NO**  
Remarks: **M-503-009**

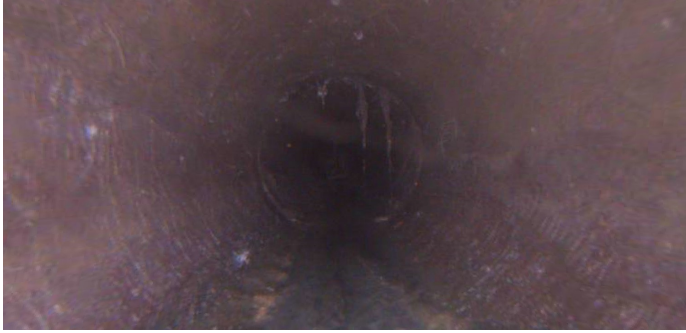
Code: **MWL**  
Description: **Water Level**

Distance (ft): **.0**  
Structural Grade: **0**  
O&M Grade: **0**  
Clock Start/From:  
Clock To:  
1st Value:  
2nd Value:  
Value Percent: **5.000**  
Continuous Index:  
Within 8" of Joint: **NO**  
Remarks:

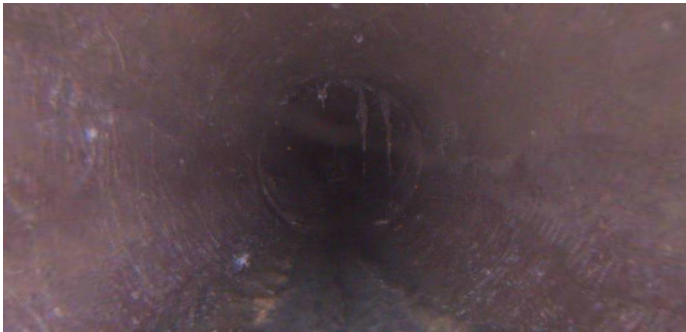
Code: **DAGS**  
Description: **Deposits Attached Grease**

Distance (ft): **.0**  
Structural Grade: **0**  
O&M Grade: **2**  
Clock Start/From: **7**  
Clock To: **5**  
1st Value:  
2nd Value:  
Value Percent: **5.000**  
Continuous Index: **S01**  
Within 8" of Joint:  
Remarks:

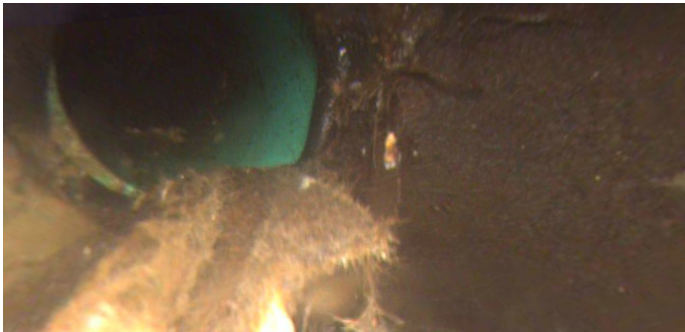
Code: **RMC**  
Description: **Roots Medium Connection**

Distance (ft): **8.1**  
Structural Grade: **0**  
O&M Grade: **3**  
Clock Start/From: **1**  
Clock To: **2**  
1st Value:  
2nd Value:  
Value Percent: **20.000**  
Continuous Index:  
Within 8" of Joint: **NO**  
Remarks:

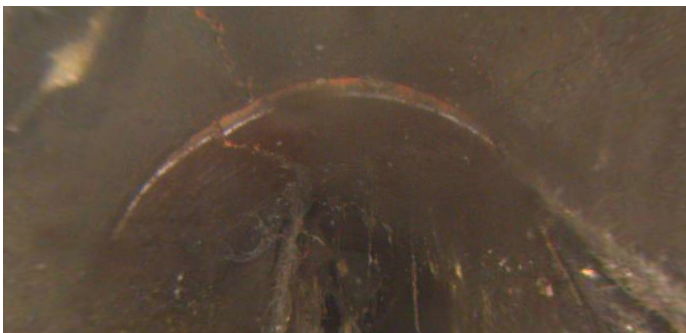
Code: **FL**  
Description: **Fracture Longitudinal**

Distance (ft): **9.8**  
Structural Grade: **3**  
O&M Grade: **0**  
Clock Start/From: **1**  
Clock To:  
1st Value:  
2nd Value:  
Value Percent:  
Continuous Index:  
Within 8" of Joint: **YES**  
Remarks:

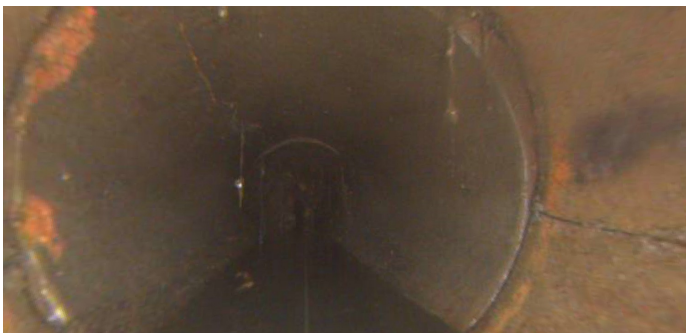
Code: **RFJ**  
Description: **Roots Fine Joint**

Distance (ft): **11.7**  
Structural Grade: **0**  
O&M Grade: **1**  
Clock Start/From: **8**  
Clock To: **4**  
1st Value:  
2nd Value:  
Value Percent:  
Continuous Index: **S02**  
Within 8" of Joint: **YES**  
Remarks:

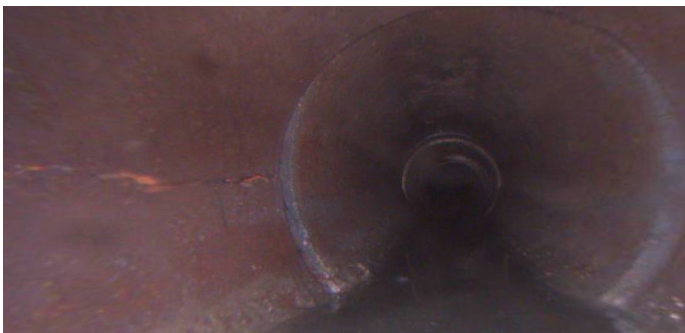
Code: **FL**  
Description: **Fracture Longitudinal**

Distance (ft): **22.8**  
Structural Grade: **3**  
O&M Grade: **0**  
Clock Start/From: **9**  
Clock To:  
1st Value:  
2nd Value:  
Value Percent:  
Continuous Index:  
Within 8" of Joint: **YES**  
Remarks:

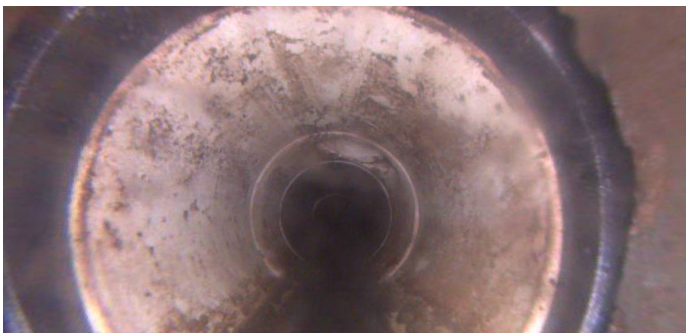
Code: **RFJ**  
Description: **Roots Fine Joint**

Distance (ft): **25.3**  
Structural Grade: **0**  
O&M Grade: **1**  
Clock Start/From: **8**  
Clock To: **4**  
1st Value:  
2nd Value:  
Value Percent:  
Continuous Index: **F02**  
Within 8" of Joint: **YES**  
Remarks:

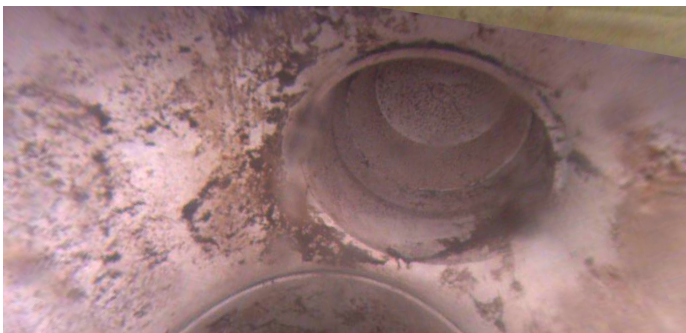
Code: **TF**  
Description: **Tap Factory**

Distance (ft): **26.8**  
Structural Grade: **0**  
O&M Grade: **0**  
Clock Start/From: **1**  
Clock To:  
1st Value: **4.000**  
2nd Value:  
Value Percent:  
Continuous Index:  
Within 8" of Joint:  
Remarks:

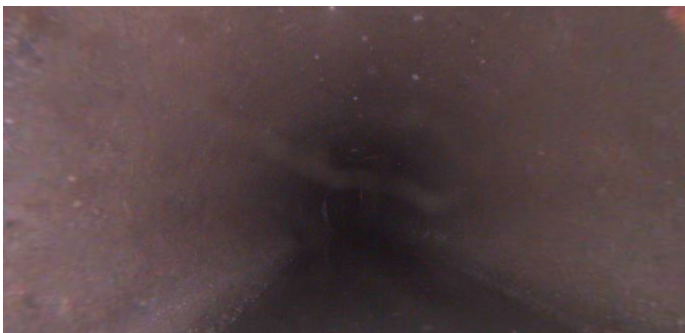
Code: **MMC**  
Description: **Material Change**

Distance (ft): **40.4**  
Structural Grade: **0**  
O&M Grade: **0**  
Clock Start/From:  
Clock To:  
1st Value:  
2nd Value:  
Value Percent:  
Continuous Index:  
Within 8" of Joint: **NO**  
Remarks: **vcp**

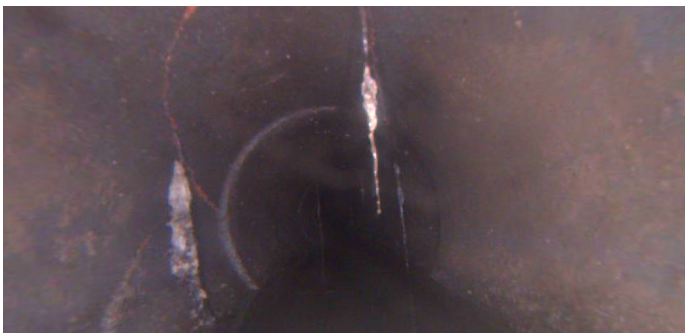
Code: **RFB**  
Description: **Roots Fine Barrel**

Distance (ft): **43.3**  
Structural Grade: **0**  
O&M Grade: **2**  
Clock Start/From: **10**  
Clock To: **12**  
1st Value:  
2nd Value:  
Value Percent:  
Continuous Index:  
Within 8" of Joint: **NO**  
Remarks:

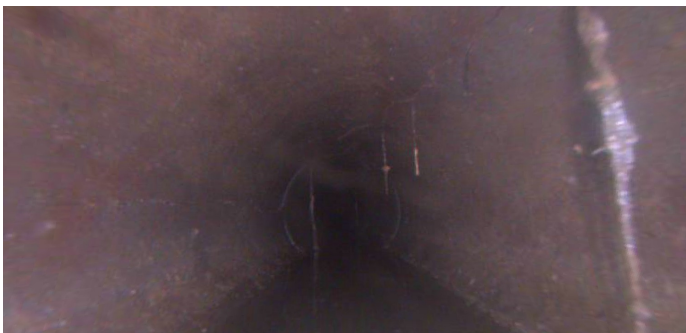
Code: **RFB**  
Description: **Roots Fine Barrel**

Distance (ft): **44.4**  
Structural Grade: **0**  
O&M Grade: **2**  
Clock Start/From: **1**  
Clock To:  
1st Value:  
2nd Value:  
Value Percent:  
Continuous Index:  
Within 8" of Joint: **NO**  
Remarks:

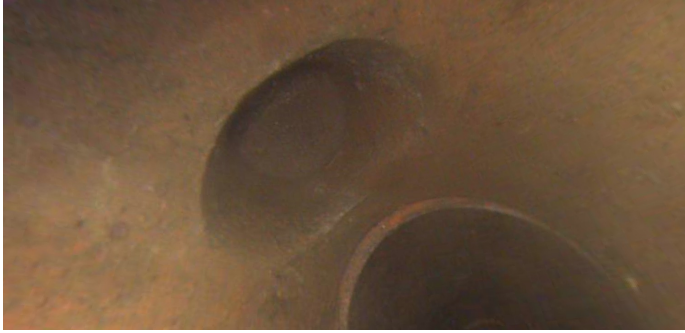
Code: **TFC**  
Description: **Tap Factory Capped**

Distance (ft): **60.3**  
Structural Grade: **0**  
O&M Grade: **0**  
Clock Start/From: **2**  
Clock To:  
1st Value: **4.000**  
2nd Value:  
Value Percent:  
Continuous Index:  
Within 8" of Joint:  
Remarks:

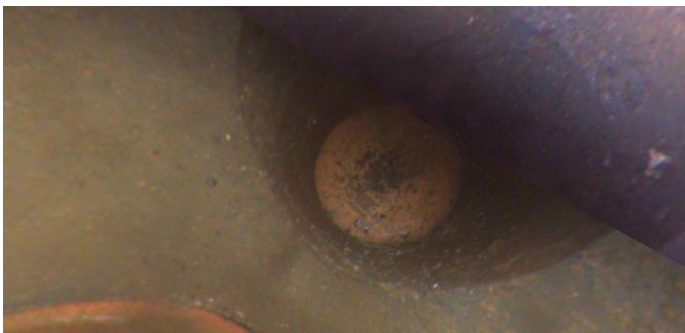
Code: **TFC**  
Description: **Tap Factory Capped**

Distance (ft): **61.9**  
Structural Grade: **0**  
O&M Grade: **0**  
Clock Start/From: **11**  
Clock To:  
1st Value: **4.000**  
2nd Value:  
Value Percent:  
Continuous Index:  
Within 8" of Joint:  
Remarks:

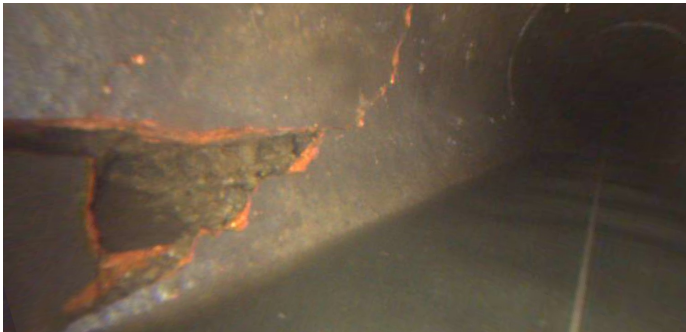
Code: **HSV**  
Description: **Hole Soil Visible**

Distance (ft): **79.8**  
Structural Grade: **5**  
O&M Grade: **0**  
Clock Start/From: **3**  
Clock To: **4**  
1st Value:  
2nd Value:  
Value Percent:  
Continuous Index:  
Within 8" of Joint:  
Remarks:
