RedZone
ROBOTICS

Total Length Surveyed (ft): **95.7**

M-503-010

M-503-009

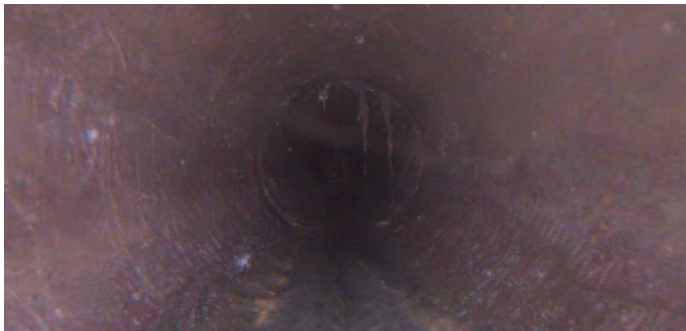
Code: **AMH**
Description: **Manhole**

Distance (ft): **.0**
Structural Grade: **0**
O&M Grade: **0**
Clock Start/From:
Clock To:
1st Value:
2nd Value:
Value Percent:
Continuous Index:
Within 8" of Joint: **NO**
Remarks: **M-503-009**

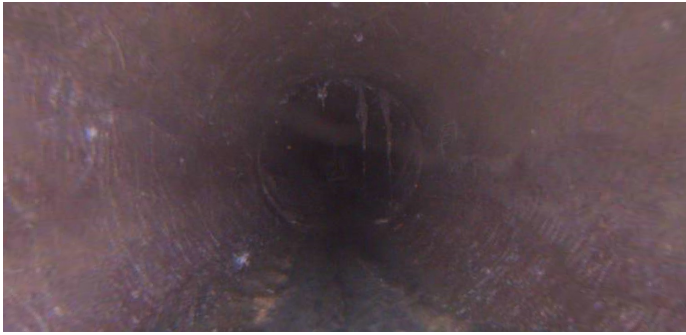
Code: **MWL**
Description: **Water Level**

Distance (ft): **.0**
Structural Grade: **0**
O&M Grade: **0**
Clock Start/From:
Clock To:
1st Value:
2nd Value:
Value Percent: **5.000**
Continuous Index:
Within 8" of Joint: **NO**
Remarks:

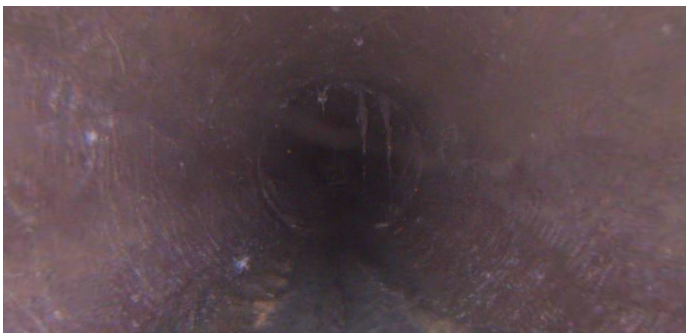
Code: **DAGS**
Description: **Deposits Attached Grease**

Distance (ft): **.0**
Structural Grade: **0**
O&M Grade: **2**
Clock Start/From: **7**
Clock To: **5**
1st Value:
2nd Value:
Value Percent: **5.000**
Continuous Index: **S01**
Within 8" of Joint:
Remarks:

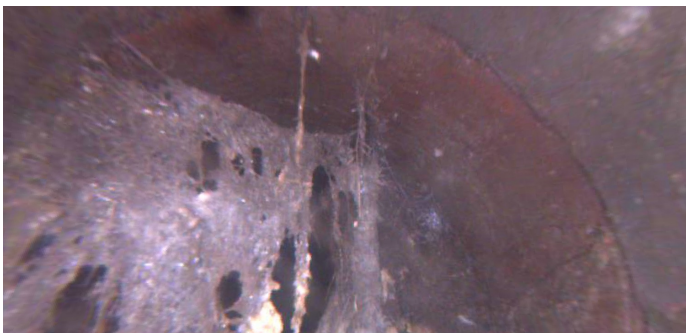
Code: **RMJ**
Description: **Roots Medium Joint**

Distance (ft): **6.7**
Structural Grade: **0**
O&M Grade: **3**
Clock Start/From: **8**
Clock To: **4**
1st Value:
2nd Value:
Value Percent: **40.000**
Continuous Index:
Within 8" of Joint: **YES**
Remarks:

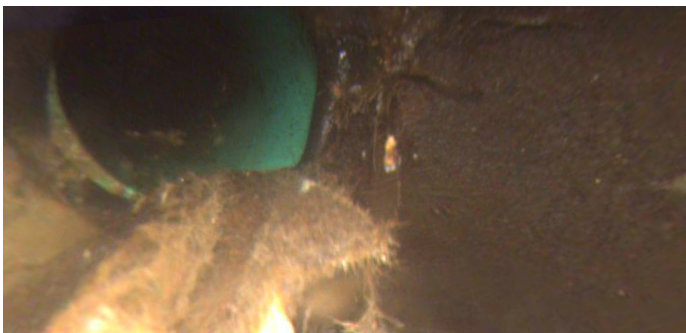
Code: **RMC**
Description: **Roots Medium Connection**

Distance (ft): **8.1**
Structural Grade: **0**
O&M Grade: **3**
Clock Start/From: **1**
Clock To: **2**
1st Value:
2nd Value:
Value Percent: **20.000**
Continuous Index:
Within 8" of Joint: **NO**
Remarks:

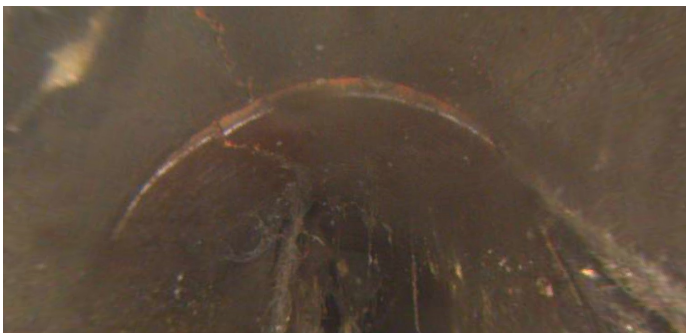
Code: **FL**
Description: **Fracture Longitudinal**

Distance (ft): **9.8**
Structural Grade: **3**
O&M Grade: **0**
Clock Start/From: **1**
Clock To:
1st Value:
2nd Value:
Value Percent:
Continuous Index:
Within 8" of Joint: **YES**
Remarks:

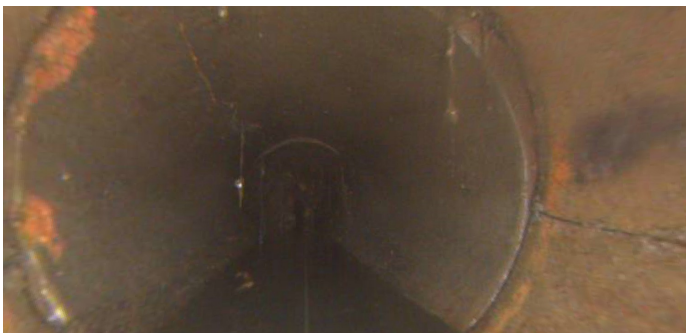
Code: **RFJ**
Description: **Roots Fine Joint**

Distance (ft): **11.7**
Structural Grade: **0**
O&M Grade: **1**
Clock Start/From: **8**
Clock To: **4**
1st Value:
2nd Value:
Value Percent:
Continuous Index: **S02**
Within 8" of Joint: **YES**
Remarks:

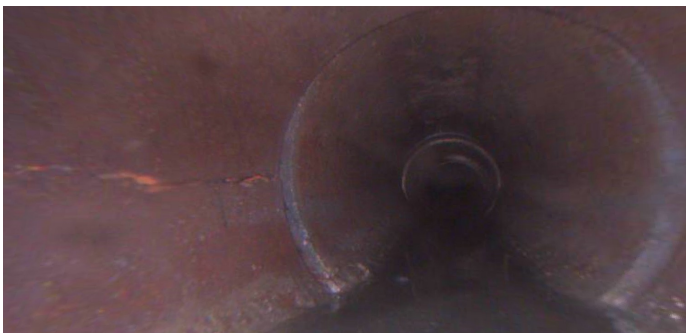
Code: **FL**
Description: **Fracture Longitudinal**

Distance (ft): **22.8**
Structural Grade: **3**
O&M Grade: **0**
Clock Start/From: **9**
Clock To:
1st Value:
2nd Value:
Value Percent:
Continuous Index:
Within 8" of Joint: **YES**
Remarks:

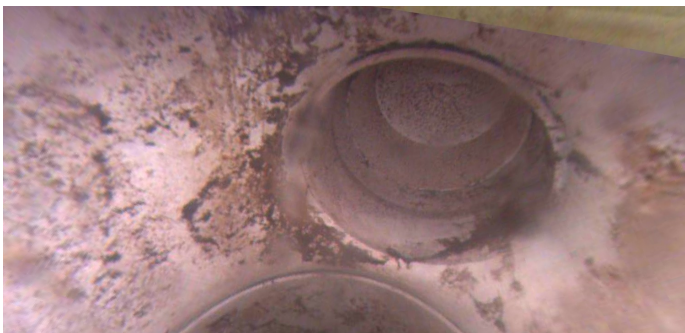
Code: **TF**
Description: **Tap Factory**

Distance (ft): **26.8**
Structural Grade: **0**
O&M Grade: **0**
Clock Start/From: **1**
Clock To:
1st Value: **4.000**
2nd Value:
Value Percent:
Continuous Index:
Within 8" of Joint:
Remarks:

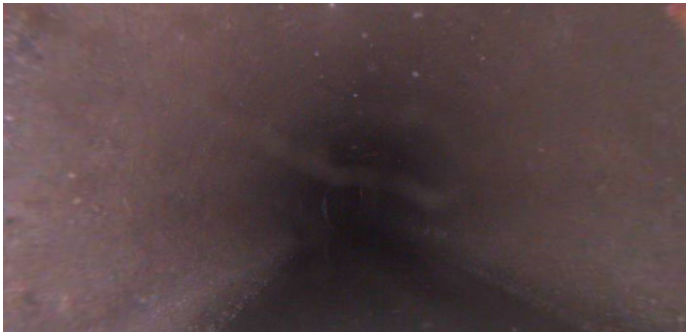
Code: **MMC**
Description: **Material Change**

Distance (ft): **40.4**
Structural Grade: **0**
O&M Grade: **0**
Clock Start/From:
Clock To:
1st Value:
2nd Value:
Value Percent:
Continuous Index:
Within 8" of Joint: **NO**
Remarks: **vcp**

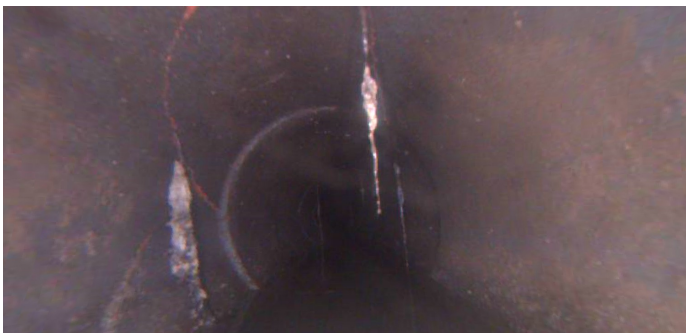
Code: **RFB**
Description: **Roots Fine Barrel**

Distance (ft): **43.3**
Structural Grade: **0**
O&M Grade: **2**
Clock Start/From: **10**
Clock To: **12**
1st Value:
2nd Value:
Value Percent:
Continuous Index:
Within 8" of Joint: **NO**
Remarks:

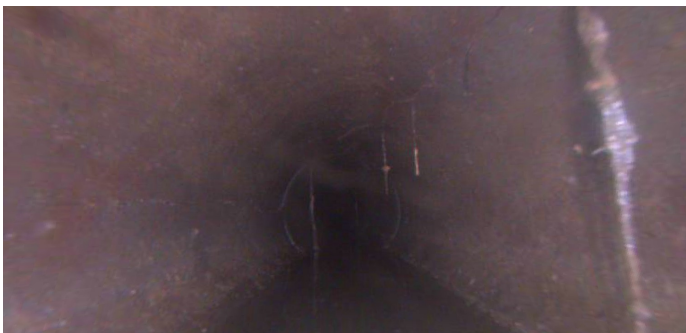
Code: **RFB**
Description: **Roots Fine Barrel**

Distance (ft): **44.4**
Structural Grade: **0**
O&M Grade: **2**
Clock Start/From: **1**
Clock To:
1st Value:
2nd Value:
Value Percent:
Continuous Index:
Within 8" of Joint: **NO**
Remarks:

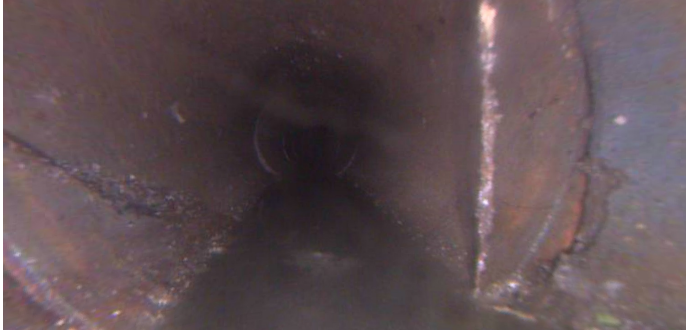
Code: **SSS**
Description: **Surface Spalling**

Distance (ft): **48.3**
Structural Grade: **2**
O&M Grade: **0**
Clock Start/From: **3**
Clock To: **4**
1st Value:
2nd Value:
Value Percent:
Continuous Index:
Within 8" of Joint: **YES**
Remarks:

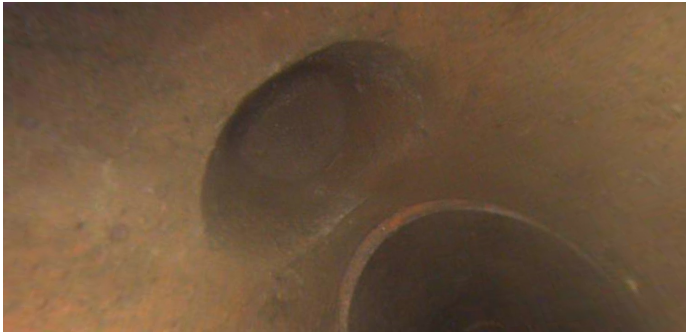
Code: **TFC**
Description: **Tap Factory Capped**

Distance (ft): **60.3**
Structural Grade: **0**
O&M Grade: **0**
Clock Start/From: **2**
Clock To:
1st Value: **4.000**
2nd Value:
Value Percent:
Continuous Index:
Within 8" of Joint:
Remarks:

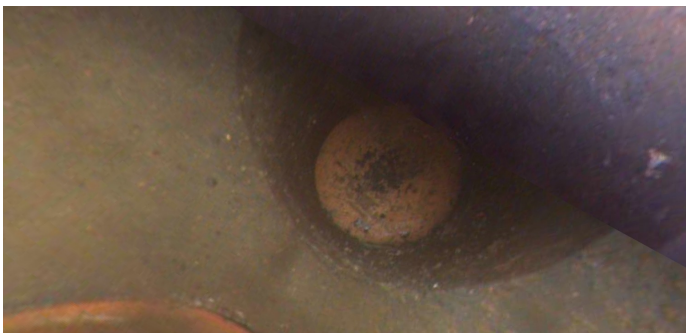
Code: **TFC**
Description: **Tap Factory Capped**

Distance (ft): **61.9**
Structural Grade: **0**
O&M Grade: **0**
Clock Start/From: **11**
Clock To:
1st Value: **4.000**
2nd Value:
Value Percent:
Continuous Index:
Within 8" of Joint:
Remarks:

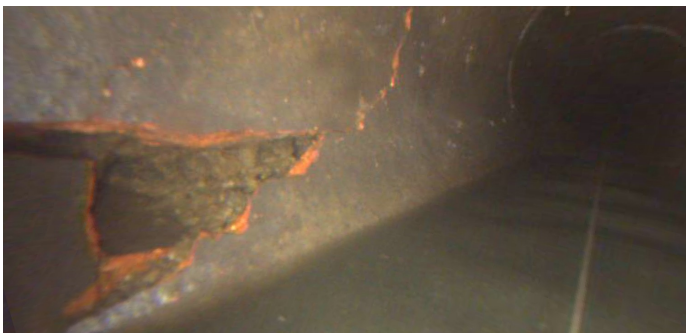
Code: **HSV**
Description: **Hole Soil Visible**

Distance (ft): **79.8**
Structural Grade: **5**
O&M Grade: **0**
Clock Start/From: **3**
Clock To: **4**
1st Value:
2nd Value:
Value Percent:
Continuous Index:
Within 8" of Joint:
Remarks:

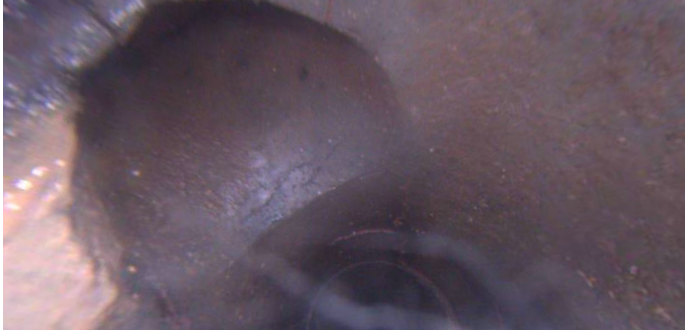
Code: **TFD**
Description: **Tap Factory Defective**

Distance (ft): **94.8**
Structural Grade: **0**
O&M Grade: **2**
Clock Start/From: **11**
Clock To:
1st Value: **4.000**
2nd Value:
Value Percent:
Continuous Index:
Within 8" of Joint:
Remarks: **fm**
