Profile/Photo Observation Report

Street:	N VIRGINIA ST	Flow Control:	Not Controlled
City:	Hobart, IN	Year Renewed:	
Location:	Other	Tape/Media #:	
Purpose:	Not Known	Dia/Height:	10"
Use:	Sanitary	Material:	PVC
Drain Area:	NA	Lining:	
Category:	NA		
Comment:

Location Details:		Direction of Survey:	Downstream
US MH:	M-503-011	DS MH:	M-503-012
		Total Length Surveyed (ft):	38.8

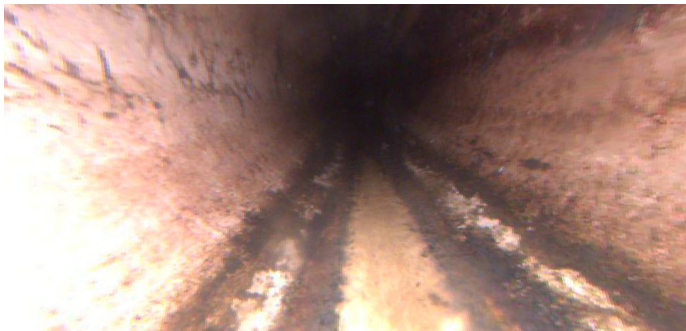
Code: **AMH**
Description: **Manhole**

Distance (ft): **.0**
Structural Grade: **0**
O&M Grade: **0**
Clock Start/From:
Clock To:
1st Value:
2nd Value:
Value Percent:
Continuous Index:
Within 8" of Joint: **NO**
Remarks: **M-503-011**

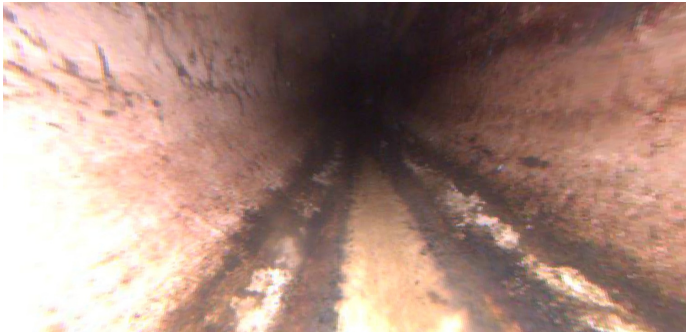
Code:	MWL
Description:	Water Level

Distance (ft):	.0
Structural Grade:	0
O&M Grade:	0
Clock Start/From:	
Clock To:	
1st Value:	
2nd Value:	
Value Percent:	5.000
Continuous Index:	
Within 8" of Joint:	NO
Remarks:

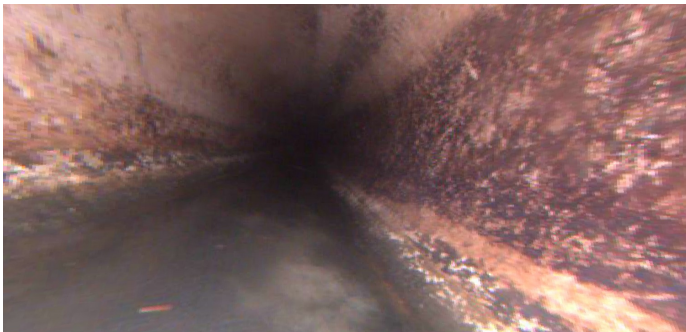
Code:	DSZ
Description:	Deposits Settled Other

Distance (ft):	9.5
Structural Grade:	0
O&M Grade:	2
Clock Start/From:	6
Clock To:	
1st Value:	
2nd Value:	
Value Percent:	5.000
Continuous Index:	S01
Within 8" of Joint:	NO
Remarks:	tissue

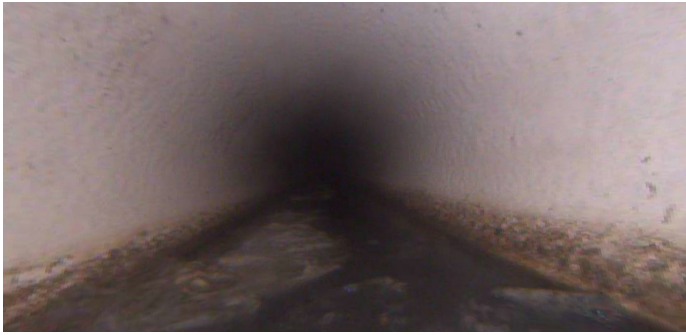
Code: **MSA**
Description: **Abandoned Survey**

Distance (ft): **38.8**
Structural Grade: **0**
O&M Grade: **0**
Clock Start/From:
Clock To:
1st Value:
2nd Value:
Value Percent:
Continuous Index:
Within 8" of Joint: **NO**
Remarks: **no blockage**

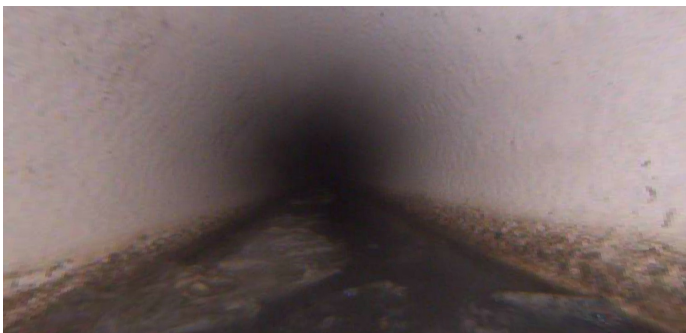
Code: **DSZ**
Description: **Deposits Settled Other**

Distance (ft): **38.8**
Structural Grade: **0**
O&M Grade: **2**
Clock Start/From: **6**
Clock To:
1st Value:
2nd Value:
Value Percent: **5.000**
Continuous Index: **F01**
Within 8" of Joint: **NO**
Remarks: **tissue**
