## Profile/Photo Observation Report

Street:	<b>W 40th ave</b>	Flow Control:	<b>Not Controlled</b>
City:	<b>Hobart, IN</b>	Year Renewed:	
Location:	<b>Other</b>	Tape/Media #:	
Purpose:	<b>Not Known</b>	Dia/Height:	<b>10"</b>
Use:	<b>Sanitary</b>	Material:	<b>PVC</b>
Drain Area:	<b>NA</b>	Lining:	
Category:	<b>NA</b>		
Comment:

Location Details:		Direction of Survey:	<b>Downstream</b>
US MH:	<b>M-503-011</b>	DS MH:	<b>M-503-012</b>
		Total Length Surveyed (ft):	<b>38.8</b>

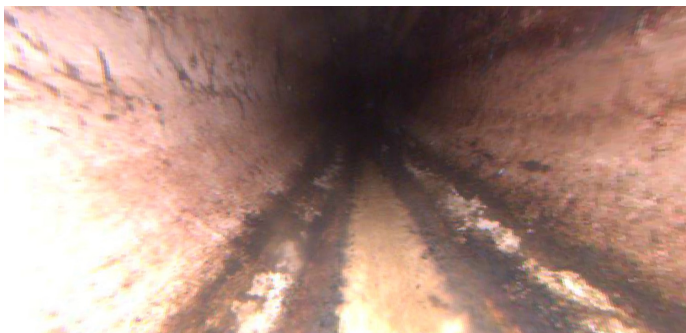
Code: **AMH**  
Description: **Manhole**

Distance (ft): **.0**  
Structural Grade: **0**  
O&M Grade: **0**  
Clock Start/From:  
Clock To:  
1st Value:  
2nd Value:  
Value Percent:  
Continuous Index:  
Within 8" of Joint: **NO**  
Remarks: **M-503-011**

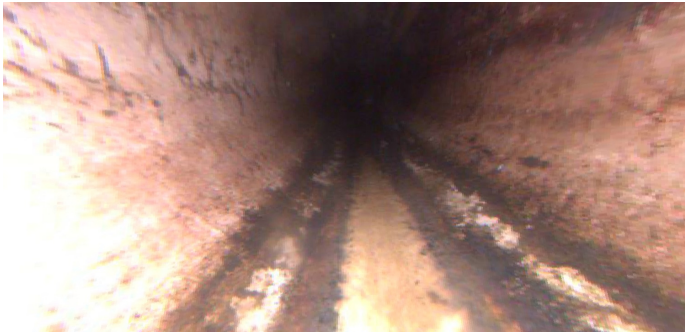
Code:	<b>MWL</b>
Description:	<b>Water Level</b>

Distance (ft):	<b>.0</b>
Structural Grade:	<b>0</b>
O&M Grade:	<b>0</b>
Clock Start/From:	
Clock To:	
1st Value:	
2nd Value:	
Value Percent:	<b>5.000</b>
Continuous Index:	
Within 8" of Joint:	<b>NO</b>
Remarks:

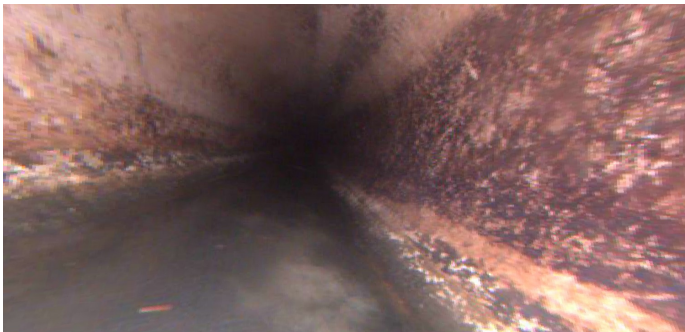
Code:	<b>DSZ</b>
Description:	<b>Deposits Settled Other</b>

Distance (ft):	<b>9.5</b>
Structural Grade:	<b>0</b>
O&M Grade:	<b>2</b>
Clock Start/From:	<b>6</b>
Clock To:	
1st Value:	
2nd Value:	
Value Percent:	<b>5.000</b>
Continuous Index:	<b>S01</b>
Within 8" of Joint:	<b>NO</b>
Remarks:	<b>tissue</b>

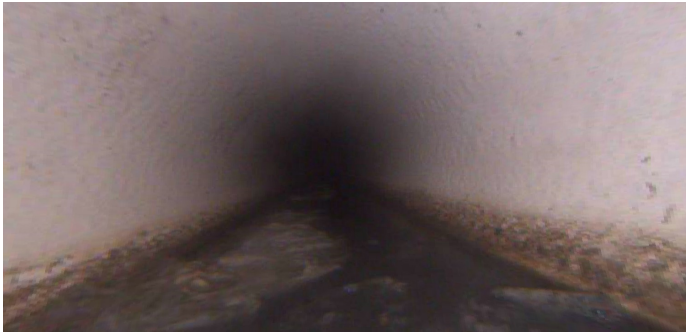
Code: **MSA**  
Description: **Abandoned Survey**

Distance (ft): **38.8**  
Structural Grade: **0**  
O&M Grade: **0**  
Clock Start/From:  
Clock To:  
1st Value:  
2nd Value:  
Value Percent:  
Continuous Index:  
Within 8" of Joint: **NO**  
Remarks: **no blockage**

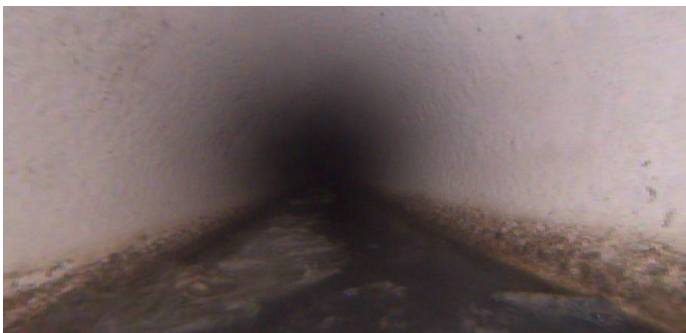
Code: **DSZ**  
Description: **Deposits Settled Other**

Distance (ft): **38.8**  
Structural Grade: **0**  
O&M Grade: **2**  
Clock Start/From: **6**  
Clock To:  
1st Value:  
2nd Value:  
Value Percent: **5.000**  
Continuous Index: **F01**  
Within 8" of Joint: **NO**  
Remarks: **tissue**
