Profile/Photo Observation Report

Street:	N VIRGINIA ST	Flow Control:	Not Controlled
City:	Hobart, IN	Year Renewed:	
Location:	Other	Tape/Media #:	
Purpose:	Not Known	Dia/Height:	10"
Use:	Sanitary	Material:	VCP
Drain Area:	NA	Lining:	
Category:	NA		
Comment:

Location Details:		Direction of Survey:	Upstream
US MH:	M-503-011	DS MH:	M-503-012
		Total Length Surveyed (ft):	25.9

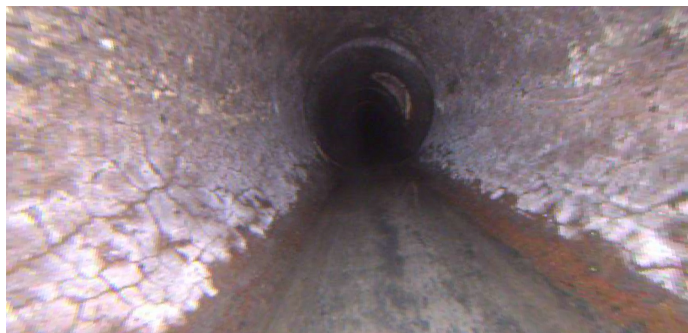
Code: **AMH**
Description: **Manhole**

Distance (ft): **.0**
Structural Grade: **0**
O&M Grade: **0**
Clock Start/From:
Clock To:
1st Value:
2nd Value:
Value Percent:
Continuous Index:
Within 8" of Joint: **NO**
Remarks: **M-503-011**

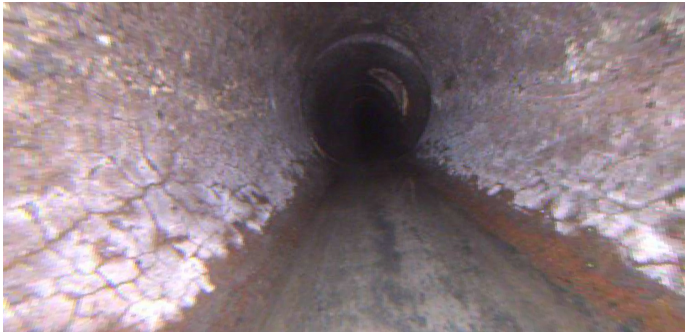
Code:	MWL
Description:	Water Level

Distance (ft):	.0
Structural Grade:	0
O&M Grade:	0
Clock Start/From:	
Clock To:	
1st Value:	
2nd Value:	
Value Percent:	5.000
Continuous Index:	
Within 8" of Joint:	NO
Remarks:

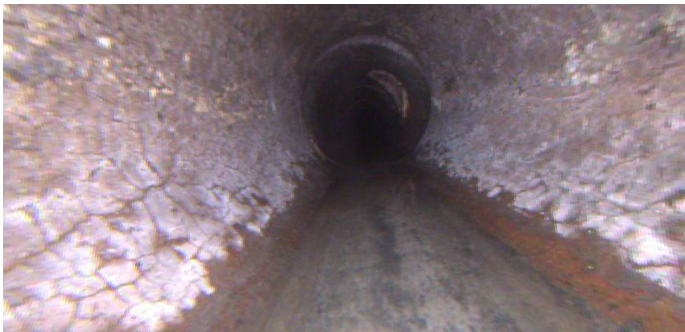
Code:	CM
Description:	Crack Multiple

Distance (ft):	.0
Structural Grade:	3
O&M Grade:	0
Clock Start/From:	7
Clock To:	5
1st Value:	
2nd Value:	
Value Percent:	
Continuous Index:	S01
Within 8" of Joint:	
Remarks:

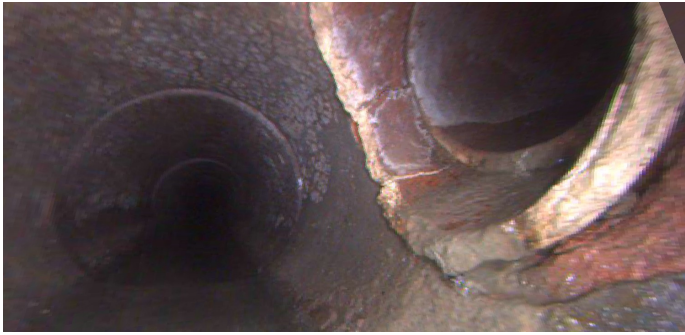
Code: **TB**
Description: **Tap Break-in**

Distance (ft): **3.7**
Structural Grade: **0**
O&M Grade: **0**
Clock Start/From: **2**
Clock To:
1st Value: **6.000**
2nd Value:
Value Percent:
Continuous Index:
Within 8" of Joint:
Remarks:

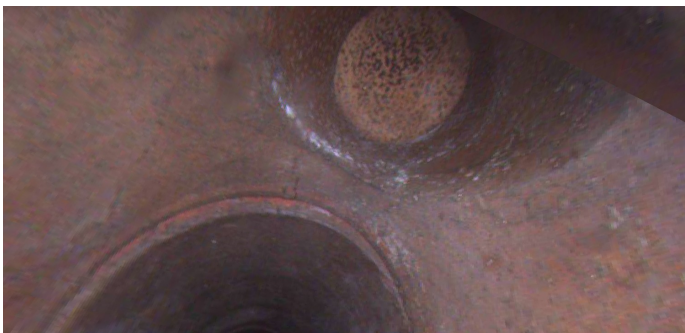
Code: **TFC**
Description: **Tap Factory Capped**

Distance (ft): **12.2**
Structural Grade: **0**
O&M Grade: **0**
Clock Start/From: **1**
Clock To:
1st Value: **4.000**
2nd Value:
Value Percent:
Continuous Index:
Within 8" of Joint: **YES**
Remarks:

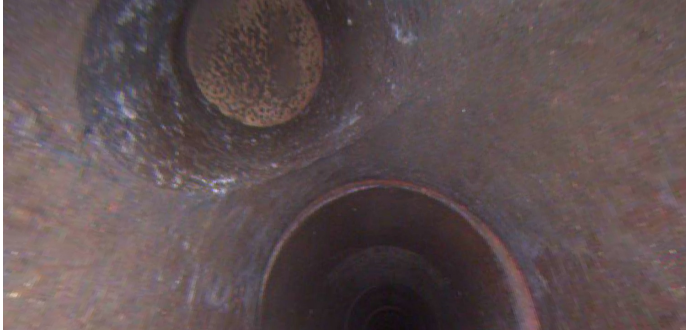
Code: **TFC**
Description: **Tap Factory Capped**

Distance (ft): **14.1**
Structural Grade: **0**
O&M Grade: **0**
Clock Start/From: **11**
Clock To:
1st Value: **4.000**
2nd Value:
Value Percent:
Continuous Index:
Within 8" of Joint: **YES**
Remarks:

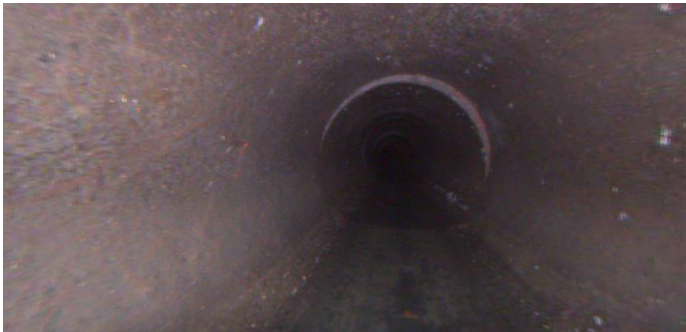
Code: **MSA**
Description: **Abandoned Survey**

Distance (ft): **25.9**
Structural Grade: **0**
O&M Grade: **0**
Clock Start/From:
Clock To:
1st Value:
2nd Value:
Value Percent:
Continuous Index:
Within 8" of Joint: **NO**
Remarks: **no blockage**

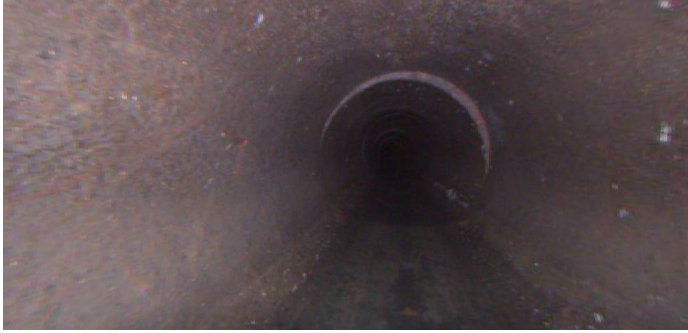
Code:	CM
Description:	Crack Multiple
Distance (ft):	25.9
Structural Grade:	3
O&M Grade:	0
Clock Start/From:	7
Clock To:	5
1st Value:	
2nd Value:	
Value Percent:	
Continuous Index:	F01
Within 8" of Joint:	
Remarks:
