Profile/Photo Observation Report

Date:	04/10/2018	Weather:		Coding:	PACP 6.0
Pipe Length (ft):	73.2	Owner:	NA	Pre Clean:	Not Known
P.O.#:		Surveyor:	Mark Ruby	PSR:	P-503-013-012
Customer:		Clean Date:	01/01/1900	Shape:	C

Location Details:		Direction of Survey:	Downstream
US MH:	M-503-012	DS MH:	M-503-013
		Total Length Surveyed (ft):	71.5

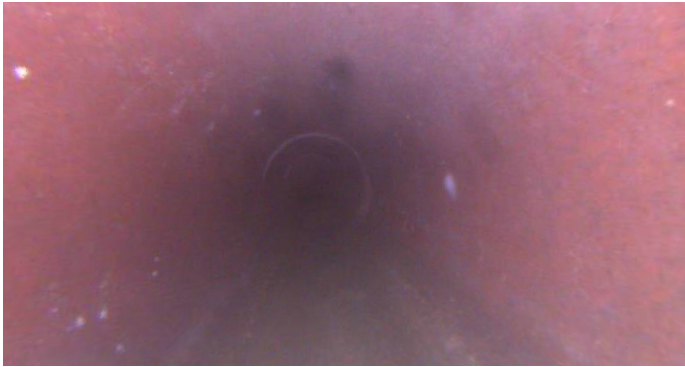
Code:	MWL
Description:	Water Level

Distance (ft):	.0
Structural Grade:	0
O&M Grade:	0
Clock Start/From:	
Clock To:	
1st Value:	
2nd Value:	
Value Percent:	10.000
Continuous Index:	
Within 8" of Joint:	NO
Remarks:

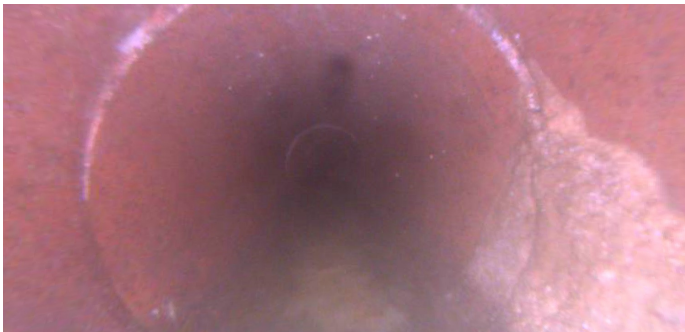
Code:	DAE
Description:	Deposits Attached Encrustation

Distance (ft):	2.9
Structural Grade:	0
O&M Grade:	2
Clock Start/From:	2
Clock To:	4
1st Value:	
2nd Value:	
Value Percent:	5.000
Continuous Index:	
Within 8" of Joint:	YES
Remarks:

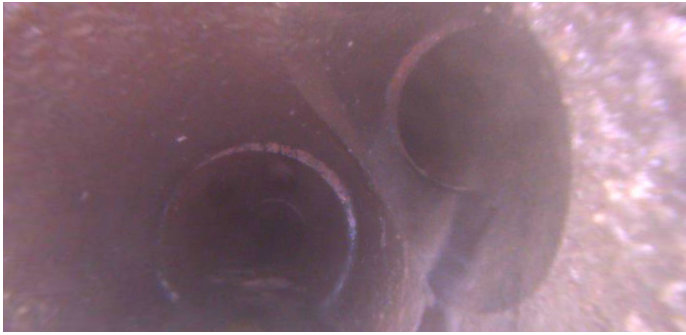
Code: **TB**
Description: **Tap Break-in**

Distance (ft): **25.8**
Structural Grade: **0**
O&M Grade: **0**
Clock Start/From: **2**
Clock To:
1st Value: **4.000**
2nd Value:
Value Percent:
Continuous Index:
Within 8" of Joint:
Remarks:

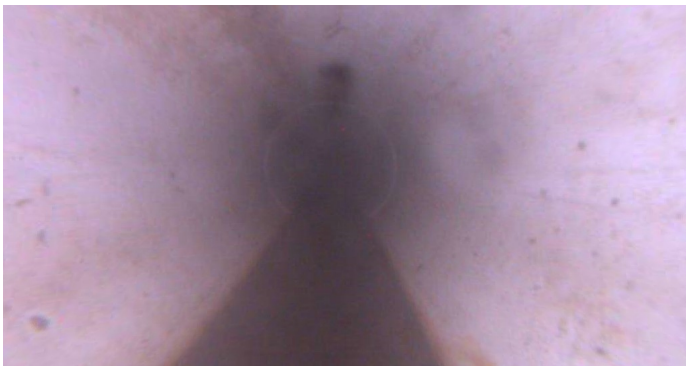
Code: **MMC**
Description: **Material Change**

Distance (ft): **50.4**
Structural Grade: **0**
O&M Grade: **0**
Clock Start/From:
Clock To:
1st Value:
2nd Value:
Value Percent:
Continuous Index:
Within 8" of Joint: **NO**
Remarks: **PVC**

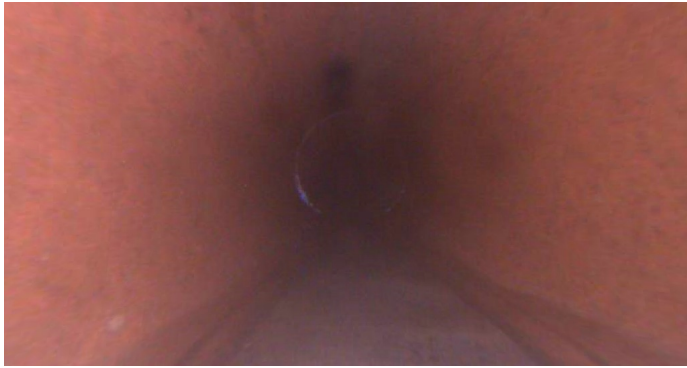
Code: **MMC**
Description: **Material Change**

Distance (ft): **64.8**
Structural Grade: **0**
O&M Grade: **0**
Clock Start/From:
Clock To:
1st Value:
2nd Value:
Value Percent:
Continuous Index:
Within 8" of Joint: **NO**
Remarks: **VCP**

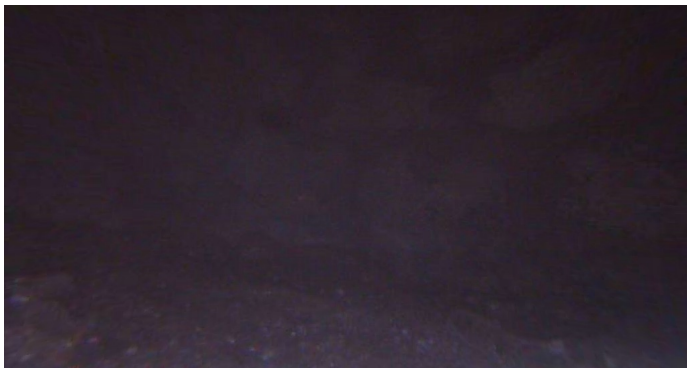
Code: **AMH**
Description: **Manhole**

Distance (ft): **71.5**
Structural Grade: **0**
O&M Grade: **0**
Clock Start/From:
Clock To:
1st Value:
2nd Value:
Value Percent:
Continuous Index:
Within 8" of Joint: **NO**
Remarks: **M-503-013**
