Profile/Photo Observation Report

RUBUIIC
Date:	09/19/2021	Weather:		Coding:	PACP 7.0
Pipe Length (ft):	247.1	Owner:	City of Hobart	Pre Clean:	Light Cleaning
P.O.#:	YES502259	Surveyor:	S. Bucklin	PSR:	P-503-014-012
Customer:	City of Hobart	Clean Date:	09/06/2021	Shape:	С
Street:	North Virginia Stre	et	Flow Control:	Not Controlled	
City:	Hobart, IN		Year Renewed:		
Location:	Local rural streets	with light traffic	, t Tape/Media #:		
Purpose:	Routine Assessme	nt	Dia/Height:	10"	
Use:	Sanitary Sewage P	ipe	Material:	VCP	
Drain Area:			Lining:	None	
Category:	NA				
Comment:					
Location Details	:		Direction of Surv	vey: Upstream	
US MH:	M-503-012	DS MH:	M-503-014	Total Length Surveyed (ft)	: 247.1
O&M Index:	1.92	O&M Quick:	342	Q O&M Rating:	211.00
Structural Index:	3.15	Structural Q	uick: 514	B Structural Rating:	167.00
Overall Index:	2.32	Overall Quic	k: 514	B Overall Rating:	378.00

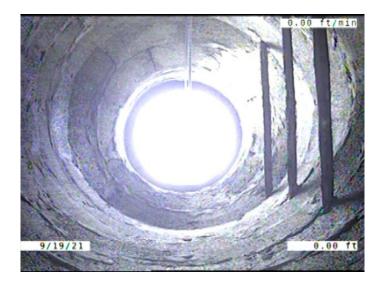
Code:	AMH
Description:	Manhole
Distance (ft):	0
Distance (ft):	.0
Structural Grade:	0
O&M Grade:	0
Clock Start/From:	
Clock To:	
1st Value:	
2nd Value:	
Value Percent:	
Continuous Index:	
Within 8" of Joint:	NO
Remarks:	M-503-014

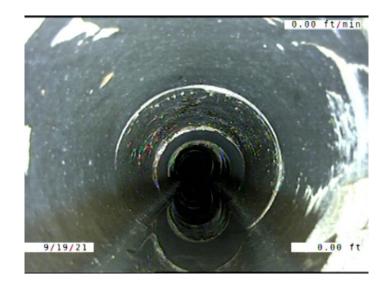
Code: Description:	MWL Miscellaneous Water Level
Distance (ft): Structural Grade: O&M Grade: Clock Start/From: Clock To: 1st Value: 2nd Value: Value Percent:	.0 0 0 5.000
Continuous Index: Within 8" of Joint: Remarks:	ΝΟ

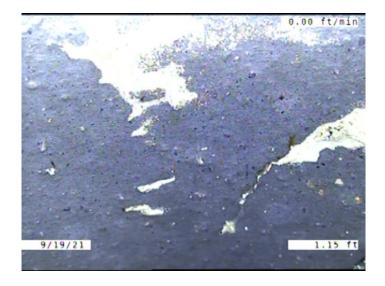
СМ
Crack Multiple
1.2
3
0
12
12
S01
YES

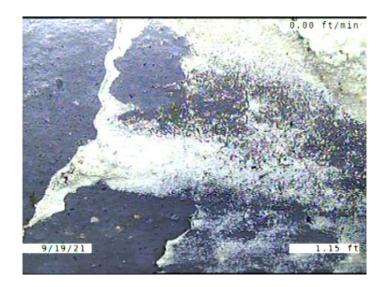
Code:	DAE
Description:	Deposits Attached Encrustation
Distance (ft): Structural Grade: O&M Grade: Clock Start/From: Clock To: 1st Value: 2nd Value: Value Percent: Continuous Index: Within 8" of Joint: Remarks:	1.2 0 2 7 5 5.000 \$02 YES

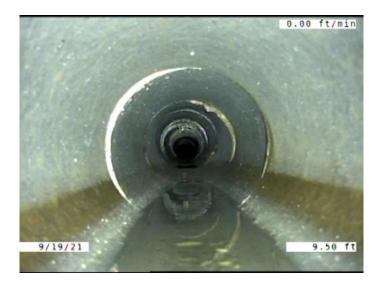
Code: Description:	MWLS Miscellaneous Water Level Sag
Distance (ft):	9.5
Structural Grade:	2
O&M Grade:	0
Clock Start/From:	
Clock To:	
1st Value:	
2nd Value:	
Value Percent:	5.000
Continuous Index:	
Within 8" of Joint:	NO
Remarks:

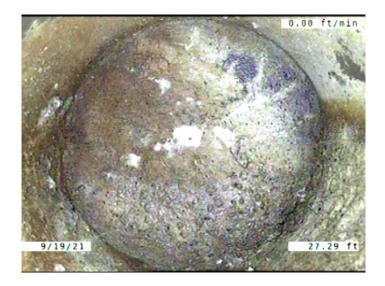
Code: Description:	TFD Tap Factory Defective
Distance (ft):	27.3
Structural Grade:	0
O&M Grade:	3
Clock Start/From:	1
Clock To:	
1st Value:	4.000
2nd Value:	
Value Percent:	
Continuous Index:	
Within 8" of Joint:	YES
Remarks:	CAPPED. LEAKING AROUND THE CAP

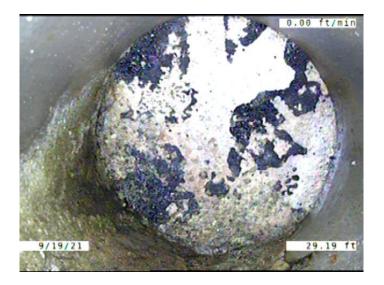
Code:	TFD
Description:	Tap Factory Defective
Distance (ft):	29.2
Structural Grade:	0
O&M Grade:	3
Clock Start/From:	11
Clock To:	
1st Value:	4.000
2nd Value:	
Value Percent:	
Continuous Index:	
Within 8" of Joint:	YES
Remarks:	CAPPED. LEAKING AROUND THE CAP

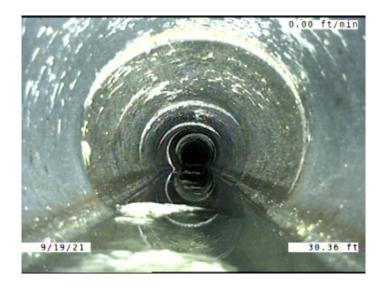
Code:	DSF
Description:	Deposits Settled Fine
Distance (ft): Structural Grade: O&M Grade: Clock Start/From: Clock To: 1st Value: 2nd Value: Value Percent:	30.4 0 2 5 7 5.000
Continuous Index:	S03
Within 8" of Joint:	YES
Remarks:	TP AND RAGS TOO

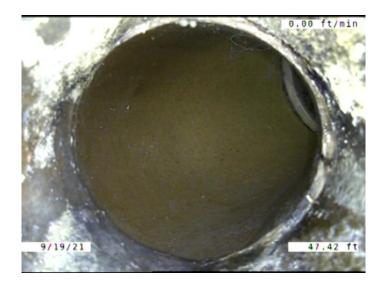
Code:	TF
Description:	Tap Factory
Distance (ft):	47.4
Distance (ft):	47.4
Structural Grade:	0
O&M Grade:	0
Clock Start/From:	1
Clock To:	
1st Value:	4.000
2nd Value:	
Value Percent:	
Continuous Index:	
Within 8" of Joint:	YES
Remarks:

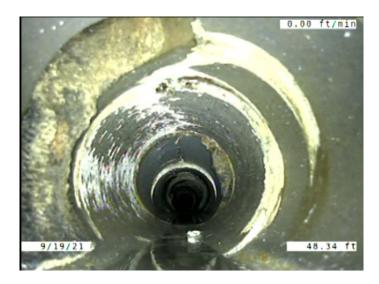
Code: Description:	CM Crack Multiple
Distance (ft): Structural Grade: O&M Grade: Clock Start/From: Clock To: 1st Value: 2nd Value: Value Percent: Continuous Index: Within 8" of Joint:	48.3 3 0 12 12 F01 YES
Remarks:

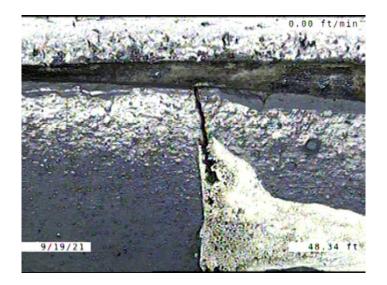
Code:	FM
Description:	Fracture Multiple
	40.2
Distance (ft):	48.3
Structural Grade:	4
O&M Grade:	0
Clock Start/From:	12
Clock To:	12
1st Value:	
2nd Value:	
Value Percent:	
Continuous Index:	S04
Within 8" of Joint:	YES
Remarks:

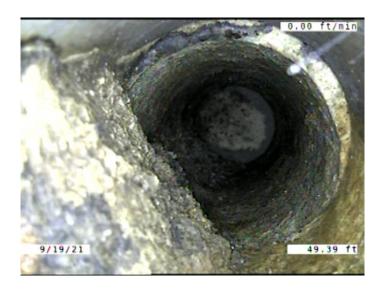
Code: Description:	TFD Tap Factory Defective
Distance (ft):	49.4
Structural Grade:	0
O&M Grade:	3
Clock Start/From:	11
Clock To:	
1st Value:	4.000
2nd Value:	
Value Percent:	
Continuous Index:	
Within 8" of Joint:	YES
Remarks:	LOOKS TO BE CAPPED

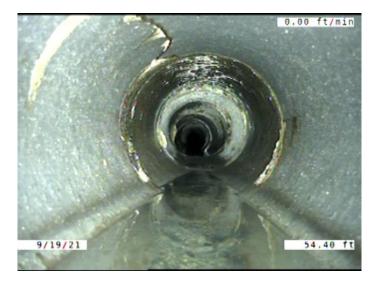
MWLS Miscellaneous Water Level Sag
54.4
2
0
5.000
NO

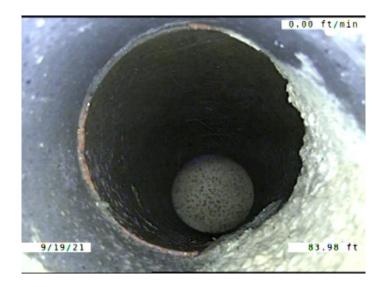
Code: Description:	TFC Tap Factory Capped
Distance (ft): Structural Grade: O&M Grade: Clock Start/From: Clock To: 1st Value: 2nd Value: Value Percent: Continuous Index: Within 8" of Joint: Remarks:	84.0 0 1 4.000 YES

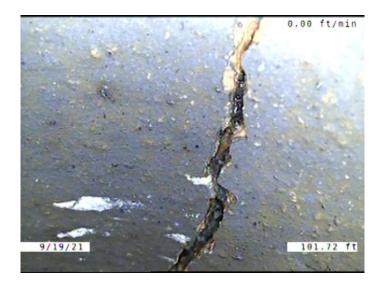
Code: Description:	BSV Broken Soil Visible
Distance (ft):	101.7
Structural Grade:	5
O&M Grade:	0
Clock Start/From:	11
Clock To:	4
1st Value:	
2nd Value:	
Value Percent:	
Continuous Index:	S05
Within 8" of Joint:	YES
Remarks:

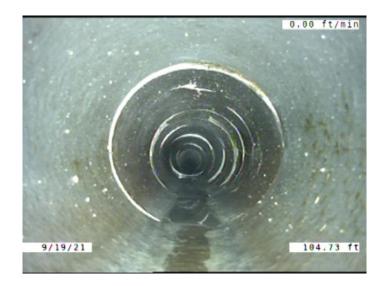
Code: Description:	BSV Broken Soil Visible
Distance (ft): Structural Grade: O&M Grade: Clock Start/From: Clock To: 1st Value: 2nd Value: Value Percent: Continuous Index: Within 8" of Joint:	104.7 5 0 11 4
Within 8" of Joint: Remarks:	YES

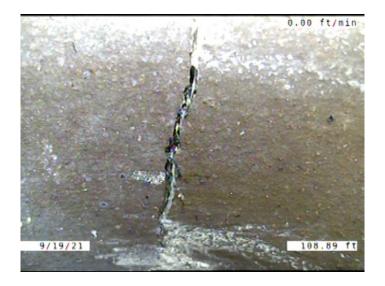
Code:	В
Description:	Broken
	100.0
Distance (ft):	108.9
Structural Grade:	4
O&M Grade:	0
Clock Start/From:	11
Clock To:	3
1st Value:	
2nd Value:	
Value Percent:	
Continuous Index:	
Within 8" of Joint:	YES
Remarks:

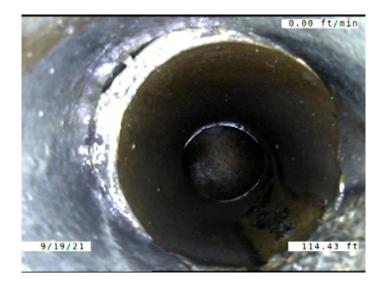
Code:	TFD
Description:	Tap Factory Defective
Distance (ft):	114.4
Structural Grade:	0
O&M Grade:	3
Clock Start/From:	1
Clock To: 1st Value: 2nd Value: Value Percent:	4.000
Value Percent: Continuous Index: Within 8" of Joint: Remarks:	YES CONSTANTLY RUNNING WATER. CONNECTION TO THE MAIN IS LEAKI

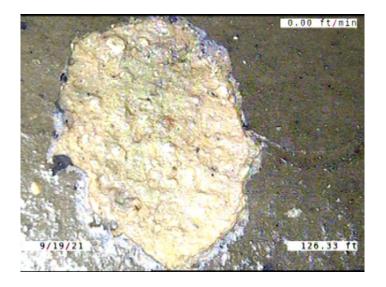
Code: SSS Description: Surface Damage Surface Spalling Distance (ft): 126.3 Structural Grade: 2 O&M Grade: 0 Clock Start/From: 4 Clock To: 7 1st Value: 2nd Value: Value Percent: Continuous Index:

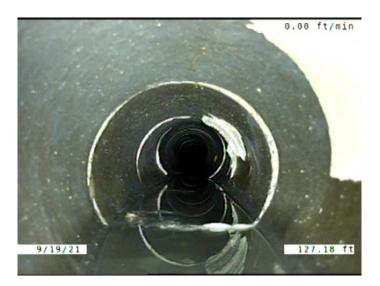
Code: Description:	MWLS Miscellaneous Water Level Sag
Distance (ft):	127.2
Structural Grade:	2
O&M Grade:	0
Clock Start/From:	
Clock To:	
1st Value:	
2nd Value:	
Value Percent:	10.000
Continuous Index:	S06
Within 8" of Joint:	NO
Remarks:

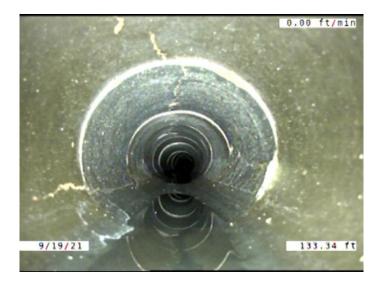
Code:	FM
Description:	Fracture Multiple
Distance (ft):	133.3
Structural Grade:	4
O&M Grade:	0
Clock Start/From:	12
Clock To:	12
1st Value:	
2nd Value:	
Value Percent:	
Continuous Index:	F04
Within 8" of Joint:	YES
Remarks:

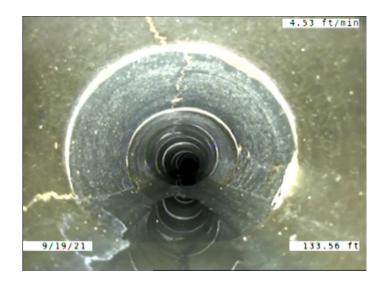
CM Crack Multiple
Structural Grade:	133.6
O&M Grade:	3
Clock Start/From:	0
Clock To:	7
1st Value:	5
2nd Value:	5
Value Percent:	807
Continuous Index:	NO

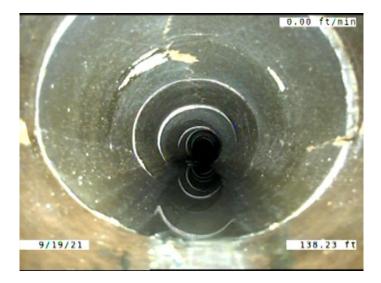
MWLS Miscellaneous Water Level Sag
138.2
2
0
10.000
F06
NO

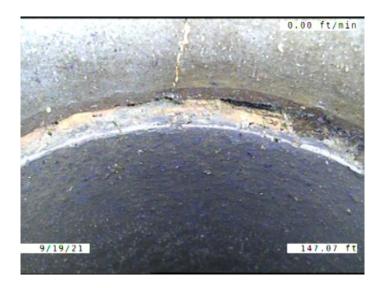
Code: Description:	JOM Joint Offset Medium
Distance (ft): Structural Grade: O&M Grade: Clock Start/From: Clock To: 1st Value: 2nd Value: Value Percent: Continuous Index:	147.1 3 0
Within 8" of Joint: Remarks:	NO

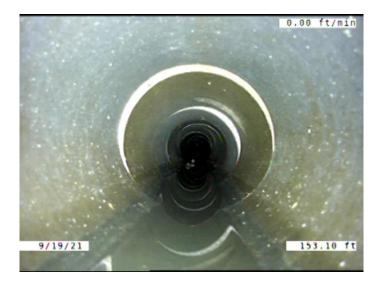
Code: Description:	MWLS Miscellaneous Water Level Sag
Distance (ft):	153.1
Structural Grade:	2
O&M Grade:	0
Clock Start/From:	
Clock To:	
1st Value:	
2nd Value:	
Value Percent:	5.000
Continuous Index:	S08
Within 8" of Joint:	NO
Remarks:

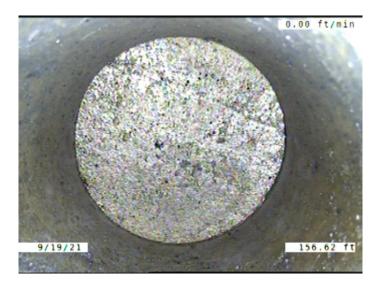
Code: Description:	TFC Tap Factory Capped
Distance (ft): Structural Grade: O&M Grade: Clock Start/From: Clock To: 1st Value: 2nd Value: Value Percent: Continuous Index: Within 8" of Joint: Remarks:	156.6 0 1 4.000 YES

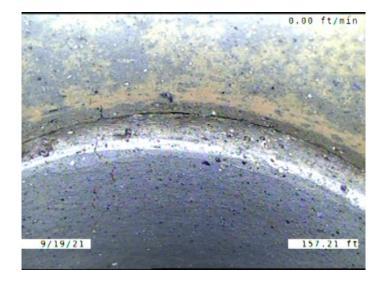
Code: Description:	JOM Joint Offset Medium
Distance (ft):	157.2
Structural Grade:	3
O&M Grade:	0
Clock Start/From:	
Clock To:	
1st Value:	
2nd Value:	
Value Percent:	
Continuous Index:	
Within 8" of Joint:	NO
Remarks:

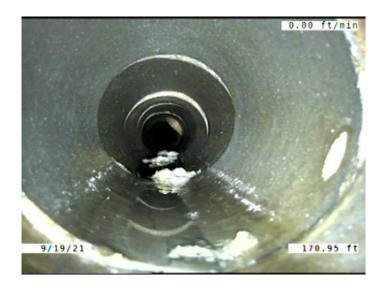
Code: Description:	MWLS Miscellaneous Water Level Sag
Distance (ft):	170.9
Structural Grade:	2
O&M Grade:	0
Clock Start/From:	
Clock To:	
1st Value:	
2nd Value:	
Value Percent:	5.000
Continuous Index:	F08
Within 8" of Joint:	NO
Remarks:

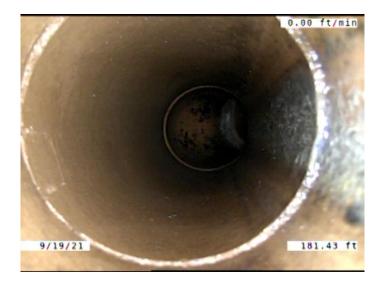
Code:	ТВІ
Description:	Tap Break-in Intruding
Distance (ft):	181.4
Structural Grade:	0
O&M Grade:	2
Clock Start/From:	2
Clock To:	
1st Value:	4.000
2nd Value:	2.000
Value Percent:	
Continuous Index:	
Within 8" of Joint:	NO
Remarks:

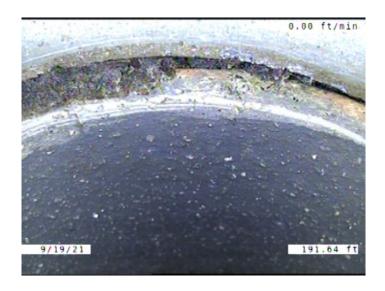
Code: Description:	JOM Joint Offset Medium
Distance (ft): Structural Grade: O&M Grade: Clock Start/From: Clock To: 1st Value: 2nd Value: Value Percent: Continuous Index:	191.6 3 0
Within 8" of Joint: Remarks:	NO

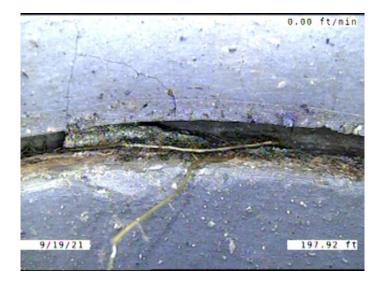
Code:	RFJ
Description:	Roots Fine Joint
Distance (ft):	197.9
Structural Grade:	0
O&M Grade:	1
Clock Start/From:	10
Clock To:	11
1st Value:	
2nd Value:	
Value Percent:	
Continuous Index:	
Within 8" of Joint:	YES
Remarks:

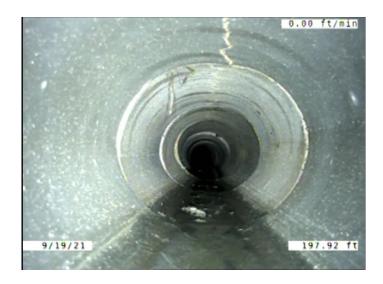
Description: F	L racture Longitudinal
Structural Grade:3O&M Grade:0Clock Start/From:1Clock To:11st Value:22nd Value:2Value Percent:2Continuous Index:5

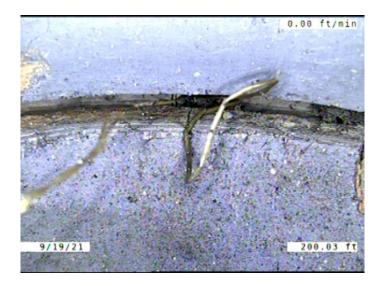
Code: Description:	RFJ Roots Fine Joint
Distance (ft):	200.0
Structural Grade:	0
O&M Grade:	1
Clock Start/From:	11
Clock To:	
1st Value:	
2nd Value:	
Value Percent:	
Continuous Index:	
Within 8" of Joint:	YES
Remarks:

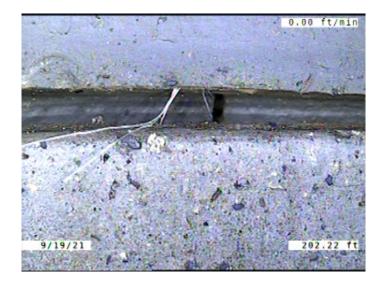
Code: Description:	RFJ Roots Fine Joint
Distance (ft):	202.2
Structural Grade:	0
O&M Grade:	1
Clock Start/From:	8
Clock To:	9
1st Value:	
2nd Value:	
Value Percent:	
Continuous Index:	
Within 8" of Joint:	YES
Remarks:

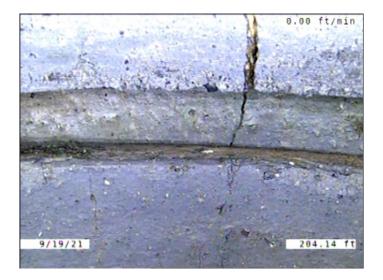
Code: Description:	FL Fracture Longitudinal
Distance (ft):	204.1
Structural Grade:	3
O&M Grade:	0
Clock Start/From:	12
Clock To:	
1st Value:	
2nd Value:	
Value Percent:	
Continuous Index:	F10
Within 8" of Joint:	NO
Remarks:

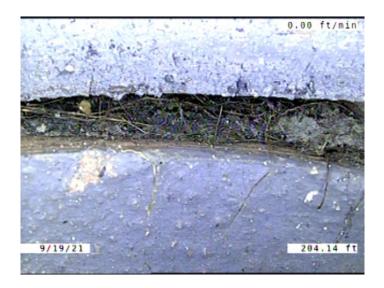
Code: Description:	RFJ Roots Fine Joint
Distance (ft):	204.1
Structural Grade:	0
O&M Grade:	1
Clock Start/From:	7
Clock To:	11
1st Value:	
2nd Value:	
Value Percent:	
Continuous Index:	
Within 8" of Joint:	YES
Remarks:

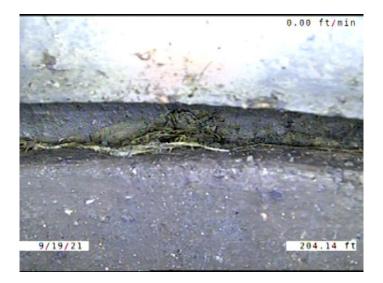
Code: Description:	RFJ Roots Fine Joint
Distance (ft):	204.1
Structural Grade:	0
O&M Grade:	1
Clock Start/From:	2
Clock To:	5
1st Value:	
2nd Value:	
Value Percent:	
Continuous Index:	
Within 8" of Joint:	YES
Remarks:

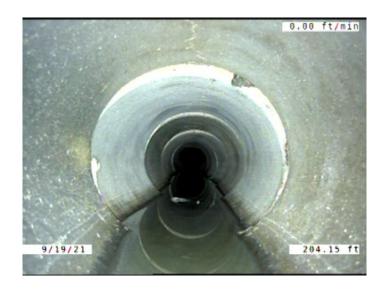
Code: Description:	MWLS Miscellaneous Water Level Sag
Distance (ft):	204.1
Structural Grade:	2
O&M Grade:	0
Clock Start/From:	
Clock To:	
1st Value:	
2nd Value:	
Value Percent:	10.000
Continuous Index:	S09
Within 8" of Joint:	NO
Remarks:

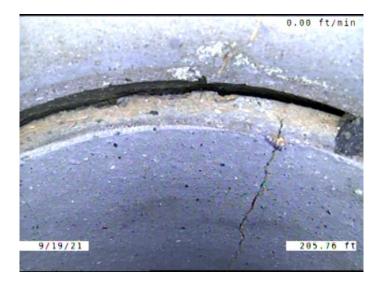
Code: Description:	JOM Joint Offset Medium
Distance (ft):	205.8
Structural Grade:	3
O&M Grade:	0
Clock Start/From:	
Clock To:	
1st Value:	
2nd Value:	
Value Percent:	
Continuous Index:	
Within 8" of Joint:	NO
Remarks:

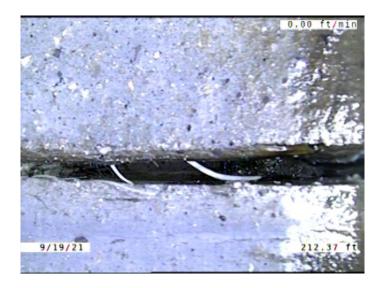
Code: Description:	RFJ Roots Fine Joint
Distance (ft):	212.4
Structural Grade:	0
O&M Grade:	1
Clock Start/From:	8
Clock To:	9
1st Value:	
2nd Value:	
Value Percent:	
Continuous Index:	
Within 8" of Joint:	YES
Remarks:

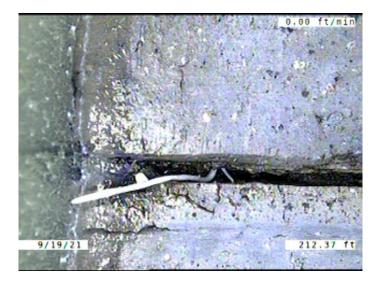
Code:	RFJ
Description:	Roots Fine Joint
Distance (ft):	212.4
Structural Grade:	0
O&M Grade:	1
Clock Start/From:	4
Clock To:	
1st Value:	
2nd Value:	
Value Percent:	
Continuous Index:	
Within 8" of Joint:	YES
Remarks:

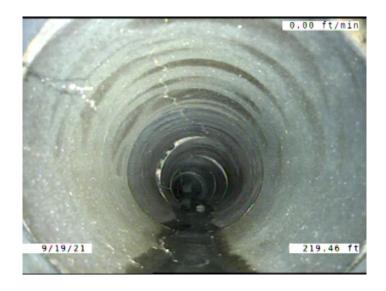
Code: Description:	MWLS Miscellaneous Water Level Sag
Distance (ft):	219.5
Structural Grade:	2
O&M Grade:	0
Clock Start/From:	
Clock To:	
1st Value:	
2nd Value:	
Value Percent:	10.000
Continuous Index:	F09
Within 8" of Joint:	NO
Remarks:

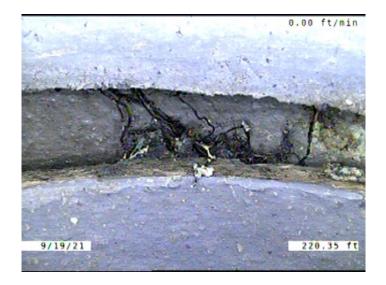
Code:	RFJ
Description:	Roots Fine Joint
Distance (ft):	220.3
Structural Grade:	0
O&M Grade:	1
Clock Start/From:	2
Clock To:	4
1st Value:	
2nd Value:	
Value Percent:	
Continuous Index:	
Within 8" of Joint:	YES
Remarks:

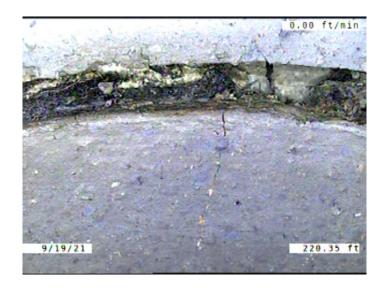
Code: Description:	RFJ Roots Fine Joint
Distance (ft): Structural Grade: O&M Grade: Clock Start/From: Clock To: 1st Value: 2nd Value: Value Percent: Continuous Index: Within 8" of Joint:	220.3 0 1 8 11 S10 YES
Remarks:

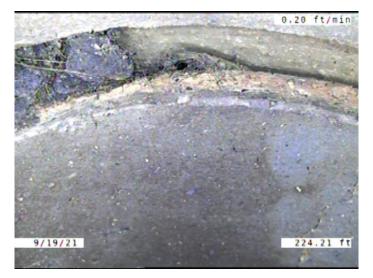
Code: JOMD Description: Joint Offset Medium Defective Distance (ft): 224.2 Structural Grade: 3 O&M Grade: 0 Clock Start/From: Clock To: 1st Value: 2nd Value: Value Percent: Continuous Index: Within 8" of Joint: NO Remarks:

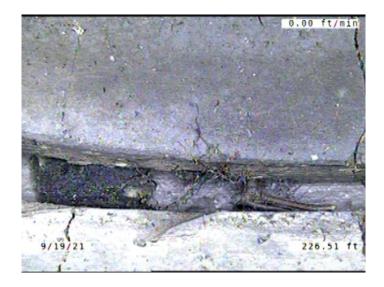
Code: Description:	RFJ Roots Fine Joint
Distance (ft): Structural Grade: O&M Grade: Clock Start/From: Clock To: 1st Value: 2nd Value:	226.5 0 1 8 4
Value Percent: Continuous Index: Within 8" of Joint: Remarks:	S11 YES

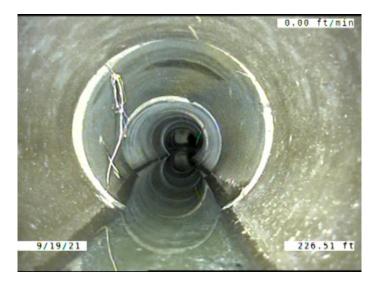
Code:	RFJ
Description:	Roots Fine Joint
	226 5
Distance (ft):	226.5
Structural Grade:	0
O&M Grade:	1
Clock Start/From:	8
Clock To:	11
1st Value:	
2nd Value:	
Value Percent:	
Continuous Index:	F10
Within 8" of Joint:	YES
Remarks:

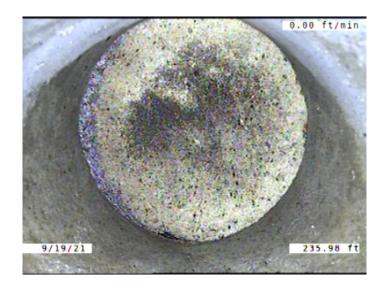
Code: Description:	TFC Tap Factory Capped
Distance (ft): Structural Grade: O&M Grade: Clock Start/From: Clock To: 1st Value: 2nd Value: Value Percent:	236.0 0 0 1 4.000
Continuous Index: Within 8" of Joint: Remarks:	YES

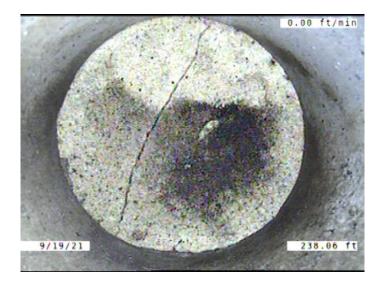
Code:	TFC
Description:	Tap Factory Capped
Distance (ft):	238.1
Structural Grade:	0
O&M Grade:	0
Clock Start/From:	11
Clock To:	
1st Value:	4.000
2nd Value:	
Value Percent:	
Continuous Index:	
Within 8" of Joint:	YES
Remarks:	CAP CRACKED

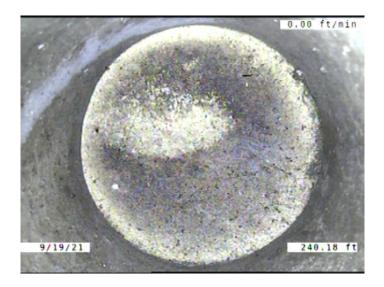
Code: Description:	TFC Tap Factory Capped
Distance (ft): Structural Grade: O&M Grade: Clock Start/From: Clock To: 1st Value: 2nd Value: Value Percent: Continuous Index: Within 8" of Joint: Remarks:	240.2 0 0 1 4.000 YES

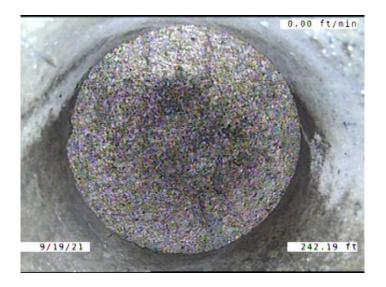
Code:	TFC
Description:	Tap Factory Capped
Distance (ft):	242.2
Structural Grade:	0
O&M Grade:	0
Clock Start/From:	11
Clock To:	
1st Value:	4.000
2nd Value:	
Value Percent:	
Continuous Index:	
Within 8" of Joint:	YES
Remarks:

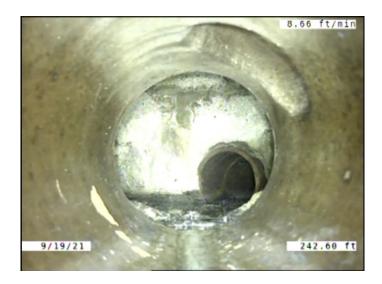
Code:	CM
Description:	Crack Multiple
Distance (ft): Structural Grade: O&M Grade: Clock Start/From: Clock To: 1st Value: 2nd Value: Value Percent: Continuous Index: Within 8" of Joint: Remarks:	242.6 3 0 7 5 5 807 NO

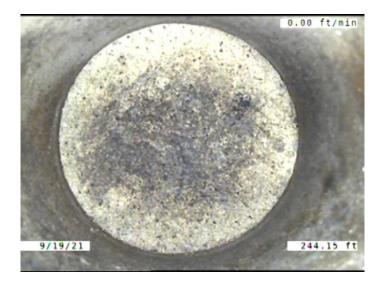
Code:	TFC
Description:	Tap Factory Capped
Distance (ft):	244.1
Structural Grade:	0
O&M Grade:	0
Clock Start/From:	1
Clock To:	
1st Value:	4.000
2nd Value:	
Value Percent:	
Continuous Index:	
Within 8" of Joint:	YES
Remarks:

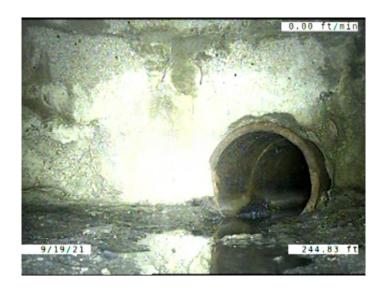
Code:	DAE
Description:	Deposits Attached Encrustation
Distance (ft): Structural Grade: O&M Grade: Clock Start/From: Clock To: 1st Value: 2nd Value: Value Percent: Continuous Index: Within 8" of Joint: Remarks:	244.8 0 2 7 5 5 5.000 F02 YES

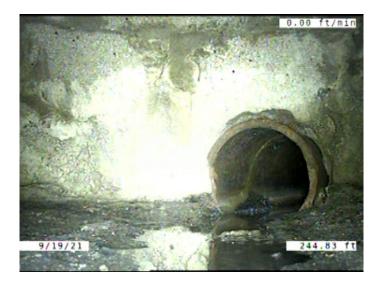
Code:	DSF
Description:	Deposits Settled Fine
Distance (ft):	244.8
Structural Grade:	0
O&M Grade:	2
Clock Start/From:	5
Clock To:	7
1st Value:	
2nd Value:	
Value Percent:	5.000
Continuous Index:	F03
Within 8" of Joint:	YES
Remarks:	TP AND RAGS TOO

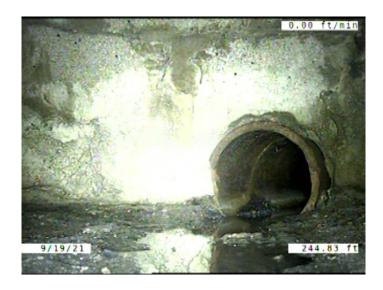
Code: Description:	RFJ Roots Fine Joint
Distance (ft): Structural Grade: O&M Grade: Clock Start/From: Clock To: 1st Value: 2nd Value: Value Percent: Continuous Index: Within 8" of Joint: Remarks:	244.8 O 1 8 4 F11 YES

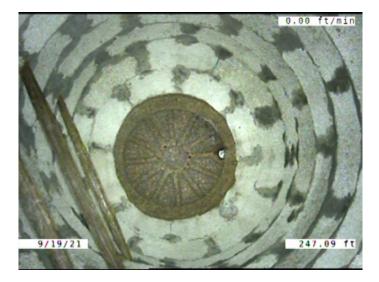
Code:	AMH
Description:	Manhole
Distance (ft):	247.1
Structural Grade:	0
O&M Grade:	0
Clock Start/From: Clock To: 1st Value: 2nd Value: Value Percent: Continuous Index: Within 8" of Joint: Remarks:	NO M-503-012
