Profile/Photo Observation Report

Date:	04/12/2018	Weather:		Coding:	PACP 6.0
Pipe Length (ft):	185.7	Owner:	NA	Pre Clean:	Not Known
P.O.#:		Surveyor:	Jen Costello	PSR:	P-503-019-017
Customer:		Clean Date:	01/01/1900	Shape:	C

Street:	ALLEY BETWEEN W 39TH PL & W 39	Flow Control:	Not Controlled
City:	Hobart, IN	Year Renewed:	
Location:	Other	Tape/Media #:	
Purpose:	Not Known	Dia/Height:	10"
Use:	Sanitary	Material:	VCP
Drain Area:	NA	Lining:	
Category:	NA		
Comment:

Location Details:		Direction of Survey:	Downstream
US MH:	M-503-017	DS MH:	M-503-019
		Total Length Surveyed (ft):	188.4

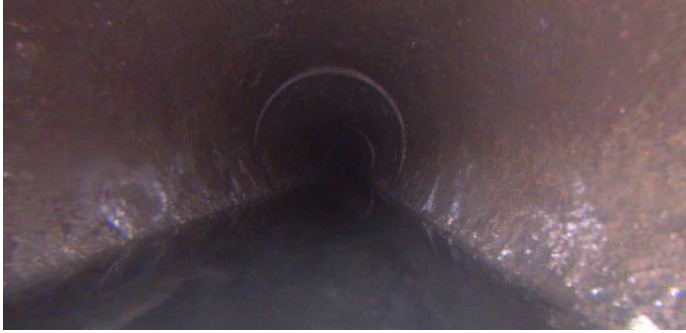
Code: **AMH**
Description: **Manhole**

Distance (ft): **.0**
Structural Grade: **0**
O&M Grade: **0**
Clock Start/From:
Clock To:
1st Value:
2nd Value:
Value Percent:
Continuous Index:
Within 8" of Joint: **NO**
Remarks: **M-503-017**

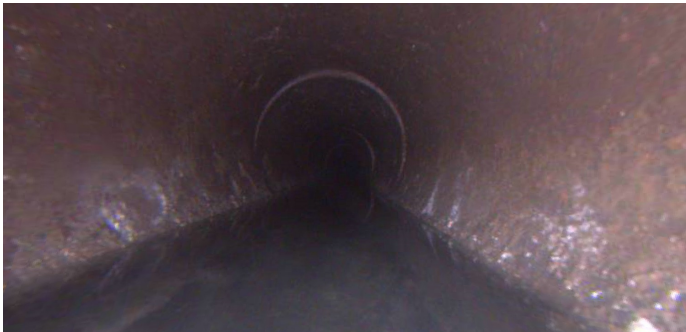
Code: **MWL**
Description: **Water Level**

Distance (ft): **.0**
Structural Grade: **0**
O&M Grade: **0**
Clock Start/From:
Clock To:
1st Value:
2nd Value:
Value Percent: **10.000**
Continuous Index:
Within 8" of Joint: **NO**
Remarks:

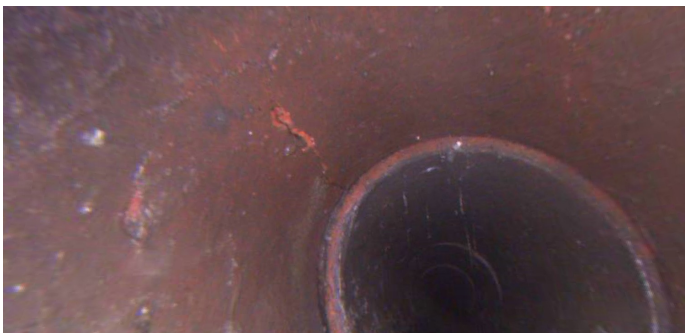
Code: **FM**
Description: **Fracture Multiple**

Distance (ft): **14.7**
Structural Grade: **4**
O&M Grade: **0**
Clock Start/From: **8**
Clock To: **11**
1st Value:
2nd Value:
Value Percent:
Continuous Index:
Within 8" of Joint: **YES**
Remarks:

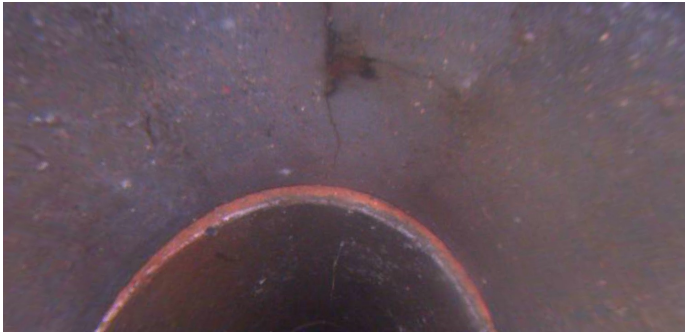
Code: **FM**
Description: **Fracture Multiple**

Distance (ft): **19.1**
Structural Grade: **4**
O&M Grade: **0**
Clock Start/From: **12**
Clock To: **1**
1st Value:
2nd Value:
Value Percent:
Continuous Index:
Within 8" of Joint: **YES**
Remarks:

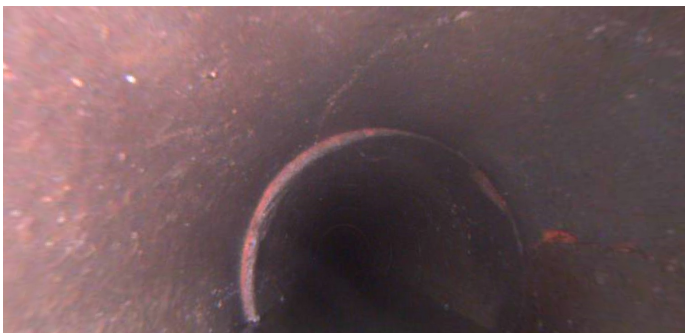
Code: **FM**
Description: **Fracture Multiple**

Distance (ft): **29.4**
Structural Grade: **4**
O&M Grade: **0**
Clock Start/From: **8**
Clock To: **4**
1st Value:
2nd Value:
Value Percent:
Continuous Index:
Within 8" of Joint: **YES**
Remarks:

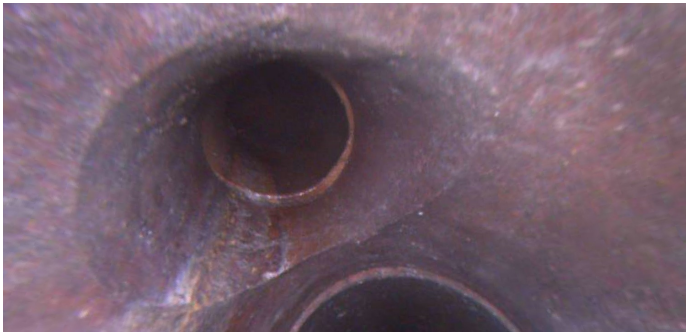
Code: **TF**
Description: **Tap Factory**

Distance (ft): **37.7**
Structural Grade: **0**
O&M Grade: **0**
Clock Start/From: **11**
Clock To:
1st Value: **4.000**
2nd Value:
Value Percent:
Continuous Index:
Within 8" of Joint:
Remarks:

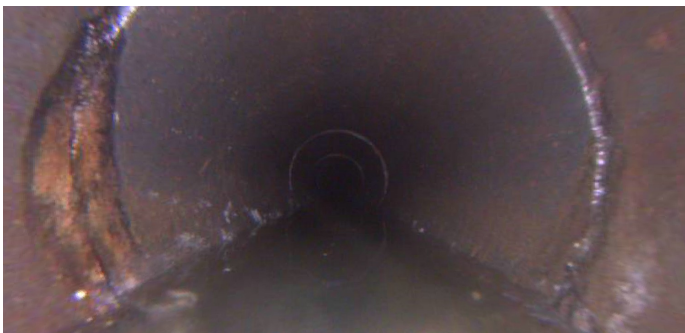
Code: **IW**
Description: **Infil Weeper**

Distance (ft): **54.9**
Structural Grade: **0**
O&M Grade: **2**
Clock Start/From: **8**
Clock To: **10**
1st Value:
2nd Value:
Value Percent:
Continuous Index:
Within 8" of Joint: **YES**
Remarks:

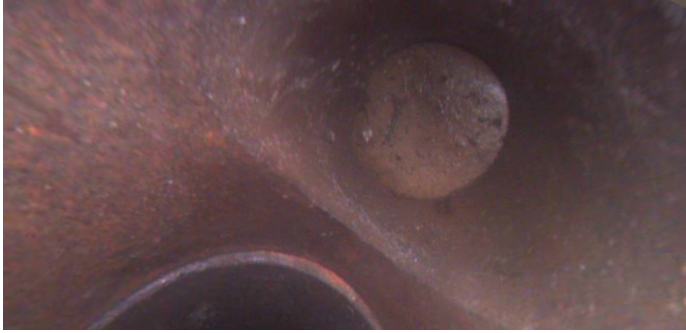
Code: **TFC**
Description: **Tap Factory Capped**

Distance (ft): **73.2**
Structural Grade: **0**
O&M Grade: **0**
Clock Start/From: **1**
Clock To:
1st Value: **4.000**
2nd Value:
Value Percent:
Continuous Index:
Within 8" of Joint:
Remarks:

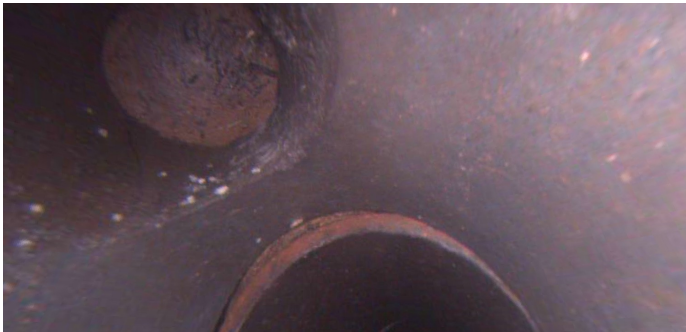
Code: **TFC**
Description: **Tap Factory Capped**

Distance (ft): **75.4**
Structural Grade: **0**
O&M Grade: **0**
Clock Start/From: **11**
Clock To:
1st Value: **4.000**
2nd Value:
Value Percent:
Continuous Index:
Within 8" of Joint:
Remarks:

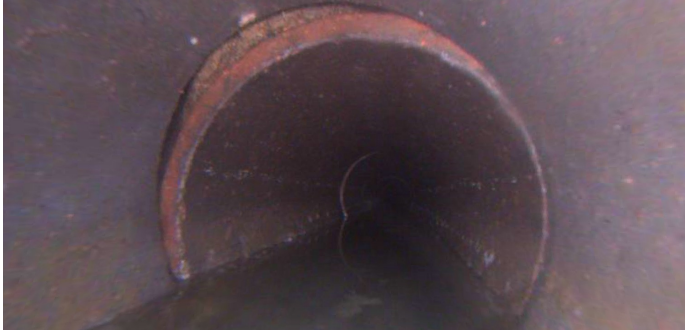
Code: **JOM**
Description: **Joint Offset Medium**

Distance (ft): **75.6**
Structural Grade: **1**
O&M Grade: **0**
Clock Start/From:
Clock To:
1st Value:
2nd Value:
Value Percent:
Continuous Index:
Within 8" of Joint: **NO**
Remarks:

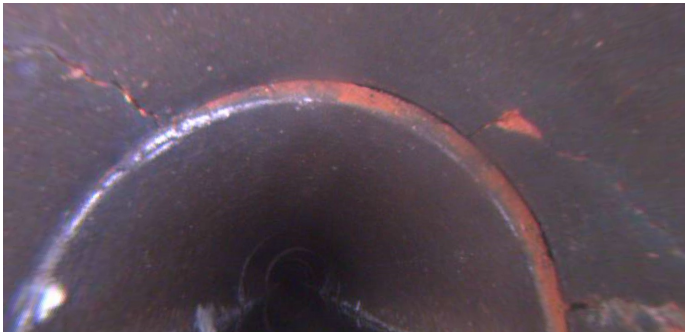
Code: **FM**
Description: **Fracture Multiple**

Distance (ft): **82.0**
Structural Grade: **4**
O&M Grade: **0**
Clock Start/From: **8**
Clock To: **4**
1st Value:
2nd Value:
Value Percent:
Continuous Index:
Within 8" of Joint: **YES**
Remarks:

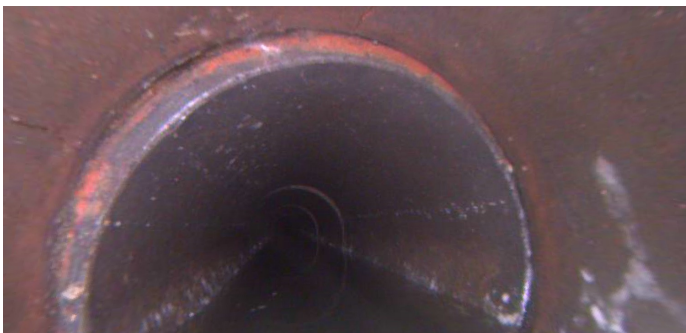
Code: **FM**
Description: **Fracture Multiple**

Distance (ft): **86.1**
Structural Grade: **4**
O&M Grade: **0**
Clock Start/From: **8**
Clock To: **4**
1st Value:
2nd Value:
Value Percent:
Continuous Index:
Within 8" of Joint: **YES**
Remarks:

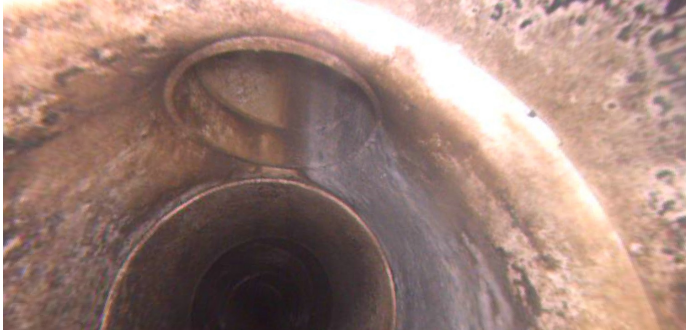
Code: **TF**
Description: **Tap Factory**

Distance (ft): **116.1**
Structural Grade: **0**
O&M Grade: **0**
Clock Start/From: **12**
Clock To:
1st Value: **4.000**
2nd Value:
Value Percent:
Continuous Index:
Within 8" of Joint:
Remarks:

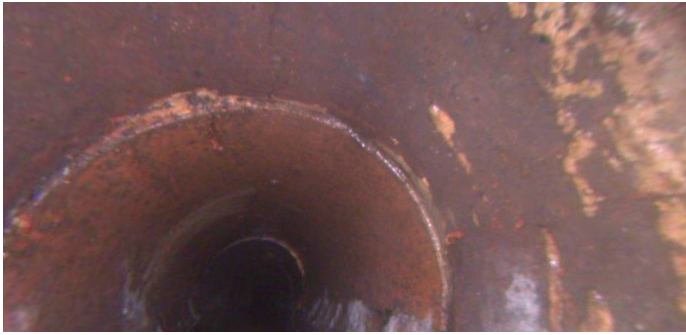
Code: **FM**
Description: **Fracture Multiple**

Distance (ft): **119.6**
Structural Grade: **4**
O&M Grade: **0**
Clock Start/From: **8**
Clock To: **4**
1st Value:
2nd Value:
Value Percent:
Continuous Index: **S01**
Within 8" of Joint: **YES**
Remarks:

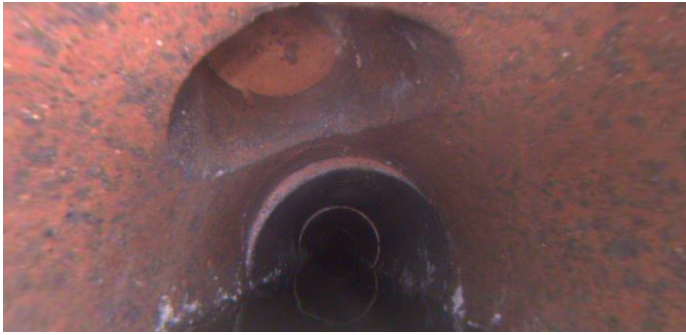
Code: **TFC**
Description: **Tap Factory Capped**

Distance (ft): **148.5**
Structural Grade: **0**
O&M Grade: **0**
Clock Start/From: **11**
Clock To:
1st Value: **4.000**
2nd Value:
Value Percent:
Continuous Index:
Within 8" of Joint:
Remarks:

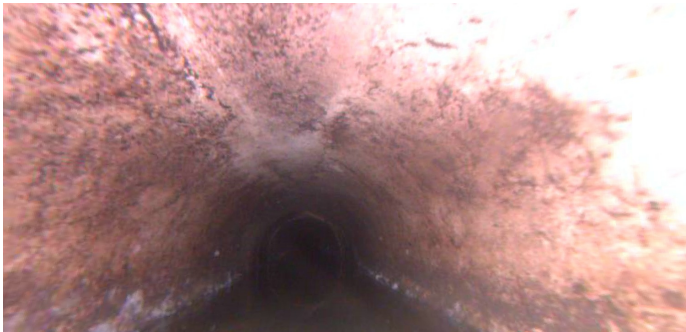
Code: **FM**
Description: **Fracture Multiple**

Distance (ft): **151.6**
Structural Grade: **4**
O&M Grade: **0**
Clock Start/From: **8**
Clock To: **4**
1st Value:
2nd Value:
Value Percent:
Continuous Index: **F01**
Within 8" of Joint: **YES**
Remarks:

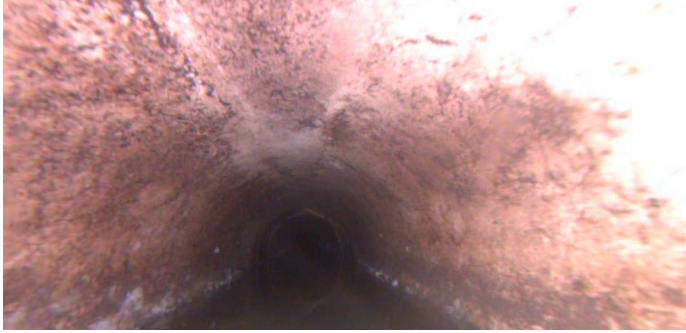
Code: **MMC**
Description: **Material Change**

Distance (ft): **151.6**
Structural Grade: **0**
O&M Grade: **0**
Clock Start/From:
Clock To:
1st Value:
2nd Value:
Value Percent:
Continuous Index:
Within 8" of Joint: **NO**
Remarks: **PVC**

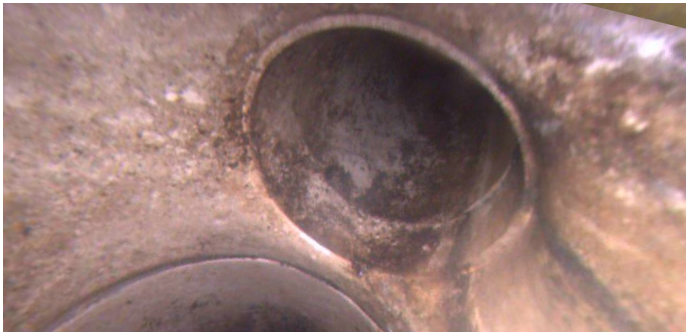
Code: **TF**
Description: **Tap Factory**

Distance (ft): **154.4**
Structural Grade: **0**
O&M Grade: **0**
Clock Start/From: **1**
Clock To:
1st Value: **4.000**
2nd Value:
Value Percent:
Continuous Index:
Within 8" of Joint:
Remarks:

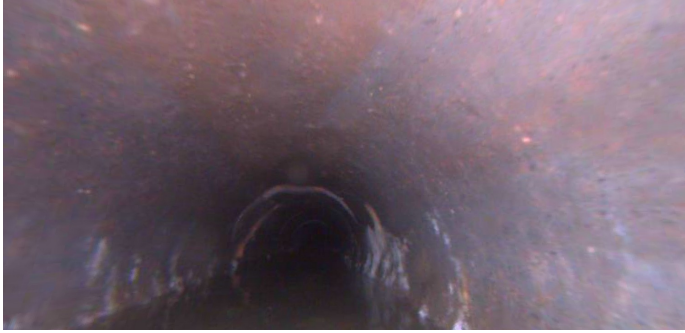
Code: **MMC**
Description: **Material Change**

Distance (ft): **158.1**
Structural Grade: **0**
O&M Grade: **0**
Clock Start/From:
Clock To:
1st Value:
2nd Value:
Value Percent:
Continuous Index:
Within 8" of Joint: **NO**
Remarks: **vcp**

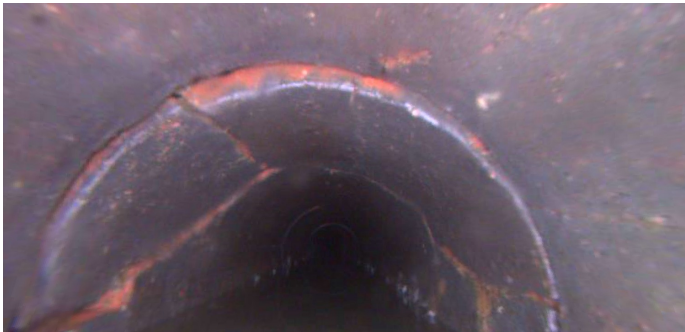
Code: **FM**
Description: **Fracture Multiple**

Distance (ft): **159.7**
Structural Grade: **4**
O&M Grade: **0**
Clock Start/From: **8**
Clock To: **4**
1st Value:
2nd Value:
Value Percent:
Continuous Index: **S02**
Within 8" of Joint: **YES**
Remarks:

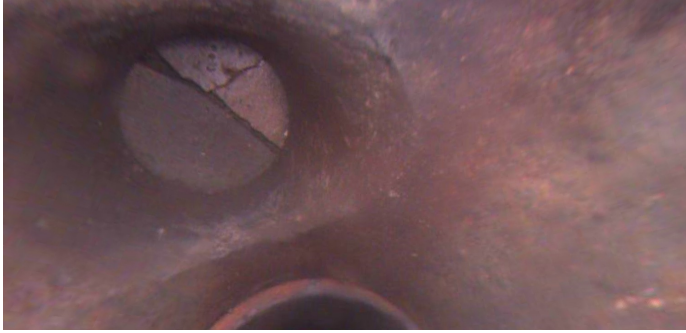
Code: **TFC**
Description: **Tap Factory Capped**

Distance (ft): **186.3**
Structural Grade: **0**
O&M Grade: **0**
Clock Start/From: **11**
Clock To:
1st Value: **4.000**
2nd Value:
Value Percent:
Continuous Index:
Within 8" of Joint:
Remarks:
