Profile/Photo Observation Report

Street:	W 40th ave	Flow Control:	Not Controlled
City:	Hobart, IN	Year Renewed:	
Location:	Other	Tape/Media #:	
Purpose:	Not Known	Dia/Height:	10"
Use:	Sanitary	Material:	VCP
Drain Area:	NA	Lining:	
Category:	NA		
Comment:

Location Details:		Direction of Survey:	Downstream
US MH:	M-503-017	DS MH:	M-503-019
		Total Length Surveyed (ft):	188.4

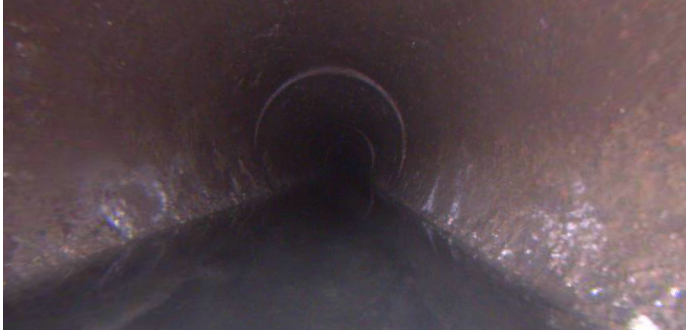
Code: **AMH**
Description: **Manhole**

Distance (ft): **.0**
Structural Grade: **0**
O&M Grade: **0**
Clock Start/From:
Clock To:
1st Value:
2nd Value:
Value Percent:
Continuous Index:
Within 8" of Joint: **NO**
Remarks: **M-503-017**

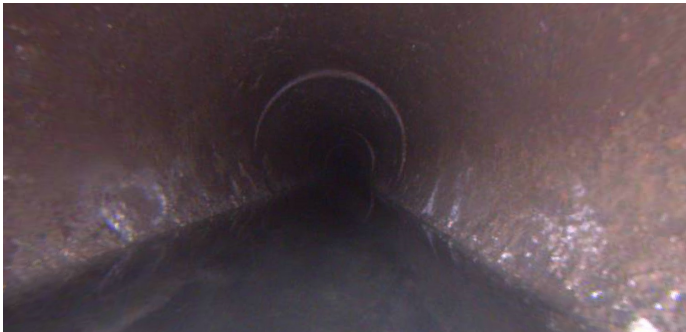
Code: **MWL**
Description: **Water Level**

Distance (ft): **.0**
Structural Grade: **0**
O&M Grade: **0**
Clock Start/From:
Clock To:
1st Value:
2nd Value:
Value Percent: **10.000**
Continuous Index:
Within 8" of Joint: **NO**
Remarks:

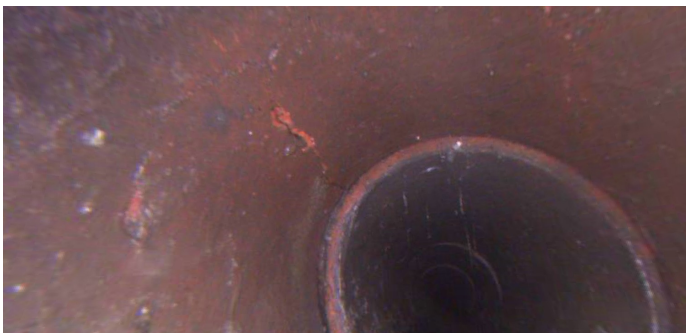
Code: **FM**
Description: **Fracture Multiple**

Distance (ft): **14.7**
Structural Grade: **4**
O&M Grade: **0**
Clock Start/From: **8**
Clock To: **11**
1st Value:
2nd Value:
Value Percent:
Continuous Index:
Within 8" of Joint: **YES**
Remarks:

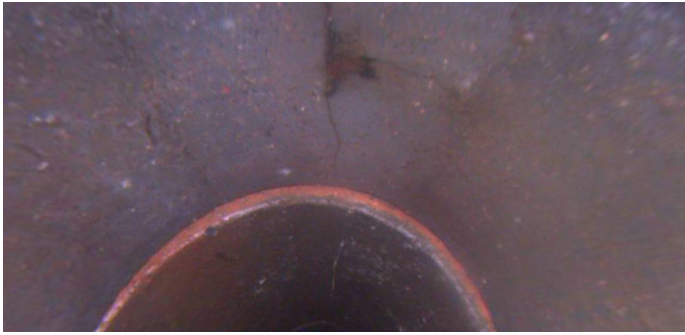
Code: **FM**
Description: **Fracture Multiple**

Distance (ft): **19.1**
Structural Grade: **4**
O&M Grade: **0**
Clock Start/From: **12**
Clock To: **1**
1st Value:
2nd Value:
Value Percent:
Continuous Index:
Within 8" of Joint: **YES**
Remarks:

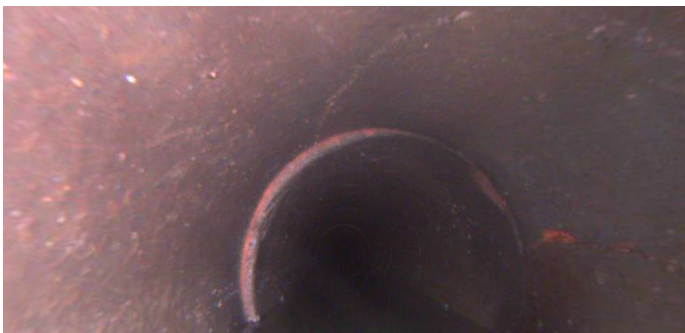
Code: **FM**
Description: **Fracture Multiple**

Distance (ft): **29.4**
Structural Grade: **4**
O&M Grade: **0**
Clock Start/From: **8**
Clock To: **4**
1st Value:
2nd Value:
Value Percent:
Continuous Index:
Within 8" of Joint: **YES**
Remarks:

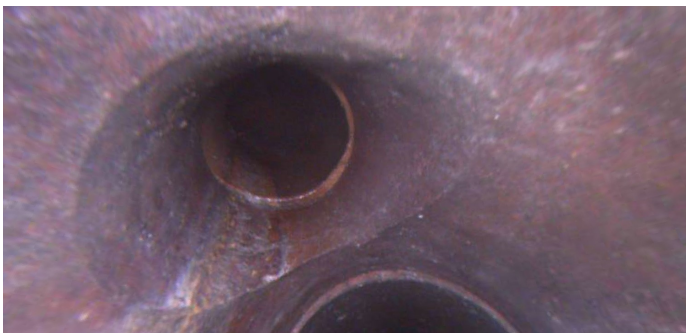
Code: **TF**
Description: **Tap Factory**

Distance (ft): **37.7**
Structural Grade: **0**
O&M Grade: **0**
Clock Start/From: **11**
Clock To:
1st Value: **4.000**
2nd Value:
Value Percent:
Continuous Index:
Within 8" of Joint:
Remarks:

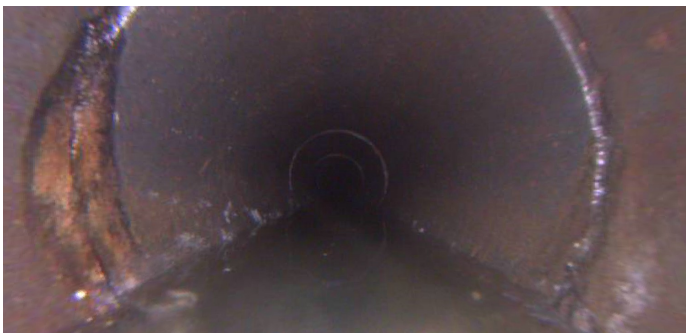
Code: **IW**
Description: **Infil Weeper**

Distance (ft): **54.9**
Structural Grade: **0**
O&M Grade: **2**
Clock Start/From: **8**
Clock To: **10**
1st Value:
2nd Value:
Value Percent:
Continuous Index:
Within 8" of Joint: **YES**
Remarks:

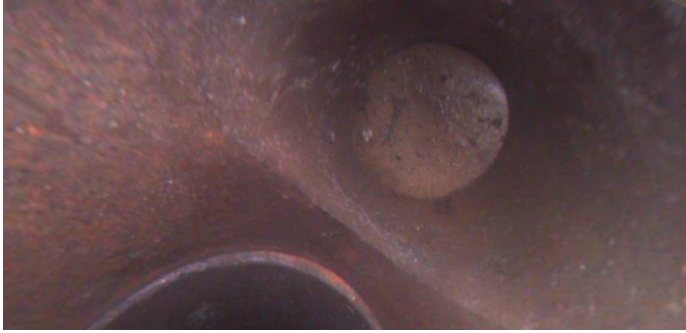
Code: **TFC**
Description: **Tap Factory Capped**

Distance (ft): **73.2**
Structural Grade: **0**
O&M Grade: **0**
Clock Start/From: **1**
Clock To:
1st Value: **4.000**
2nd Value:
Value Percent:
Continuous Index:
Within 8" of Joint:
Remarks:

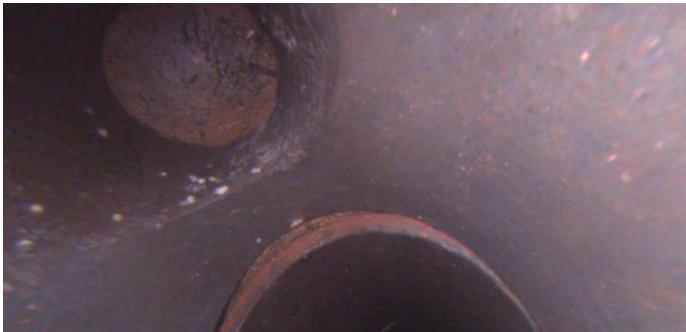
Code: **TFC**
Description: **Tap Factory Capped**

Distance (ft): **75.4**
Structural Grade: **0**
O&M Grade: **0**
Clock Start/From: **11**
Clock To:
1st Value: **4.000**
2nd Value:
Value Percent:
Continuous Index:
Within 8" of Joint:
Remarks:

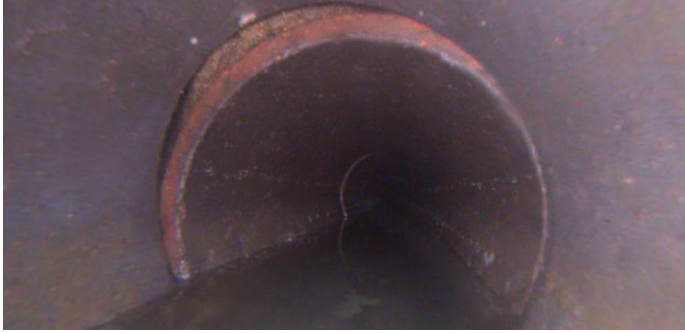
Code: **JOM**
Description: **Joint Offset Medium**

Distance (ft): **75.6**
Structural Grade: **1**
O&M Grade: **0**
Clock Start/From:
Clock To:
1st Value:
2nd Value:
Value Percent:
Continuous Index:
Within 8" of Joint: **NO**
Remarks:

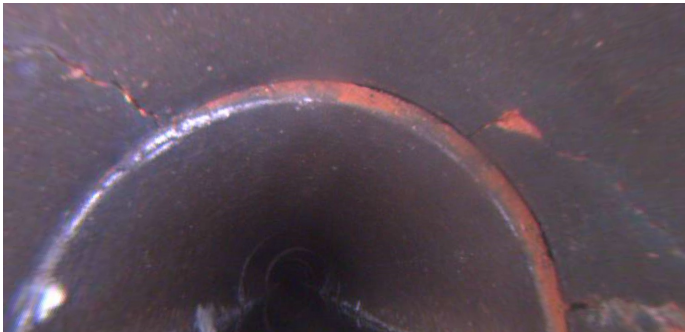
Code: **FM**
Description: **Fracture Multiple**

Distance (ft): **82.0**
Structural Grade: **4**
O&M Grade: **0**
Clock Start/From: **8**
Clock To: **4**
1st Value:
2nd Value:
Value Percent:
Continuous Index:
Within 8" of Joint: **YES**
Remarks:

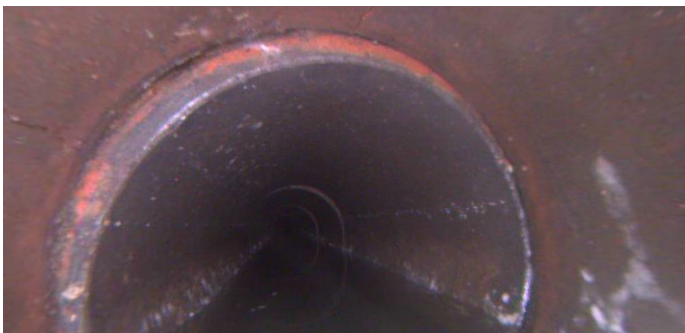
Code: **FM**
Description: **Fracture Multiple**

Distance (ft): **86.1**
Structural Grade: **4**
O&M Grade: **0**
Clock Start/From: **8**
Clock To: **4**
1st Value:
2nd Value:
Value Percent:
Continuous Index:
Within 8" of Joint: **YES**
Remarks:

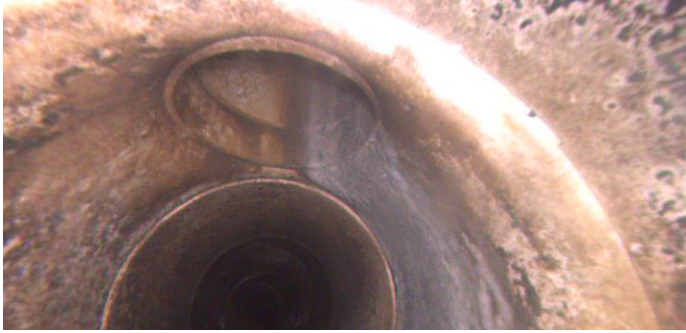
Code: **TF**
Description: **Tap Factory**

Distance (ft): **116.1**
Structural Grade: **0**
O&M Grade: **0**
Clock Start/From: **12**
Clock To:
1st Value: **4.000**
2nd Value:
Value Percent:
Continuous Index:
Within 8" of Joint:
Remarks:

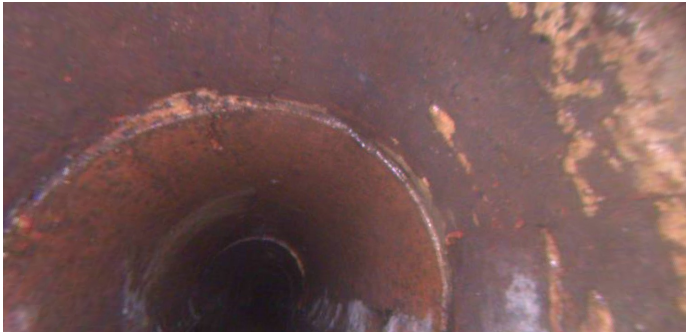
Code: **FM**
Description: **Fracture Multiple**

Distance (ft): **119.6**
Structural Grade: **4**
O&M Grade: **0**
Clock Start/From: **8**
Clock To: **4**
1st Value:
2nd Value:
Value Percent:
Continuous Index: **S01**
Within 8" of Joint: **YES**
Remarks:

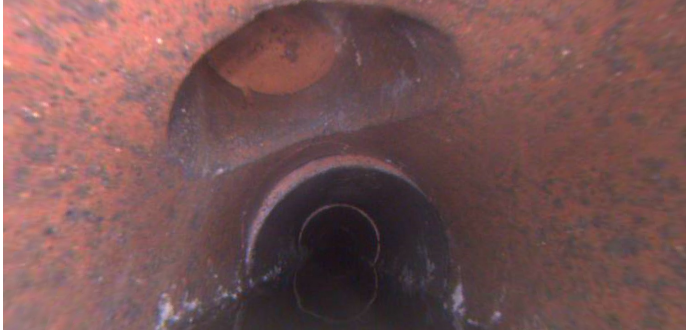
Code: **TFC**
Description: **Tap Factory Capped**

Distance (ft): **148.5**
Structural Grade: **0**
O&M Grade: **0**
Clock Start/From: **11**
Clock To:
1st Value: **4.000**
2nd Value:
Value Percent:
Continuous Index:
Within 8" of Joint:
Remarks:

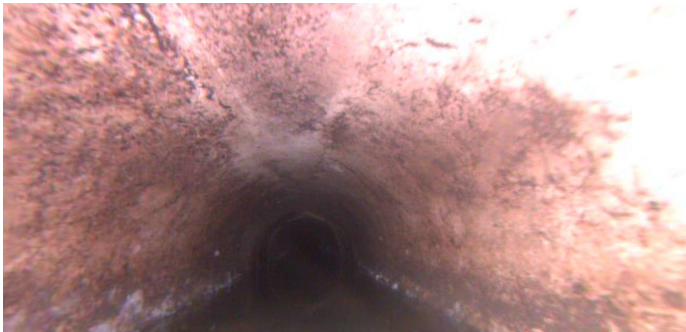
Code: **FM**
Description: **Fracture Multiple**

Distance (ft): **151.6**
Structural Grade: **4**
O&M Grade: **0**
Clock Start/From: **8**
Clock To: **4**
1st Value:
2nd Value:
Value Percent:
Continuous Index: **F01**
Within 8" of Joint: **YES**
Remarks:

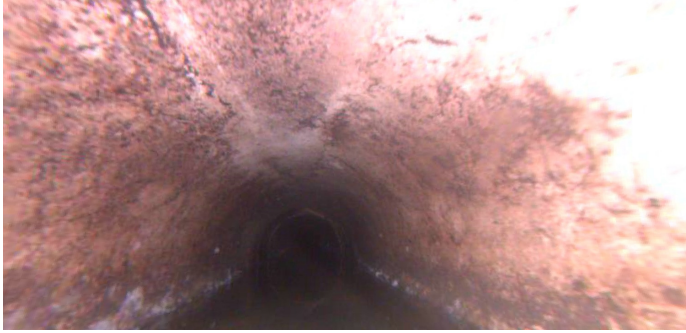
Code: **MMC**
Description: **Material Change**

Distance (ft): **151.6**
Structural Grade: **0**
O&M Grade: **0**
Clock Start/From:
Clock To:
1st Value:
2nd Value:
Value Percent:
Continuous Index:
Within 8" of Joint: **NO**
Remarks: **PVC**

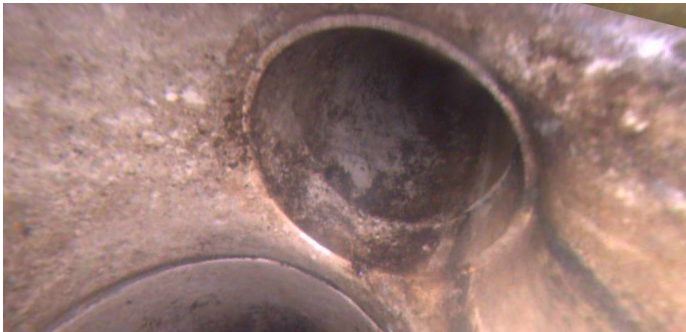
Code: **TF**
Description: **Tap Factory**

Distance (ft): **154.4**
Structural Grade: **0**
O&M Grade: **0**
Clock Start/From: **1**
Clock To:
1st Value: **4.000**
2nd Value:
Value Percent:
Continuous Index:
Within 8" of Joint:
Remarks:

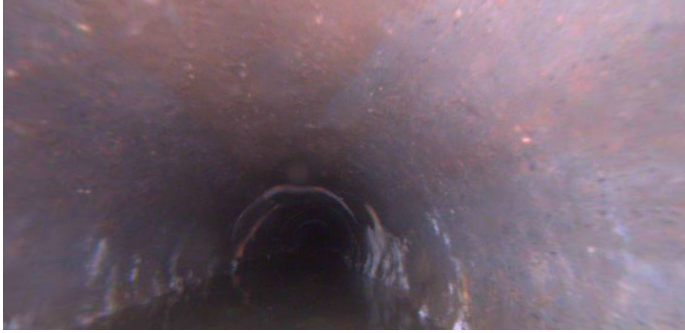
Code: **MMC**
Description: **Material Change**

Distance (ft): **158.1**
Structural Grade: **0**
O&M Grade: **0**
Clock Start/From:
Clock To:
1st Value:
2nd Value:
Value Percent:
Continuous Index:
Within 8" of Joint: **NO**
Remarks: **vcp**

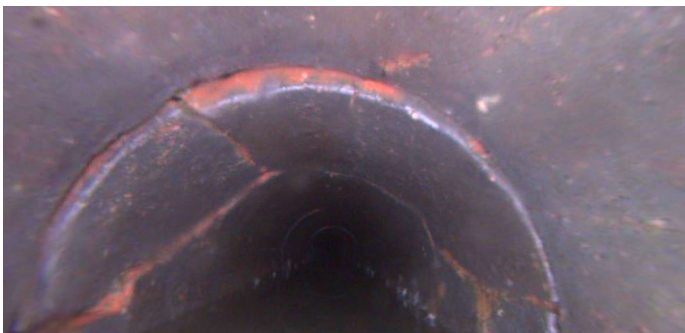
Code: **FM**
Description: **Fracture Multiple**

Distance (ft): **159.7**
Structural Grade: **4**
O&M Grade: **0**
Clock Start/From: **8**
Clock To: **4**
1st Value:
2nd Value:
Value Percent:
Continuous Index: **S02**
Within 8" of Joint: **YES**
Remarks:
