## Profile/Photo Observation Report

Street:	<b>N VIRGINIA ST</b>	Flow Control:	<b>Not Controlled</b>
City:	<b>Hobart, IN</b>	Year Renewed:	
Location:	<b>Other</b>	Tape/Media #:	
Purpose:	<b>Not Known</b>	Dia/Height:	<b>10"</b>
Use:	<b>Sanitary</b>	Material:	<b>VCP</b>
Drain Area:	<b>NA</b>	Lining:	
Category:	<b>NA</b>		
Comment:

Location Details:		Direction of Survey:	<b>Downstream</b>
US MH:	<b>M-503-021</b>	DS MH:	<b>M-503-022</b>
		Total Length Surveyed (ft):	<b>173.7</b>

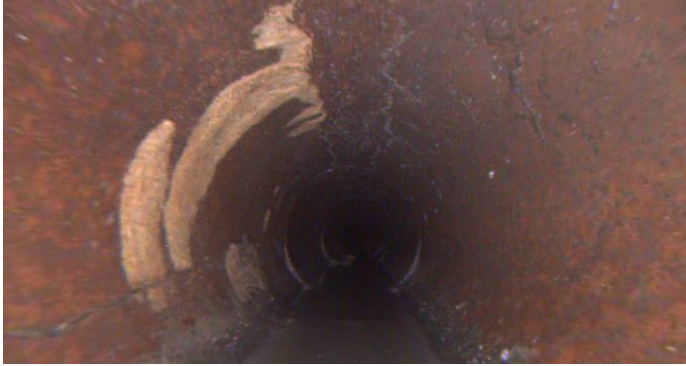
Code: **FM**  
Description: **Fracture Multiple**

Distance (ft): **1.4**  
Structural Grade: **4**  
O&M Grade: **0**  
Clock Start/From: **7**  
Clock To: **1**  
1st Value:  
2nd Value:  
Value Percent:  
Continuous Index:  
Within 8" of Joint:  
Remarks:

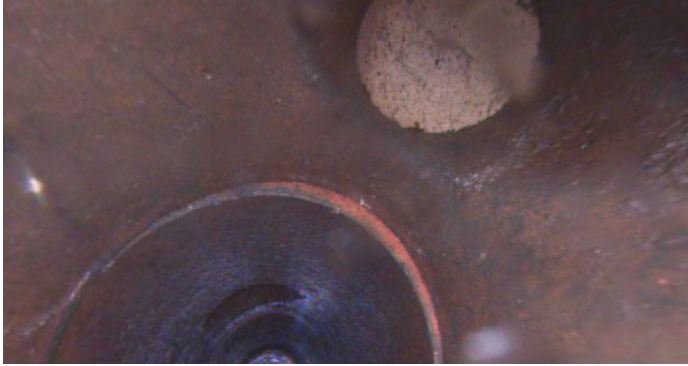
Code: **TFC**  
Description: **Tap Factory Capped**

Distance (ft): **12.4**  
Structural Grade: **0**  
O&M Grade: **0**  
Clock Start/From: **10**  
Clock To:  
1st Value: **4.000**  
2nd Value:  
Value Percent:  
Continuous Index:  
Within 8" of Joint:  
Remarks:

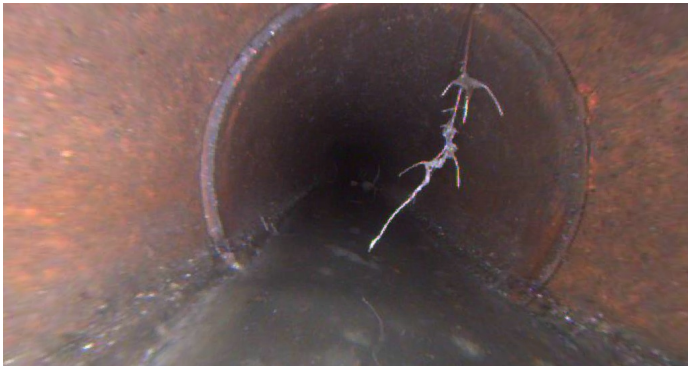
Code: **RFJ**  
Description: **Roots Fine Joint**

Distance (ft): **21.0**  
Structural Grade: **0**  
O&M Grade: **1**  
Clock Start/From: **1**  
Clock To:  
1st Value:  
2nd Value:  
Value Percent:  
Continuous Index:  
Within 8" of Joint: **YES**  
Remarks:

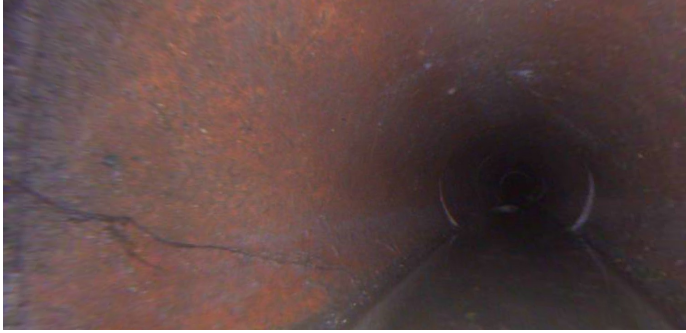
Code: **RFJ**  
Description: **Roots Fine Joint**

Distance (ft): **35.6**  
Structural Grade: **0**  
O&M Grade: **1**  
Clock Start/From: **9**  
Clock To:  
1st Value:  
2nd Value:  
Value Percent:  
Continuous Index:  
Within 8" of Joint: **YES**  
Remarks:

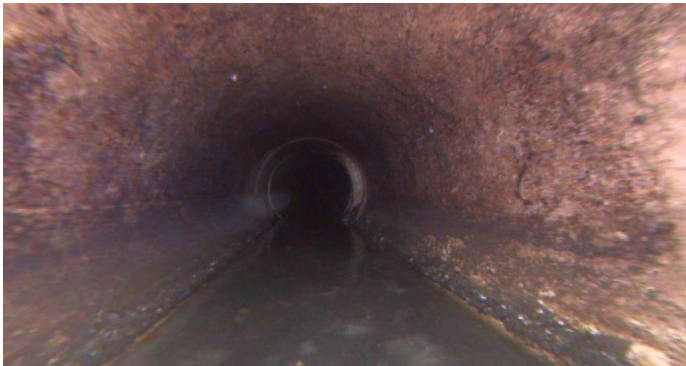
Code: **MMC**  
Description: **Material Change**

Distance (ft): **45.8**  
Structural Grade: **0**  
O&M Grade: **0**  
Clock Start/From:  
Clock To:  
1st Value:  
2nd Value:  
Value Percent:  
Continuous Index:  
Within 8" of Joint: **NO**  
Remarks: **PVC**

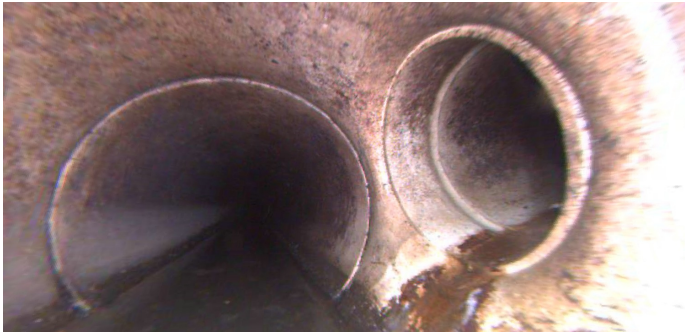
Code: **TFA**  
Description: **Tap Factory Active**

Distance (ft): **47.7**  
Structural Grade: **0**  
O&M Grade: **0**  
Clock Start/From: **3**  
Clock To:  
1st Value: **4.000**  
2nd Value:  
Value Percent:  
Continuous Index:  
Within 8" of Joint:  
Remarks:

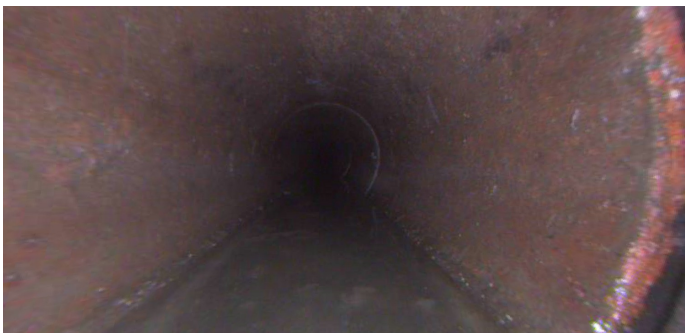
Code: **MMC**  
Description: **Material Change**

Distance (ft): **53.7**  
Structural Grade: **0**  
O&M Grade: **0**  
Clock Start/From:  
Clock To:  
1st Value:  
2nd Value:  
Value Percent:  
Continuous Index:  
Within 8" of Joint: **NO**  
Remarks: **vcp**

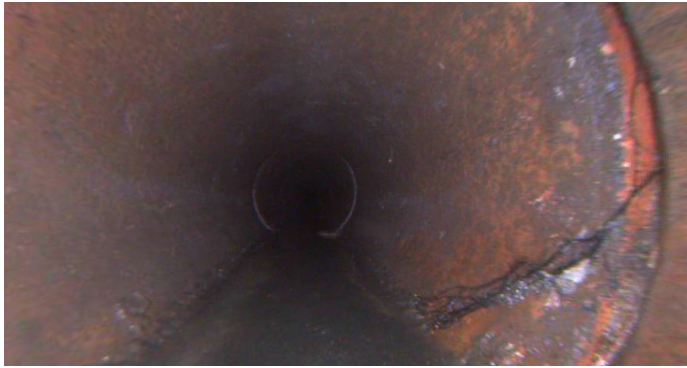
Code: **RFJ**  
Description: **Roots Fine Joint**

Distance (ft): **61.7**  
Structural Grade: **0**  
O&M Grade: **1**  
Clock Start/From: **5**  
Clock To:  
1st Value:  
2nd Value:  
Value Percent:  
Continuous Index:  
Within 8" of Joint: **YES**  
Remarks:

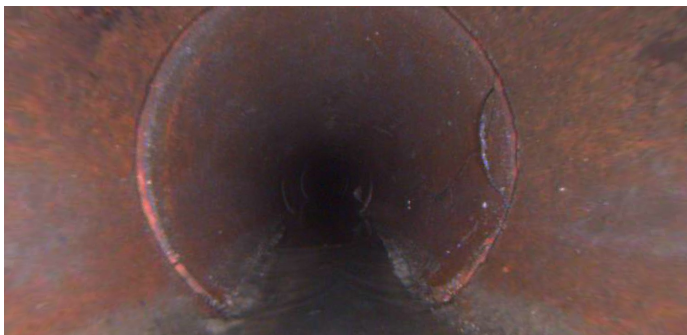
Code: **RFJ**  
Description: **Roots Fine Joint**

Distance (ft): **65.3**  
Structural Grade: **0**  
O&M Grade: **1**  
Clock Start/From: **2**  
Clock To: **3**  
1st Value:  
2nd Value:  
Value Percent:  
Continuous Index:  
Within 8" of Joint: **YES**  
Remarks:

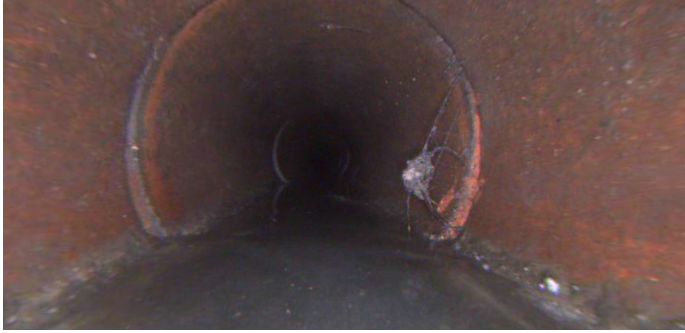
Code: **RFJ**  
Description: **Roots Fine Joint**

Distance (ft): **67.3**  
Structural Grade: **0**  
O&M Grade: **1**  
Clock Start/From: **2**  
Clock To: **4**  
1st Value:  
2nd Value:  
Value Percent:  
Continuous Index:  
Within 8" of Joint: **YES**  
Remarks:

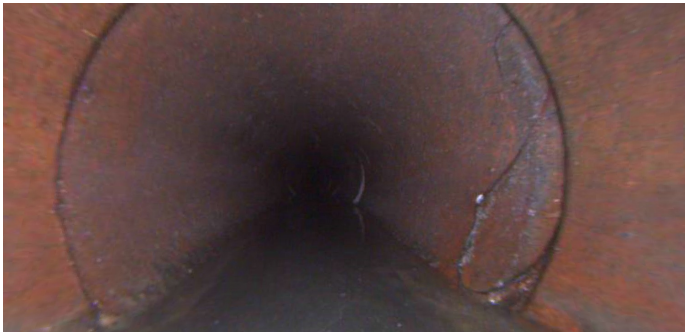
Code: **RFJ**  
Description: **Roots Fine Joint**

Distance (ft): **71.5**  
Structural Grade: **0**  
O&M Grade: **1**  
Clock Start/From: **1**  
Clock To: **4**  
1st Value:  
2nd Value:  
Value Percent:  
Continuous Index:  
Within 8" of Joint: **YES**  
Remarks:

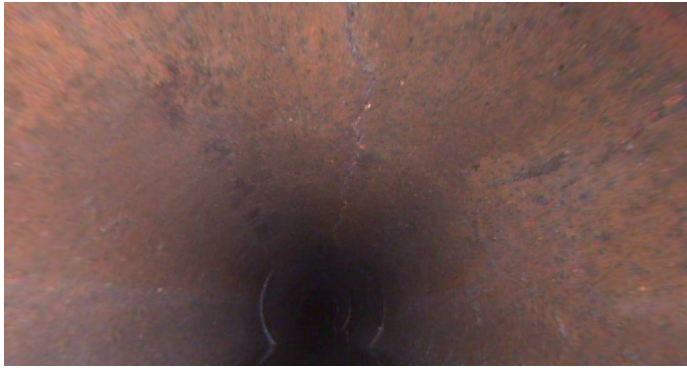
Code: **CL**  
Description: **Crack Longitudinal**

Distance (ft): **74.0**  
Structural Grade: **2**  
O&M Grade: **0**  
Clock Start/From: **12**  
Clock To:  
1st Value:  
2nd Value:  
Value Percent:  
Continuous Index:  
Within 8" of Joint:  
Remarks:

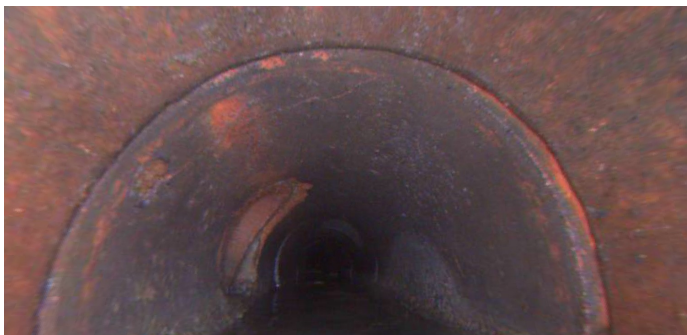
Code: **CC**  
Description: **Crack Circumferential**

Distance (ft): **79.6**  
Structural Grade: **1**  
O&M Grade: **0**  
Clock Start/From: **9**  
Clock To: **12**  
1st Value:  
2nd Value:  
Value Percent:  
Continuous Index:  
Within 8" of Joint: **YES**  
Remarks:

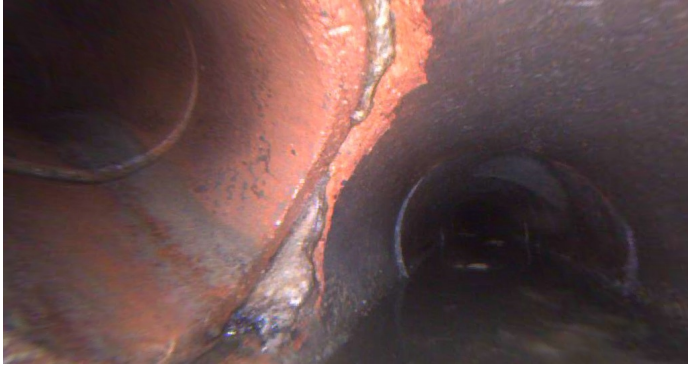
Code: **TB**  
Description: **Tap Break-in**

Distance (ft): **80.7**  
Structural Grade: **0**  
O&M Grade: **0**  
Clock Start/From: **10**  
Clock To:  
1st Value: **4.000**  
2nd Value:  
Value Percent:  
Continuous Index:  
Within 8" of Joint:  
Remarks:

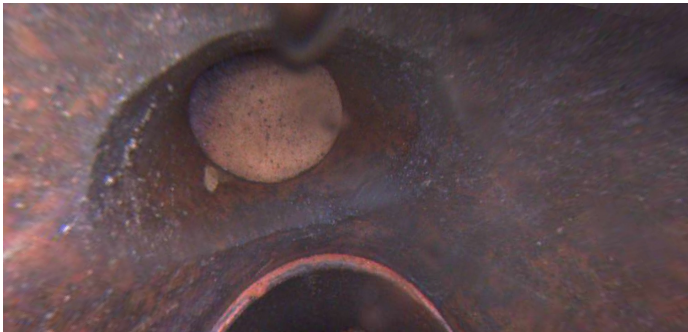
Code: **TFC**  
Description: **Tap Factory Capped**

Distance (ft): **83.0**  
Structural Grade: **0**  
O&M Grade: **0**  
Clock Start/From: **12**  
Clock To:  
1st Value: **4.000**  
2nd Value:  
Value Percent:  
Continuous Index:  
Within 8" of Joint:  
Remarks:

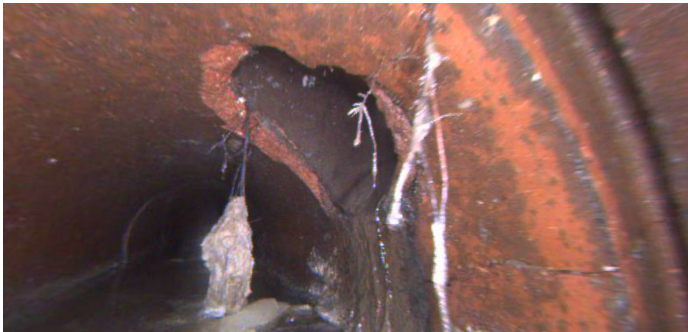
Code: **FM**  
Description: **Fracture Multiple**

Distance (ft): **102.1**  
Structural Grade: **4**  
O&M Grade: **0**  
Clock Start/From: **1**  
Clock To: **3**  
1st Value:  
2nd Value:  
Value Percent:  
Continuous Index:  
Within 8" of Joint: **YES**  
Remarks:

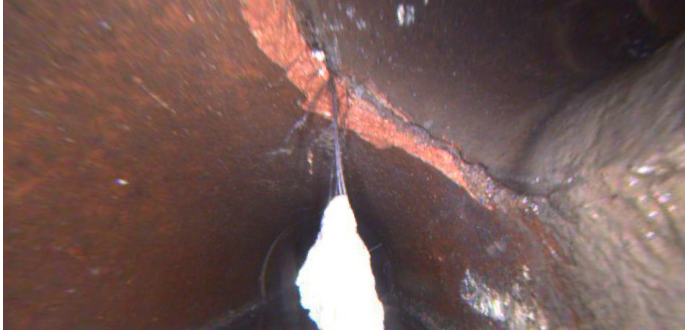
Code: **RFC**  
Description: **Roots Fine Connection**

Distance (ft): **102.5**  
Structural Grade: **0**  
O&M Grade: **1**  
Clock Start/From: **12**  
Clock To:  
1st Value:  
2nd Value:  
Value Percent:  
Continuous Index:  
Within 8" of Joint: **NO**  
Remarks:

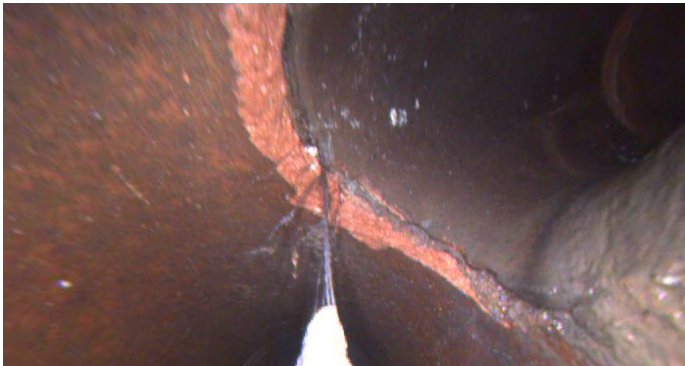
Code: **TBD**  
Description: **Tap Break-in Defective**

Distance (ft): **102.5**  
Structural Grade: **0**  
O&M Grade: **3**  
Clock Start/From: **2**  
Clock To:  
1st Value: **4.000**  
2nd Value:  
Value Percent:  
Continuous Index:  
Within 8" of Joint:  
Remarks: **Roots**

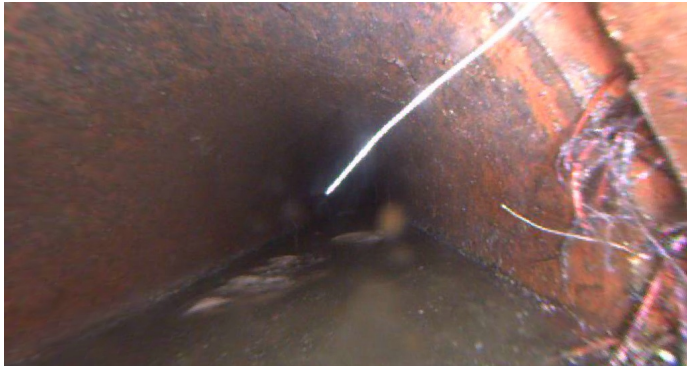
Code: **RFJ**  
Description: **Roots Fine Joint**

Distance (ft): **104.1**  
Structural Grade: **0**  
O&M Grade: **1**  
Clock Start/From: **3**  
Clock To: **5**  
1st Value:  
2nd Value:  
Value Percent:  
Continuous Index:  
Within 8" of Joint: **YES**  
Remarks:

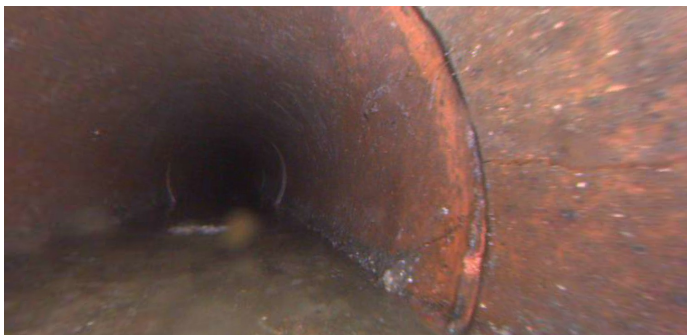
Code: **CL**  
Description: **Crack Longitudinal**

Distance (ft): **105.9**  
Structural Grade: **2**  
O&M Grade: **0**  
Clock Start/From: **3**  
Clock To:  
1st Value:  
2nd Value:  
Value Percent:  
Continuous Index:  
Within 8" of Joint: **YES**  
Remarks:

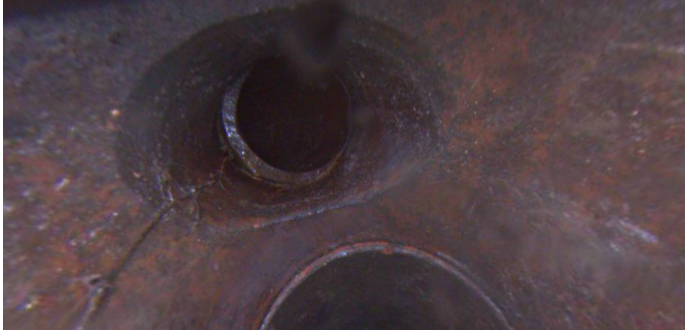
Code: **TFD**  
Description: **Tap Factory Defective**

Distance (ft): **117.4**  
Structural Grade: **0**  
O&M Grade: **2**  
Clock Start/From: **1**  
Clock To:  
1st Value: **4.000**  
2nd Value:  
Value Percent:  
Continuous Index:  
Within 8" of Joint:  
Remarks: **ROOTS**

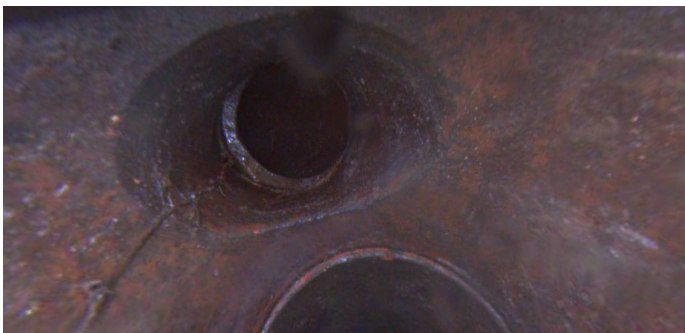
Code: **RFL**  
Description: **Roots Fine Lateral**

Distance (ft): **117.4**  
Structural Grade: **0**  
O&M Grade: **1**  
Clock Start/From: **1**  
Clock To:  
1st Value:  
2nd Value:  
Value Percent:  
Continuous Index:  
Within 8" of Joint: **NO**  
Remarks:

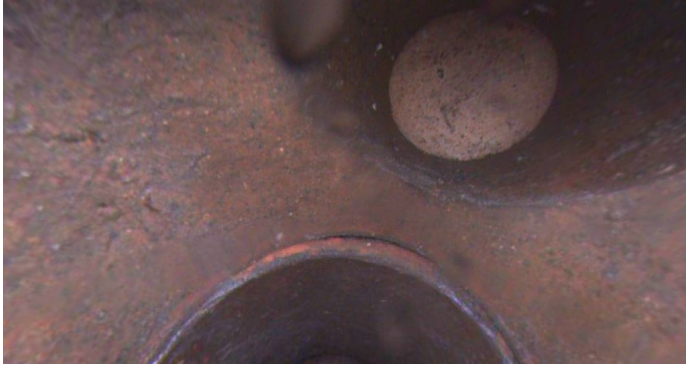
Code: **TFC**  
Description: **Tap Factory Capped**

Distance (ft): **119.2**  
Structural Grade: **0**  
O&M Grade: **0**  
Clock Start/From: **11**  
Clock To:  
1st Value: **4.000**  
2nd Value:  
Value Percent:  
Continuous Index:  
Within 8" of Joint:  
Remarks:

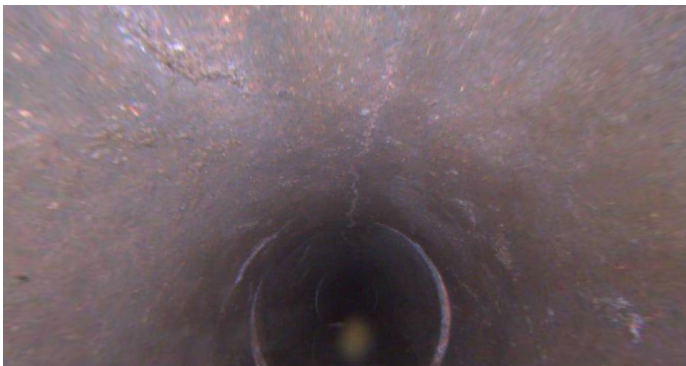
Code: **CL**  
Description: **Crack Longitudinal**

Distance (ft): **121.1**  
Structural Grade: **2**  
O&M Grade: **0**  
Clock Start/From: **12**  
Clock To:  
1st Value:  
2nd Value:  
Value Percent:  
Continuous Index:  
Within 8" of Joint:  
Remarks:

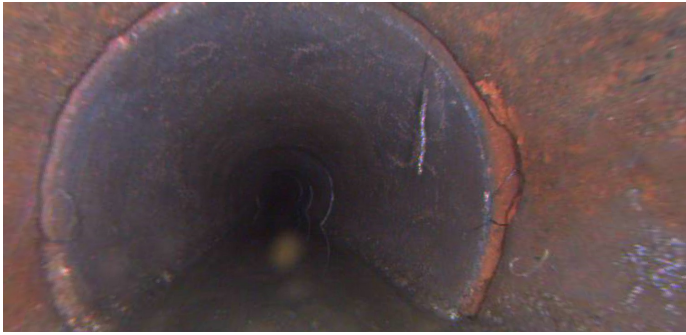
Code: **RFJ**  
Description: **Roots Fine Joint**

Distance (ft): **126.0**  
Structural Grade: **0**  
O&M Grade: **1**  
Clock Start/From: **2**  
Clock To: **3**  
1st Value:  
2nd Value:  
Value Percent:  
Continuous Index:  
Within 8" of Joint: **YES**  
Remarks:

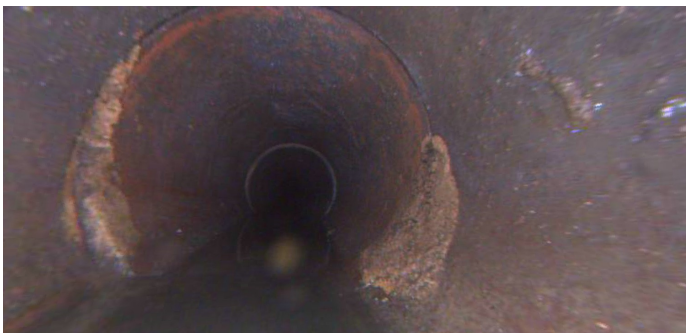
Code: **DAE**  
Description: **Deposits Attached Encrustation**

Distance (ft): **133.8**  
Structural Grade: **0**  
O&M Grade: **2**  
Clock Start/From: **8**  
Clock To: **4**  
1st Value:  
2nd Value:  
Value Percent: **5.000**  
Continuous Index:  
Within 8" of Joint: **YES**  
Remarks:

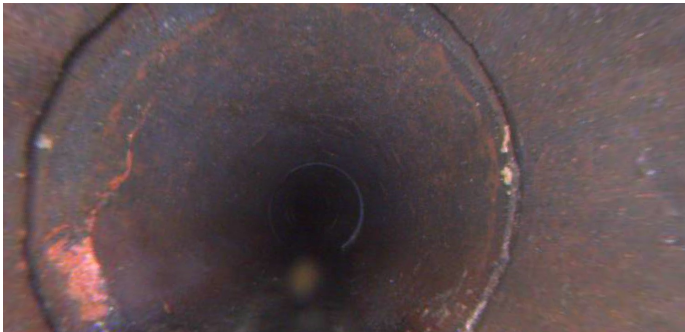
Code: **CS**  
Description: **Crack Spiral**

Distance (ft): **148.2**  
Structural Grade: **2**  
O&M Grade: **0**  
Clock Start/From: **9**  
Clock To: **11**  
1st Value:  
2nd Value:  
Value Percent:  
Continuous Index:  
Within 8" of Joint: **YES**  
Remarks:

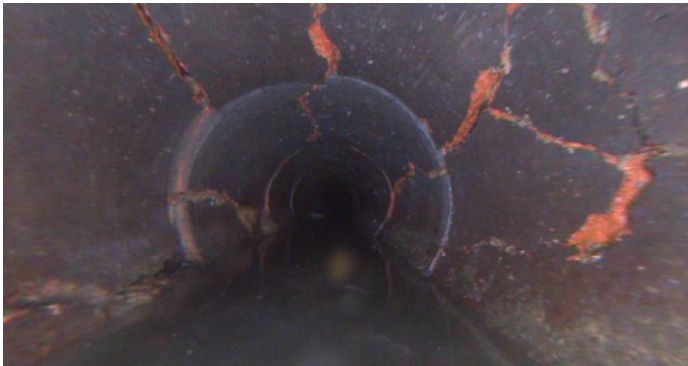
Code:	<b>FM</b>
Description:	<b>Fracture Multiple</b>
Distance (ft):	<b>161.9</b>
Structural Grade:	<b>4</b>
O&M Grade:	<b>0</b>
Clock Start/From:	<b>7</b>
Clock To:	<b>5</b>
1st Value:	
2nd Value:	
Value Percent:	
Continuous Index:	
Within 8" of Joint:	
Remarks:

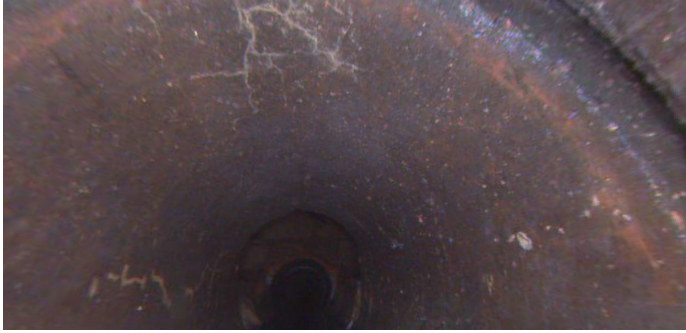
Code: **CM**  
Description: **Crack Multiple**

Distance (ft): **170.4**  
Structural Grade: **3**  
O&M Grade: **0**  
Clock Start/From: **8**  
Clock To: **12**  
1st Value:  
2nd Value:  
Value Percent:  
Continuous Index:  
Within 8" of Joint: **YES**  
Remarks:

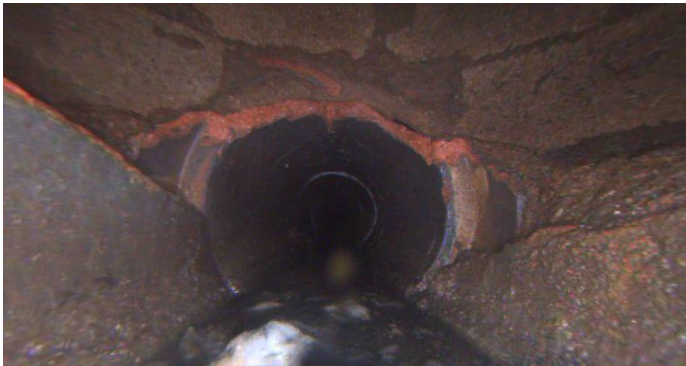
Code: **AMH**  
Description: **Manhole**

Distance (ft): **173.7**  
Structural Grade: **0**  
O&M Grade: **0**  
Clock Start/From:  
Clock To:  
1st Value:  
2nd Value:  
Value Percent:  
Continuous Index:  
Within 8" of Joint: **NO**  
Remarks: **M-503-022**
