## Profile/Photo Observation Report

Street:	<b>ALLEY BETWEEN W 39TH PL &amp; W 39</b>	Flow Control:	<b>Not Controlled</b>
City:	<b>Hobart, IN</b>	Year Renewed:	
Location:	<b>Other</b>	Tape/Media #:	
Purpose:	<b>Not Known</b>	Dia/Height:	<b>10"</b>
Use:	<b>Sanitary</b>	Material:	<b>VCP</b>
Drain Area:	<b>NA</b>	Lining:	
Category:	<b>NA</b>		
Comment:

Location Details:		Direction of Survey:	<b>Upstream</b>
US MH:	<b>M-503-022</b>	DS MH:	<b>M-503-023</b>
		Total Length Surveyed (ft):	<b>146.2</b>

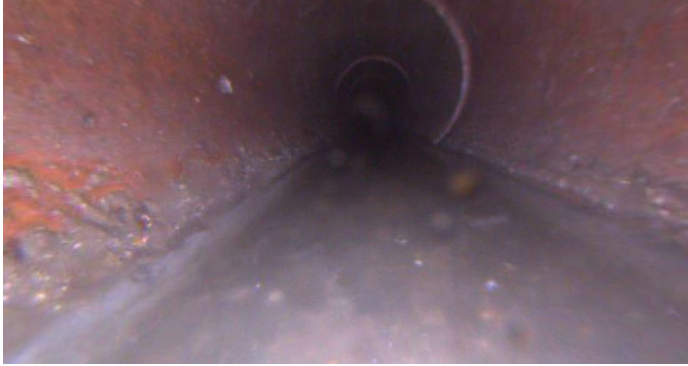
Code: **AMH**  
Description: **Manhole**

Distance (ft): **.0**  
Structural Grade: **0**  
O&M Grade: **0**  
Clock Start/From:  
Clock To:  
1st Value:  
2nd Value:  
Value Percent:  
Continuous Index:  
Within 8" of Joint: **NO**  
Remarks: **M-503-022**

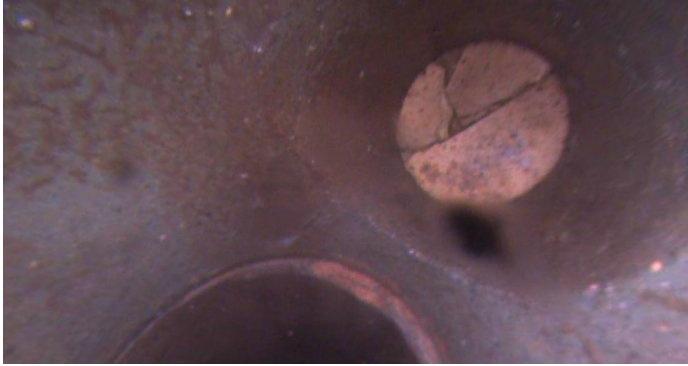
Code: **TFC**  
Description: **Tap Factory Capped**

Distance (ft): **26.6**  
Structural Grade: **0**  
O&M Grade: **0**  
Clock Start/From: **2**  
Clock To:  
1st Value: **4.000**  
2nd Value:  
Value Percent:  
Continuous Index:  
Within 8" of Joint:  
Remarks:

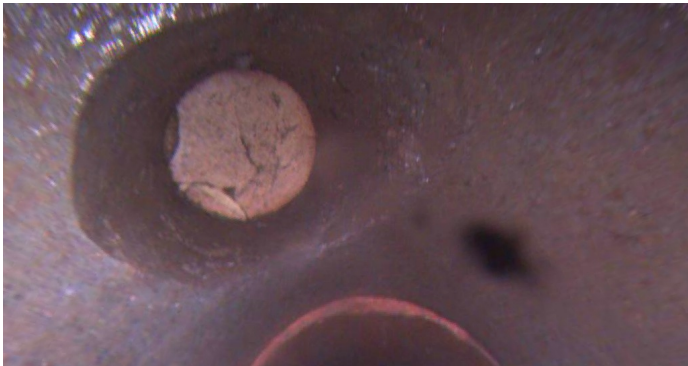
Code: **TFC**  
Description: **Tap Factory Capped**

Distance (ft): **28.4**  
Structural Grade: **0**  
O&M Grade: **0**  
Clock Start/From: **10**  
Clock To:  
1st Value: **4.000**  
2nd Value:  
Value Percent:  
Continuous Index:  
Within 8" of Joint:  
Remarks:

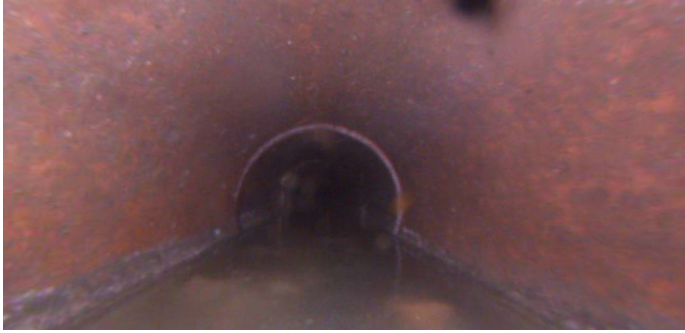
Code: **MWL**  
Description: **Water Level**

Distance (ft): **75.3**  
Structural Grade: **0**  
O&M Grade: **0**  
Clock Start/From:  
Clock To:  
1st Value:  
2nd Value:  
Value Percent: **30.000**  
Continuous Index:  
Within 8" of Joint: **NO**  
Remarks:

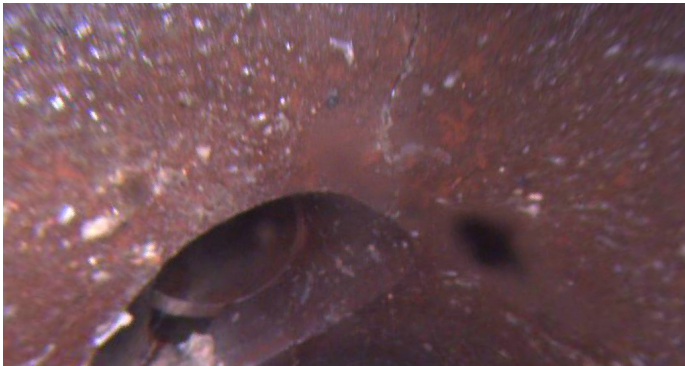
Code: **FL**  
Description: **Fracture Longitudinal**

Distance (ft): **77.5**  
Structural Grade: **3**  
O&M Grade: **0**  
Clock Start/From: **12**  
Clock To:  
1st Value:  
2nd Value:  
Value Percent:  
Continuous Index:  
Within 8" of Joint:  
Remarks:

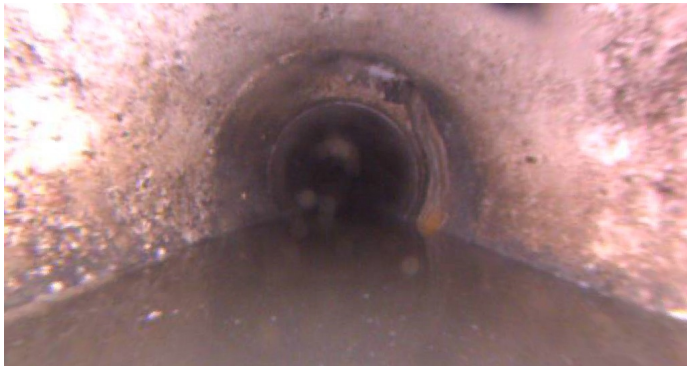
Code: **MMC**  
Description: **Material Change**

Distance (ft): **112.3**  
Structural Grade: **0**  
O&M Grade: **0**  
Clock Start/From:  
Clock To:  
1st Value:  
2nd Value:  
Value Percent:  
Continuous Index:  
Within 8" of Joint: **NO**  
Remarks: **PVC**

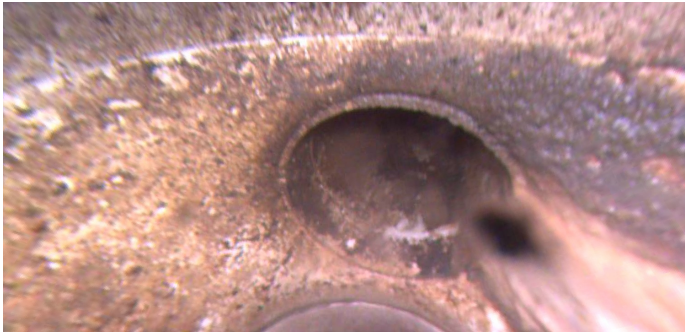
Code: **TFA**  
Description: **Tap Factory Active**

Distance (ft): **113.3**  
Structural Grade: **0**  
O&M Grade: **0**  
Clock Start/From: **12**  
Clock To:  
1st Value: **4.000**  
2nd Value:  
Value Percent:  
Continuous Index:  
Within 8" of Joint:  
Remarks:

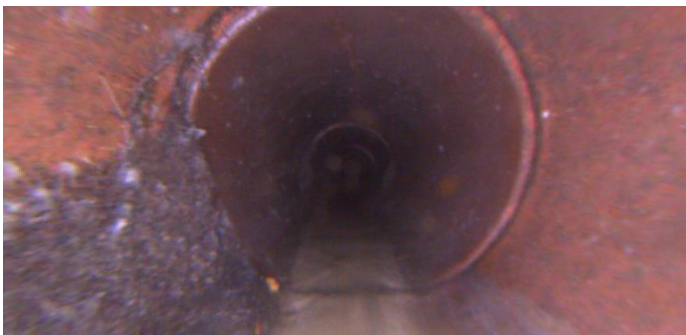
Code: **RMJ**  
Description: **Roots Medium Joint**

Distance (ft): **122.7**  
Structural Grade: **0**  
O&M Grade: **3**  
Clock Start/From: **7**  
Clock To: **9**  
1st Value:  
2nd Value:  
Value Percent: **5.000**  
Continuous Index:  
Within 8" of Joint: **YES**  
Remarks:

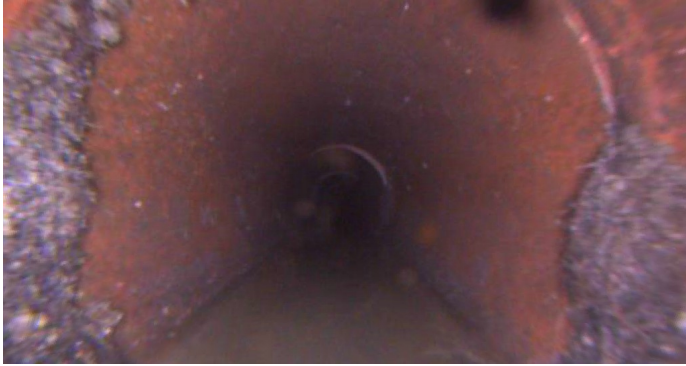
Code: **RMJ**  
Description: **Roots Medium Joint**

Distance (ft): **124.9**  
Structural Grade: **0**  
O&M Grade: **3**  
Clock Start/From: **7**  
Clock To: **5**  
1st Value:  
2nd Value:  
Value Percent: **5.000**  
Continuous Index: **S01**  
Within 8" of Joint: **YES**  
Remarks:

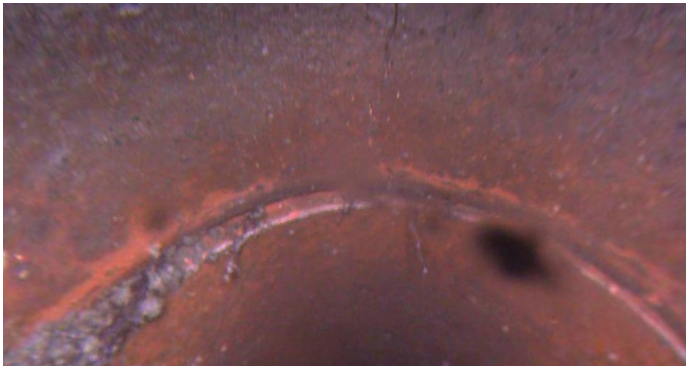
Code: **CL**  
Description: **Crack Longitudinal**

Distance (ft): **124.9**  
Structural Grade: **2**  
O&M Grade: **0**  
Clock Start/From: **12**  
Clock To:  
1st Value:  
2nd Value:  
Value Percent:  
Continuous Index:  
Within 8" of Joint: **YES**  
Remarks:

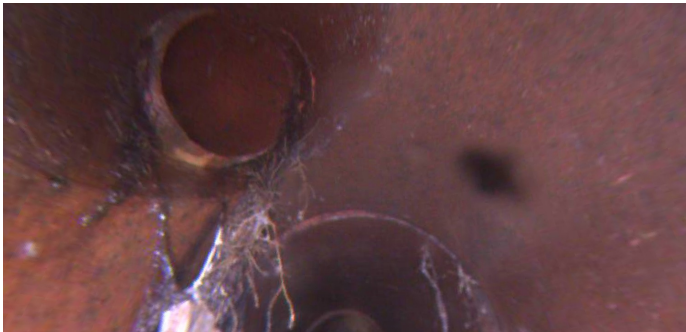
Code: **RML**  
Description: **Roots Medium Lateral**

Distance (ft): **138.7**  
Structural Grade: **0**  
O&M Grade: **3**  
Clock Start/From: **10**  
Clock To:  
1st Value:  
2nd Value:  
Value Percent: **5.000**  
Continuous Index:  
Within 8" of Joint: **NO**  
Remarks:
