## Profile/Photo Observation Report

Date:	<b>04/10/2018</b>	Weather:		Coding:	<b>PACP 6.0</b>
Pipe Length (ft):	<b>179.9</b>	Owner:	<b>NA</b>	Pre Clean:	<b>Not Known</b>
P.O.#:		Surveyor:	<b>Mark Ruby</b>	PSR:	<b>P-503-023-022</b>
Customer:		Clean Date:	<b>01/01/1900</b>	Shape:	<b>C</b>

Street:	<b>W 40th ave</b>	Flow Control:	<b>Not Controlled</b>
City:	<b>Hobart, IN</b>	Year Renewed:	
Location:	<b>Other</b>	Tape/Media #:	
Purpose:	<b>Not Known</b>	Dia/Height:	<b>10"</b>
Use:	<b>Sanitary</b>	Material:	<b>VCP</b>
Drain Area:	<b>NA</b>	Lining:	
Category:	<b>NA</b>		
Comment:

Location Details:		Direction of Survey:	<b>Upstream</b>
US MH:	<b>M-503-022</b>	DS MH:	<b>M-503-023</b>
		Total Length Surveyed (ft):	<b>146.2</b>

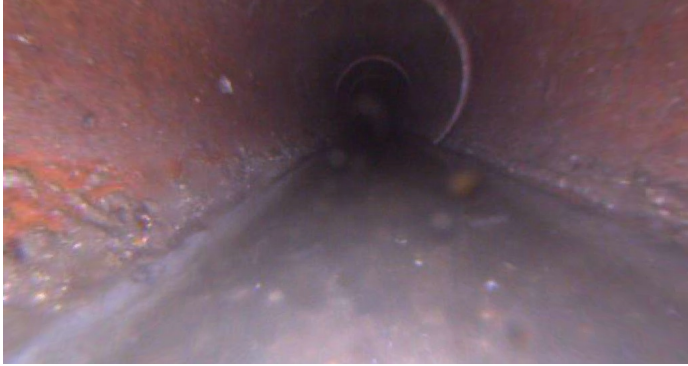
Code: **AMH**  
Description: **Manhole**

Distance (ft): **.0**  
Structural Grade: **0**  
O&M Grade: **0**  
Clock Start/From:  
Clock To:  
1st Value:  
2nd Value:  
Value Percent:  
Continuous Index:  
Within 8" of Joint: **NO**  
Remarks: **M-503-022**

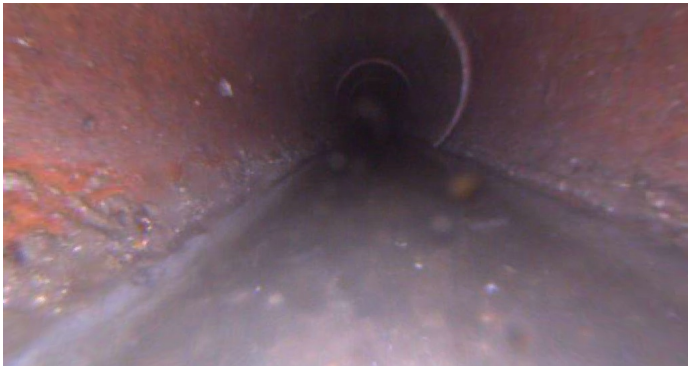
Code: **MWL**  
Description: **Water Level**

Distance (ft): **.0**  
Structural Grade: **0**  
O&M Grade: **0**  
Clock Start/From:  
Clock To:  
1st Value:  
2nd Value:  
Value Percent: **10.000**  
Continuous Index:  
Within 8" of Joint: **NO**  
Remarks:

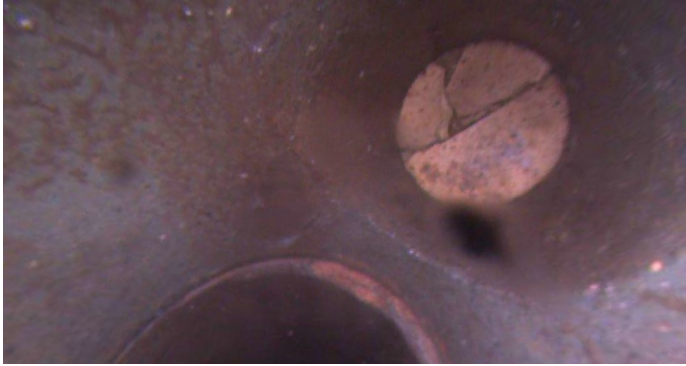
Code: **TFC**  
Description: **Tap Factory Capped**

Distance (ft): **26.6**  
Structural Grade: **0**  
O&M Grade: **0**  
Clock Start/From: **2**  
Clock To:  
1st Value: **4.000**  
2nd Value:  
Value Percent:  
Continuous Index:  
Within 8" of Joint:  
Remarks:

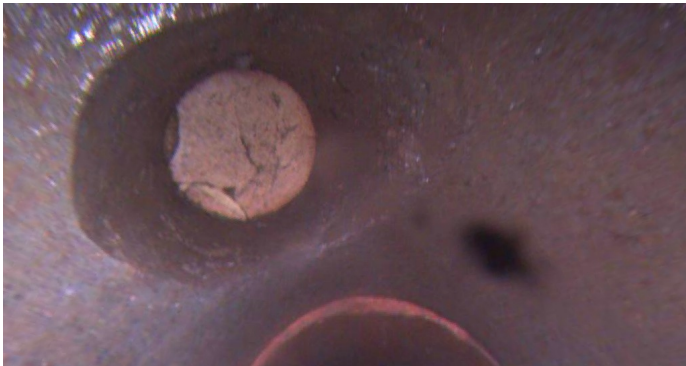
Code: **TFC**  
Description: **Tap Factory Capped**

Distance (ft): **28.4**  
Structural Grade: **0**  
O&M Grade: **0**  
Clock Start/From: **10**  
Clock To:  
1st Value: **4.000**  
2nd Value:  
Value Percent:  
Continuous Index:  
Within 8" of Joint:  
Remarks:

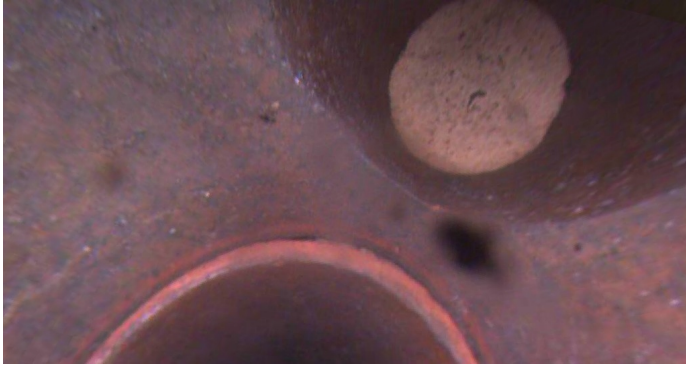
Code: **TFC**  
Description: **Tap Factory Capped**

Distance (ft): **63.5**  
Structural Grade: **0**  
O&M Grade: **0**  
Clock Start/From: **2**  
Clock To:  
1st Value: **4.000**  
2nd Value:  
Value Percent:  
Continuous Index:  
Within 8" of Joint:  
Remarks:

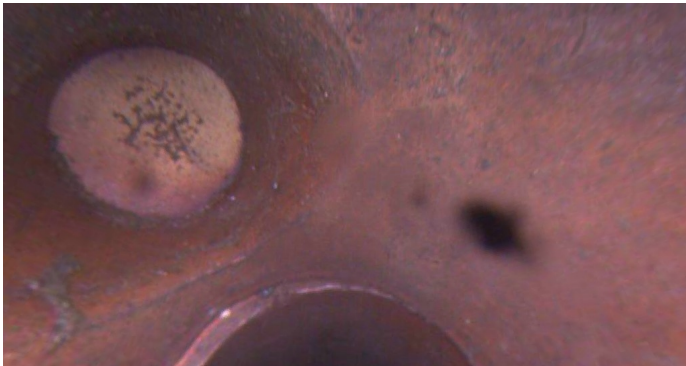
Code: **TFC**  
Description: **Tap Factory Capped**

Distance (ft): **65.5**  
Structural Grade: **0**  
O&M Grade: **0**  
Clock Start/From: **10**  
Clock To:  
1st Value: **4.000**  
2nd Value:  
Value Percent:  
Continuous Index:  
Within 8" of Joint:  
Remarks:

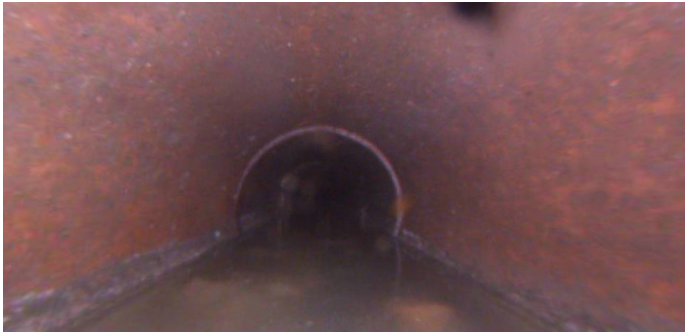
Code: **MWL**  
Description: **Water Level**

Distance (ft): **75.3**  
Structural Grade: **0**  
O&M Grade: **0**  
Clock Start/From:  
Clock To:  
1st Value:  
2nd Value:  
Value Percent: **30.000**  
Continuous Index:  
Within 8" of Joint: **NO**  
Remarks:

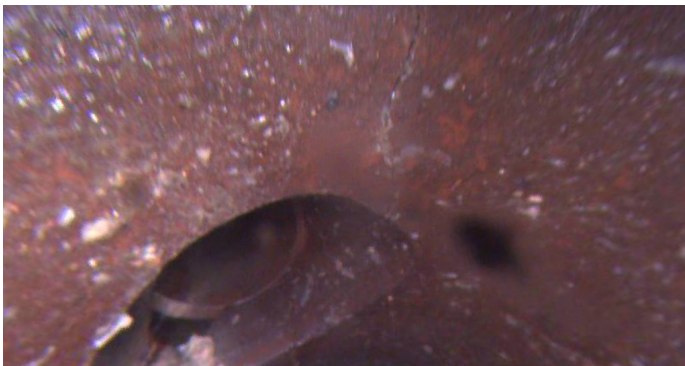
Code: **FL**  
Description: **Fracture Longitudinal**

Distance (ft): **77.5**  
Structural Grade: **3**  
O&M Grade: **0**  
Clock Start/From: **12**  
Clock To:  
1st Value:  
2nd Value:  
Value Percent:  
Continuous Index:  
Within 8" of Joint:  
Remarks:

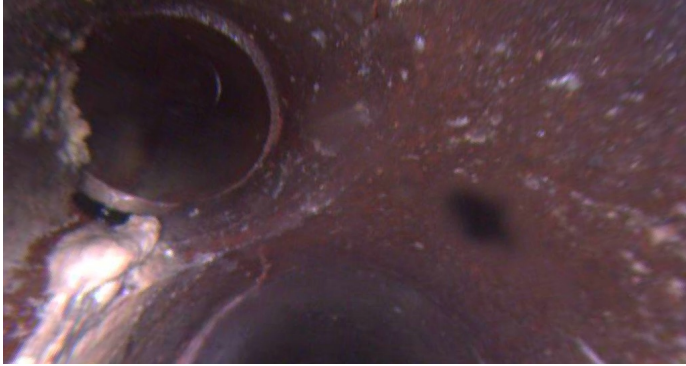
Code: **TF**  
Description: **Tap Factory**

Distance (ft): **77.8**  
Structural Grade: **0**  
O&M Grade: **0**  
Clock Start/From: **10**  
Clock To:  
1st Value: **4.000**  
2nd Value:  
Value Percent:  
Continuous Index:  
Within 8" of Joint:  
Remarks:

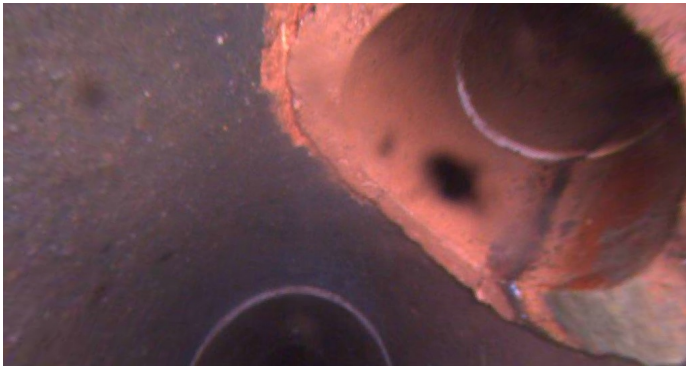
Code: **TBI**  
Description: **Tap Break-in Intruding**

Distance (ft): **85.4**  
Structural Grade: **0**  
O&M Grade: **2**  
Clock Start/From: **2**  
Clock To:  
1st Value: **4.000**  
2nd Value: **1.000**  
Value Percent:  
Continuous Index:  
Within 8" of Joint:  
Remarks:

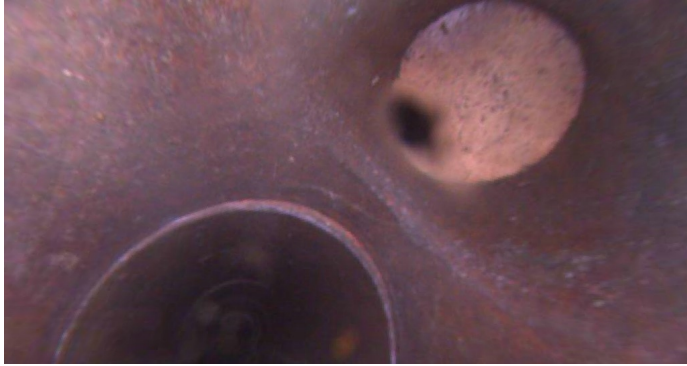
Code: **TFC**  
Description: **Tap Factory Capped**

Distance (ft): **104.0**  
Structural Grade: **0**  
O&M Grade: **0**  
Clock Start/From: **10**  
Clock To:  
1st Value: **4.000**  
2nd Value:  
Value Percent:  
Continuous Index:  
Within 8" of Joint:  
Remarks:

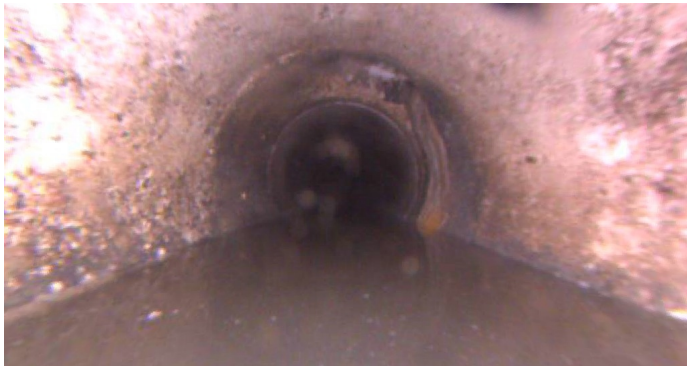
Code: **MMC**  
Description: **Material Change**

Distance (ft): **112.3**  
Structural Grade: **0**  
O&M Grade: **0**  
Clock Start/From:  
Clock To:  
1st Value:  
2nd Value:  
Value Percent:  
Continuous Index:  
Within 8" of Joint: **NO**  
Remarks: **PVC**

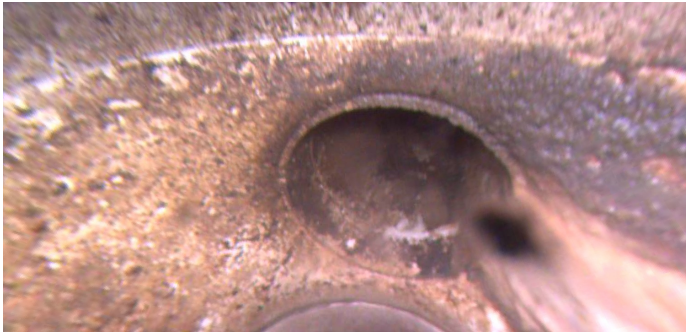
Code: **TFA**  
Description: **Tap Factory Active**

Distance (ft): **113.3**  
Structural Grade: **0**  
O&M Grade: **0**  
Clock Start/From: **12**  
Clock To:  
1st Value: **4.000**  
2nd Value:  
Value Percent:  
Continuous Index:  
Within 8" of Joint:  
Remarks:

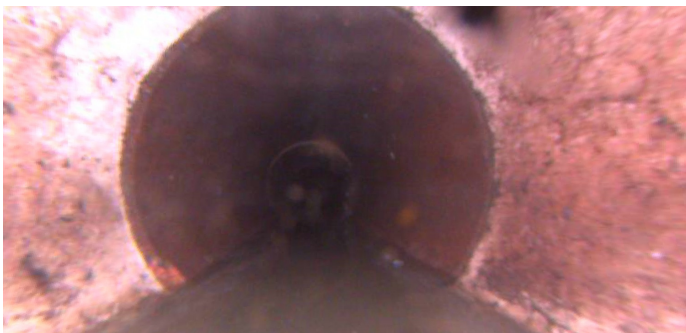
Code: **MMC**  
Description: **Material Change**

Distance (ft): **116.5**  
Structural Grade: **0**  
O&M Grade: **0**  
Clock Start/From:  
Clock To:  
1st Value:  
2nd Value:  
Value Percent:  
Continuous Index:  
Within 8" of Joint: **NO**  
Remarks: **VCP**

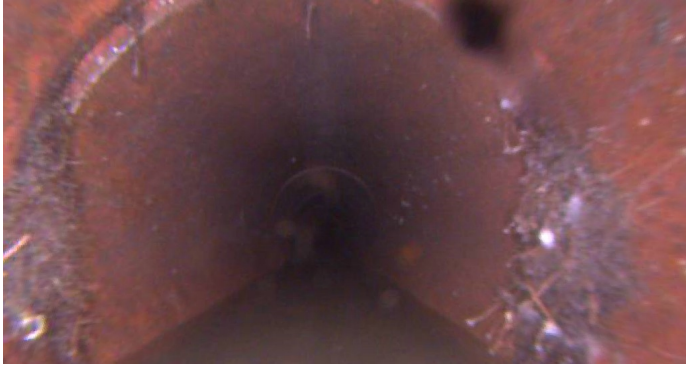
Code: **RFJ**  
Description: **Roots Fine Joint**

Distance (ft): **118.7**  
Structural Grade: **0**  
O&M Grade: **1**  
Clock Start/From: **7**  
Clock To: **5**  
1st Value:  
2nd Value:  
Value Percent:  
Continuous Index:  
Within 8" of Joint: **YES**  
Remarks:

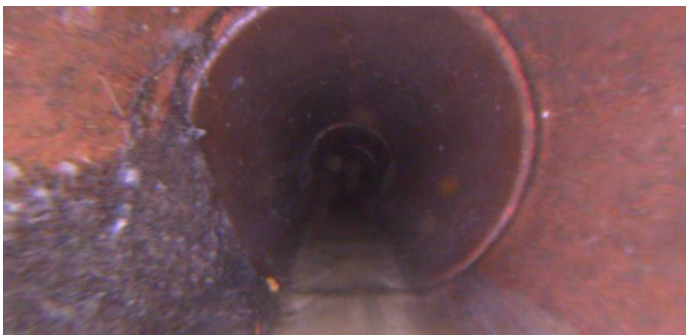
Code: **RMJ**  
Description: **Roots Medium Joint**

Distance (ft): **122.7**  
Structural Grade: **0**  
O&M Grade: **3**  
Clock Start/From: **7**  
Clock To: **9**  
1st Value:  
2nd Value:  
Value Percent: **5.000**  
Continuous Index:  
Within 8" of Joint: **YES**  
Remarks:

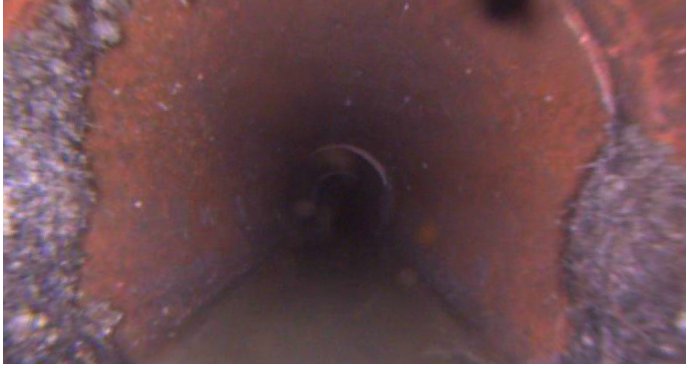
Code: **RMJ**  
Description: **Roots Medium Joint**

Distance (ft): **124.9**  
Structural Grade: **0**  
O&M Grade: **3**  
Clock Start/From: **7**  
Clock To: **5**  
1st Value:  
2nd Value:  
Value Percent: **5.000**  
Continuous Index: **S01**  
Within 8" of Joint: **YES**  
Remarks:

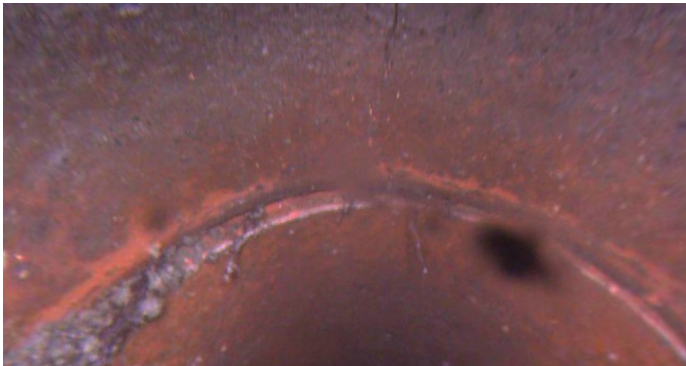
Code: **CL**  
Description: **Crack Longitudinal**

Distance (ft): **124.9**  
Structural Grade: **2**  
O&M Grade: **0**  
Clock Start/From: **12**  
Clock To:  
1st Value:  
2nd Value:  
Value Percent:  
Continuous Index:  
Within 8" of Joint: **YES**  
Remarks:

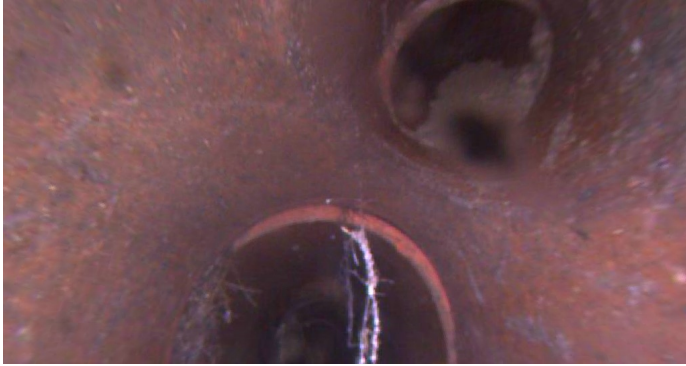
Code: **TF**  
Description: **Tap Factory**

Distance (ft): **136.5**  
Structural Grade: **0**  
O&M Grade: **0**  
Clock Start/From: **2**  
Clock To:  
1st Value: **4.000**  
2nd Value:  
Value Percent:  
Continuous Index:  
Within 8" of Joint:  
Remarks:

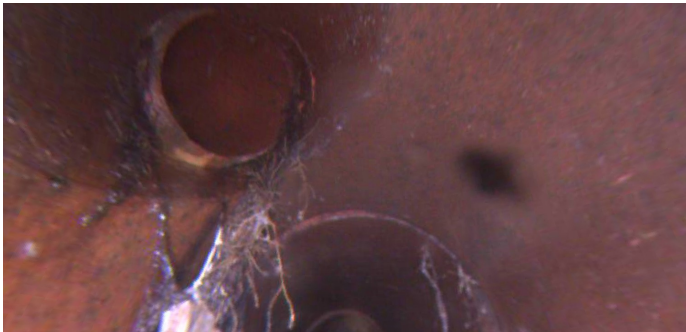
Code: **RML**  
Description: **Roots Medium Lateral**

Distance (ft): **138.7**  
Structural Grade: **0**  
O&M Grade: **3**  
Clock Start/From: **10**  
Clock To:  
1st Value:  
2nd Value:  
Value Percent: **5.000**  
Continuous Index:  
Within 8" of Joint: **NO**  
Remarks:

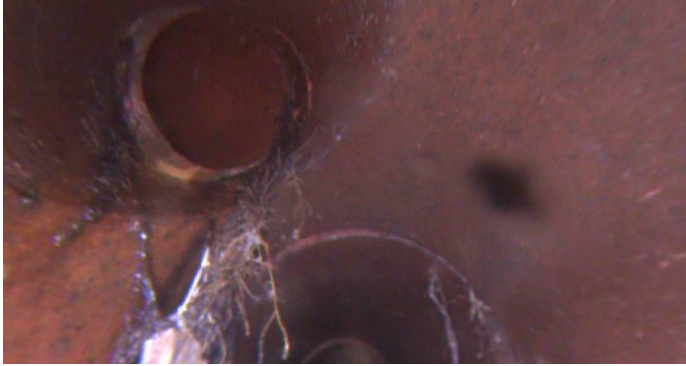
Code: **TFD**  
Description: **Tap Factory Defective**

Distance (ft): **138.7**  
Structural Grade: **0**  
O&M Grade: **2**  
Clock Start/From: **10**  
Clock To:  
1st Value: **4.000**  
2nd Value:  
Value Percent:  
Continuous Index:  
Within 8" of Joint:  
Remarks: **RFL**

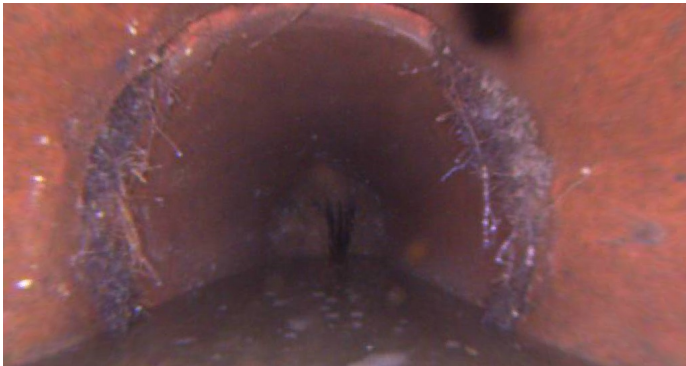
Code: **RMJ**  
Description: **Roots Medium Joint**

Distance (ft): **143.2**  
Structural Grade: **0**  
O&M Grade: **3**  
Clock Start/From: **7**  
Clock To: **5**  
1st Value:  
2nd Value:  
Value Percent: **5.000**  
Continuous Index: **F01**  
Within 8" of Joint: **YES**  
Remarks:

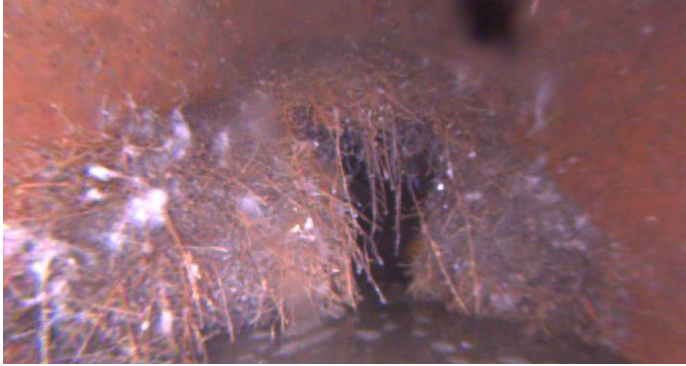
Code: **RBJ**  
 Description: **Roots Ball Joint**

Distance (ft): **145.0**  
 Structural Grade: **0**  
 O&M Grade: **4**  
 Clock Start/From: **8**  
 Clock To: **4**  
 1st Value:  
 2nd Value:  
 Value Percent: **80.000**  
 Continuous Index:  
 Within 8" of Joint: **YES**  
 Remarks:

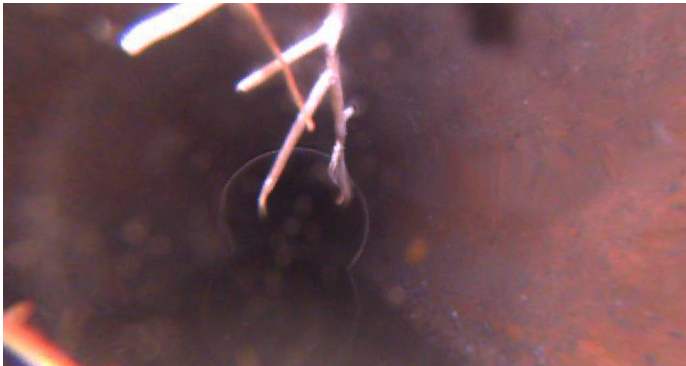
Code: **MSA**  
 Description: **Abandoned Survey**

Distance (ft): **146.2**  
 Structural Grade: **0**  
 O&M Grade: **0**  
 Clock Start/From:  
 Clock To:  
 1st Value:  
 2nd Value:  
 Value Percent:  
 Continuous Index:  
 Within 8" of Joint: **NO**  
 Remarks: **RMJ**
