Profile/Photo Observation Report

Date:	09/20/2021	Weather:		Coding:	PACP 7.0
Pipe Length (ft):	180.0	Owner:	City of Hobart	Pre Clean:	Heavy Cleaning
P.O.#:	YES502259	Surveyor:	S. Bucklin	PSR:	P-503-023-022
Customer:	City of Hobart	Clean Date:	09/04/2021	Shape:	C

Street:	West 39th Avenue	Flow Control:	Not Controlled
City:	Hobart, IN	Year Renewed:	
Location:	Alley	Tape/Media #:	
Purpose:	Routine Assessment	Dia/Height:	10"
Use:	Sanitary Sewage Pipe	Material:	VCP
Drain Area:		Lining:	None
Category:	NA		
Comment:

Location Details:		Direction of Survey:	Downstream
US MH:	M-503-022	DS MH:	M-503-023
		Total Length Surveyed (ft):	30.7

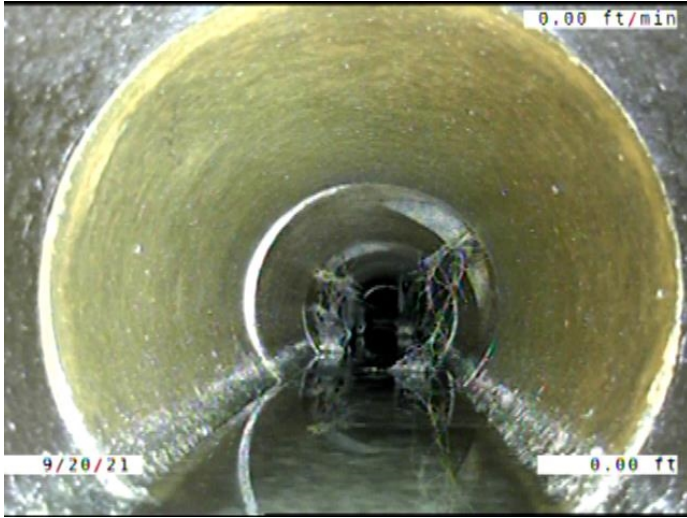
Code: **MWL**
Description: **Miscellaneous Water Level**

Distance (ft): **.0**
Structural Grade: **0**
O&M Grade: **0**
Clock Start/From:
Clock To:
1st Value:
2nd Value:
Value Percent: **5.000**
Continuous Index:
Within 8" of Joint: **NO**
Remarks:

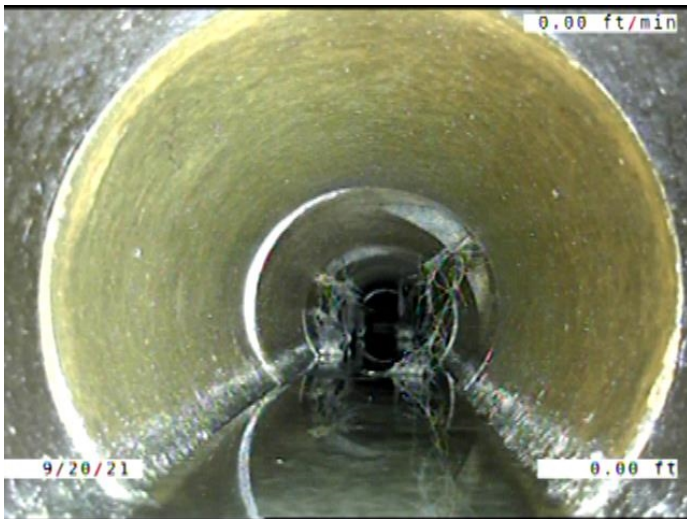
Code: **DSF**
Description: **Deposits Settled Fine**

Distance (ft): **.0**
Structural Grade: **0**
O&M Grade: **2**
Clock Start/From: **5**
Clock To: **7**
1st Value:
2nd Value:
Value Percent: **5.000**
Continuous Index: **S01**
Within 8" of Joint: **YES**
Remarks:

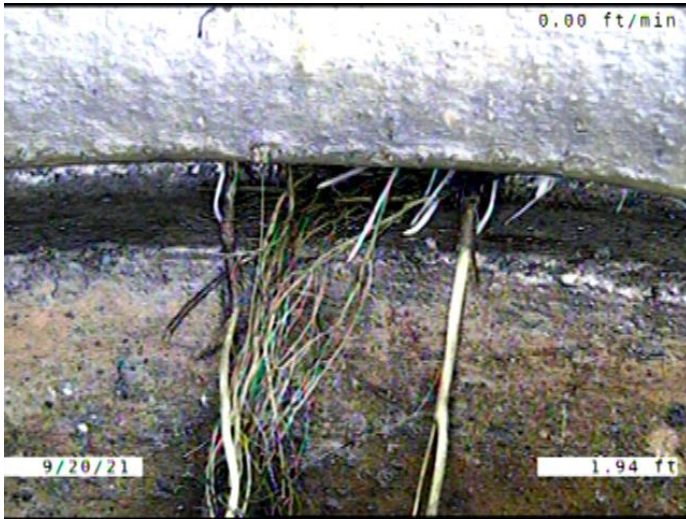
Code: **RFJ**
 Description: **Roots Fine Joint**

Distance (ft): **1.9**
 Structural Grade: **0**
 O&M Grade: **1**
 Clock Start/From: **1**
 Clock To: **2**
 1st Value:
 2nd Value:
 Value Percent:
 Continuous Index:
 Within 8" of Joint: **YES**
 Remarks:

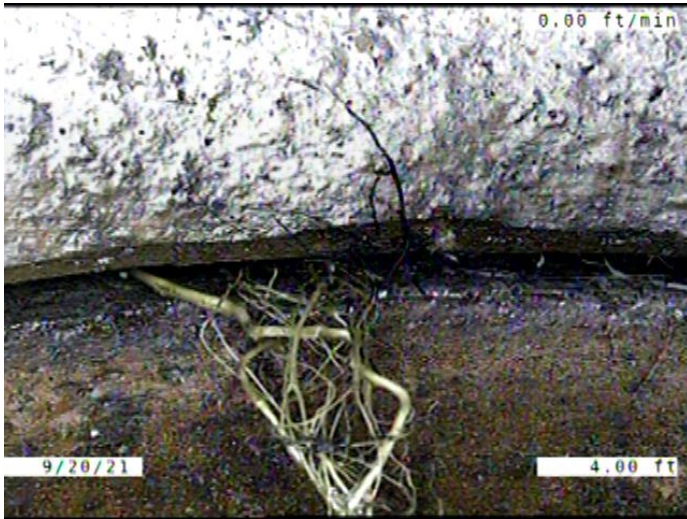
Code: **RFJ**
 Description: **Roots Fine Joint**

Distance (ft): **4.0**
 Structural Grade: **0**
 O&M Grade: **1**
 Clock Start/From: **9**
 Clock To: **2**
 1st Value:
 2nd Value:
 Value Percent:
 Continuous Index:
 Within 8" of Joint: **YES**
 Remarks:

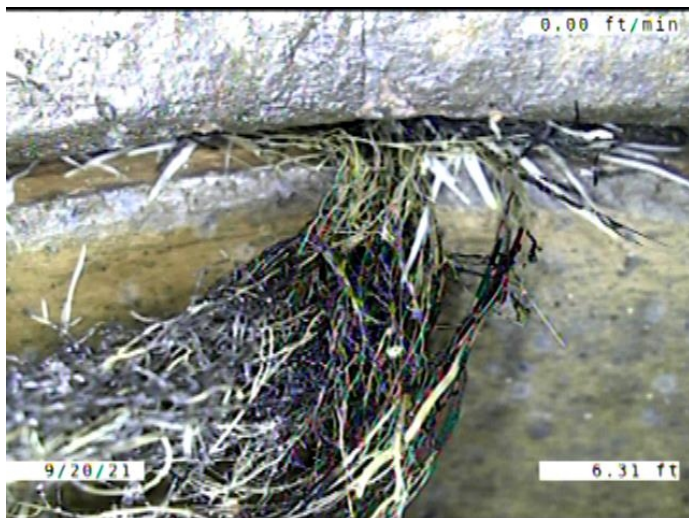
Code:	RMJ
Description:	Roots Medium Joint
Distance (ft):	6.3
Structural Grade:	0
O&M Grade:	3
Clock Start/From:	9
Clock To:	2
1st Value:	
2nd Value:	
Value Percent:	5.000
Continuous Index:	S02
Within 8" of Joint:	YES
Remarks:

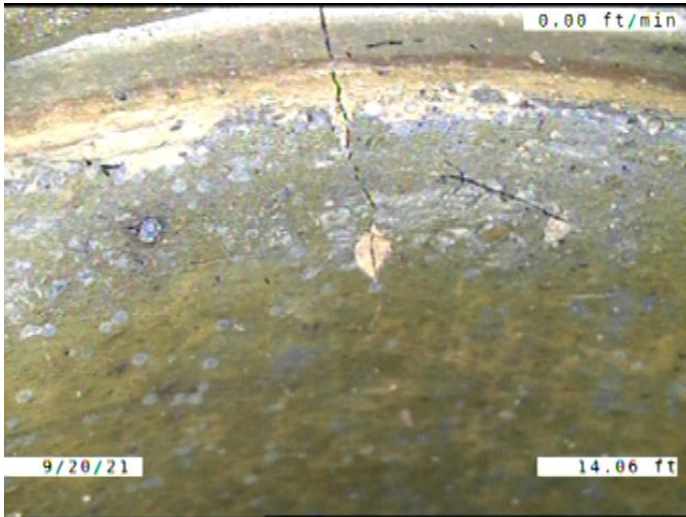
Code: **CM**
Description: **Crack Multiple**

Distance (ft): **14.1**
Structural Grade: **3**
O&M Grade: **0**
Clock Start/From: **10**
Clock To: **2**
1st Value:
2nd Value:
Value Percent:
Continuous Index:
Within 8" of Joint: **YES**
Remarks:

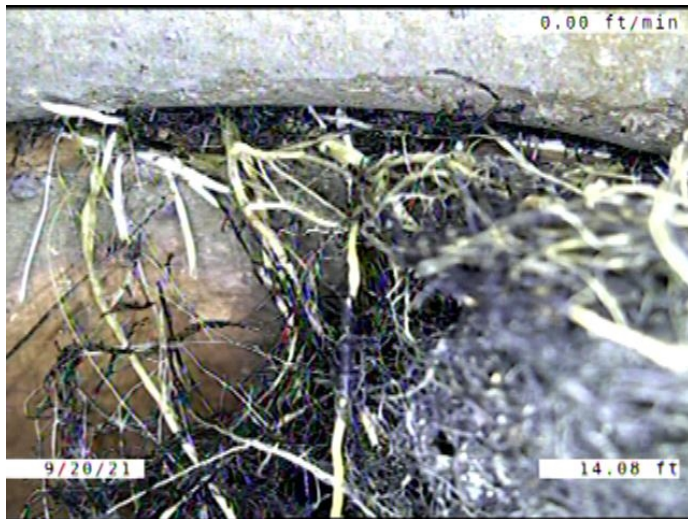
Code: **RMJ**
 Description: **Roots Medium Joint**

Distance (ft): **14.1**
 Structural Grade: **0**
 O&M Grade: **3**
 Clock Start/From: **12**
 Clock To: **4**
 1st Value:
 2nd Value:
 Value Percent: **20.000**
 Continuous Index:
 Within 8" of Joint: **YES**
 Remarks:

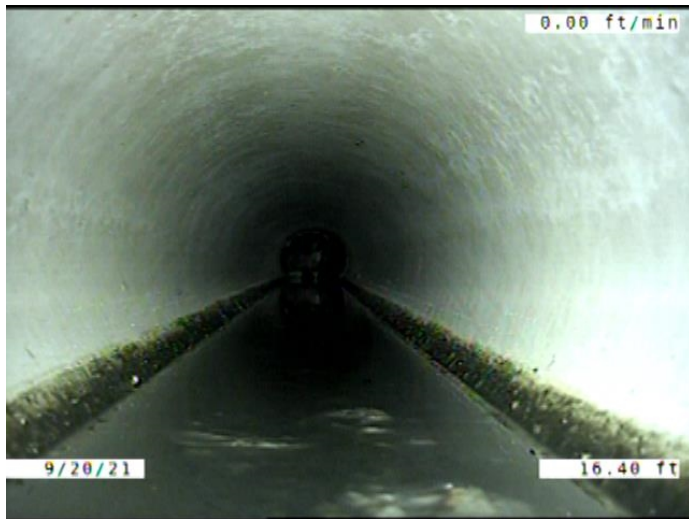
Code: **RMJ**
 Description: **Roots Medium Joint**

Distance (ft): **16.4**
 Structural Grade: **0**
 O&M Grade: **3**
 Clock Start/From: **9**
 Clock To: **2**
 1st Value:
 2nd Value:
 Value Percent: **5.000**
 Continuous Index: **F02**
 Within 8" of Joint: **YES**
 Remarks:
