Profile/Photo Observation Report

Date:	04/10/2018	Weather:		Coding:	PACP 6.0
Pipe Length (ft):	176.0	Owner:	NA	Pre Clean:	Not Known
P.O.#:		Surveyor:	Mark Ruby	PSR:	P-503-024-023
Customer:		Clean Date:	01/01/1900	Shape:	C

Street:	ALLEY BETWEEN W 39TH PL & W 39	Flow Control:	Not Controlled
City:	Hobart, IN	Year Renewed:	
Location:	Other	Tape/Media #:	
Purpose:	Not Known	Dia/Height:	10"
Use:	Sanitary	Material:	VCP
Drain Area:	NA	Lining:	
Category:	NA		
Comment:

Location Details:		Direction of Survey:	Upstream
US MH:	M-503-023	DS MH:	M-503-024
		Total Length Surveyed (ft):	148.4

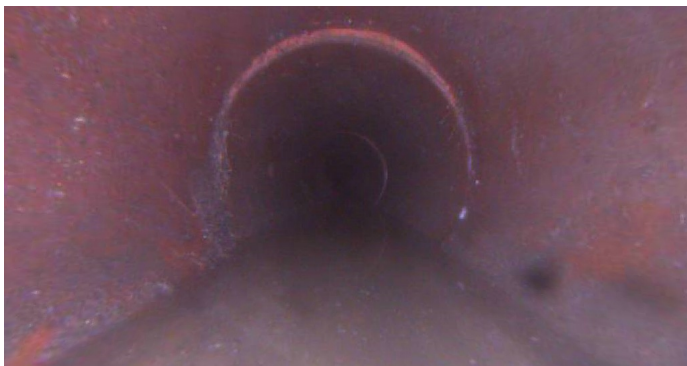
Code: **AMH**
 Description: **Manhole**

Distance (ft): **.0**
 Structural Grade: **0**
 O&M Grade: **0**
 Clock Start/From:
 Clock To:
 1st Value:
 2nd Value:
 Value Percent:
 Continuous Index:
 Within 8" of Joint: **NO**
 Remarks: **M-503-023**

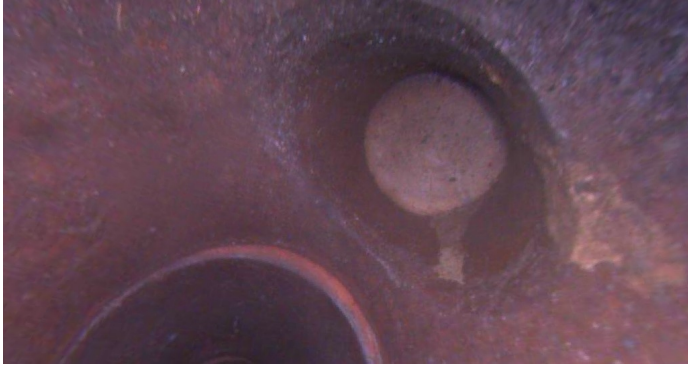
Code: **TFC**
Description: **Tap Factory Capped**

Distance (ft): **23.3**
Structural Grade: **0**
O&M Grade: **0**
Clock Start/From: **2**
Clock To:
1st Value: **4.000**
2nd Value:
Value Percent:
Continuous Index:
Within 8" of Joint:
Remarks:

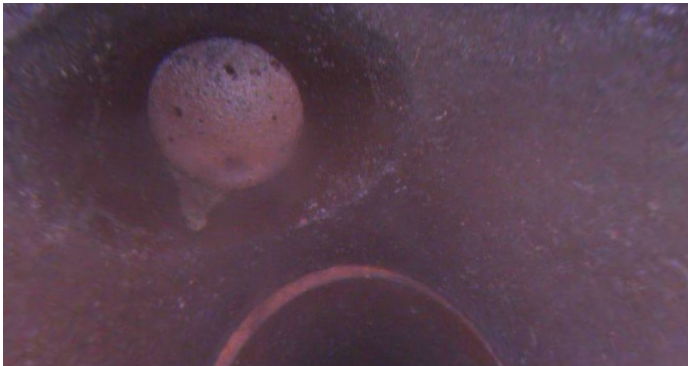
Code: **TFC**
Description: **Tap Factory Capped**

Distance (ft): **25.3**
Structural Grade: **0**
O&M Grade: **0**
Clock Start/From: **11**
Clock To:
1st Value: **4.000**
2nd Value:
Value Percent:
Continuous Index:
Within 8" of Joint:
Remarks:

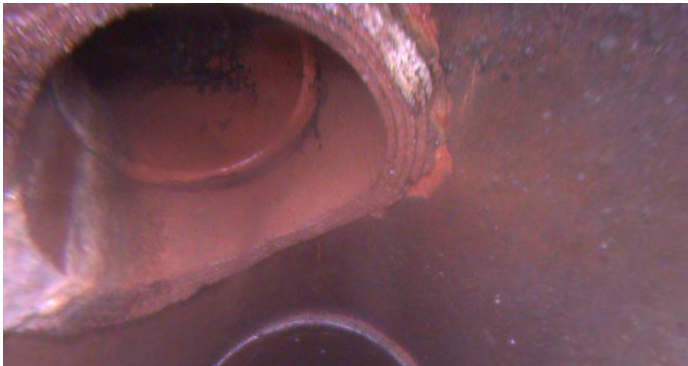
Code: **TB**
Description: **Tap Break-in**

Distance (ft): **33.2**
Structural Grade: **0**
O&M Grade: **0**
Clock Start/From: **10**
Clock To:
1st Value: **4.000**
2nd Value:
Value Percent:
Continuous Index:
Within 8" of Joint:
Remarks:

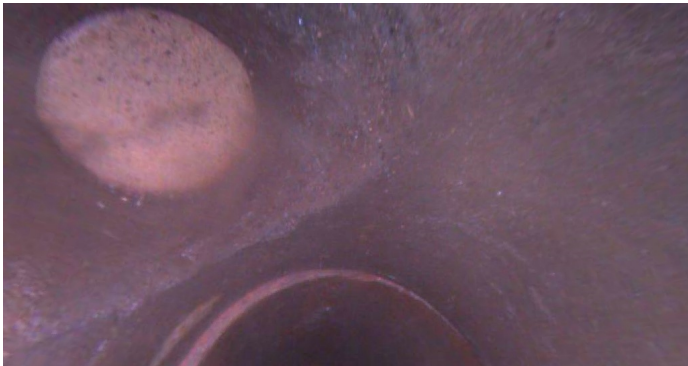
Code: **TFC**
Description: **Tap Factory Capped**

Distance (ft): **65.7**
Structural Grade: **0**
O&M Grade: **0**
Clock Start/From: **10**
Clock To:
1st Value: **4.000**
2nd Value:
Value Percent:
Continuous Index:
Within 8" of Joint:
Remarks:

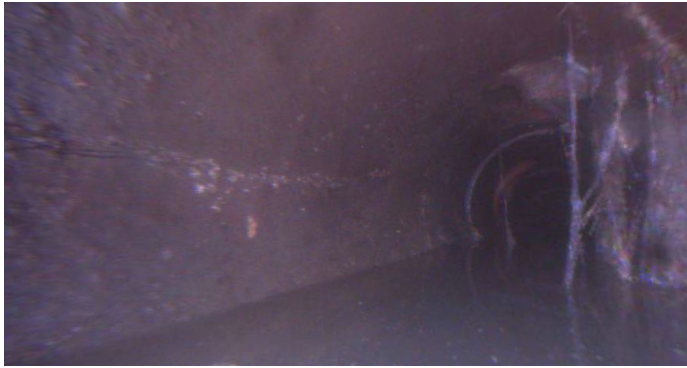
Code: **CL**
Description: **Crack Longitudinal**

Distance (ft): **84.7**
Structural Grade: **2**
O&M Grade: **0**
Clock Start/From: **8**
Clock To:
1st Value:
2nd Value:
Value Percent:
Continuous Index:
Within 8" of Joint:
Remarks:

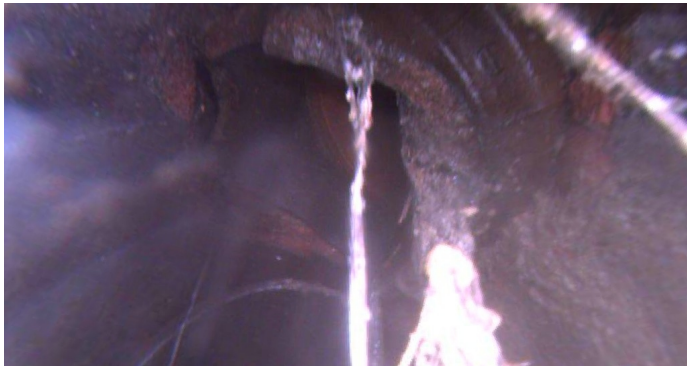
Code: **TBD**
Description: **Tap Break-in Defective**

Distance (ft): **85.7**
Structural Grade: **0**
O&M Grade: **3**
Clock Start/From: **2**
Clock To:
1st Value: **4.000**
2nd Value:
Value Percent:
Continuous Index:
Within 8" of Joint:
Remarks: **RFL**

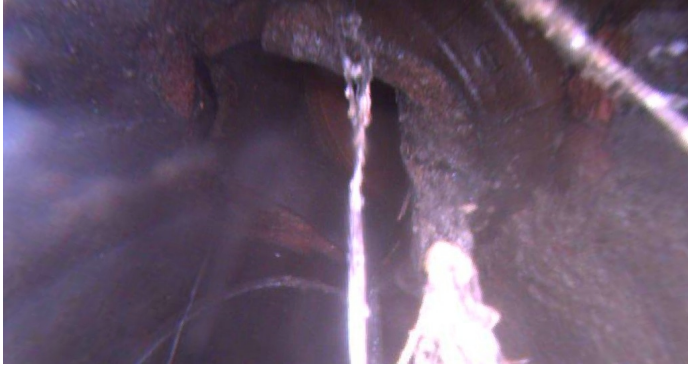
Code: **RFL**
Description: **Roots Fine Lateral**

Distance (ft): **85.7**
Structural Grade: **0**
O&M Grade: **1**
Clock Start/From: **2**
Clock To:
1st Value:
2nd Value:
Value Percent:
Continuous Index:
Within 8" of Joint: **NO**
Remarks:

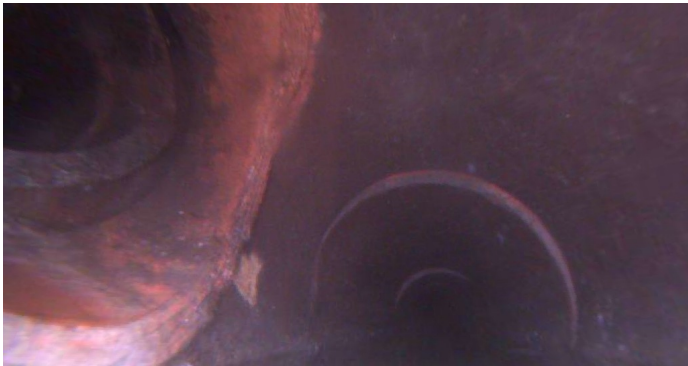
Code: **TB**
Description: **Tap Break-in**

Distance (ft): **87.5**
Structural Grade: **0**
O&M Grade: **0**
Clock Start/From: **9**
Clock To:
1st Value: **4.000**
2nd Value:
Value Percent:
Continuous Index:
Within 8" of Joint:
Remarks:

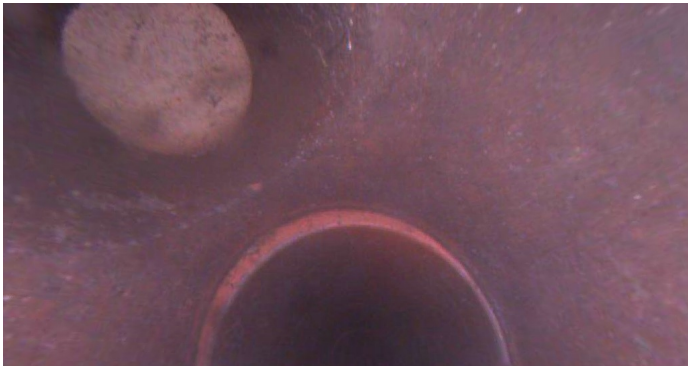
Code: **TFC**
Description: **Tap Factory Capped**

Distance (ft): **103.8**
Structural Grade: **0**
O&M Grade: **0**
Clock Start/From: **10**
Clock To:
1st Value: **4.000**
2nd Value:
Value Percent:
Continuous Index:
Within 8" of Joint:
Remarks:

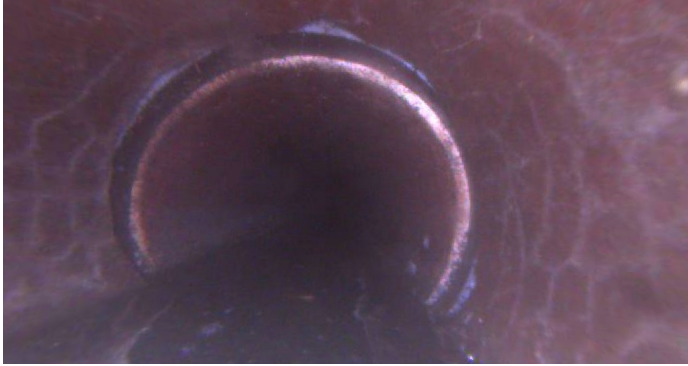
Code: **CM**
Description: **Crack Multiple**

Distance (ft): **125.7**
Structural Grade: **3**
O&M Grade: **0**
Clock Start/From: **7**
Clock To: **5**
1st Value:
2nd Value:
Value Percent:
Continuous Index:
Within 8" of Joint:
Remarks:

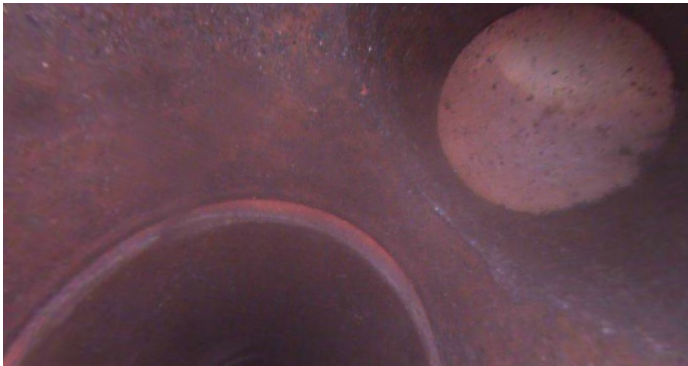
Code: **TFC**
Description: **Tap Factory Capped**

Distance (ft): **138.0**
Structural Grade: **0**
O&M Grade: **0**
Clock Start/From: **2**
Clock To:
1st Value: **4.000**
2nd Value:
Value Percent:
Continuous Index:
Within 8" of Joint:
Remarks:

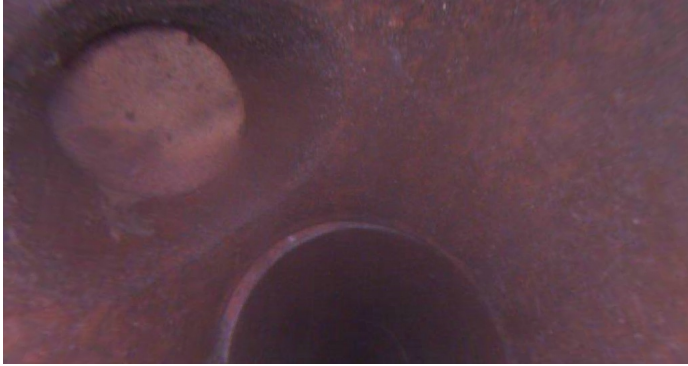
Code: **TFC**
Description: **Tap Factory Capped**

Distance (ft): **139.8**
Structural Grade: **0**
O&M Grade: **0**
Clock Start/From: **10**
Clock To:
1st Value: **4.000**
2nd Value:
Value Percent:
Continuous Index:
Within 8" of Joint:
Remarks:

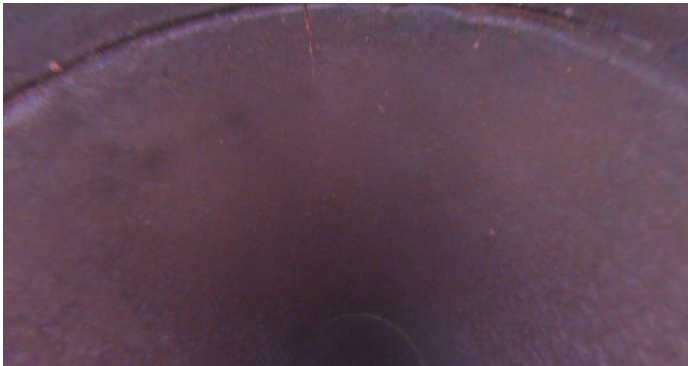
Code: **CL**
Description: **Crack Longitudinal**

Distance (ft): **142.5**
Structural Grade: **2**
O&M Grade: **0**
Clock Start/From: **12**
Clock To:
1st Value:
2nd Value:
Value Percent:
Continuous Index:
Within 8" of Joint: **YES**
Remarks:
