Profile/Photo Observation Report

Street:	W 40th ave	Flow Control:	Not Controlled
City:	Hobart, IN	Year Renewed:	
Location:	Other	Tape/Media #:	
Purpose:	Not Known	Dia/Height:	10"
Use:	Sanitary	Material:	VCP
Drain Area:	NA	Lining:	
Category:	NA		
Comment:

Location Details:		Direction of Survey:	Downstream
US MH:	M-503-032	DS MH:	M-503-031
		Total Length Surveyed (ft):	157.7

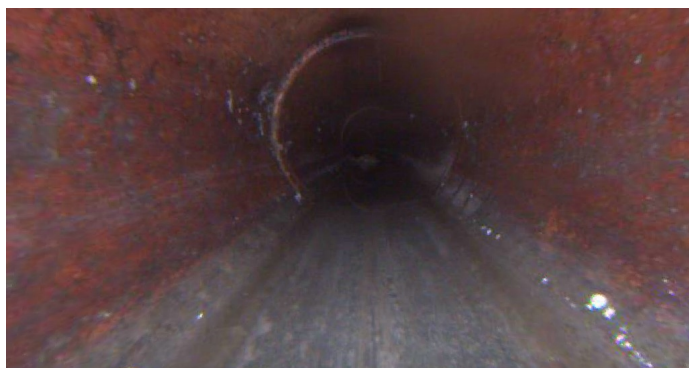
Code: **AMH**
 Description: **Manhole**

Distance (ft): **.0**
 Structural Grade: **0**
 O&M Grade: **0**
 Clock Start/From:
 Clock To:
 1st Value:
 2nd Value:
 Value Percent:
 Continuous Index:
 Within 8" of Joint: **NO**
 Remarks: **M-503-032**

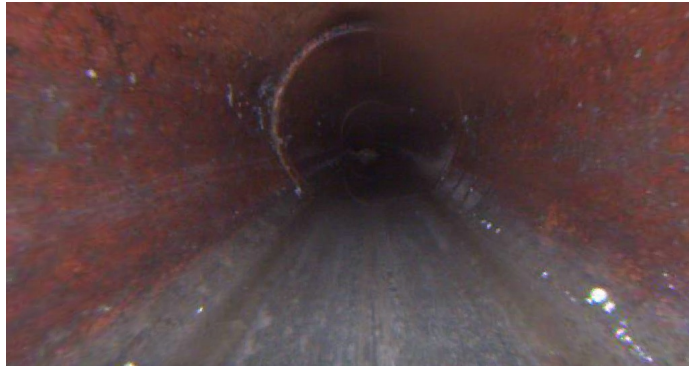
Code: **MWL**
Description: **Water Level**

Distance (ft): **.0**
Structural Grade: **0**
O&M Grade: **0**
Clock Start/From:
Clock To:
1st Value:
2nd Value:
Value Percent: **10.000**
Continuous Index:
Within 8" of Joint: **NO**
Remarks:

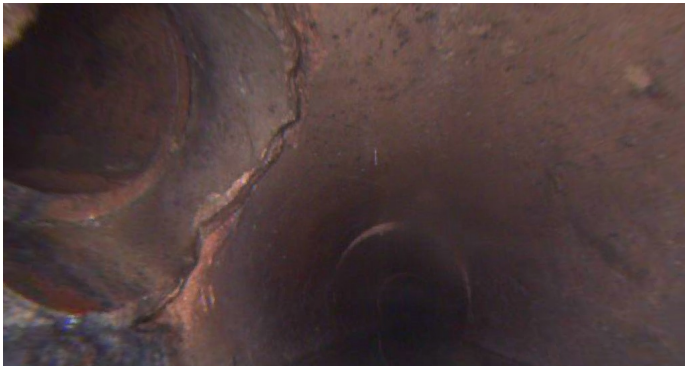
Code: **TBI**
Description: **Tap Break-in Intruding**

Distance (ft): **53.2**
Structural Grade: **0**
O&M Grade: **2**
Clock Start/From: **10**
Clock To:
1st Value: **4.000**
2nd Value: **1.000**
Value Percent:
Continuous Index:
Within 8" of Joint:
Remarks:

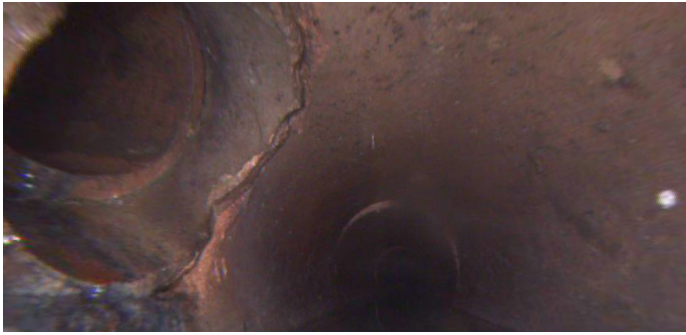
Code: **FM**
Description: **Fracture Multiple**

Distance (ft): **53.2**
Structural Grade: **4**
O&M Grade: **0**
Clock Start/From: **8**
Clock To: **4**
1st Value:
2nd Value:
Value Percent:
Continuous Index: **F01**
Within 8" of Joint: **YES**
Remarks:

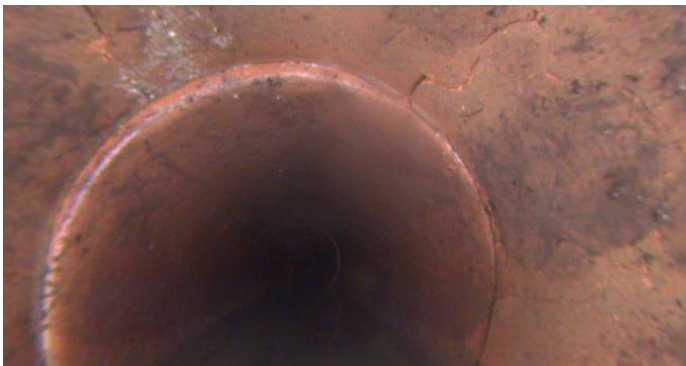
Code: **FM**
Description: **Fracture Multiple**

Distance (ft): **57.5**
Structural Grade: **4**
O&M Grade: **0**
Clock Start/From: **7**
Clock To: **5**
1st Value:
2nd Value:
Value Percent:
Continuous Index:
Within 8" of Joint: **YES**
Remarks:

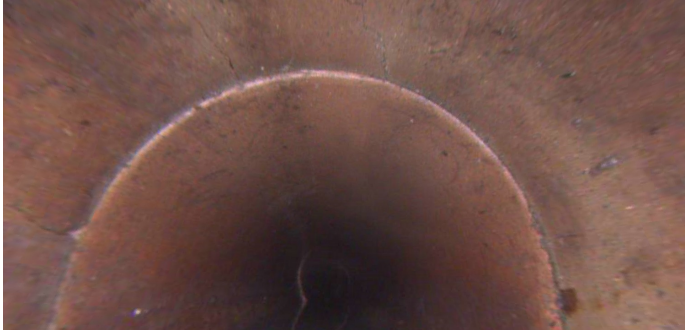
Code: **FM**
Description: **Fracture Multiple**

Distance (ft): **63.5**
Structural Grade: **4**
O&M Grade: **0**
Clock Start/From: **8**
Clock To: **4**
1st Value:
2nd Value:
Value Percent:
Continuous Index:
Within 8" of Joint: **YES**
Remarks:

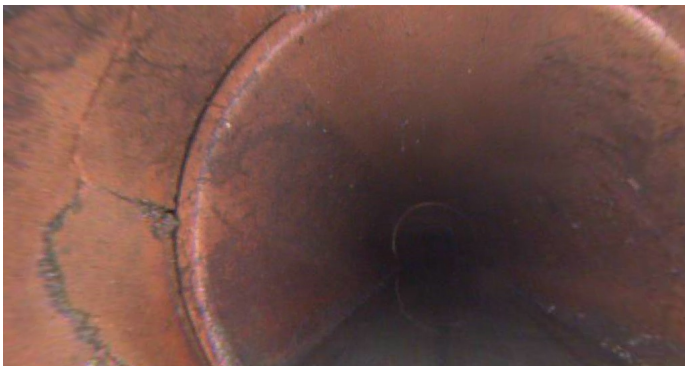
Code: **FM**
Description: **Fracture Multiple**

Distance (ft): **75.2**
Structural Grade: **4**
O&M Grade: **0**
Clock Start/From: **7**
Clock To: **5**
1st Value:
2nd Value:
Value Percent:
Continuous Index: **S02**
Within 8" of Joint: **YES**
Remarks:

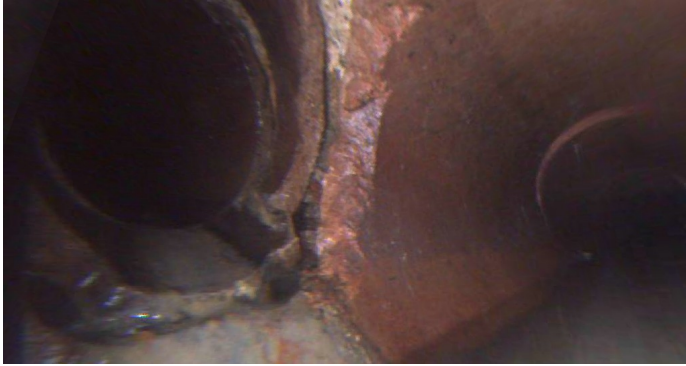
Code: **TBI**
Description: **Tap Break-in Intruding**

Distance (ft): **97.0**
Structural Grade: **0**
O&M Grade: **2**
Clock Start/From: **8**
Clock To:
1st Value: **4.000**
2nd Value: **1.000**
Value Percent:
Continuous Index:
Within 8" of Joint:
Remarks:

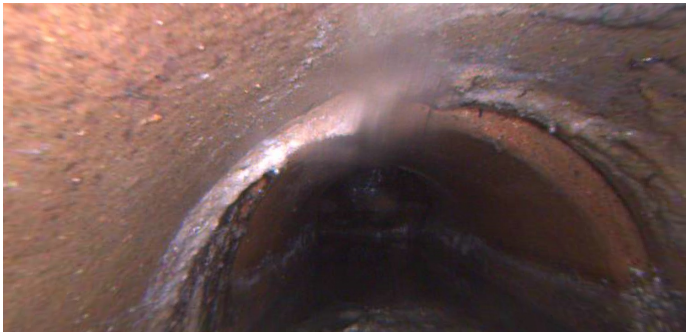
Code: **DAE**
Description: **Deposits Attached Encrustation**

Distance (ft): **154.5**
Structural Grade: **0**
O&M Grade: **2**
Clock Start/From: **8**
Clock To: **4**
1st Value:
2nd Value:
Value Percent: **5.000**
Continuous Index:
Within 8" of Joint: **YES**
Remarks:

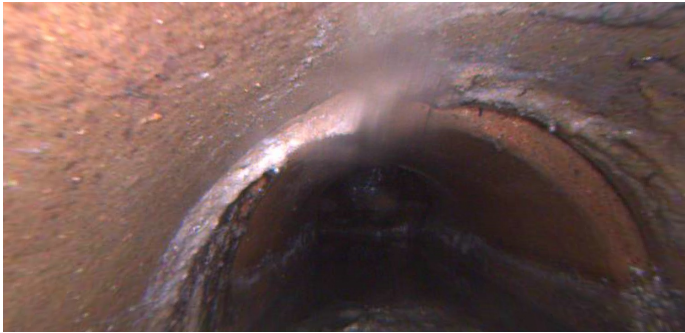
Code: **IW**
Description: **Infil Weeper**

Distance (ft): **154.5**
Structural Grade: **0**
O&M Grade: **2**
Clock Start/From: **8**
Clock To: **4**
1st Value:
2nd Value:
Value Percent:
Continuous Index:
Within 8" of Joint: **YES**
Remarks:

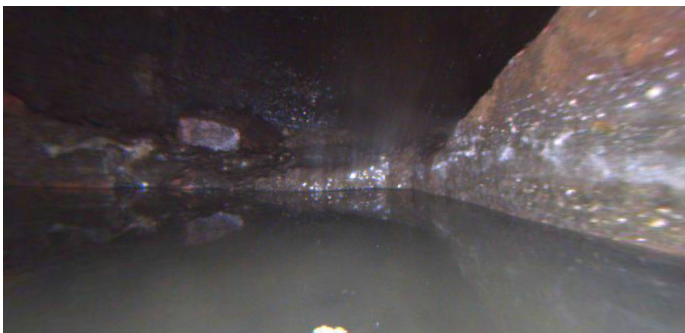
Code: **FM**
Description: **Fracture Multiple**

Distance (ft): **156.1**
Structural Grade: **4**
O&M Grade: **0**
Clock Start/From: **7**
Clock To: **5**
1st Value:
2nd Value:
Value Percent:
Continuous Index: **F02**
Within 8" of Joint: **YES**
Remarks:
