Profile/Photo Observation Report

Date:	09/08/2021	Weather:		Coding:	PACP 7.0
Pipe Length (ft):	331.0	Owner:	City of Hobart	Pre Clean:	Heavy Cleaning
P.O.#:	YES502259	Surveyor:	S. Bucklin	PSR:	P-503-033-032
Customer:	City of Hobart	Clean Date:	09/08/2021	Shape:	C

Street:	41st Avenue	Flow Control:	Not Controlled
City:	Hobart, IN	Year Renewed:	
Location:	Alley	Tape/Media #:	
Purpose:	Routine Assessment	Dia/Height:	8"
Use:	Sanitary Sewage Pipe	Material:	VCP
Drain Area:		Lining:	None
Category:	NA		
Comment:			
Location Details:		Direction of Survey:	Downstream
US MH:	M-503-032	DS MH:	M-503-033
		Total Length Surveyed (ft):	287.6

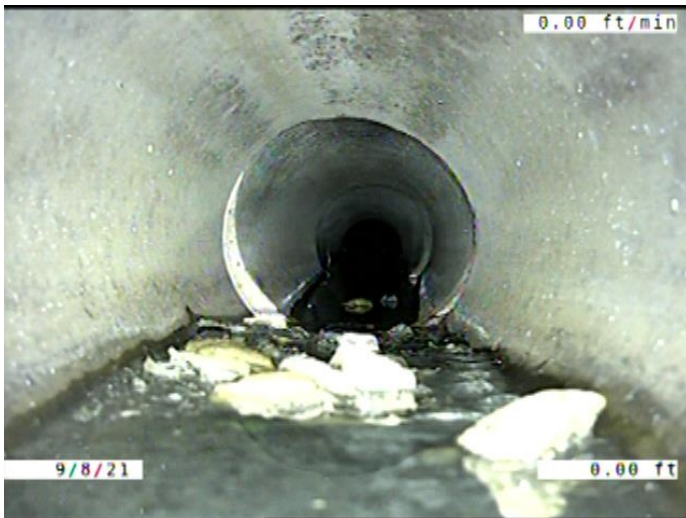
Code: **MWL**
 Description: **Miscellaneous Water Level**

Distance (ft): **.0**
 Structural Grade: **0**
 O&M Grade: **0**
 Clock Start/From:
 Clock To:
 1st Value:
 2nd Value:
 Value Percent: **5.000**
 Continuous Index:
 Within 8" of Joint: **NO**
 Remarks:

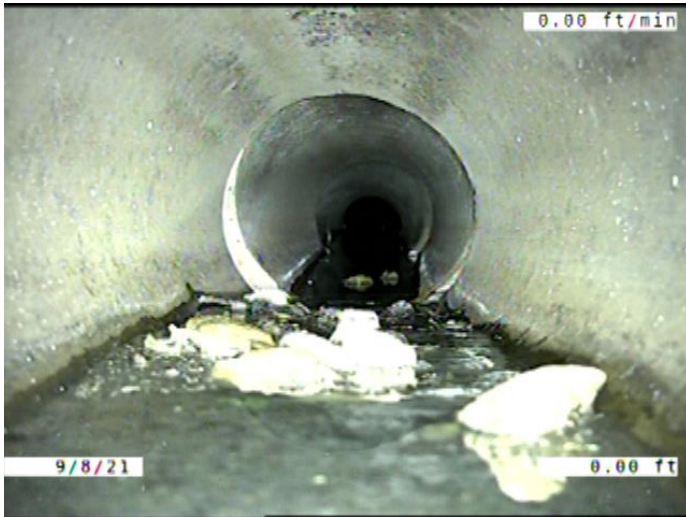
Code: **DSF**
 Description: **Deposits Settled Fine**

Distance (ft): **.0**
 Structural Grade: **0**
 O&M Grade: **2**
 Clock Start/From: **5**
 Clock To: **7**
 1st Value:
 2nd Value:
 Value Percent: **5.000**
 Continuous Index: **S01**
 Within 8" of Joint: **YES**
 Remarks:

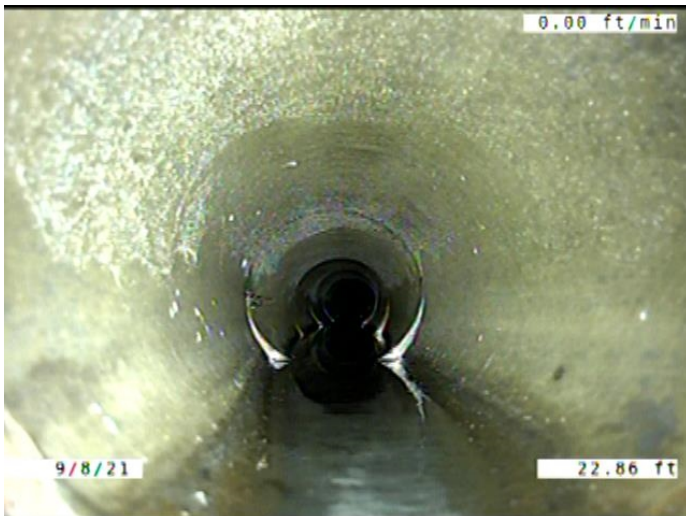
Code: **MWLS**
 Description: **Miscellaneous Water Level Sag**

Distance (ft): **22.9**
 Structural Grade: **2**
 O&M Grade: **0**
 Clock Start/From:
 Clock To:
 1st Value:
 2nd Value:
 Value Percent: **10.000**
 Continuous Index: **F02**
 Within 8" of Joint: **NO**
 Remarks:

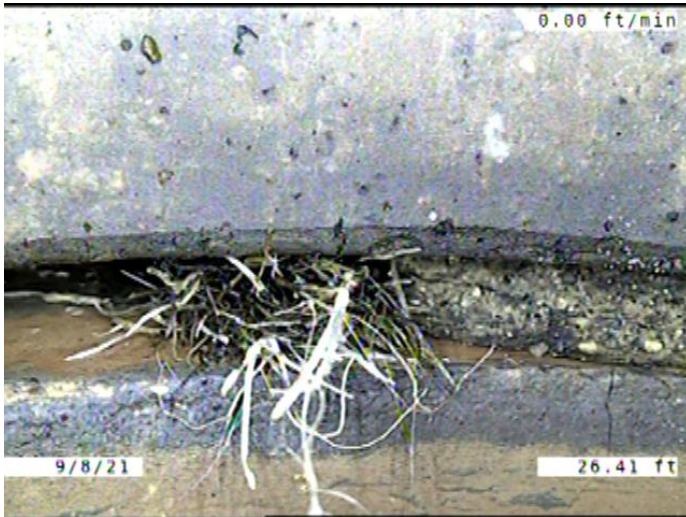
Code: **RFJ**
Description: **Roots Fine Joint**

Distance (ft): **26.4**
Structural Grade: **0**
O&M Grade: **1**
Clock Start/From: **9**
Clock To:
1st Value:
2nd Value:
Value Percent:
Continuous Index:
Within 8" of Joint: **YES**
Remarks:

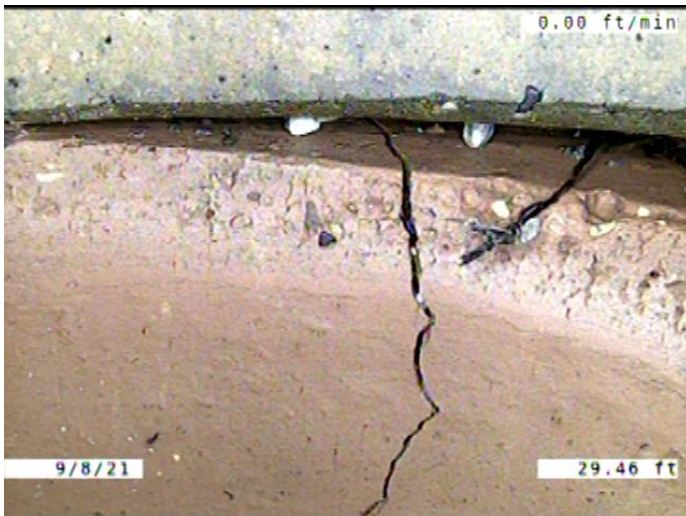
Code: **FL**
Description: **Fracture Longitudinal**

Distance (ft): **29.5**
Structural Grade: **3**
O&M Grade: **0**
Clock Start/From: **2**
Clock To:
1st Value:
2nd Value:
Value Percent:
Continuous Index:
Within 8" of Joint: **YES**
Remarks:

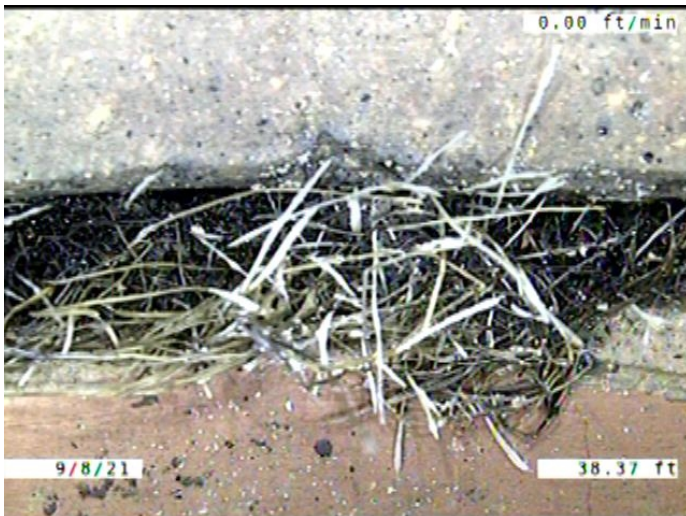
Code: **RFJ**
 Description: **Roots Fine Joint**

Distance (ft): **38.4**
 Structural Grade: **0**
 O&M Grade: **1**
 Clock Start/From: **7**
 Clock To: **11**
 1st Value:
 2nd Value:
 Value Percent:
 Continuous Index: **S04**
 Within 8" of Joint: **YES**
 Remarks:

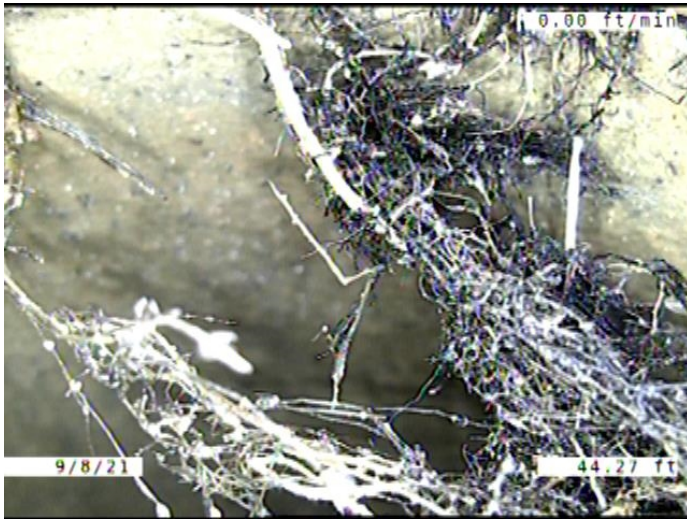
Code: **RMJ**
 Description: **Roots Medium Joint**

Distance (ft): **44.3**
 Structural Grade: **0**
 O&M Grade: **3**
 Clock Start/From: **1**
 Clock To: **3**
 1st Value:
 2nd Value:
 Value Percent: **5.000**
 Continuous Index:
 Within 8" of Joint: **YES**
 Remarks:

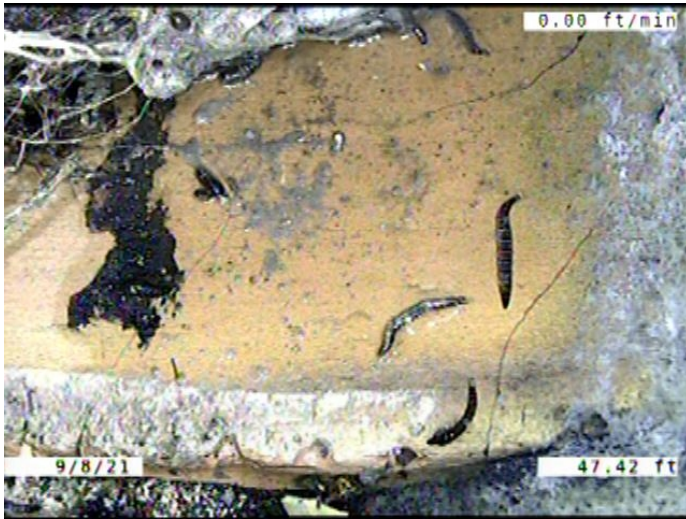
Code: **CM**
 Description: **Crack Multiple**

Distance (ft): **47.4**
 Structural Grade: **3**
 O&M Grade: **0**
 Clock Start/From: **6**
 Clock To: **8**
 1st Value:
 2nd Value:
 Value Percent:
 Continuous Index:
 Within 8" of Joint: **YES**
 Remarks:

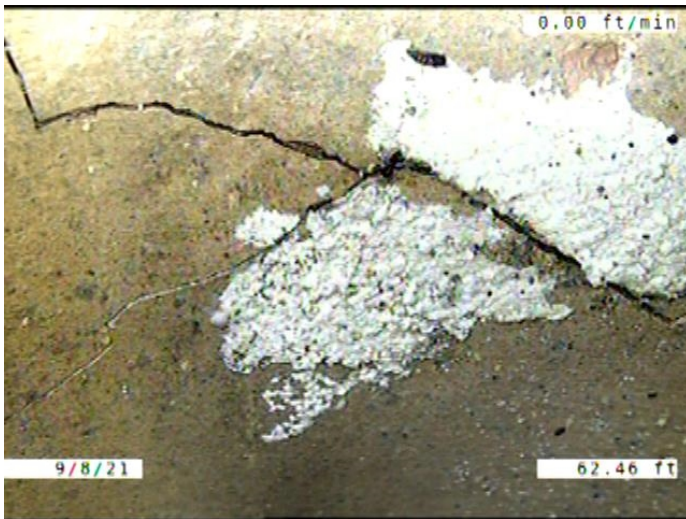
Code: **B**
 Description: **Broken**

Distance (ft): **62.5**
 Structural Grade: **4**
 O&M Grade: **0**
 Clock Start/From: **8**
 Clock To: **10**
 1st Value:
 2nd Value:
 Value Percent:
 Continuous Index:
 Within 8" of Joint: **YES**
 Remarks:

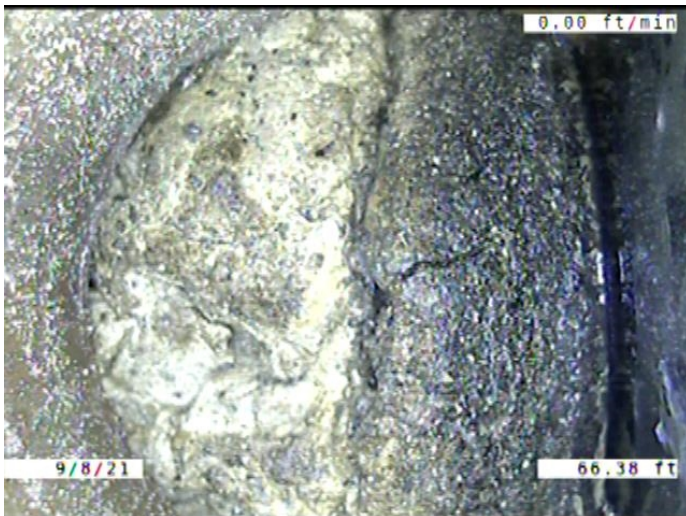
Code: **TFD**
 Description: **Tap Factory Defective**

Distance (ft): **66.4**
 Structural Grade: **0**
 O&M Grade: **3**
 Clock Start/From: **3**
 Clock To:
 1st Value: **4.000**
 2nd Value:
 Value Percent:
 Continuous Index:
 Within 8" of Joint: **YES**
 Remarks: **CAPPED**

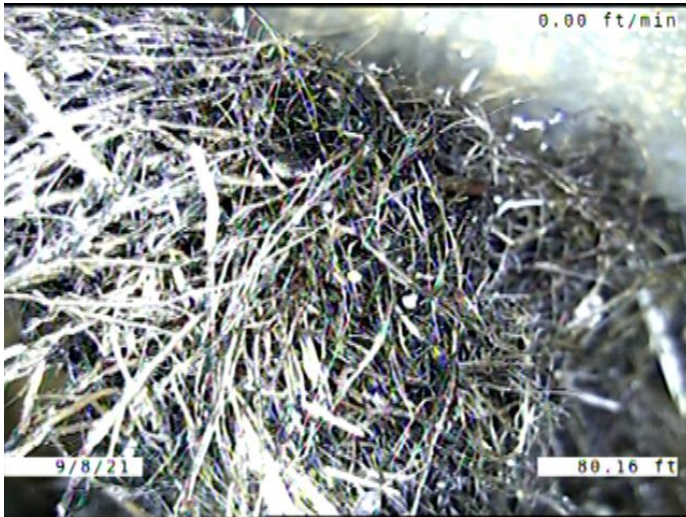
Code: **RMJ**
 Description: **Roots Medium Joint**

Distance (ft): **80.2**
 Structural Grade: **0**
 O&M Grade: **3**
 Clock Start/From: **9**
 Clock To: **11**
 1st Value:
 2nd Value:
 Value Percent: **10.000**
 Continuous Index:
 Within 8" of Joint: **YES**
 Remarks:

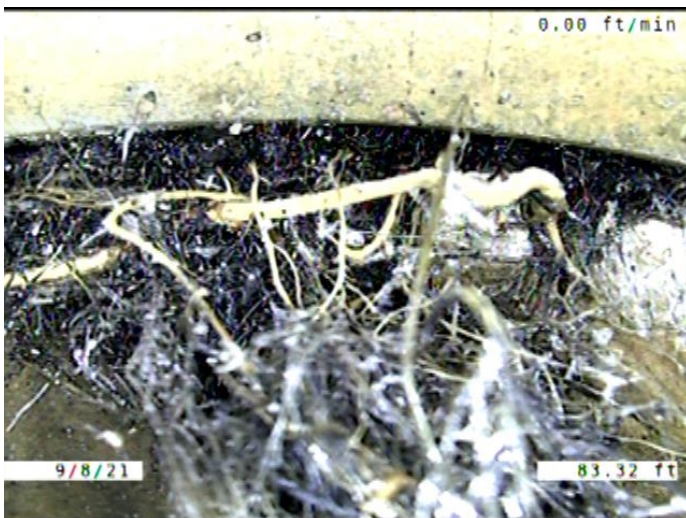
Code: **RMJ**
 Description: **Roots Medium Joint**

Distance (ft): **83.3**
 Structural Grade: **0**
 O&M Grade: **3**
 Clock Start/From: **12**
 Clock To: **3**
 1st Value:
 2nd Value:
 Value Percent: **5.000**
 Continuous Index:
 Within 8" of Joint: **YES**
 Remarks:

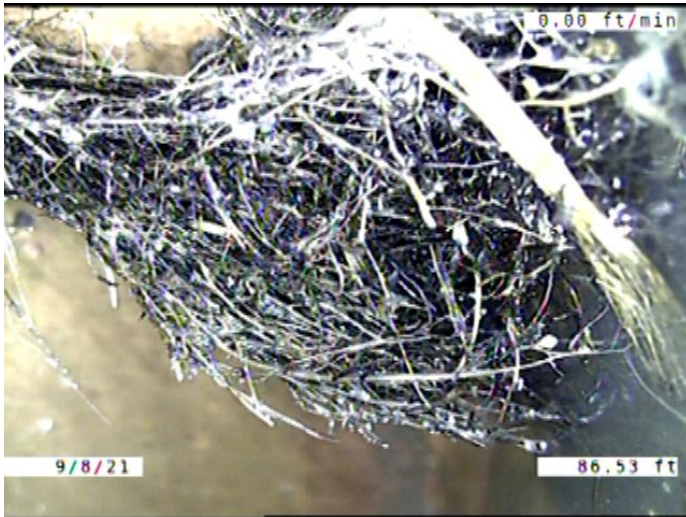
Code: **RMJ**
 Description: **Roots Medium Joint**

Distance (ft): **86.5**
 Structural Grade: **0**
 O&M Grade: **3**
 Clock Start/From: **12**
 Clock To: **3**
 1st Value:
 2nd Value:
 Value Percent: **5.000**
 Continuous Index:
 Within 8" of Joint: **YES**
 Remarks:

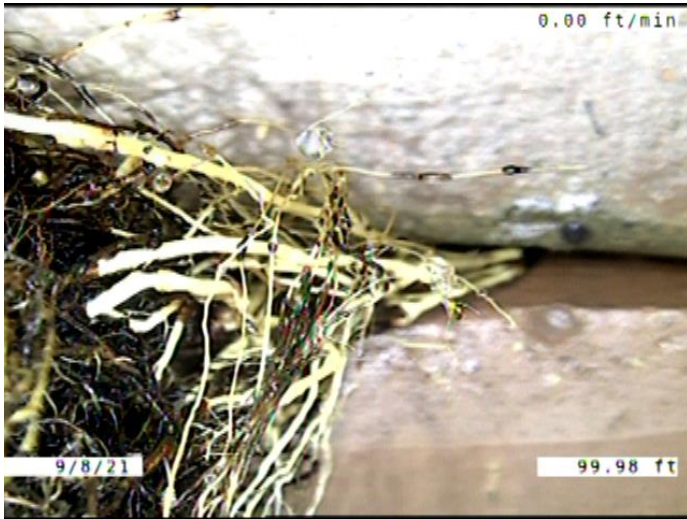
Code: **RMJ**
 Description: **Roots Medium Joint**

Distance (ft): **100.0**
 Structural Grade: **0**
 O&M Grade: **3**
 Clock Start/From: **8**
 Clock To: **11**
 1st Value:
 2nd Value:
 Value Percent: **5.000**
 Continuous Index: **S06**
 Within 8" of Joint: **YES**
 Remarks:

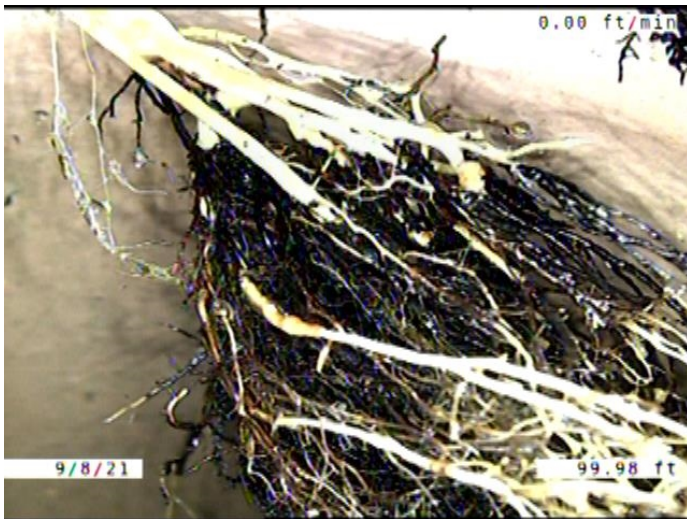
Code: **RMJ**
 Description: **Roots Medium Joint**

Distance (ft): **100.0**
 Structural Grade: **0**
 O&M Grade: **3**
 Clock Start/From: **1**
 Clock To: **4**
 1st Value:
 2nd Value:
 Value Percent: **5.000**
 Continuous Index: **S05**
 Within 8" of Joint: **YES**
 Remarks:

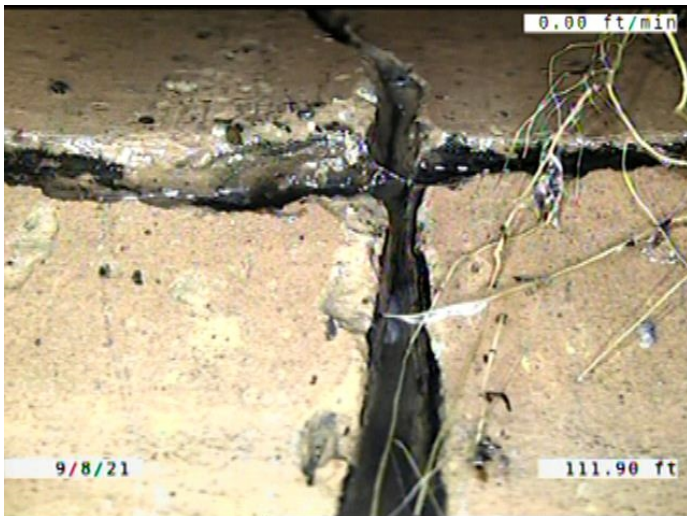
Code: **B**
 Description: **Broken**

Distance (ft): **111.9**
 Structural Grade: **4**
 O&M Grade: **0**
 Clock Start/From: **3**
 Clock To: **9**
 1st Value:
 2nd Value:
 Value Percent:
 Continuous Index:
 Within 8" of Joint: **YES**
 Remarks:

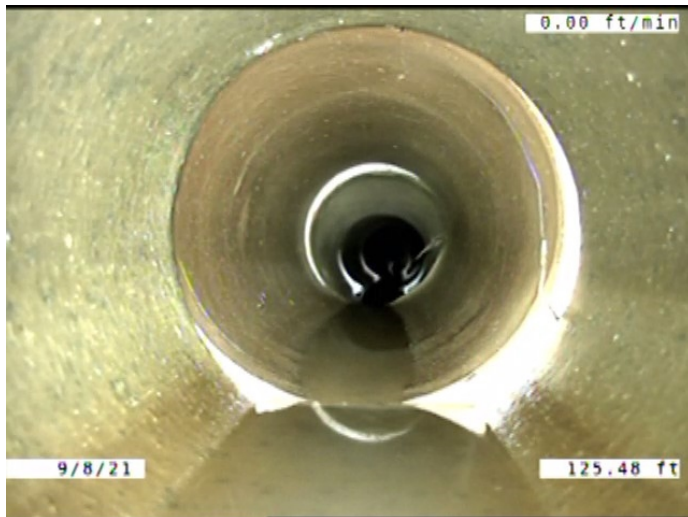
Code: **RMJ**
 Description: **Roots Medium Joint**

Distance (ft): **125.5**
 Structural Grade: **0**
 O&M Grade: **3**
 Clock Start/From: **8**
 Clock To: **11**
 1st Value:
 2nd Value:
 Value Percent: **5.000**
 Continuous Index: **F06**
 Within 8" of Joint: **YES**
 Remarks:

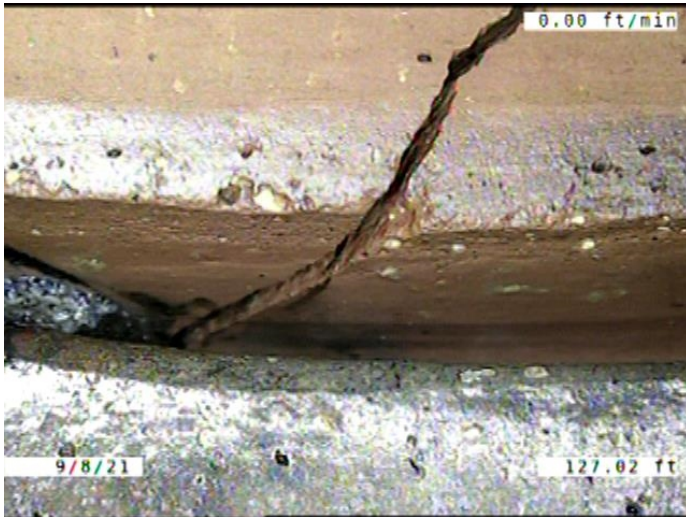
Code: **FM**
 Description: **Fracture Multiple**

Distance (ft): **127.0**
 Structural Grade: **4**
 O&M Grade: **0**
 Clock Start/From: **1**
 Clock To: **4**
 1st Value:
 2nd Value:
 Value Percent:
 Continuous Index:
 Within 8" of Joint: **YES**
 Remarks:

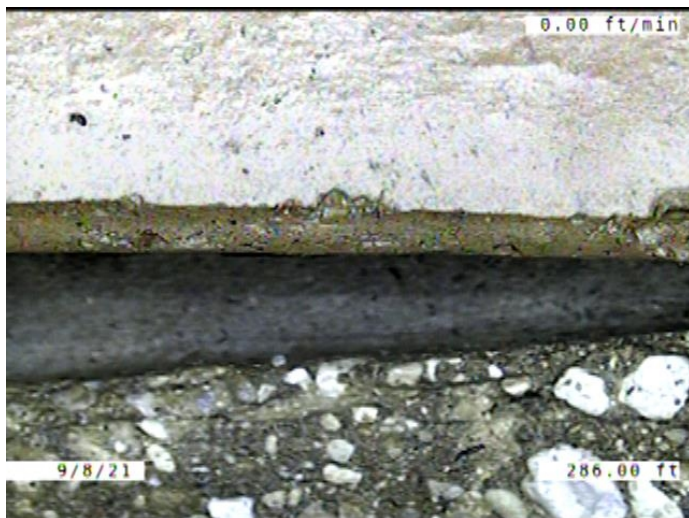
Code: **MMC**
Description: **Miscellaneous Material Change**

Distance (ft): **286.0**
Structural Grade: **0**
O&M Grade: **0**
Clock Start/From:
Clock To:
1st Value:
2nd Value:
Value Percent:
Continuous Index:
Within 8" of Joint: **NO**
Remarks: **VCP TO CONCRETE**

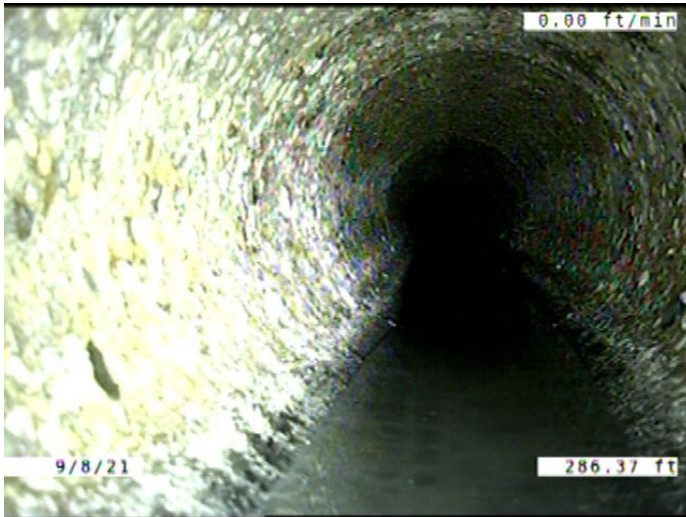
Code:	MSC
Description:	Miscellaneous Shape/Size Change
Distance (ft):	286.4
Structural Grade:	0
O&M Grade:	0
Clock Start/From:	
Clock To:	
1st Value:	10.000
2nd Value:	
Value Percent:	
Continuous Index:	
Within 8" of Joint:	NO
Remarks:	8" TO 10"

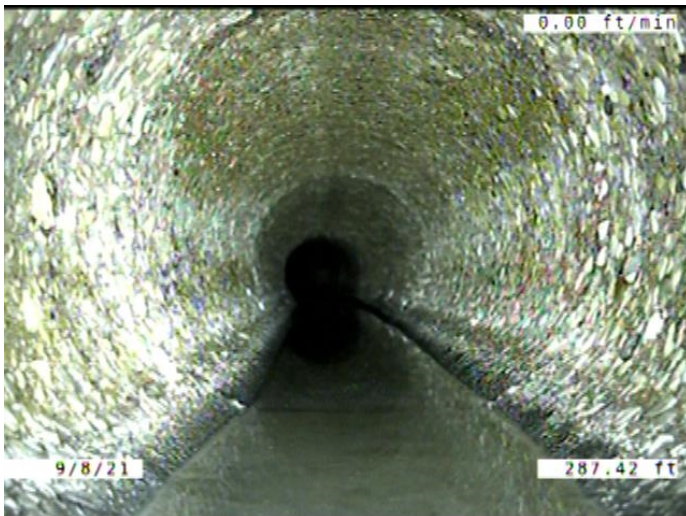
Code:	DSF
Description:	Deposits Settled Fine
Distance (ft):	287.4
Structural Grade:	0
O&M Grade:	2
Clock Start/From:	5
Clock To:	7
1st Value:	
2nd Value:	
Value Percent:	5.000
Continuous Index:	F01
Within 8" of Joint:	YES
Remarks:

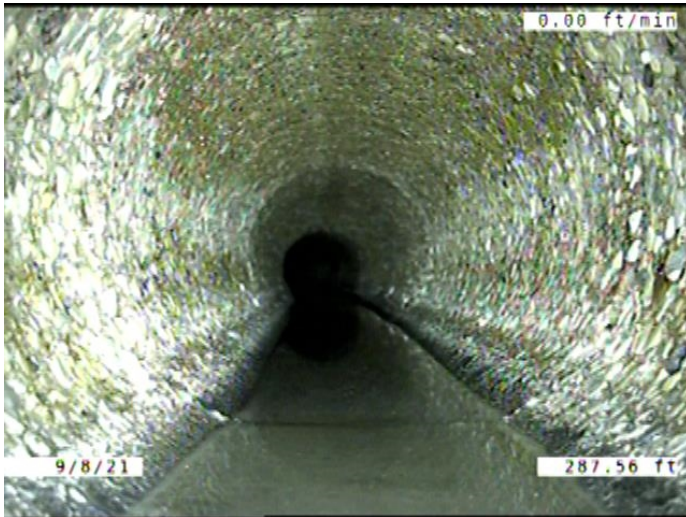
Code:	MSA
Description:	Miscellaneous Survey Abandoned
Distance (ft):	287.6
Structural Grade:	0
O&M Grade:	0
Clock Start/From:	
Clock To:	
1st Value:	
2nd Value:	
Value Percent:	
Continuous Index:	
Within 8" of Joint:	NO
Remarks:	MADE IT TO THE POINT OF OVERLAP. REVERSAL COMPLETE
