# Profile/Photo Observation Report

Date:	<b>09/08/2021</b>	Weather:		Coding:	<b>PACP 7.0</b>
Pipe Length (ft):	<b>331.0</b>	Owner:	<b>City of Hobart</b>	Pre Clean:	<b>Heavy Cleaning</b>
P.O.#:	<b>YES502259</b>	Surveyor:	<b>S. Bucklin</b>	PSR:	<b>P-503-033-032</b>
Customer:	<b>City of Hobart</b>	Clean Date:	<b>09/08/2021</b>	Shape:	<b>C</b>

Street:	<b>41st Avenue</b>	Flow Control:	<b>Not Controlled</b>
City:	<b>Hobart, IN</b>	Year Renewed:	
Location:	<b>Alley</b>	Tape/Media #:	
Purpose:	<b>Routine Assessment</b>	Dia/Height:	<b>8"</b>
Use:	<b>Sanitary Sewage Pipe</b>	Material:	<b>VCP</b>
Drain Area:		Lining:	<b>None</b>
Category:	<b>NA</b>		
Comment:			
Location Details:		Direction of Survey:	<b>Downstream</b>
US MH:	<b>M-503-032</b>	DS MH:	<b>M-503-033</b>
		Total Length Surveyed (ft):	<b>287.6</b>

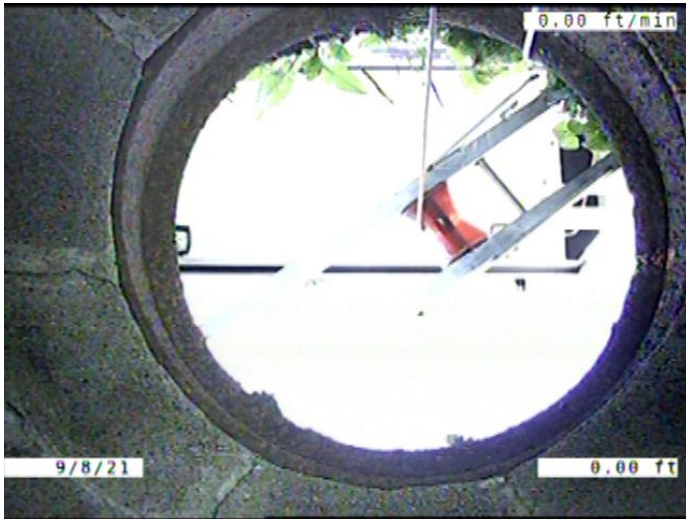
Code: **AMH**  
 Description: **Manhole**

Distance (ft): **.0**  
 Structural Grade: **0**  
 O&M Grade: **0**  
 Clock Start/From:  
 Clock To:  
 1st Value:  
 2nd Value:  
 Value Percent:  
 Continuous Index:  
 Within 8" of Joint: **NO**  
 Remarks: **M-503-032**

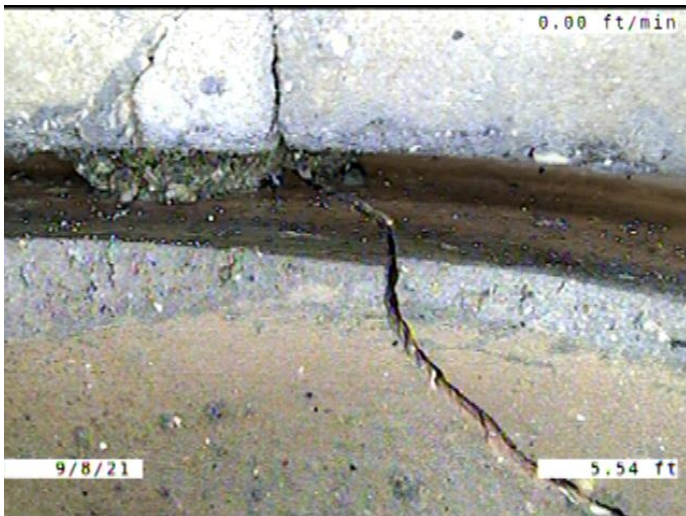
Code: **B**  
 Description: **Broken**

Distance (ft): **5.5**  
 Structural Grade: **4**  
 O&M Grade: **0**  
 Clock Start/From: **1**  
 Clock To: **3**  
 1st Value:  
 2nd Value:  
 Value Percent:  
 Continuous Index:  
 Within 8" of Joint: **YES**  
 Remarks:

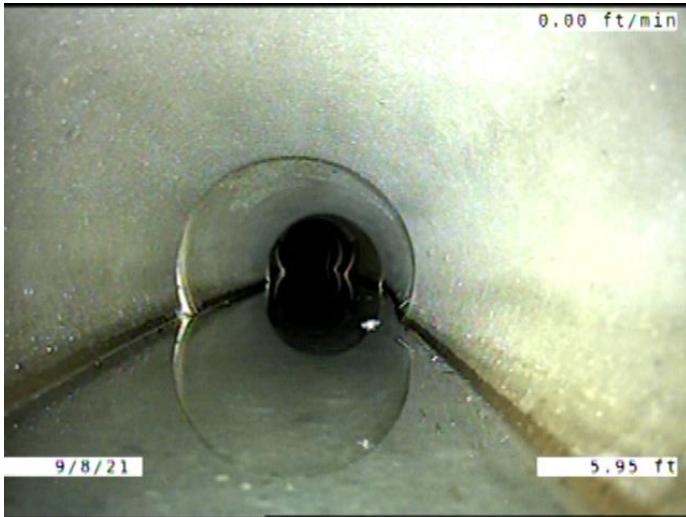
Code: **MWLS**  
Description: **Miscellaneous Water Level Sag**

Distance (ft): **5.9**  
Structural Grade: **2**  
O&M Grade: **0**  
Clock Start/From:  
Clock To:  
1st Value:  
2nd Value:  
Value Percent: **10.000**  
Continuous Index: **S02**  
Within 8" of Joint: **NO**  
Remarks:

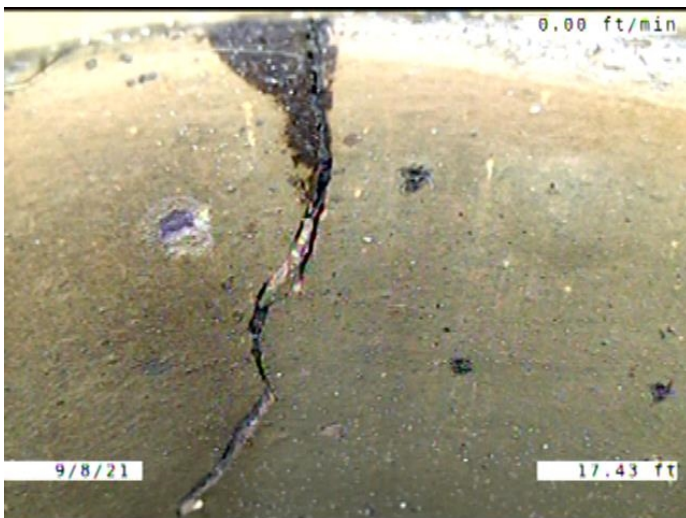
Code: **FM**  
Description: **Fracture Multiple**

Distance (ft): **17.4**  
Structural Grade: **4**  
O&M Grade: **0**  
Clock Start/From: **7**  
Clock To: **5**  
1st Value:  
2nd Value:  
Value Percent:  
Continuous Index:  
Within 8" of Joint: **YES**  
Remarks:

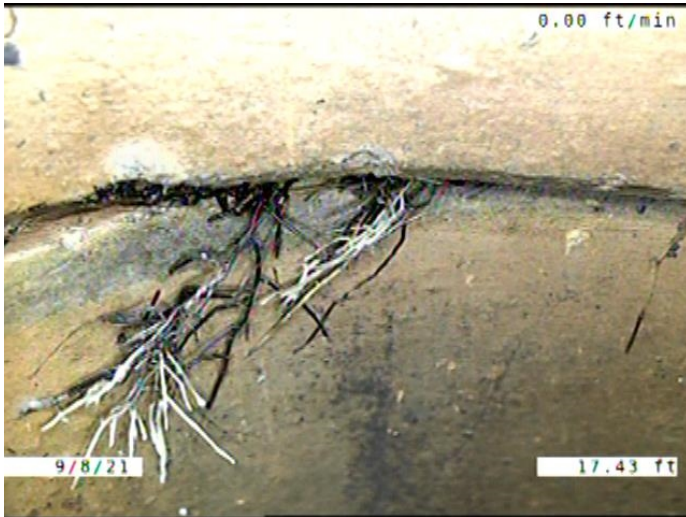
Code: **RFJ**  
 Description: **Roots Fine Joint**

Distance (ft): **17.4**  
 Structural Grade: **0**  
 O&M Grade: **1**  
 Clock Start/From: **9**  
 Clock To:  
 1st Value:  
 2nd Value:  
 Value Percent:  
 Continuous Index:  
 Within 8" of Joint: **YES**  
 Remarks:

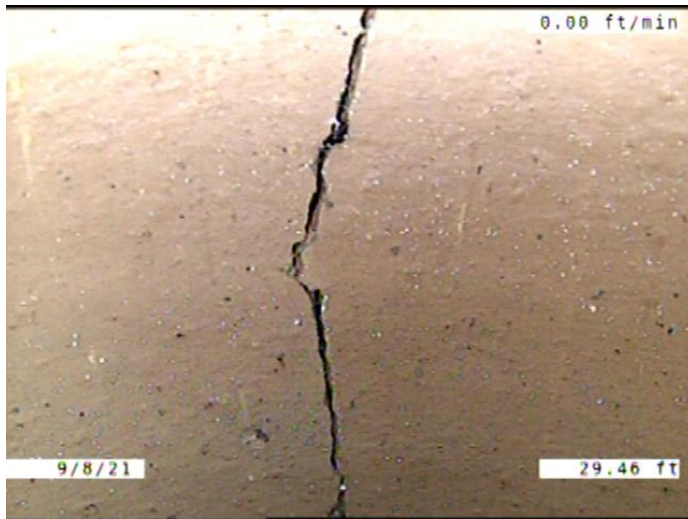
Code: **FS**  
 Description: **Fracture Spiral**

Distance (ft): **29.5**  
 Structural Grade: **3**  
 O&M Grade: **0**  
 Clock Start/From: **7**  
 Clock To: **11**  
 1st Value:  
 2nd Value:  
 Value Percent:  
 Continuous Index:  
 Within 8" of Joint: **YES**  
 Remarks:

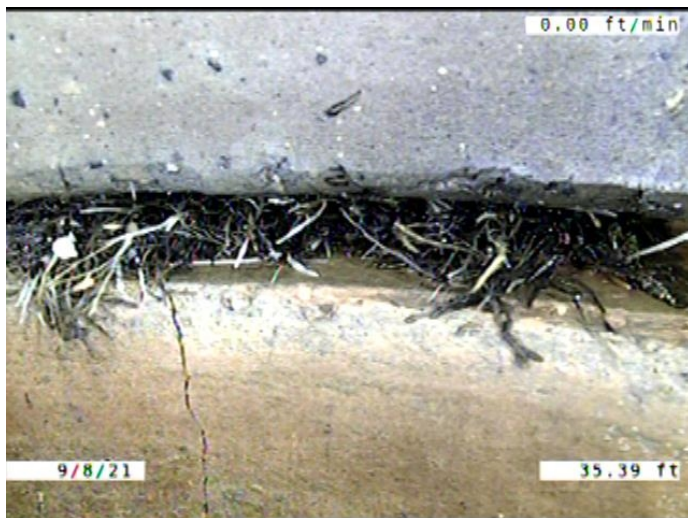
Code: **RFJ**  
 Description: **Roots Fine Joint**

Distance (ft): **35.4**  
 Structural Grade: **0**  
 O&M Grade: **1**  
 Clock Start/From: **1**  
 Clock To: **3**  
 1st Value:  
 2nd Value:  
 Value Percent:  
 Continuous Index: **S03**  
 Within 8" of Joint: **YES**  
 Remarks:

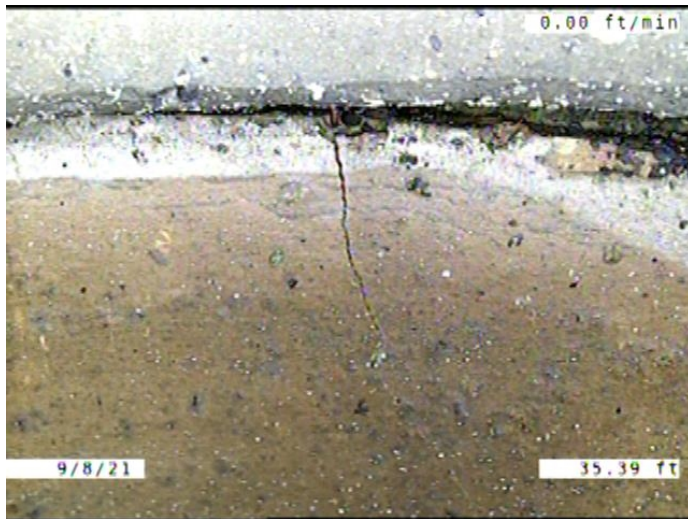
Code: **CS**  
 Description: **Crack Spiral**

Distance (ft): **35.4**  
 Structural Grade: **2**  
 O&M Grade: **0**  
 Clock Start/From: **12**  
 Clock To: **3**  
 1st Value:  
 2nd Value:  
 Value Percent:  
 Continuous Index:  
 Within 8" of Joint: **YES**  
 Remarks:

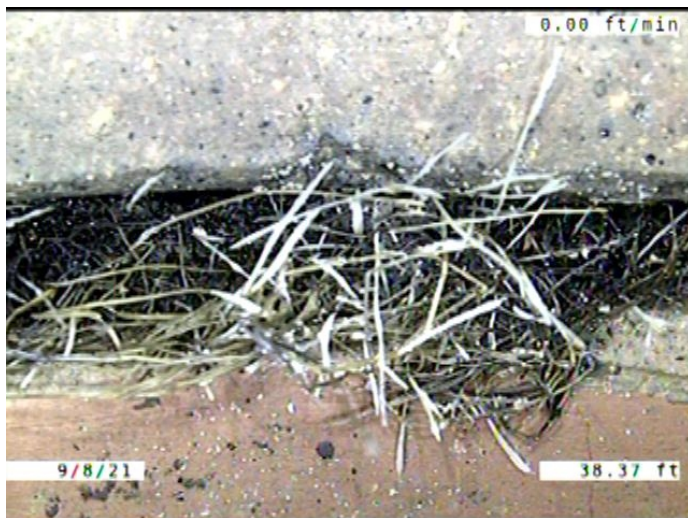
Code: **RFJ**  
 Description: **Roots Fine Joint**

Distance (ft): **38.4**  
 Structural Grade: **0**  
 O&M Grade: **1**  
 Clock Start/From: **7**  
 Clock To: **11**  
 1st Value:  
 2nd Value:  
 Value Percent:  
 Continuous Index: **S04**  
 Within 8" of Joint: **YES**  
 Remarks:

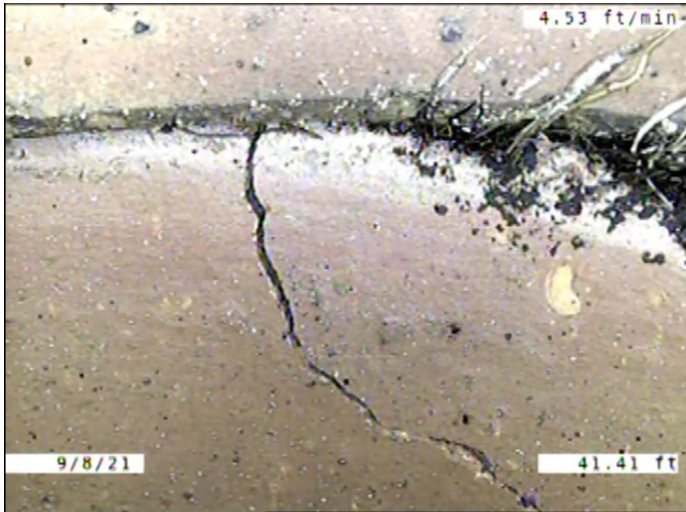
Code: **FC**  
Description: **Fracture Circumferential**

Distance (ft): **41.4**  
Structural Grade: **2**  
O&M Grade: **0**  
Clock Start/From: **1**  
Clock To: **2**  
1st Value:  
2nd Value:  
Value Percent:  
Continuous Index:  
Within 8" of Joint: **YES**  
Remarks:

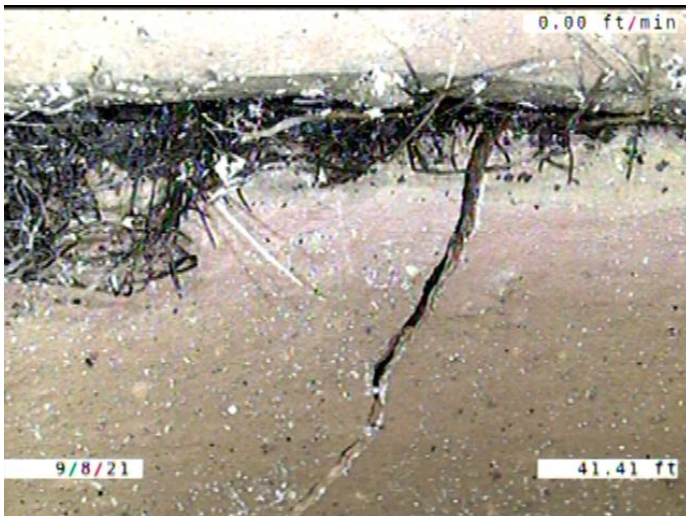
Code: **B**  
Description: **Broken**

Distance (ft): **41.4**  
Structural Grade: **4**  
O&M Grade: **0**  
Clock Start/From: **7**  
Clock To: **10**  
1st Value:  
2nd Value:  
Value Percent:  
Continuous Index:  
Within 8" of Joint: **YES**  
Remarks:

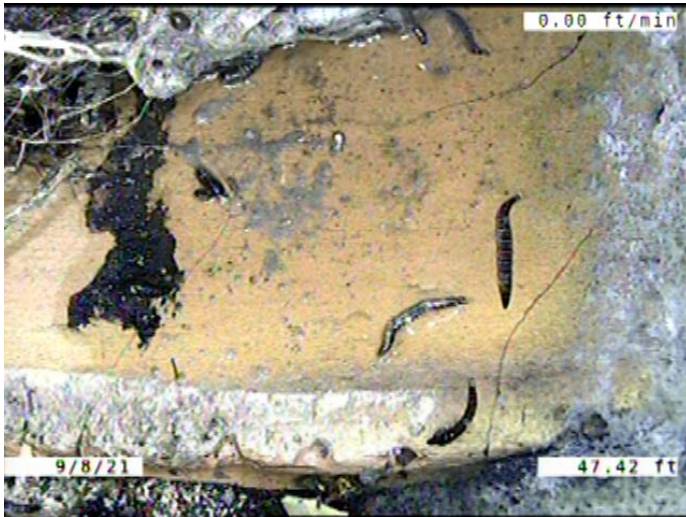
Code: **CM**  
 Description: **Crack Multiple**

Distance (ft): **47.4**  
 Structural Grade: **3**  
 O&M Grade: **0**  
 Clock Start/From: **6**  
 Clock To: **8**  
 1st Value:  
 2nd Value:  
 Value Percent:  
 Continuous Index:  
 Within 8" of Joint: **YES**  
 Remarks:

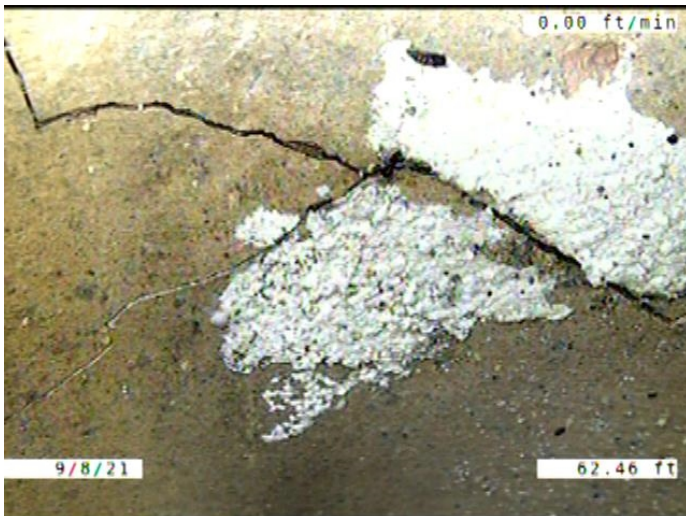
Code: **B**  
 Description: **Broken**

Distance (ft): **62.5**  
 Structural Grade: **4**  
 O&M Grade: **0**  
 Clock Start/From: **8**  
 Clock To: **10**  
 1st Value:  
 2nd Value:  
 Value Percent:  
 Continuous Index:  
 Within 8" of Joint: **YES**  
 Remarks:

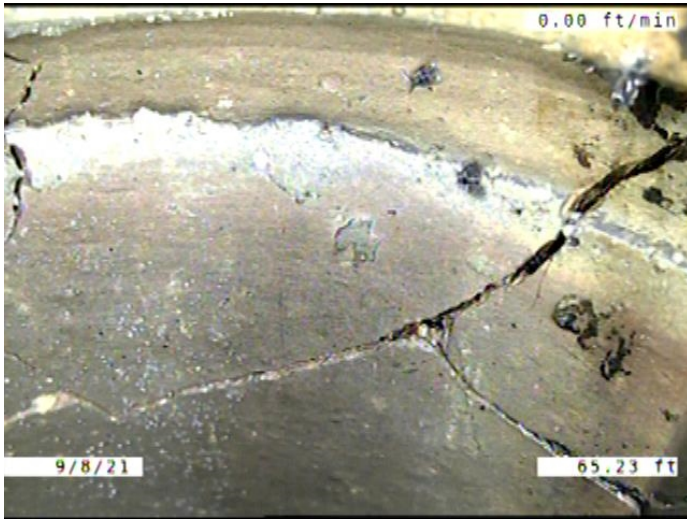
Code: **FM**  
 Description: **Fracture Multiple**

Distance (ft): **65.2**  
 Structural Grade: **4**  
 O&M Grade: **0**  
 Clock Start/From: **12**  
 Clock To: **4**  
 1st Value:  
 2nd Value:  
 Value Percent:  
 Continuous Index:  
 Within 8" of Joint: **YES**  
 Remarks:

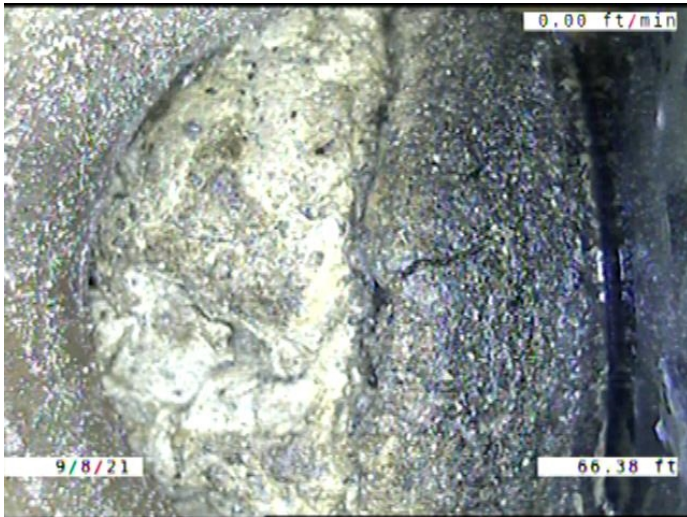
Code: **TFD**  
 Description: **Tap Factory Defective**

Distance (ft): **66.4**  
 Structural Grade: **0**  
 O&M Grade: **3**  
 Clock Start/From: **3**  
 Clock To:  
 1st Value: **4.000**  
 2nd Value:  
 Value Percent:  
 Continuous Index:  
 Within 8" of Joint: **YES**  
 Remarks: **CAPPED**

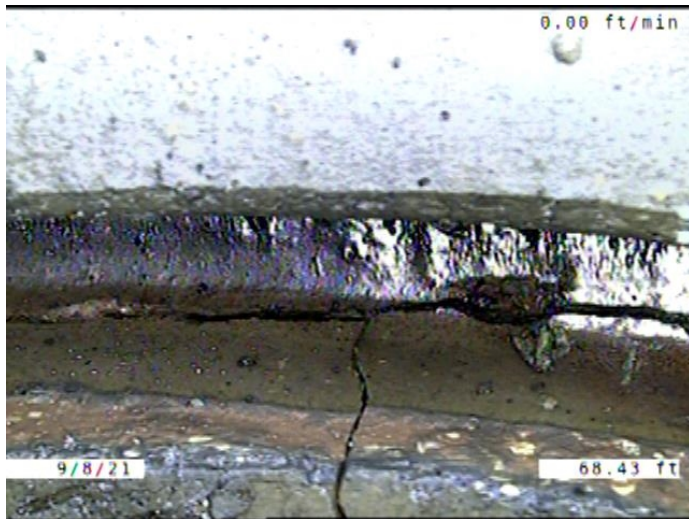
Code: **FC**  
 Description: **Fracture Circumferential**

Distance (ft): **68.4**  
 Structural Grade: **2**  
 O&M Grade: **0**  
 Clock Start/From: **3**  
 Clock To: **4**  
 1st Value:  
 2nd Value:  
 Value Percent:  
 Continuous Index:  
 Within 8" of Joint: **YES**  
 Remarks:

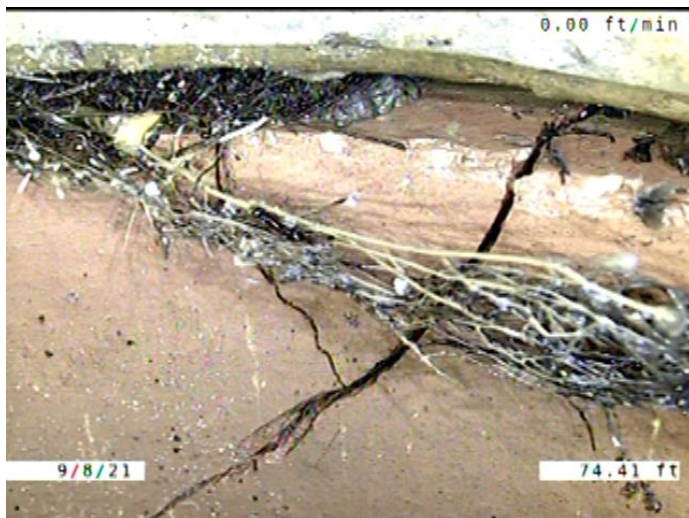
Code: **FM**  
 Description: **Fracture Multiple**

Distance (ft): **74.4**  
 Structural Grade: **4**  
 O&M Grade: **0**  
 Clock Start/From: **9**  
 Clock To: **3**  
 1st Value:  
 2nd Value:  
 Value Percent:  
 Continuous Index:  
 Within 8" of Joint: **YES**  
 Remarks:

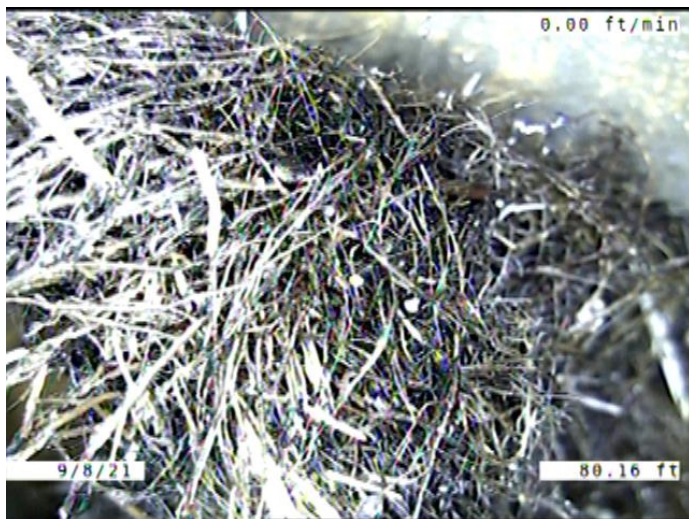
Code: **RMJ**  
 Description: **Roots Medium Joint**

Distance (ft): **80.2**  
 Structural Grade: **0**  
 O&M Grade: **3**  
 Clock Start/From: **9**  
 Clock To: **11**  
 1st Value:  
 2nd Value:  
 Value Percent: **10.000**  
 Continuous Index:  
 Within 8" of Joint: **YES**  
 Remarks:

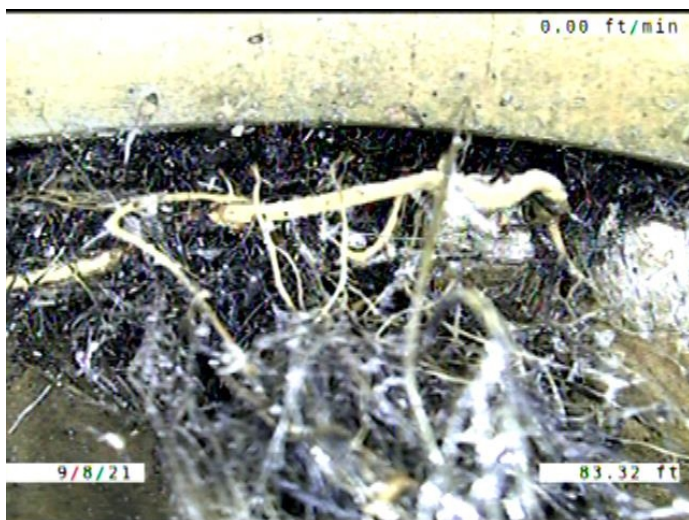
Code: **RMJ**  
 Description: **Roots Medium Joint**

Distance (ft): **83.3**  
 Structural Grade: **0**  
 O&M Grade: **3**  
 Clock Start/From: **12**  
 Clock To: **3**  
 1st Value:  
 2nd Value:  
 Value Percent: **5.000**  
 Continuous Index:  
 Within 8" of Joint: **YES**  
 Remarks:

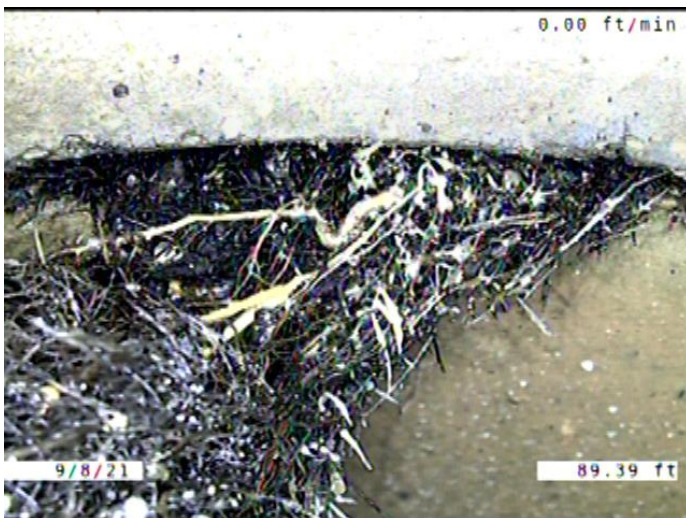
Code: **RMJ**  
 Description: **Roots Medium Joint**

Distance (ft): **89.4**  
 Structural Grade: **0**  
 O&M Grade: **3**  
 Clock Start/From: **9**  
 Clock To: **10**  
 1st Value:  
 2nd Value:  
 Value Percent: **5.000**  
 Continuous Index:  
 Within 8" of Joint: **YES**  
 Remarks:

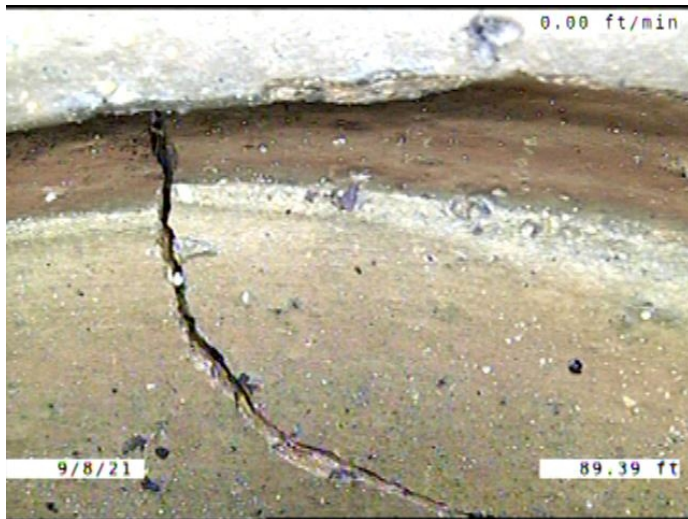
Code: **FM**  
 Description: **Fracture Multiple**

Distance (ft): **89.4**  
 Structural Grade: **4**  
 O&M Grade: **0**  
 Clock Start/From: **1**  
 Clock To: **3**  
 1st Value:  
 2nd Value:  
 Value Percent:  
 Continuous Index:  
 Within 8" of Joint: **YES**  
 Remarks:

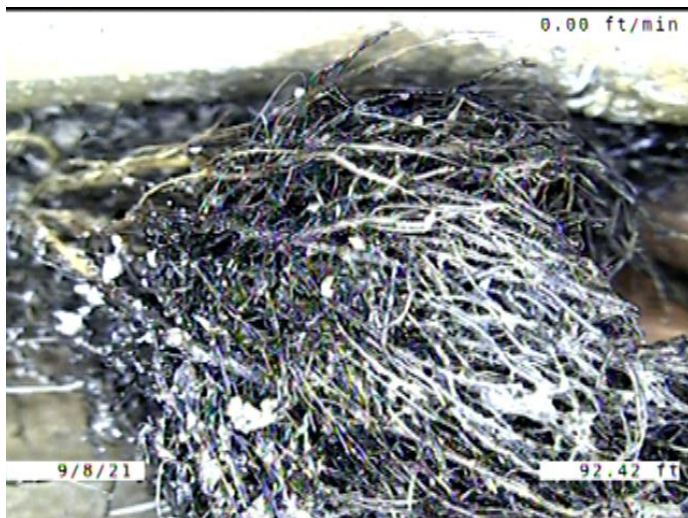
Code: **RMJ**  
 Description: **Roots Medium Joint**

Distance (ft): **92.4**  
 Structural Grade: **0**  
 O&M Grade: **3**  
 Clock Start/From: **1**  
 Clock To: **3**  
 1st Value:  
 2nd Value:  
 Value Percent: **5.000**  
 Continuous Index:  
 Within 8" of Joint: **YES**  
 Remarks:

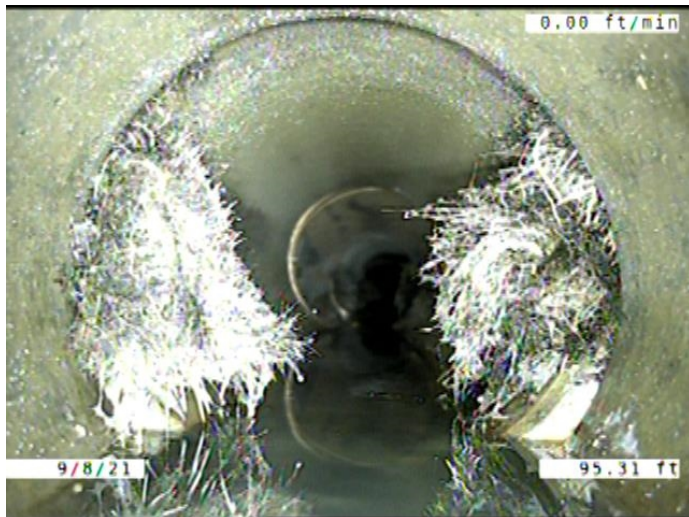
Code: **RMJ**  
 Description: **Roots Medium Joint**

Distance (ft): **95.3**  
 Structural Grade: **0**  
 O&M Grade: **3**  
 Clock Start/From: **8**  
 Clock To: **4**  
 1st Value:  
 2nd Value:  
 Value Percent: **15.000**  
 Continuous Index:  
 Within 8" of Joint: **YES**  
 Remarks:

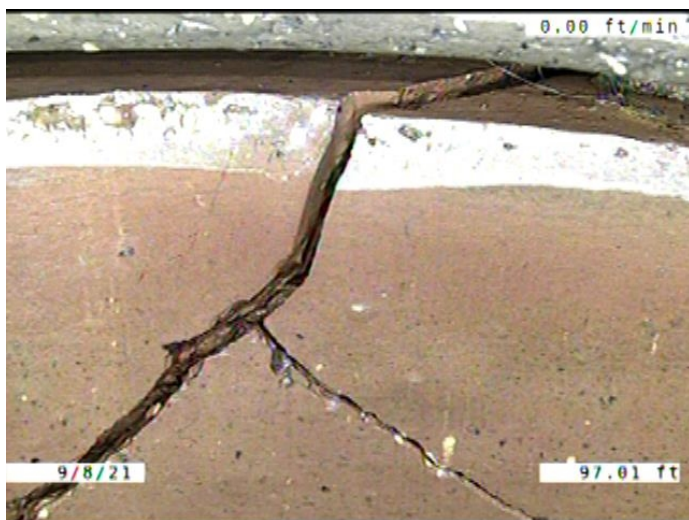
Code: **B**  
 Description: **Broken**

Distance (ft): **97.0**  
 Structural Grade: **4**  
 O&M Grade: **0**  
 Clock Start/From: **10**  
 Clock To: **4**  
 1st Value:  
 2nd Value:  
 Value Percent:  
 Continuous Index:  
 Within 8" of Joint: **YES**  
 Remarks:

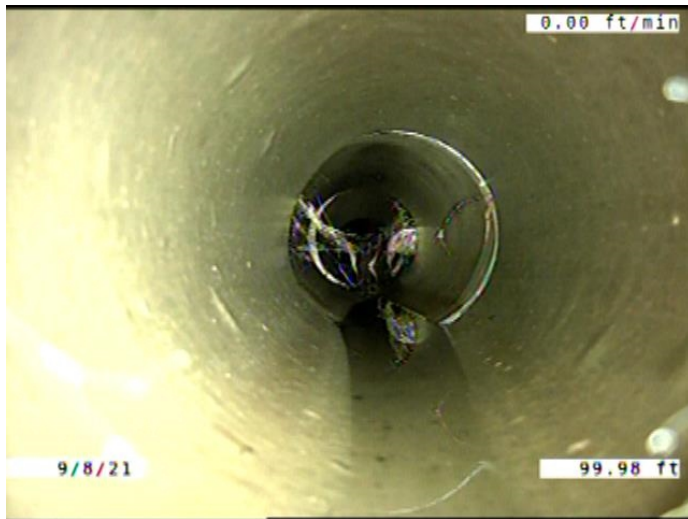
Code: **RFJ**  
Description: **Roots Fine Joint**

Distance (ft): **100.0**  
Structural Grade: **0**  
O&M Grade: **1**  
Clock Start/From: **1**  
Clock To: **3**  
1st Value:  
2nd Value:  
Value Percent:  
Continuous Index: **F03**  
Within 8" of Joint: **YES**  
Remarks:

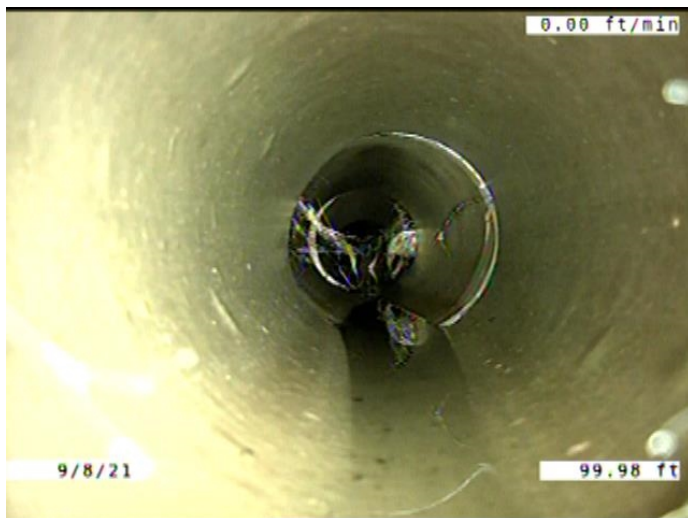
Code: **RFJ**  
Description: **Roots Fine Joint**

Distance (ft): **100.0**  
Structural Grade: **0**  
O&M Grade: **1**  
Clock Start/From: **7**  
Clock To: **11**  
1st Value:  
2nd Value:  
Value Percent:  
Continuous Index: **F04**  
Within 8" of Joint: **YES**  
Remarks:

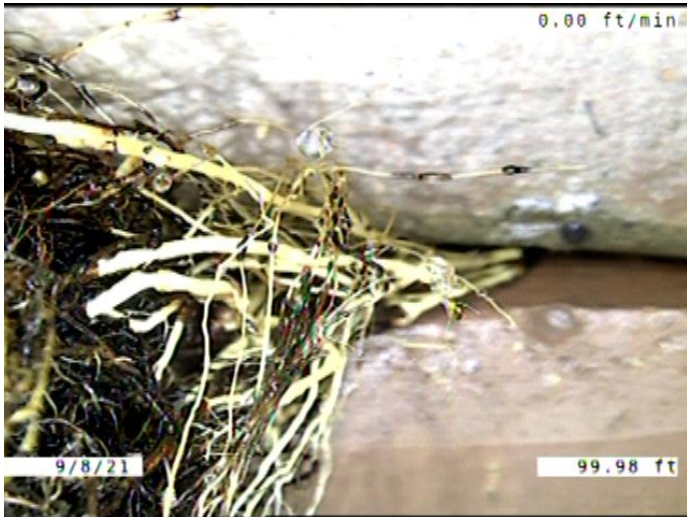
Code: **RMJ**  
 Description: **Roots Medium Joint**

Distance (ft): **100.0**  
 Structural Grade: **0**  
 O&M Grade: **3**  
 Clock Start/From: **8**  
 Clock To: **11**  
 1st Value:  
 2nd Value:  
 Value Percent: **5.000**  
 Continuous Index: **S06**  
 Within 8" of Joint: **YES**  
 Remarks:

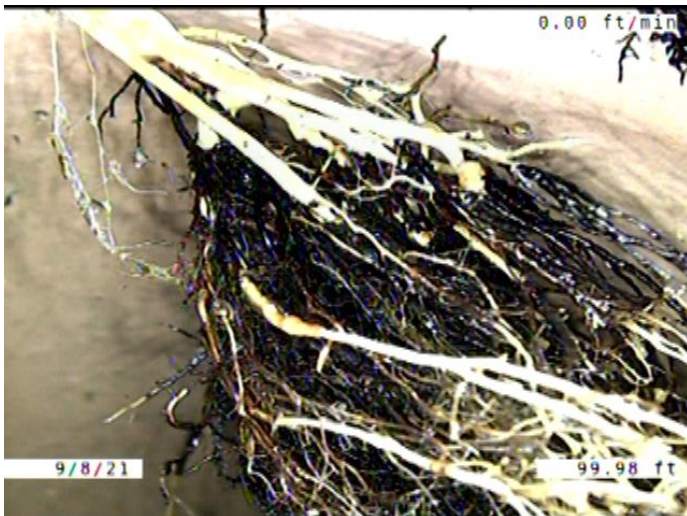
Code: **RMJ**  
 Description: **Roots Medium Joint**

Distance (ft): **100.0**  
 Structural Grade: **0**  
 O&M Grade: **3**  
 Clock Start/From: **1**  
 Clock To: **4**  
 1st Value:  
 2nd Value:  
 Value Percent: **5.000**  
 Continuous Index: **S05**  
 Within 8" of Joint: **YES**  
 Remarks:

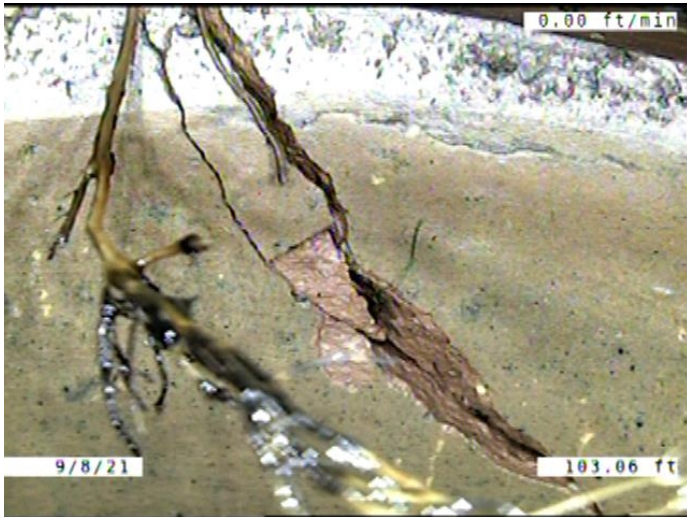
Code: **B**  
Description: **Broken**

Distance (ft): **103.1**  
Structural Grade: **4**  
O&M Grade: **0**  
Clock Start/From: **2**  
Clock To: **5**  
1st Value:  
2nd Value:  
Value Percent:  
Continuous Index:  
Within 8" of Joint: **YES**  
Remarks:

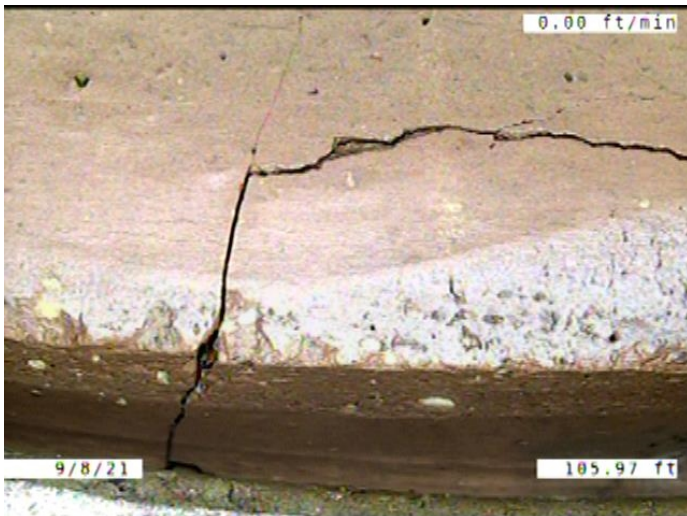
Code: **FM**  
Description: **Fracture Multiple**

Distance (ft): **106.0**  
Structural Grade: **4**  
O&M Grade: **0**  
Clock Start/From: **7**  
Clock To: **9**  
1st Value:  
2nd Value:  
Value Percent:  
Continuous Index:  
Within 8" of Joint: **YES**  
Remarks:

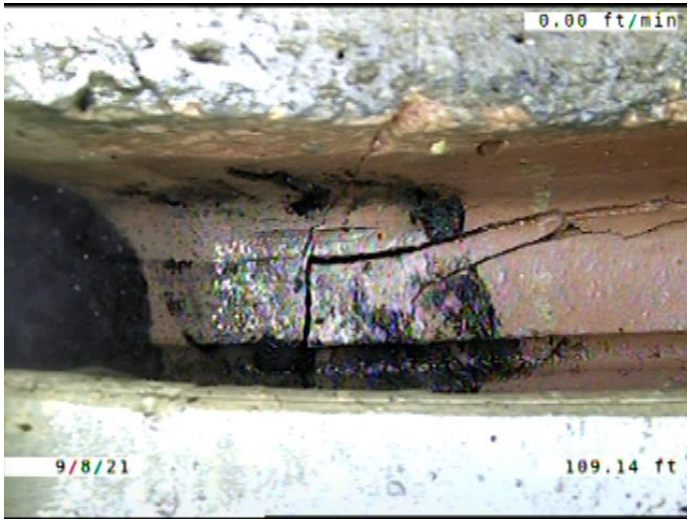
Code: **FM**  
 Description: **Fracture Multiple**

Distance (ft): **109.1**  
 Structural Grade: **4**  
 O&M Grade: **0**  
 Clock Start/From: **3**  
 Clock To: **4**  
 1st Value:  
 2nd Value:  
 Value Percent:  
 Continuous Index:  
 Within 8" of Joint: **YES**  
 Remarks:

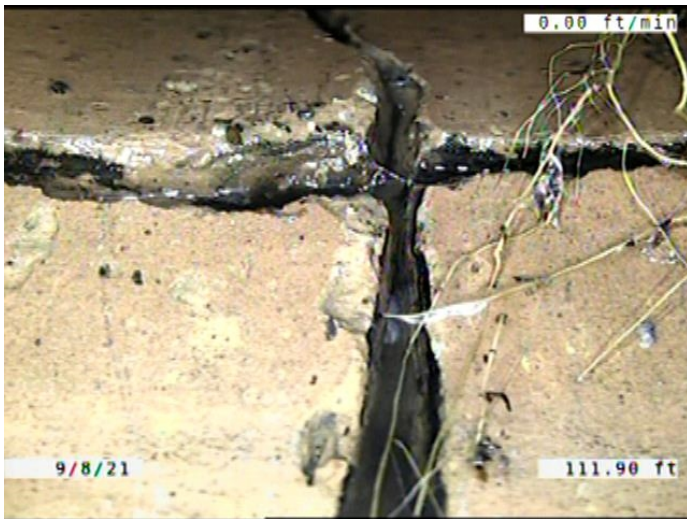
Code: **B**  
 Description: **Broken**

Distance (ft): **111.9**  
 Structural Grade: **4**  
 O&M Grade: **0**  
 Clock Start/From: **3**  
 Clock To: **9**  
 1st Value:  
 2nd Value:  
 Value Percent:  
 Continuous Index:  
 Within 8" of Joint: **YES**  
 Remarks:

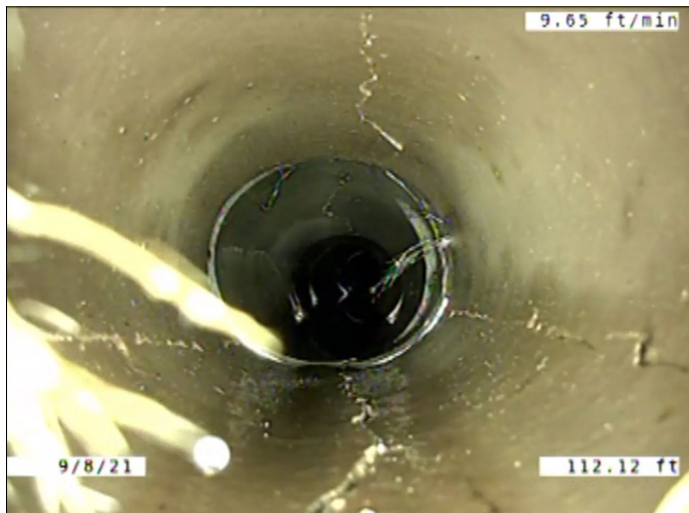
Code: **CM**  
Description: **Crack Multiple**

Distance (ft): **112.1**  
Structural Grade: **3**  
O&M Grade: **0**  
Clock Start/From: **7**  
Clock To: **5**  
1st Value:  
2nd Value:  
Value Percent:  
Continuous Index: **S07**  
Within 8" of Joint: **YES**  
Remarks:

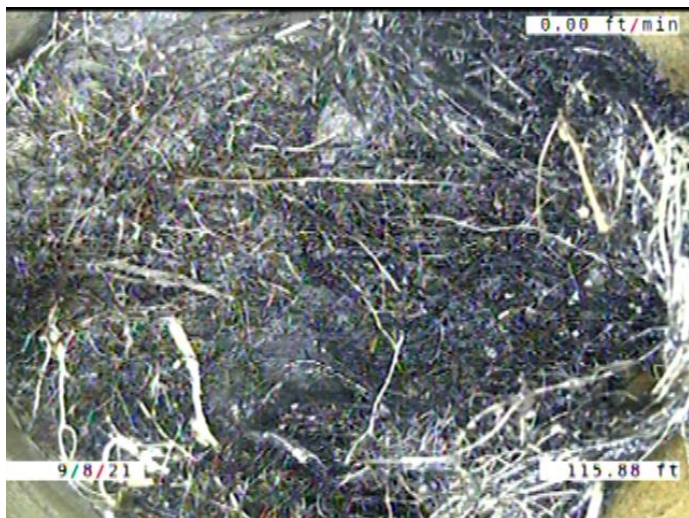
Code: **TFD**  
Description: **Tap Factory Defective**

Distance (ft): **115.9**  
Structural Grade: **0**  
O&M Grade: **3**  
Clock Start/From: **3**  
Clock To:  
1st Value: **4.000**  
2nd Value:  
Value Percent:  
Continuous Index:  
Within 8" of Joint: **YES**  
Remarks: **100% PLUGGED WITH ROOTS**

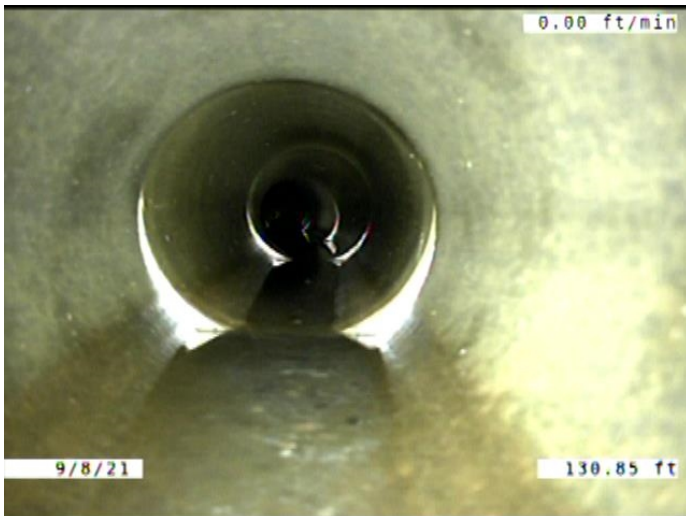
Code: **RMJ**  
 Description: **Roots Medium Joint**

Distance (ft): **130.8**  
 Structural Grade: **0**  
 O&M Grade: **3**  
 Clock Start/From: **1**  
 Clock To: **4**  
 1st Value:  
 2nd Value:  
 Value Percent: **5.000**  
 Continuous Index: **F05**  
 Within 8" of Joint: **YES**  
 Remarks:

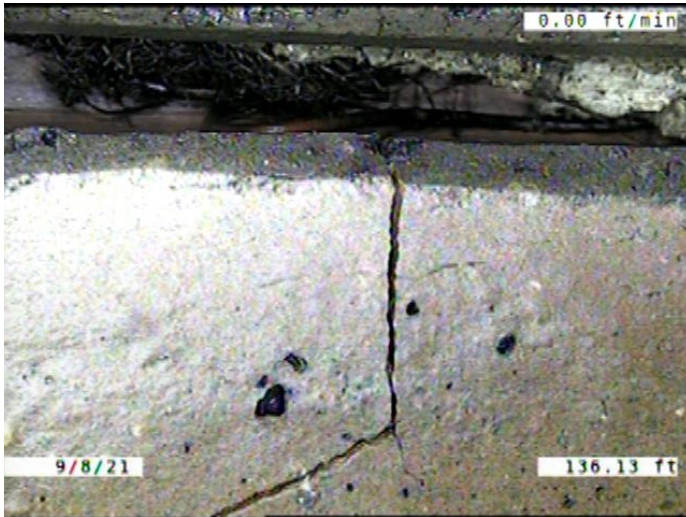
Code: **FM**  
Description: **Fracture Multiple**

Distance (ft): **136.1**  
Structural Grade: **4**  
O&M Grade: **0**  
Clock Start/From: **8**  
Clock To: **11**  
1st Value:  
2nd Value:  
Value Percent:  
Continuous Index:  
Within 8" of Joint: **YES**  
Remarks:

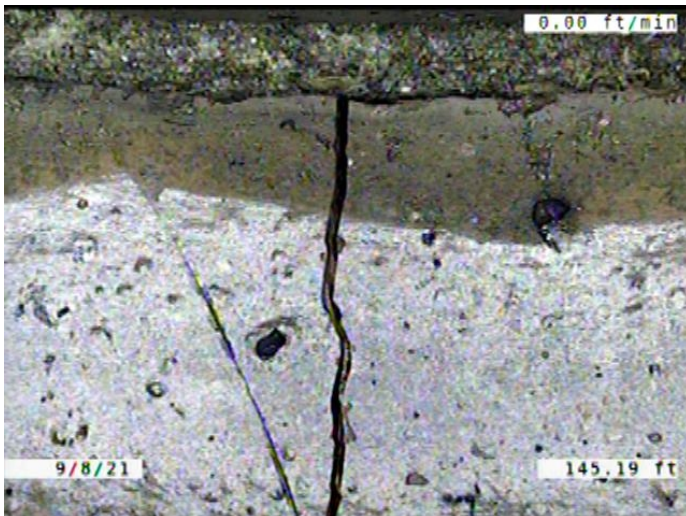
Code: **FM**  
Description: **Fracture Multiple**

Distance (ft): **145.2**  
Structural Grade: **4**  
O&M Grade: **0**  
Clock Start/From: **6**  
Clock To: **12**  
1st Value:  
2nd Value:  
Value Percent:  
Continuous Index:  
Within 8" of Joint: **YES**  
Remarks:

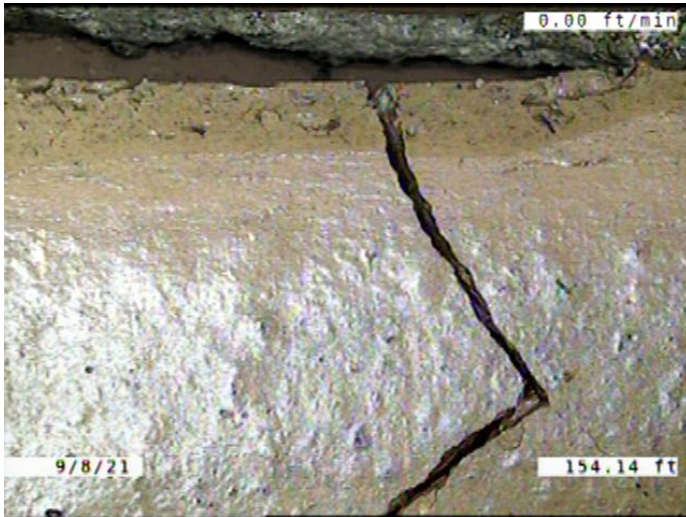
Code: **FM**  
 Description: **Fracture Multiple**

Distance (ft): **154.1**  
 Structural Grade: **4**  
 O&M Grade: **0**  
 Clock Start/From: **7**  
 Clock To: **12**  
 1st Value:  
 2nd Value:  
 Value Percent:  
 Continuous Index:  
 Within 8" of Joint: **YES**  
 Remarks:

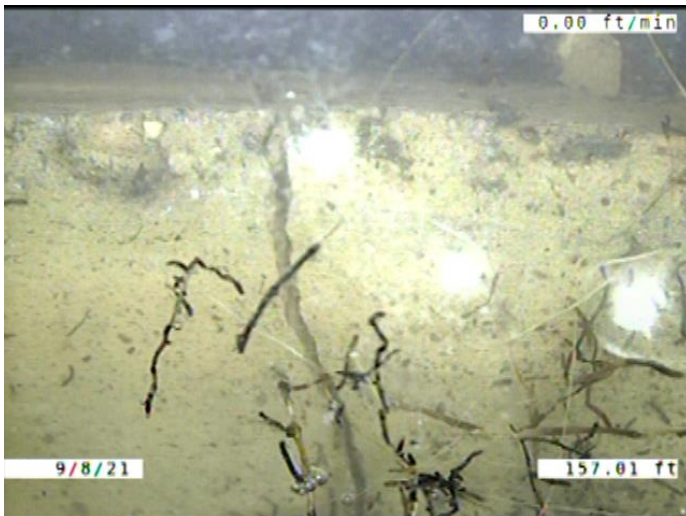
Code: **FM**  
 Description: **Fracture Multiple**

Distance (ft): **157.0**  
 Structural Grade: **4**  
 O&M Grade: **0**  
 Clock Start/From: **12**  
 Clock To: **12**  
 1st Value:  
 2nd Value:  
 Value Percent:  
 Continuous Index: **S08**  
 Within 8" of Joint: **YES**  
 Remarks:

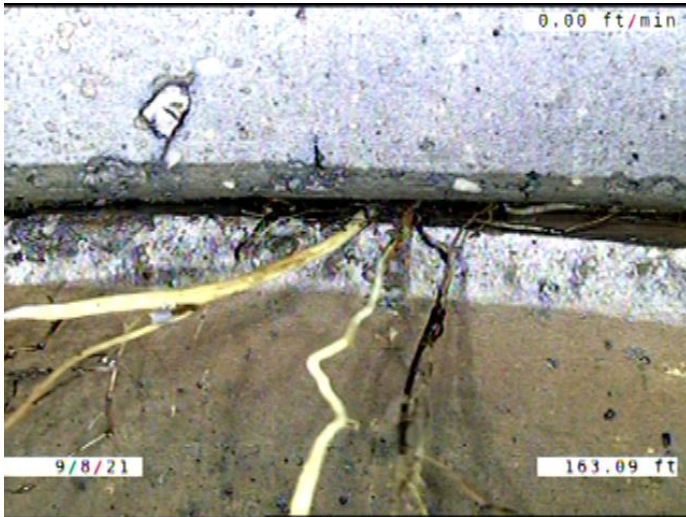
Code: **RFJ**  
 Description: **Roots Fine Joint**

Distance (ft): **163.1**  
 Structural Grade: **0**  
 O&M Grade: **1**  
 Clock Start/From: **10**  
 Clock To: **1**  
 1st Value:  
 2nd Value:  
 Value Percent:  
 Continuous Index:  
 Within 8" of Joint: **YES**  
 Remarks:

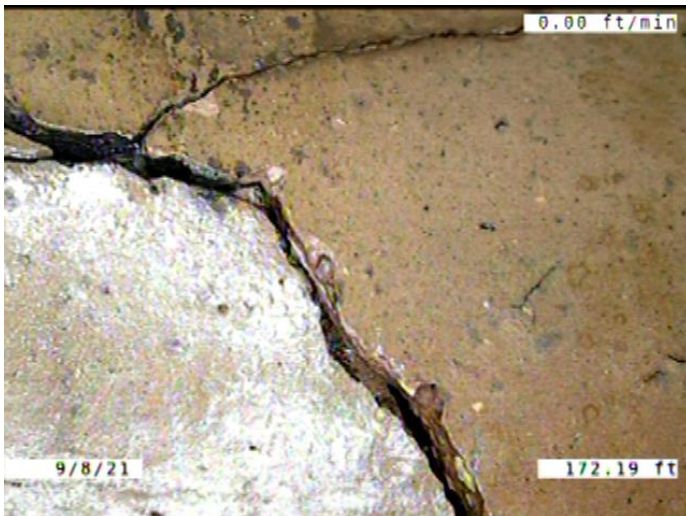
Code: **B**  
 Description: **Broken**

Distance (ft): **172.2**  
 Structural Grade: **4**  
 O&M Grade: **0**  
 Clock Start/From: **2**  
 Clock To: **5**  
 1st Value:  
 2nd Value:  
 Value Percent:  
 Continuous Index:  
 Within 8" of Joint: **YES**  
 Remarks:

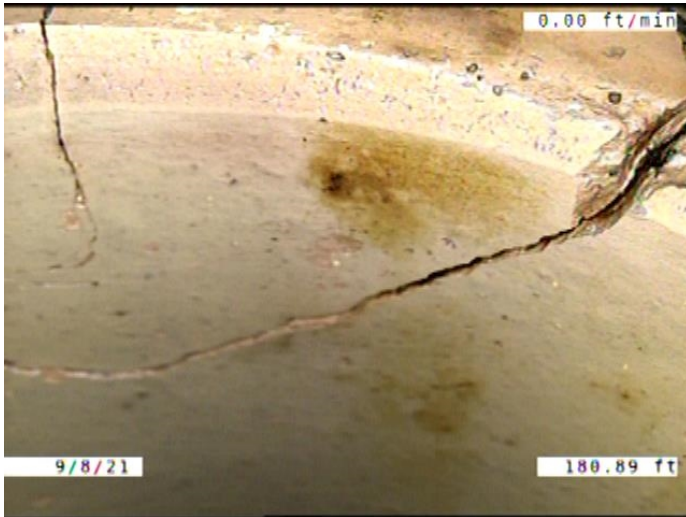
Code: **B**  
 Description: **Broken**

Distance (ft): **180.9**  
 Structural Grade: **4**  
 O&M Grade: **0**  
 Clock Start/From: **1**  
 Clock To: **4**  
 1st Value:  
 2nd Value:  
 Value Percent:  
 Continuous Index:  
 Within 8" of Joint: **YES**  
 Remarks:

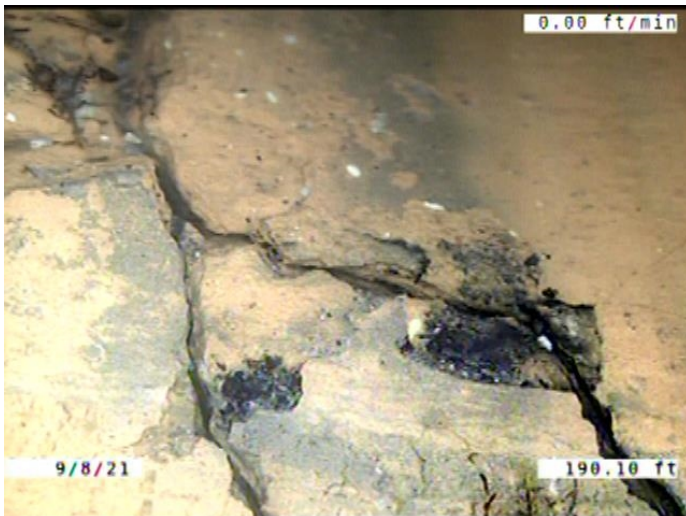
Code: **DR**  
 Description: **Deformed Rigid**

Distance (ft): **190.1**  
 Structural Grade: **4**  
 O&M Grade: **0**  
 Clock Start/From:  
 Clock To:  
 1st Value:  
 2nd Value:  
 Value Percent: **5.000**  
 Continuous Index: **S09**  
 Within 8" of Joint: **NO**  
 Remarks:

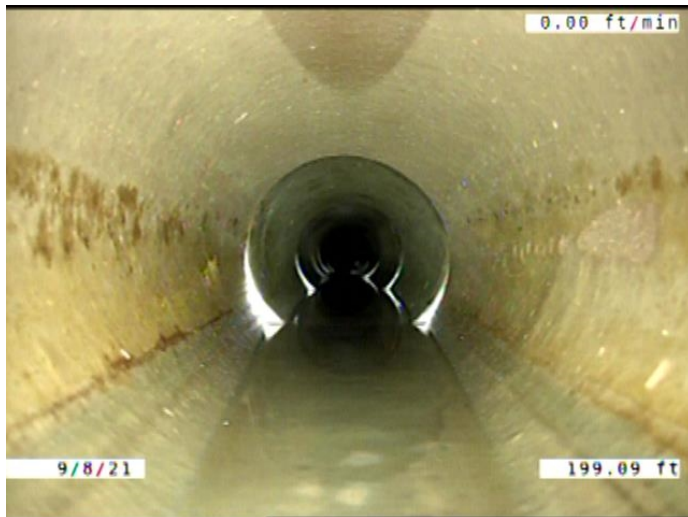
Code: **DR**  
 Description: **Deformed Rigid**

Distance (ft): **199.1**  
 Structural Grade: **4**  
 O&M Grade: **0**  
 Clock Start/From:  
 Clock To:  
 1st Value:  
 2nd Value:  
 Value Percent: **5.000**  
 Continuous Index: **F09**  
 Within 8" of Joint: **NO**  
 Remarks:

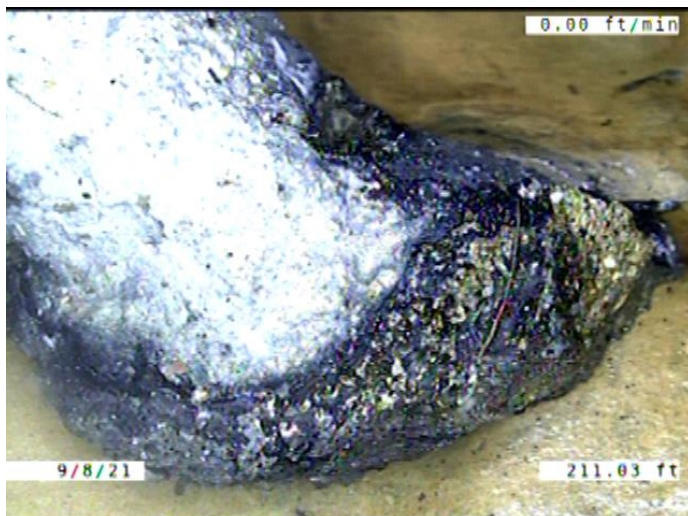
Code: **DAE**  
 Description: **Deposits Attached Encrustation**

Distance (ft): **211.0**  
 Structural Grade: **0**  
 O&M Grade: **2**  
 Clock Start/From: **4**  
 Clock To: **7**  
 1st Value:  
 2nd Value:  
 Value Percent: **5.000**  
 Continuous Index:  
 Within 8" of Joint: **YES**  
 Remarks:

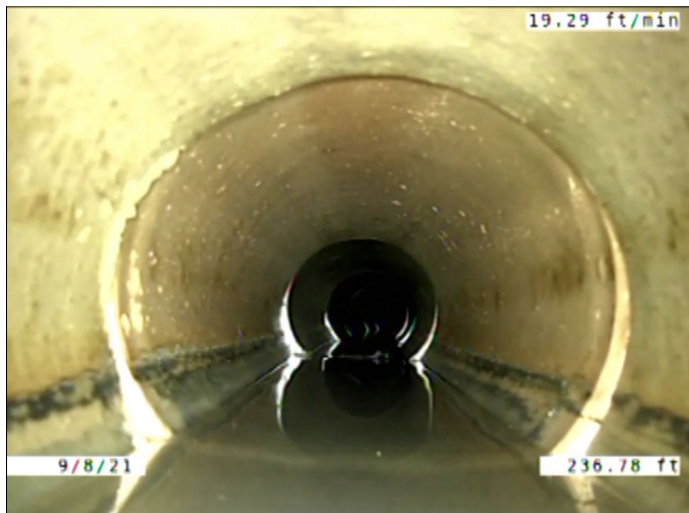
Code: **FM**  
 Description: **Fracture Multiple**

Distance (ft): **236.8**  
 Structural Grade: **4**  
 O&M Grade: **0**  
 Clock Start/From: **12**  
 Clock To: **12**  
 1st Value:  
 2nd Value:  
 Value Percent:  
 Continuous Index: **F08**  
 Within 8" of Joint: **YES**  
 Remarks:

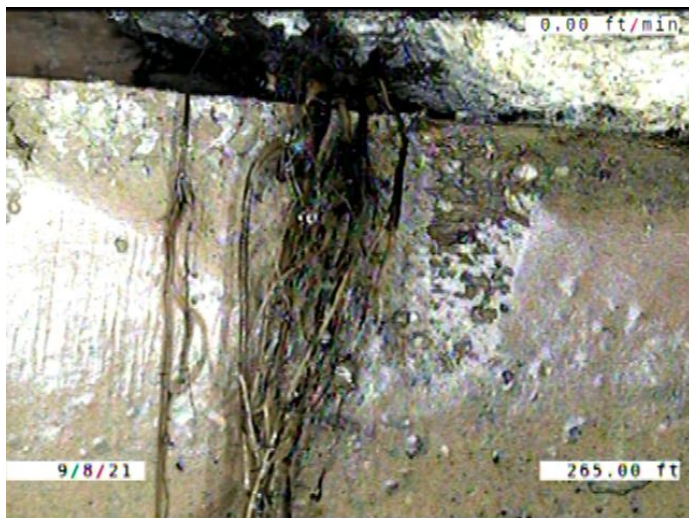
Code: **RFJ**  
 Description: **Roots Fine Joint**

Distance (ft): **265.0**  
 Structural Grade: **0**  
 O&M Grade: **1**  
 Clock Start/From: **10**  
 Clock To:  
 1st Value:  
 2nd Value:  
 Value Percent:  
 Continuous Index:  
 Within 8" of Joint: **YES**  
 Remarks:

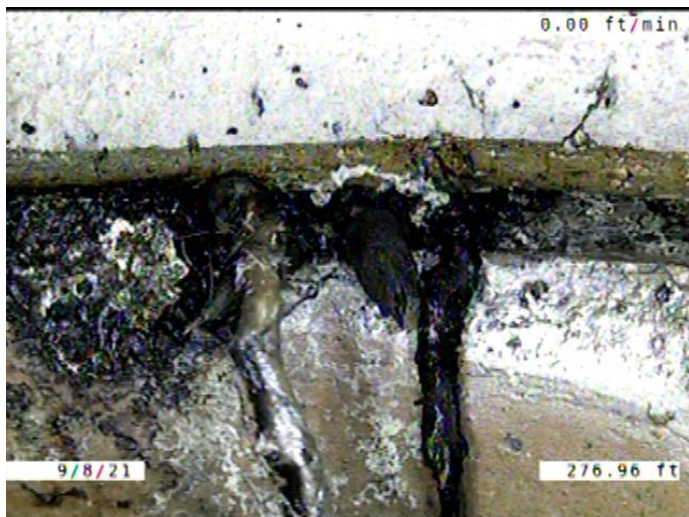
Code: **RFJ**  
 Description: **Roots Fine Joint**

Distance (ft): **277.0**  
 Structural Grade: **0**  
 O&M Grade: **1**  
 Clock Start/From: **1**  
 Clock To: **2**  
 1st Value:  
 2nd Value:  
 Value Percent:  
 Continuous Index:  
 Within 8" of Joint: **YES**  
 Remarks:

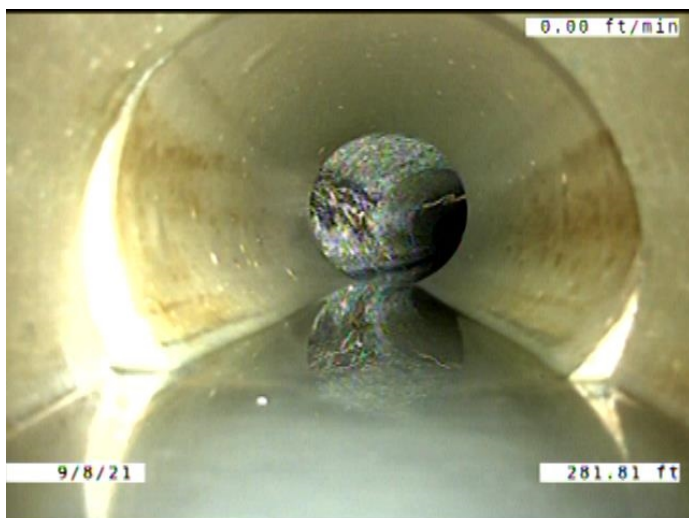
Code: **MWLS**  
 Description: **Miscellaneous Water Level Sag**

Distance (ft): **281.8**  
 Structural Grade: **2**  
 O&M Grade: **0**  
 Clock Start/From:  
 Clock To:  
 1st Value:  
 2nd Value:  
 Value Percent: **10.000**  
 Continuous Index:  
 Within 8" of Joint: **NO**  
 Remarks:

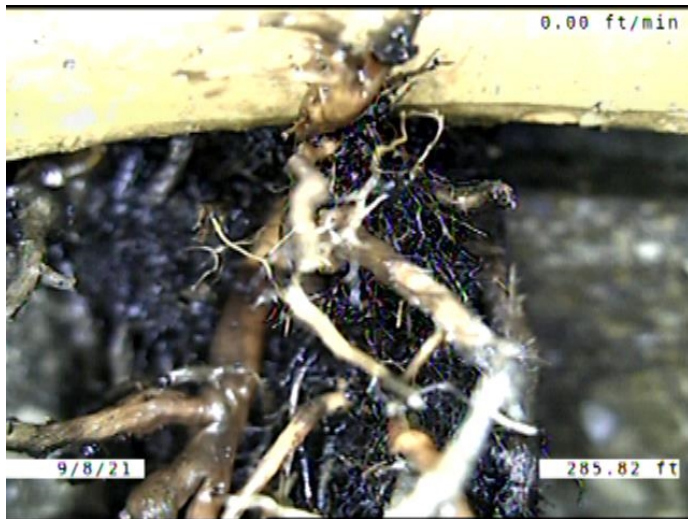
Code: **RMJ**  
 Description: **Roots Medium Joint**

Distance (ft): **285.8**  
 Structural Grade: **0**  
 O&M Grade: **3**  
 Clock Start/From: **8**  
 Clock To: **10**  
 1st Value:  
 2nd Value:  
 Value Percent: **5.000**  
 Continuous Index:  
 Within 8" of Joint: **YES**  
 Remarks:

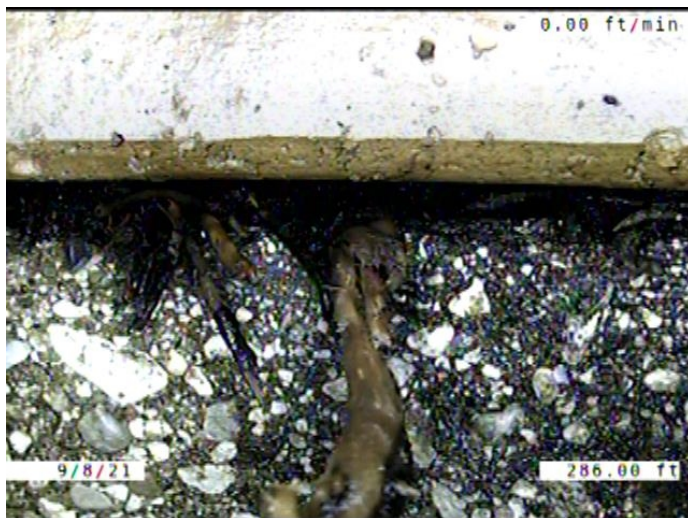
Code: **RFJ**  
 Description: **Roots Fine Joint**

Distance (ft): **286.0**  
 Structural Grade: **0**  
 O&M Grade: **1**  
 Clock Start/From: **2**  
 Clock To: **3**  
 1st Value:  
 2nd Value:  
 Value Percent:  
 Continuous Index:  
 Within 8" of Joint: **YES**  
 Remarks:

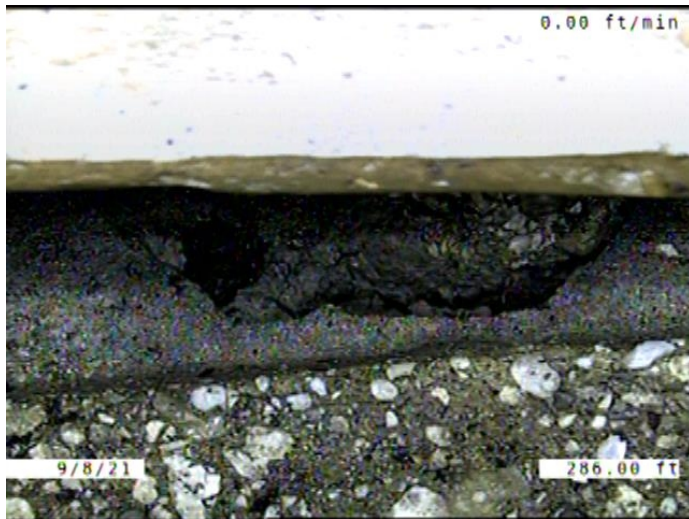
Code: **SMW**  
Description: **Surface Damage Missing Wall**

Distance (ft): **286.0**  
Structural Grade: **5**  
O&M Grade: **0**  
Clock Start/From: **11**  
Clock To: **12**  
1st Value:  
2nd Value:  
Value Percent:  
Continuous Index:  
Within 8" of Joint: **YES**  
Remarks: **SOIL VISIBLE**
