# Profile/Photo Observation Report

Date:	<b>09/08/2021</b>	Weather:		Coding:	<b>PACP 7.0</b>
Pipe Length (ft):	<b>331.0</b>	Owner:	<b>City of Hobart</b>	Pre Clean:	<b>Heavy Cleaning</b>
P.O.#:	<b>YES502259</b>	Surveyor:	<b>S. Bucklin</b>	PSR:	<b>P-503-033-032</b>
Customer:	<b>City of Hobart</b>	Clean Date:	<b>09/08/2021</b>	Shape:	<b>C</b>

Street:	<b>41st Avenue</b>	Flow Control:	<b>Not Controlled</b>
City:	<b>Hobart, IN</b>	Year Renewed:	
Location:	<b>Alley</b>	Tape/Media #:	
Purpose:	<b>Routine Assessment</b>	Dia/Height:	<b>8"</b>
Use:	<b>Sanitary Sewage Pipe</b>	Material:	<b>VCP</b>
Drain Area:		Lining:	<b>None</b>
Category:	<b>NA</b>		
Comment:			
Location Details:		Direction of Survey:	<b>Downstream</b>
US MH:	<b>M-503-032</b>	DS MH:	<b>M-503-033</b>
		Total Length Surveyed (ft):	<b>287.6</b>

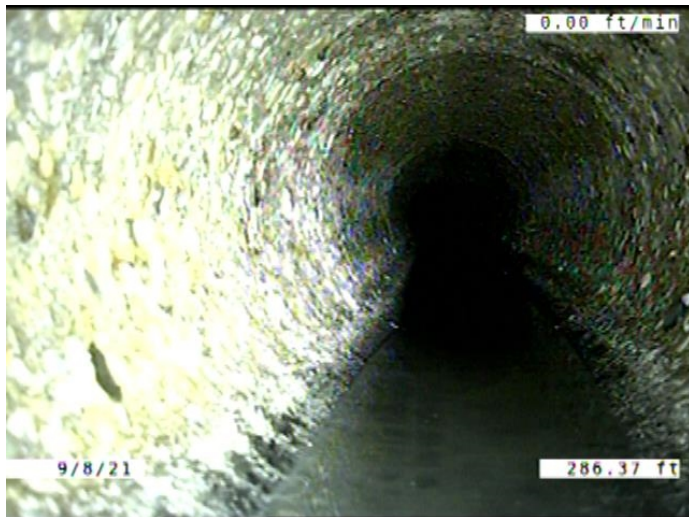
Code: **MSC**  
 Description: **Miscellaneous Shape/Size Change**

Distance (ft): **286.4**  
 Structural Grade: **0**  
 O&M Grade: **0**  
 Clock Start/From:  
 Clock To:  
 1st Value: **10.000**  
 2nd Value:  
 Value Percent:  
 Continuous Index:  
 Within 8" of Joint: **NO**  
 Remarks: **8" TO 10"**

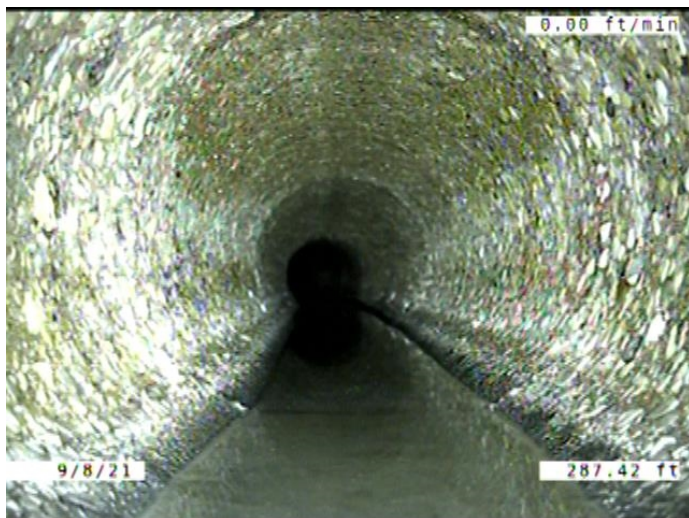
Code: **DSF**  
 Description: **Deposits Settled Fine**

Distance (ft): **287.4**  
 Structural Grade: **0**  
 O&M Grade: **2**  
 Clock Start/From: **5**  
 Clock To: **7**  
 1st Value:  
 2nd Value:  
 Value Percent: **5.000**  
 Continuous Index: **F01**  
 Within 8" of Joint: **YES**  
 Remarks:
