Profile/Photo Observation Report

Street:	ALLEY BETWEEN N COLORADO ST &	Flow Control:	Not Controlled
City:	Hobart, IN	Year Renewed:	
Location:	Other	Tape/Media #:	
Purpose:	Not Known	Dia/Height:	10"
Use:	Sanitary	Material:	VCP
Drain Area:	NA	Lining:	
Category:	NA		
Comment:

Location Details:		Direction of Survey:	Upstream
US MH:	M-503-036	DS MH:	M-503-035
		Total Length Surveyed (ft):	30.6

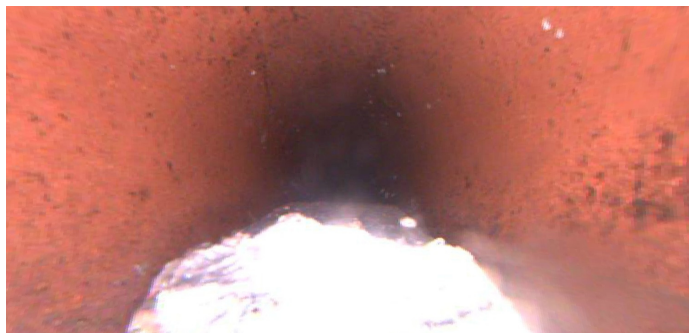
Code: **AMH**
 Description: **Manhole**

Distance (ft): **.0**
 Structural Grade: **0**
 O&M Grade: **0**
 Clock Start/From:
 Clock To:
 1st Value:
 2nd Value:
 Value Percent:
 Continuous Index:
 Within 8" of Joint: **NO**
 Remarks: **M-503-035**

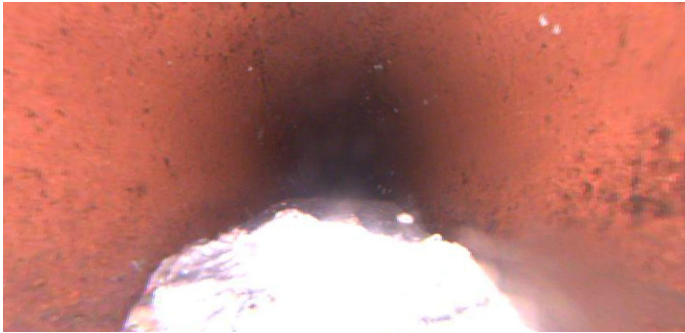
Code:	MWL
Description:	Water Level

Distance (ft):	.0
Structural Grade:	0
O&M Grade:	0
Clock Start/From:	
Clock To:	
1st Value:	
2nd Value:	
Value Percent:	5.000
Continuous Index:	
Within 8" of Joint:	NO
Remarks:

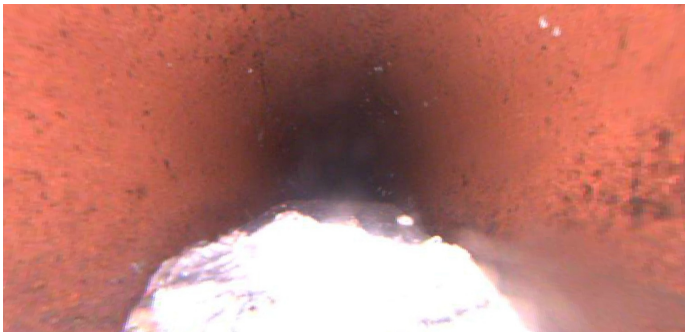
Code:	DSC
Description:	Deposits Settled Compacted

Distance (ft):	.0
Structural Grade:	0
O&M Grade:	3
Clock Start/From:	6
Clock To:	
1st Value:	
2nd Value:	
Value Percent:	15.000
Continuous Index:	S01
Within 8" of Joint:	NO
Remarks:	block of concrete/ashpalt??

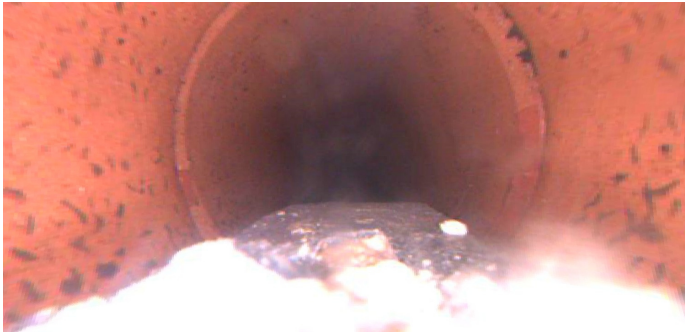
Code: **MSA**
Description: **Abandoned Survey**

Distance (ft): **30.6**
Structural Grade: **0**
O&M Grade: **0**
Clock Start/From:
Clock To:
1st Value:
2nd Value:
Value Percent:
Continuous Index:
Within 8" of Joint: **NO**
Remarks: **dsc**

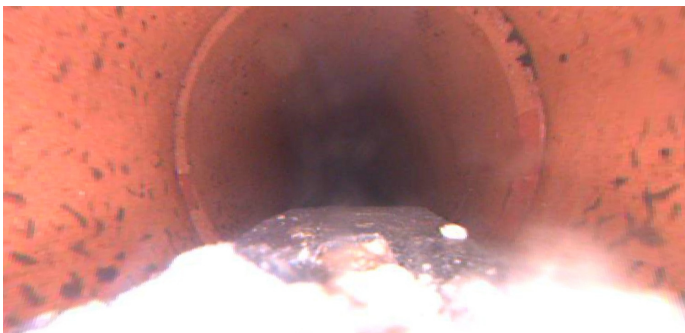
Code: **DSC**
Description: **Deposits Settled Compacted**

Distance (ft): **30.6**
Structural Grade: **0**
O&M Grade: **3**
Clock Start/From: **6**
Clock To:
1st Value:
2nd Value:
Value Percent: **15.000**
Continuous Index: **F01**
Within 8" of Joint: **NO**
Remarks: **block of concrete/ashpalt??**
