## Profile/Photo Observation Report

Street:	<b>canender st</b>	Flow Control:	<b>Not Controlled</b>
City:	<b>Hobart, IN</b>	Year Renewed:	
Location:	<b>Other</b>	Tape/Media #:	
Purpose:	<b>Not Known</b>	Dia/Height:	<b>10"</b>
Use:	<b>Sanitary</b>	Material:	<b>VCP</b>
Drain Area:	<b>NA</b>	Lining:	
Category:	<b>NA</b>		
Comment:

Location Details:		Direction of Survey:	<b>Upstream</b>
US MH:	<b>M-503-036</b>	DS MH:	<b>M-503-035</b>
		Total Length Surveyed (ft):	<b>30.6</b>

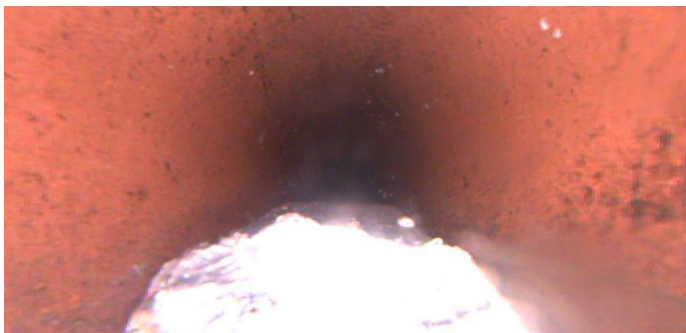
Code: **AMH**  
Description: **Manhole**

Distance (ft): **.0**  
Structural Grade: **0**  
O&M Grade: **0**  
Clock Start/From:  
Clock To:  
1st Value:  
2nd Value:  
Value Percent:  
Continuous Index:  
Within 8" of Joint: **NO**  
Remarks: **M-503-035**

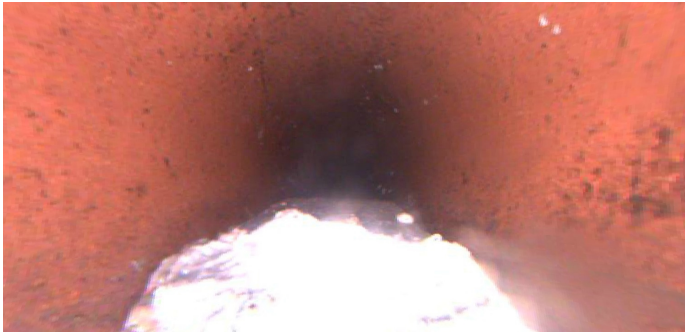
Code:	<b>MWL</b>
Description:	<b>Water Level</b>

Distance (ft):	<b>.0</b>
Structural Grade:	<b>0</b>
O&M Grade:	<b>0</b>
Clock Start/From:	
Clock To:	
1st Value:	
2nd Value:	
Value Percent:	<b>5.000</b>
Continuous Index:	
Within 8" of Joint:	<b>NO</b>
Remarks:

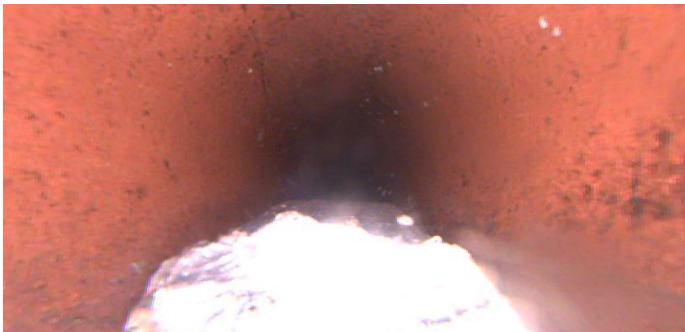
Code:	<b>DSC</b>
Description:	<b>Deposits Settled Compacted</b>

Distance (ft):	<b>.0</b>
Structural Grade:	<b>0</b>
O&M Grade:	<b>3</b>
Clock Start/From:	<b>6</b>
Clock To:	
1st Value:	
2nd Value:	
Value Percent:	<b>15.000</b>
Continuous Index:	<b>S01</b>
Within 8" of Joint:	<b>NO</b>
Remarks:	<b>block of concrete/ashpalt??</b>

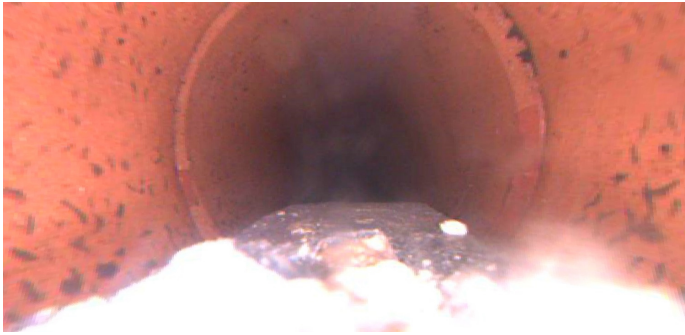
Code: **MSA**  
Description: **Abandoned Survey**

Distance (ft): **30.6**  
Structural Grade: **0**  
O&M Grade: **0**  
Clock Start/From:  
Clock To:  
1st Value:  
2nd Value:  
Value Percent:  
Continuous Index:  
Within 8" of Joint: **NO**  
Remarks: **dsc**

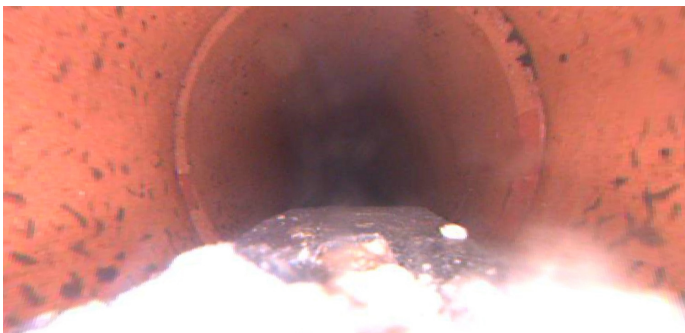
Code: **DSC**  
Description: **Deposits Settled Compacted**

Distance (ft): **30.6**  
Structural Grade: **0**  
O&M Grade: **3**  
Clock Start/From: **6**  
Clock To:  
1st Value:  
2nd Value:  
Value Percent: **15.000**  
Continuous Index: **F01**  
Within 8" of Joint: **NO**  
Remarks: **block of concrete/ashpalt??**
