Profile/Photo Observation Report

Street:	40th. Ave.	Flow Control:	Not Controlled
City:	Hobart, IN	Year Renewed:	
Location:	Light Highway	Tape/Media #:	
Purpose:	Routine Assessment	Dia/Height:	8"
Use:	Sanitary	Material:	VCP
Drain Area:	NA	Lining:	
Category:	NA		
Comment:

Location Details:		Direction of Survey:	Upstream
US MH:	M-503-037	DS MH:	M-503-036
		Total Length Surveyed (ft):	5.0

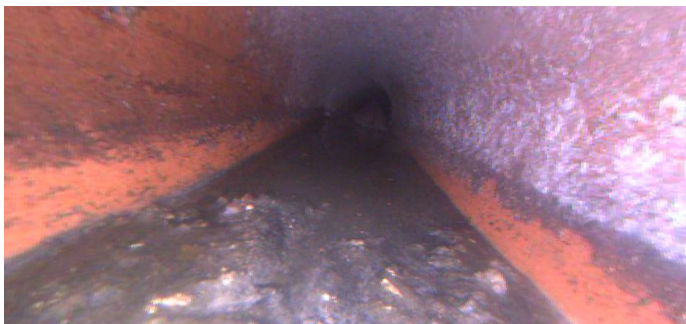
Code: **AMH**
Description: **Manhole**

Distance (ft): **.0**
Structural Grade: **0**
O&M Grade: **0**
Clock Start/From:
Clock To:
1st Value:
2nd Value:
Value Percent:
Continuous Index:
Within 8" of Joint: **NO**
Remarks: **M-503-036**

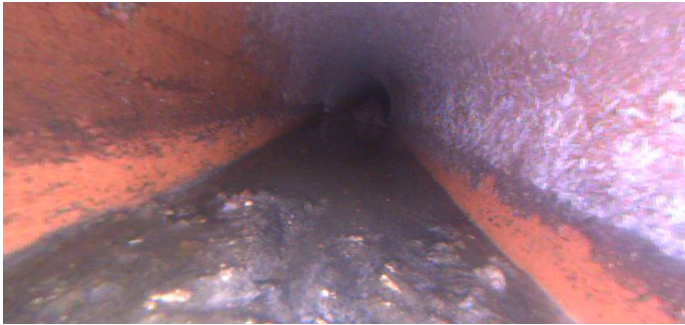
Code:	MWL
Description:	Water Level

Distance (ft):	.0
Structural Grade:	0
O&M Grade:	0
Clock Start/From:	
Clock To:	
1st Value:	
2nd Value:	
Value Percent:	5.000
Continuous Index:	
Within 8" of Joint:	NO
Remarks:

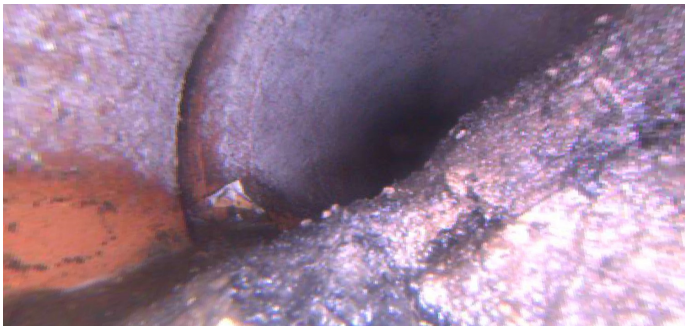
Code:	MSA
Description:	Abandoned Survey

Distance (ft):	5.0
Structural Grade:	0
O&M Grade:	0
Clock Start/From:	
Clock To:	
1st Value:	
2nd Value:	
Value Percent:	
Continuous Index:	
Within 8" of Joint:	NO
Remarks:	ROOT INFILTRATION
