Profile/Photo Observation Report

Date:	04/07/2018	Weather:		Coding:	PACP 6.0
Pipe Length (ft):	204.7	Owner:	NA	Pre Clean:	Not Known
P.O.#:		Surveyor:	Mark Ruby	PSR:	P-503-037-038
Customer:		Clean Date:	01/01/1900	Shape:	C

Street:	W 40TH AVE	Flow Control:	Not Controlled
City:	Hobart, IN	Year Renewed:	
Location:	Other	Tape/Media #:	
Purpose:	Not Known	Dia/Height:	10"
Use:	Sanitary	Material:	VCP
Drain Area:	NA	Lining:	
Category:	NA		
Comment:

Location Details:		Direction of Survey:	Downstream
US MH:	M-503-038	DS MH:	M-503-037
		Total Length Surveyed (ft):	208.1

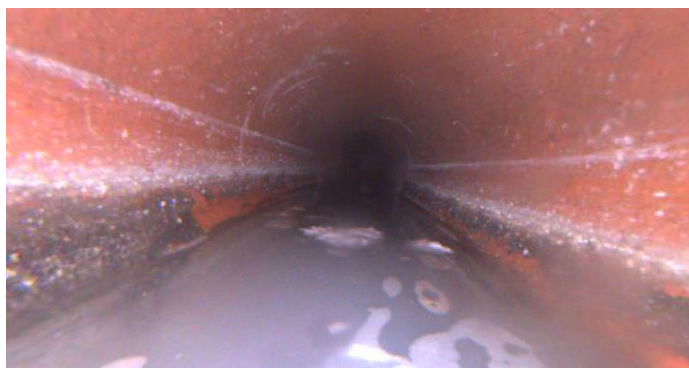
Code: **AMH**
 Description: **Manhole**

Distance (ft): **.0**
 Structural Grade: **0**
 O&M Grade: **0**
 Clock Start/From:
 Clock To:
 1st Value:
 2nd Value:
 Value Percent:
 Continuous Index:
 Within 8" of Joint: **NO**
 Remarks: **M-503-038**

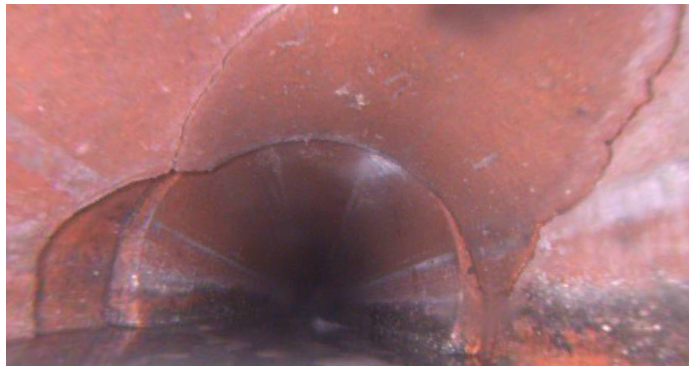
Code: **FM**
Description: **Fracture Multiple**

Distance (ft): **3.8**
Structural Grade: **4**
O&M Grade: **0**
Clock Start/From: **7**
Clock To: **5**
1st Value:
2nd Value:
Value Percent:
Continuous Index:
Within 8" of Joint: **YES**
Remarks:

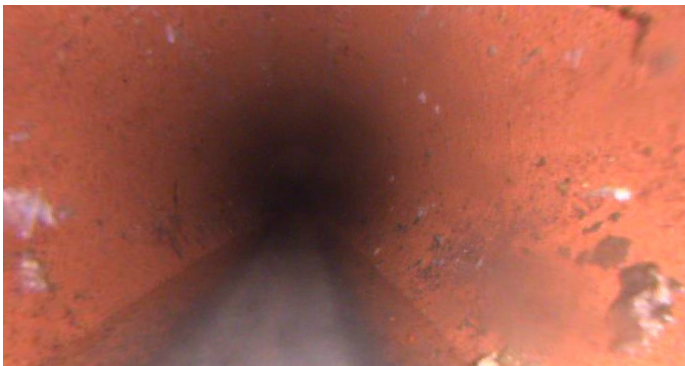
Code: **MMC**
Description: **Material Change**

Distance (ft): **77.8**
Structural Grade: **0**
O&M Grade: **0**
Clock Start/From:
Clock To:
1st Value:
2nd Value:
Value Percent:
Continuous Index:
Within 8" of Joint: **NO**
Remarks: **VCP**

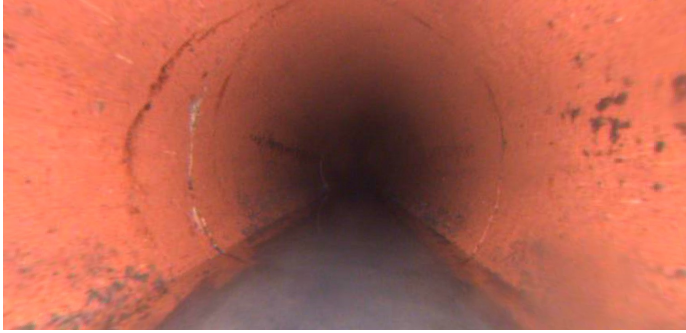
Code: **FM**
Description: **Fracture Multiple**

Distance (ft): **83.9**
Structural Grade: **4**
O&M Grade: **0**
Clock Start/From: **8**
Clock To: **4**
1st Value:
2nd Value:
Value Percent:
Continuous Index:
Within 8" of Joint:
Remarks:

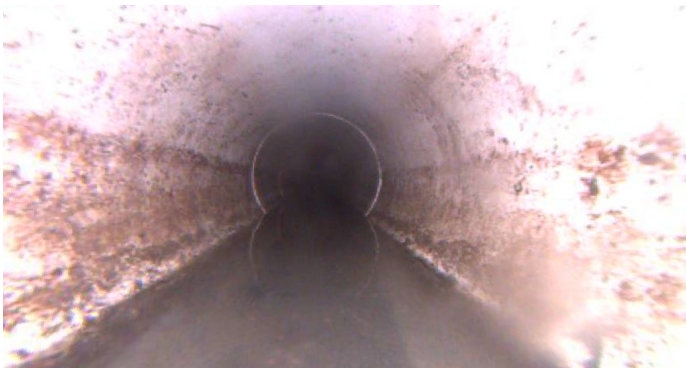
Code: **MMC**
Description: **Material Change**

Distance (ft): **112.2**
Structural Grade: **0**
O&M Grade: **0**
Clock Start/From:
Clock To:
1st Value:
2nd Value:
Value Percent:
Continuous Index:
Within 8" of Joint: **NO**
Remarks: **PVC**

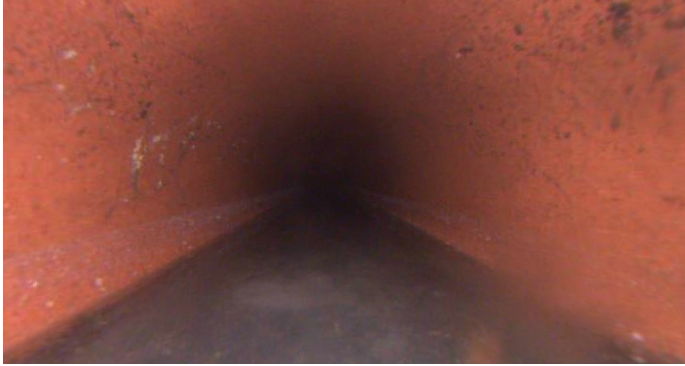
Code: **MMC**
Description: **Material Change**

Distance (ft): **115.6**
Structural Grade: **0**
O&M Grade: **0**
Clock Start/From:
Clock To:
1st Value:
2nd Value:
Value Percent:
Continuous Index:
Within 8" of Joint: **NO**
Remarks: **VCP**

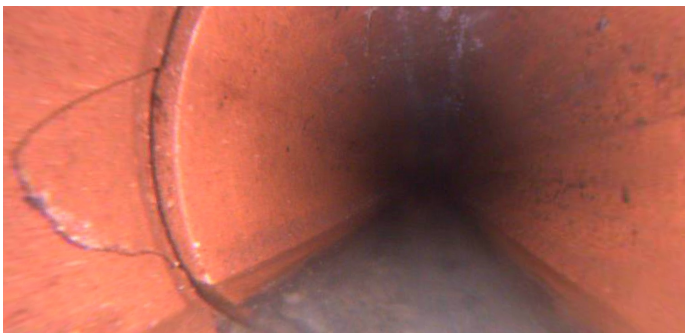
Code: **FS**
Description: **Fracture Spiral**

Distance (ft): **129.8**
Structural Grade: **3**
O&M Grade: **0**
Clock Start/From: **8**
Clock To: **9**
1st Value:
2nd Value:
Value Percent:
Continuous Index:
Within 8" of Joint: **YES**
Remarks:

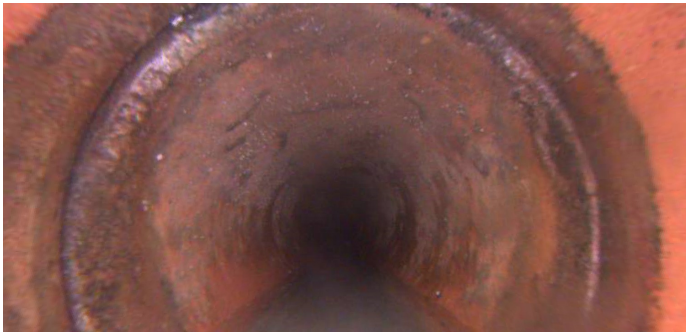
Code: **IW**
Description: **Infil Weeper**

Distance (ft): **186.3**
Structural Grade: **0**
O&M Grade: **2**
Clock Start/From: **8**
Clock To: **4**
1st Value:
2nd Value:
Value Percent:
Continuous Index:
Within 8" of Joint: **YES**
Remarks:

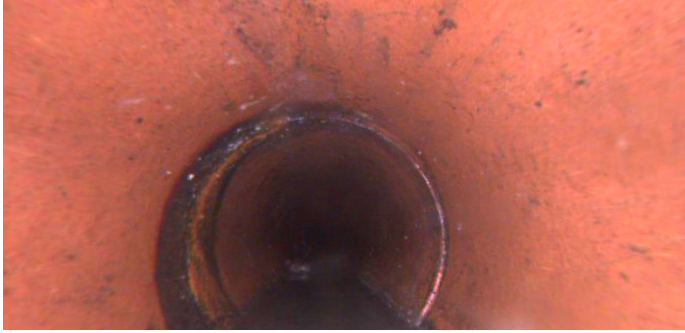
Code: **IW**
Description: **Infil Weeper**

Distance (ft): **201.3**
Structural Grade: **0**
O&M Grade: **2**
Clock Start/From: **8**
Clock To: **12**
1st Value:
2nd Value:
Value Percent:
Continuous Index:
Within 8" of Joint: **YES**
Remarks:
