Profile/Photo Observation Report

Street:	canender st	Flow Control:	Not Controlled
City:	Hobart, IN	Year Renewed:	
Location:	Other	Tape/Media #:	
Purpose:	Not Known	Dia/Height:	10"
Use:	Sanitary	Material:	VCP
Drain Area:	NA	Lining:	
Category:	NA		
Comment:

Location Details:		Direction of Survey:	Upstream
US MH:	M-503-039	DS MH:	M-503-038
		Total Length Surveyed (ft):	193.0

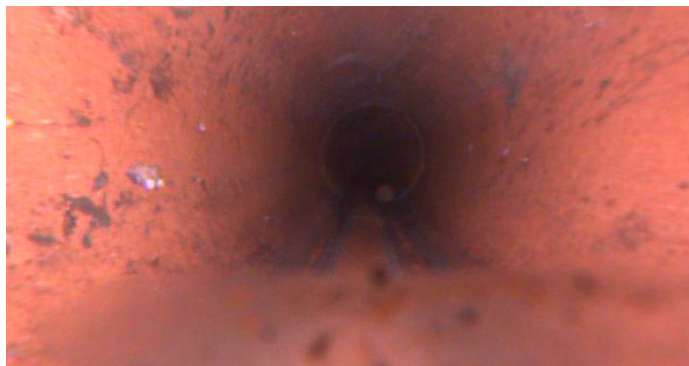
Code: **AMH**
 Description: **Manhole**
 Distance (ft): **.0**
 Structural Grade: **0**
 O&M Grade: **0**
 Clock Start/From:
 Clock To:
 1st Value:
 2nd Value:
 Value Percent:
 Continuous Index:
 Within 8" of Joint: **NO**
 Remarks: **M-503-038**

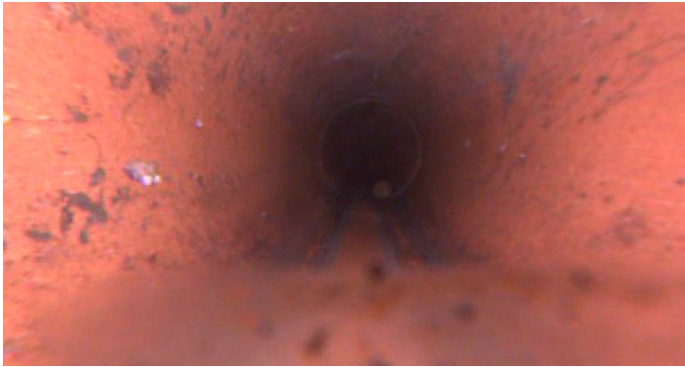
Code:	MWL
Description:	Water Level

Distance (ft):	.0
Structural Grade:	0
O&M Grade:	0
Clock Start/From:	
Clock To:	
1st Value:	
2nd Value:	
Value Percent:	10.000
Continuous Index:	
Within 8" of Joint:	NO
Remarks:

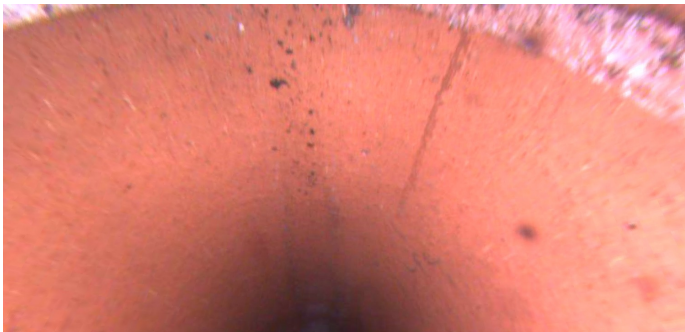
Code:	CL
Description:	Crack Longitudinal

Distance (ft):	13.0
Structural Grade:	2
O&M Grade:	0
Clock Start/From:	1
Clock To:	
1st Value:	
2nd Value:	
Value Percent:	
Continuous Index:	
Within 8" of Joint:	YES
Remarks:

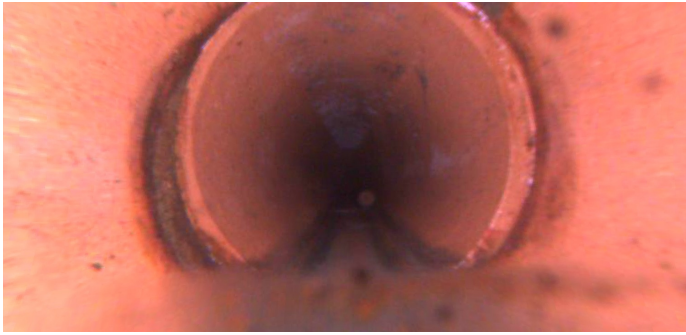
Code: **IW**
Description: **Infil Weeper**

Distance (ft): **32.3**
Structural Grade: **0**
O&M Grade: **2**
Clock Start/From: **8**
Clock To: **4**
1st Value:
2nd Value:
Value Percent:
Continuous Index:
Within 8" of Joint: **YES**
Remarks:

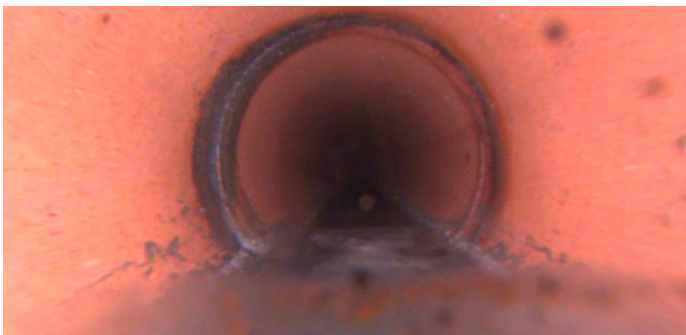
Code: **IW**
Description: **Infil Weeper**

Distance (ft): **37.1**
Structural Grade: **0**
O&M Grade: **2**
Clock Start/From: **8**
Clock To: **4**
1st Value:
2nd Value:
Value Percent:
Continuous Index: **S01**
Within 8" of Joint: **YES**
Remarks:

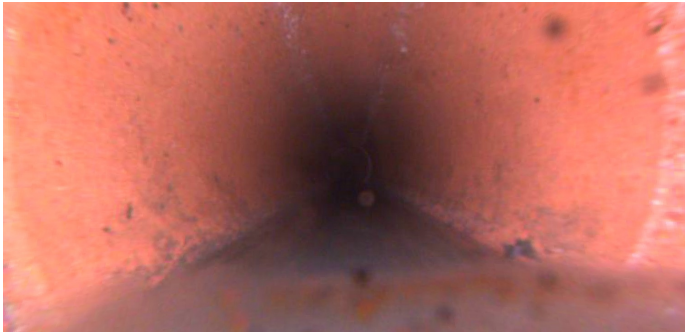
Code: **IW**
Description: **Infil Weeper**

Distance (ft): **52.5**
Structural Grade: **0**
O&M Grade: **2**
Clock Start/From: **8**
Clock To: **4**
1st Value:
2nd Value:
Value Percent:
Continuous Index: **F01**
Within 8" of Joint: **YES**
Remarks:

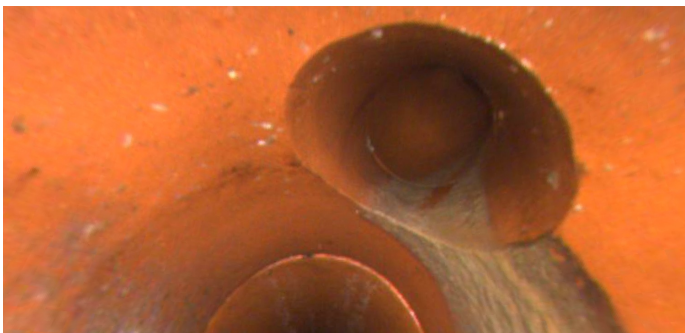
Code: **TF**
Description: **Tap Factory**

Distance (ft): **59.0**
Structural Grade: **0**
O&M Grade: **0**
Clock Start/From: **11**
Clock To:
1st Value: **4.000**
2nd Value:
Value Percent:
Continuous Index:
Within 8" of Joint:
Remarks:

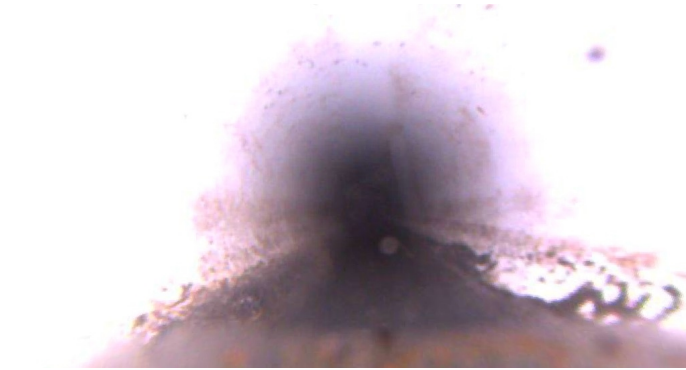
Code: **MMC**
Description: **Material Change**

Distance (ft): **84.0**
Structural Grade: **0**
O&M Grade: **0**
Clock Start/From:
Clock To:
1st Value:
2nd Value:
Value Percent:
Continuous Index:
Within 8" of Joint: **NO**
Remarks: **PVC**

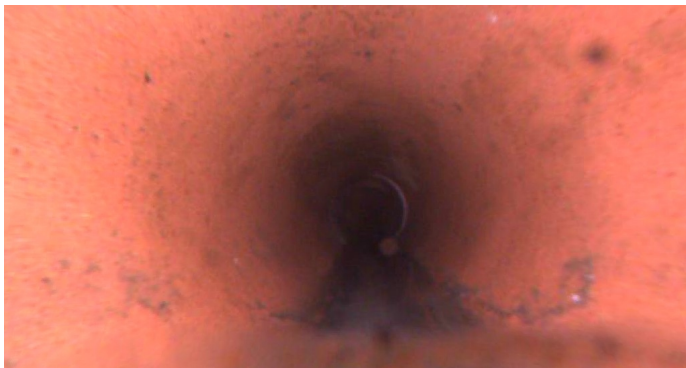
Code: **MMC**
Description: **Material Change**

Distance (ft): **91.0**
Structural Grade: **0**
O&M Grade: **0**
Clock Start/From:
Clock To:
1st Value:
2nd Value:
Value Percent:
Continuous Index:
Within 8" of Joint: **NO**
Remarks: **VCP**

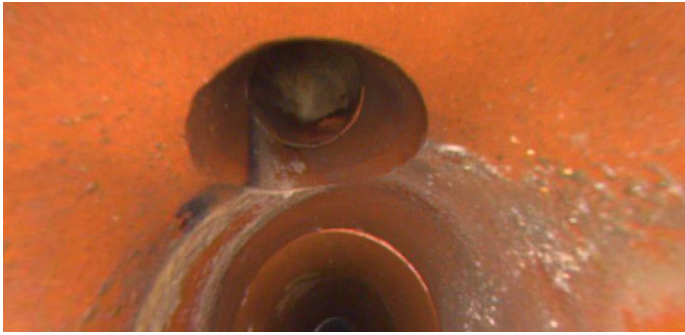
Code: **TF**
Description: **Tap Factory**

Distance (ft): **95.8**
Structural Grade: **0**
O&M Grade: **0**
Clock Start/From: **12**
Clock To:
1st Value: **4.000**
2nd Value:
Value Percent:
Continuous Index:
Within 8" of Joint:
Remarks:

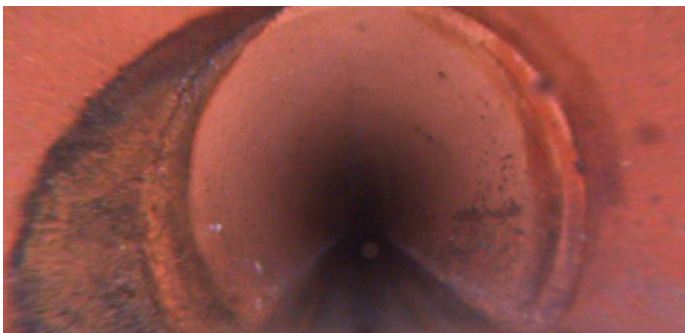
Code: **IW**
Description: **Infil Weeper**

Distance (ft): **95.8**
Structural Grade: **0**
O&M Grade: **2**
Clock Start/From: **8**
Clock To: **4**
1st Value:
2nd Value:
Value Percent:
Continuous Index:
Within 8" of Joint: **YES**
Remarks:

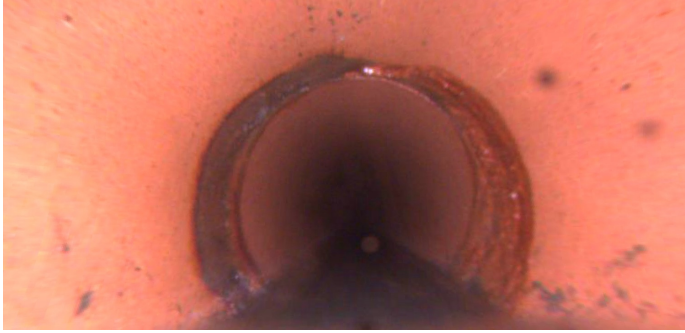
Code: **IW**
Description: **Infil Weeper**

Distance (ft): **100.4**
Structural Grade: **0**
O&M Grade: **2**
Clock Start/From: **8**
Clock To: **4**
1st Value:
2nd Value:
Value Percent:
Continuous Index:
Within 8" of Joint: **YES**
Remarks:

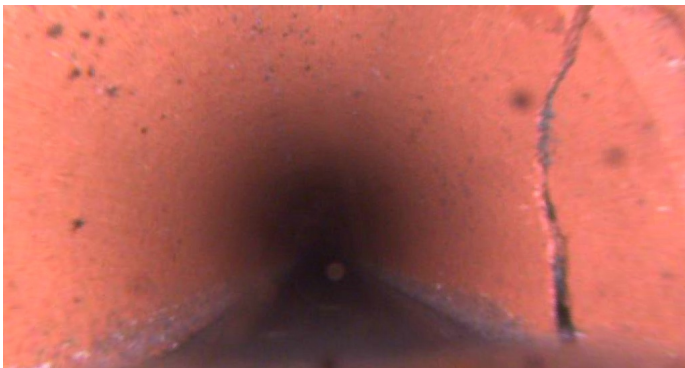
Code: **FS**
Description: **Fracture Spiral**

Distance (ft): **115.8**
Structural Grade: **3**
O&M Grade: **0**
Clock Start/From: **2**
Clock To: **5**
1st Value:
2nd Value:
Value Percent:
Continuous Index:
Within 8" of Joint: **YES**
Remarks:

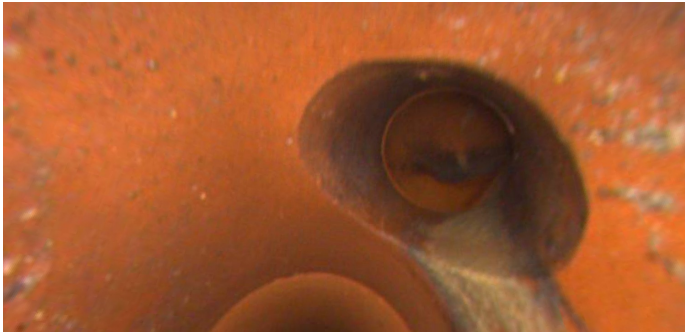
Code: **TF**
Description: **Tap Factory**

Distance (ft): **132.3**
Structural Grade: **0**
O&M Grade: **0**
Clock Start/From: **10**
Clock To:
1st Value: **4.000**
2nd Value:
Value Percent:
Continuous Index:
Within 8" of Joint:
Remarks:

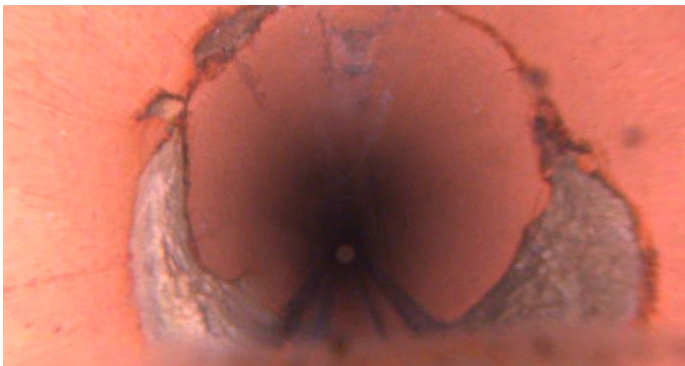
Code: **FC**
Description: **Fracture Circumferential**

Distance (ft): **138.7**
Structural Grade: **2**
O&M Grade: **0**
Clock Start/From: **7**
Clock To: **5**
1st Value:
2nd Value:
Value Percent:
Continuous Index:
Within 8" of Joint:
Remarks:

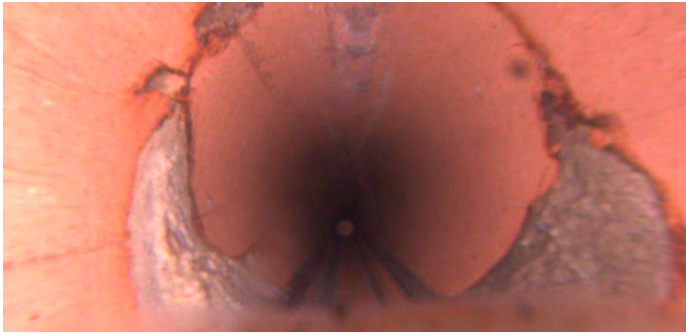
Code: **DAE**
Description: **Deposits Attached Encrustation**

Distance (ft): **138.7**
Structural Grade: **0**
O&M Grade: **2**
Clock Start/From: **8**
Clock To: **4**
1st Value:
2nd Value:
Value Percent: **5.000**
Continuous Index:
Within 8" of Joint: **NO**
Remarks:

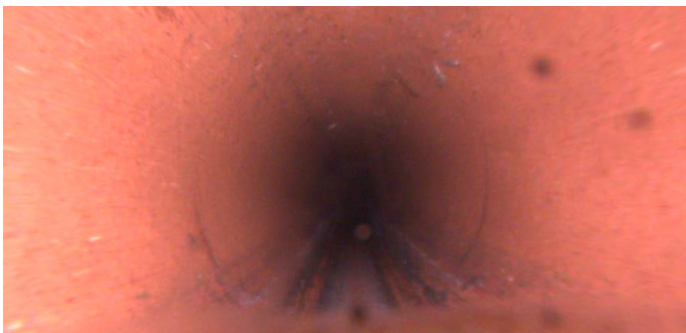
Code: **FC**
Description: **Fracture Circumferential**

Distance (ft): **143.9**
Structural Grade: **2**
O&M Grade: **0**
Clock Start/From: **3**
Clock To: **9**
1st Value:
2nd Value:
Value Percent:
Continuous Index:
Within 8" of Joint:
Remarks:

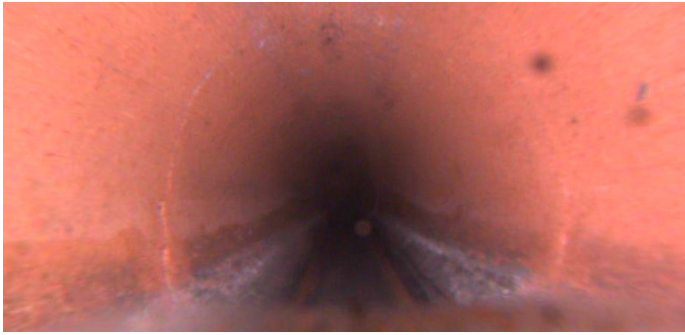
Code: **FC**
Description: **Fracture Circumferential**

Distance (ft): **149.2**
Structural Grade: **2**
O&M Grade: **0**
Clock Start/From: **12**
Clock To: **12**
1st Value:
2nd Value:
Value Percent:
Continuous Index:
Within 8" of Joint:
Remarks:

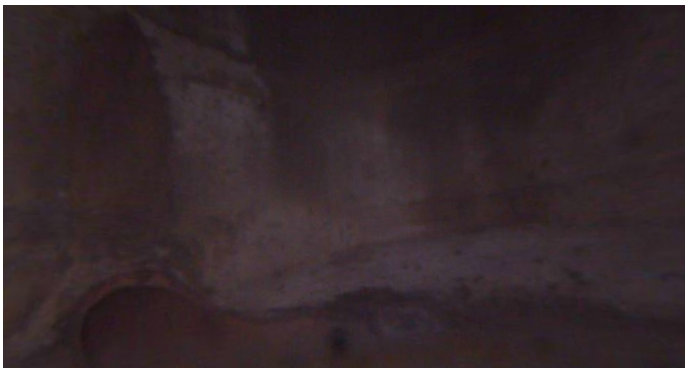
Code: **AMH**
Description: **Manhole**

Distance (ft): **193.0**
Structural Grade: **0**
O&M Grade: **0**
Clock Start/From:
Clock To:
1st Value:
2nd Value:
Value Percent:
Continuous Index:
Within 8" of Joint: **NO**
Remarks: **M-503-039**
