## Profile/Photo Observation Report

Street:	<b>PENNSYLVANIA ST &amp; N CAVENDER S</b>	Flow Control:	<b>Not Controlled</b>
City:	<b>Hobart, IN</b>	Year Renewed:	
Location:	<b>Other</b>	Tape/Media #:	
Purpose:	<b>Not Known</b>	Dia/Height:	<b>10"</b>
Use:	<b>Sanitary</b>	Material:	<b>VCP</b>
Drain Area:	<b>NA</b>	Lining:	
Category:	<b>NA</b>		
Comment:

Location Details:		Direction of Survey:	<b>Upstream</b>
US MH:	<b>M-503-040</b>	DS MH:	<b>M-503-039</b>
		Total Length Surveyed (ft):	<b>207.2</b>

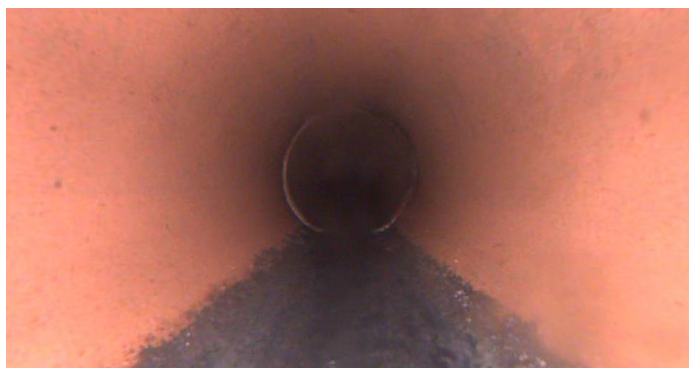
Code: **AMH**  
 Description: **Manhole**

Distance (ft): **.0**  
 Structural Grade: **0**  
 O&M Grade: **0**  
 Clock Start/From:  
 Clock To:  
 1st Value:  
 2nd Value:  
 Value Percent:  
 Continuous Index:  
 Within 8" of Joint: **NO**  
 Remarks: **M-503-039**

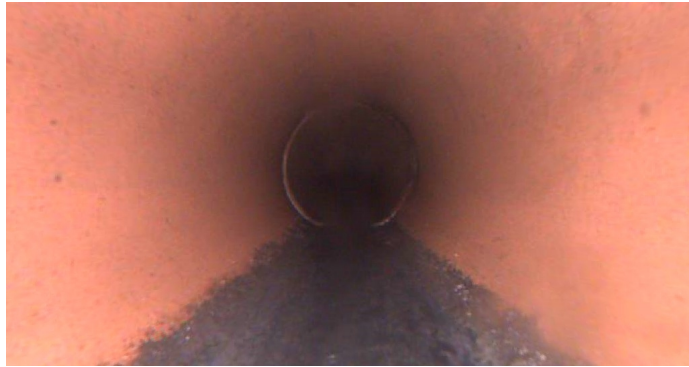
Code:	<b>MWL</b>
Description:	<b>Water Level</b>
Distance (ft):	<b>.0</b>
Structural Grade:	<b>0</b>
O&M Grade:	<b>0</b>
Clock Start/From:	
Clock To:	
1st Value:	
2nd Value:	
Value Percent:	<b>10.000</b>
Continuous Index:	
Within 8" of Joint:	<b>NO</b>
Remarks:

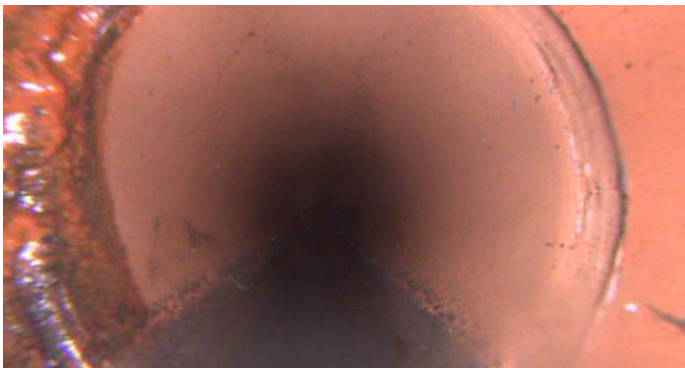
Code: **DAZ**  
Description: **Deposits Attached Other**

Distance (ft): **79.5**  
Structural Grade: **0**  
O&M Grade: **2**  
Clock Start/From: **7**  
Clock To: **5**  
1st Value:  
2nd Value:  
Value Percent: **5.000**  
Continuous Index: **F01**  
Within 8" of Joint: **YES**  
Remarks:

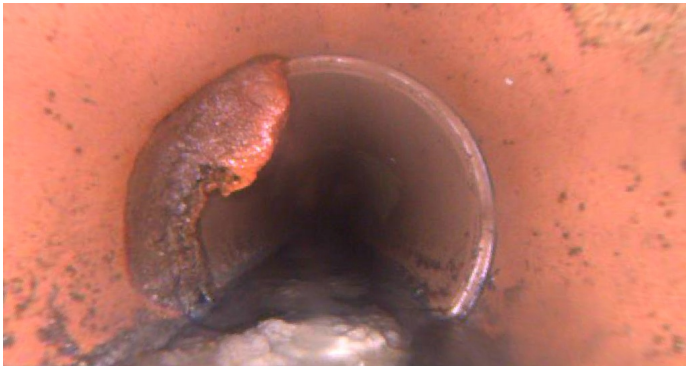
Code:	<b>DAZ</b>
Description:	<b>Deposits Attached Other</b>
Distance (ft):	<b>140.9</b>
Structural Grade:	<b>0</b>
O&M Grade:	<b>2</b>
Clock Start/From:	<b>7</b>
Clock To:	<b>11</b>
1st Value:	
2nd Value:	
Value Percent:	<b>5.000</b>
Continuous Index:	
Within 8" of Joint:	<b>YES</b>
Remarks:
