Profile/Photo Observation Report

Date:	04/07/2018	Weather:		Coding:	PACP 6.0
Pipe Length (ft):	208.1	Owner:	NA	Pre Clean:	Not Known
P.O.#:		Surveyor:	Mark Ruby	PSR:	P-503-039-040
Customer:		Clean Date:	01/01/1900	Shape:	C

Street:	canender st	Flow Control:	Not Controlled
City:	Hobart, IN	Year Renewed:	
Location:	Other	Tape/Media #:	
Purpose:	Not Known	Dia/Height:	10"
Use:	Sanitary	Material:	VCP
Drain Area:	NA	Lining:	
Category:	NA		
Comment:

Location Details:		Direction of Survey:	Upstream
US MH:	M-503-040	DS MH:	M-503-039
		Total Length Surveyed (ft):	207.2

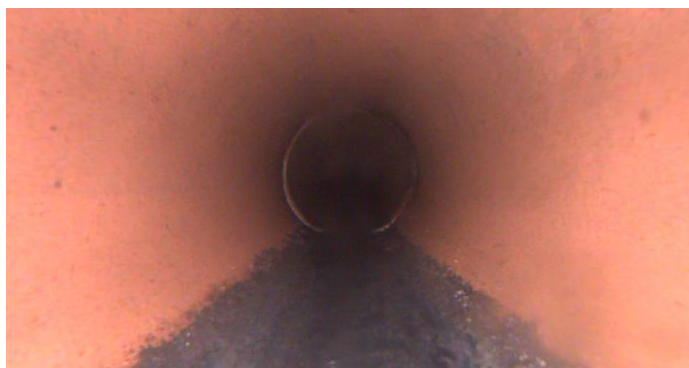
Code: **AMH**
 Description: **Manhole**

Distance (ft): **.0**
 Structural Grade: **0**
 O&M Grade: **0**
 Clock Start/From:
 Clock To:
 1st Value:
 2nd Value:
 Value Percent:
 Continuous Index:
 Within 8" of Joint: **NO**
 Remarks: **M-503-039**

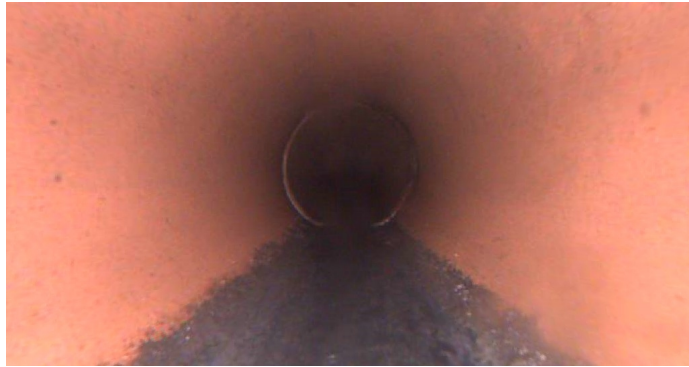
Code:	MWL
Description:	Water Level
Distance (ft):	.0
Structural Grade:	0
O&M Grade:	0
Clock Start/From:	
Clock To:	
1st Value:	
2nd Value:	
Value Percent:	10.000
Continuous Index:	
Within 8" of Joint:	NO
Remarks:

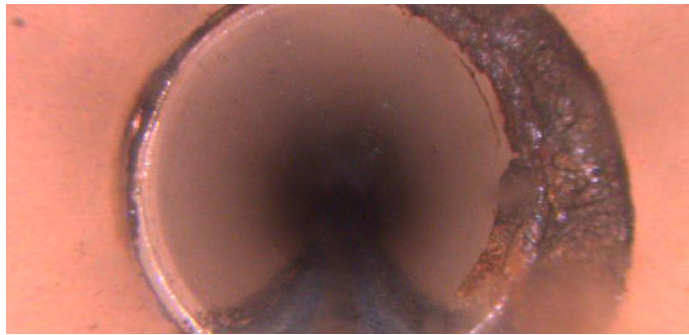
Code:	IW
Description:	Infil Weeper
Distance (ft):	2.6
Structural Grade:	0
O&M Grade:	2
Clock Start/From:	8
Clock To:	4
1st Value:	
2nd Value:	
Value Percent:	
Continuous Index:	S02
Within 8" of Joint:	YES
Remarks:

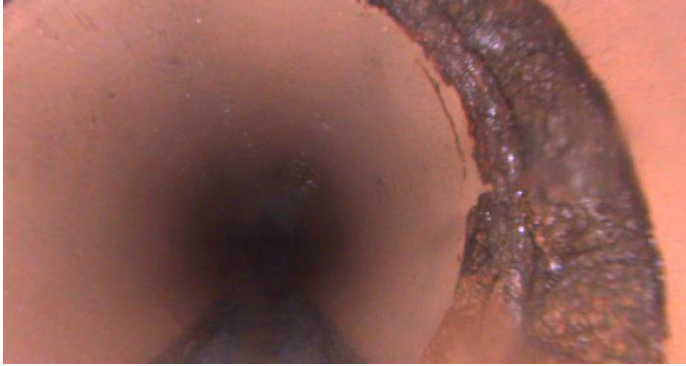
Code: **DAZ**
Description: **Deposits Attached Other**

Distance (ft): **2.7**
Structural Grade: **0**
O&M Grade: **2**
Clock Start/From: **12**
Clock To: **5**
1st Value:
2nd Value:
Value Percent: **5.000**
Continuous Index:
Within 8" of Joint: **YES**
Remarks:

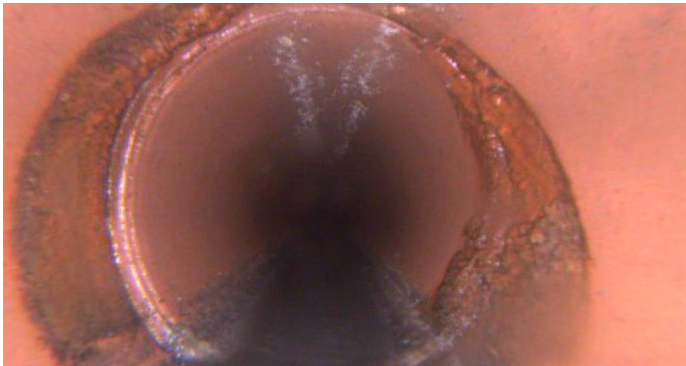
Code: **DAZ**
Description: **Deposits Attached Other**

Distance (ft): **33.2**
Structural Grade: **0**
O&M Grade: **2**
Clock Start/From: **7**
Clock To: **5**
1st Value:
2nd Value:
Value Percent: **5.000**
Continuous Index:
Within 8" of Joint: **YES**
Remarks:

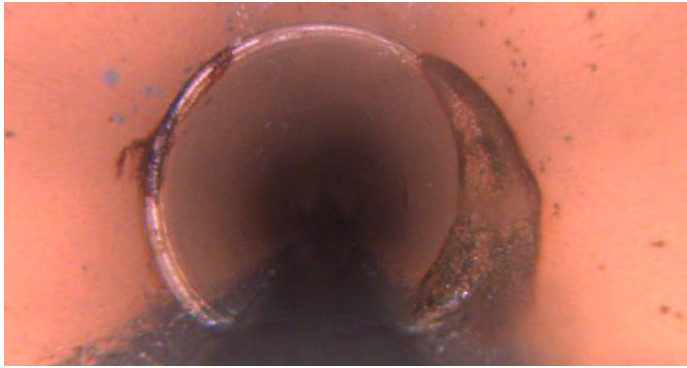
Code:	DAZ
Description:	Deposits Attached Other
Distance (ft):	48.6
Structural Grade:	0
O&M Grade:	2
Clock Start/From:	1
Clock To:	5
1st Value:	
2nd Value:	
Value Percent:	5.000
Continuous Index:	
Within 8" of Joint:	YES
Remarks:

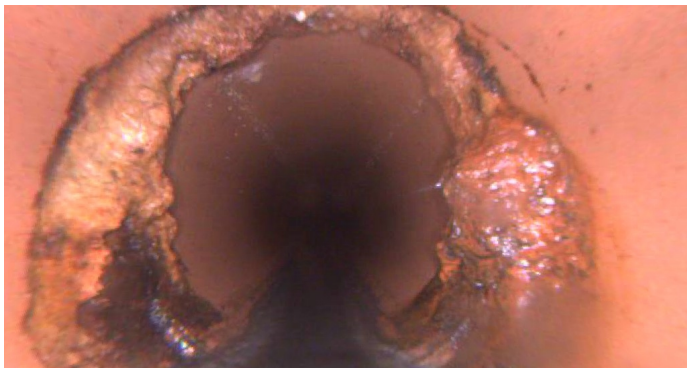
Code:	DAZ
Description:	Deposits Attached Other
Distance (ft):	53.7
Structural Grade:	0
O&M Grade:	2
Clock Start/From:	7
Clock To:	5
1st Value:	
2nd Value:	
Value Percent:	5.000
Continuous Index:	S01
Within 8" of Joint:	YES
Remarks:

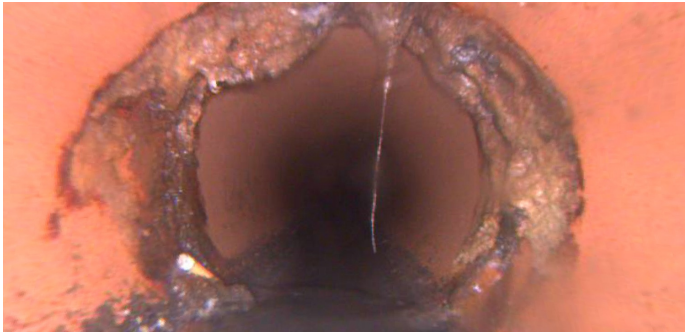
Code: **RFJ**
Description: **Roots Fine Joint**

Distance (ft): **74.2**
Structural Grade: **0**
O&M Grade: **1**
Clock Start/From: **12**
Clock To:
1st Value:
2nd Value:
Value Percent:
Continuous Index:
Within 8" of Joint: **YES**
Remarks:

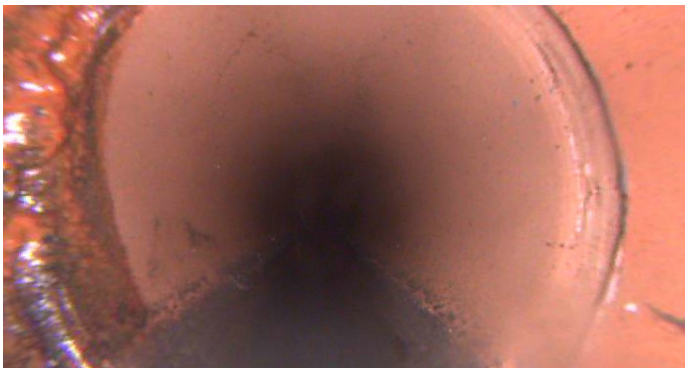
Code: **DAZ**
Description: **Deposits Attached Other**

Distance (ft): **79.5**
Structural Grade: **0**
O&M Grade: **2**
Clock Start/From: **7**
Clock To: **5**
1st Value:
2nd Value:
Value Percent: **5.000**
Continuous Index: **F01**
Within 8" of Joint: **YES**
Remarks:

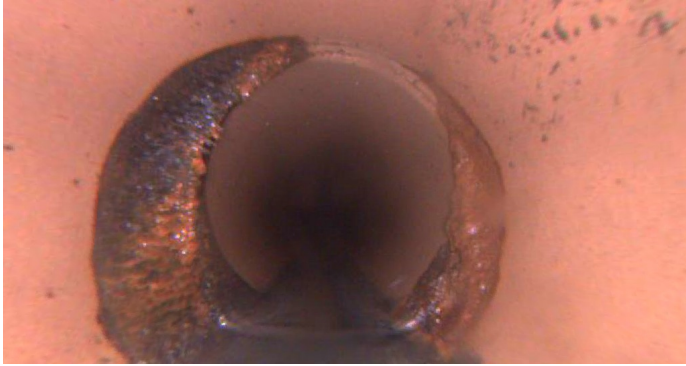
Code:	DAZ
Description:	Deposits Attached Other
Distance (ft):	104.9
Structural Grade:	0
O&M Grade:	2
Clock Start/From:	7
Clock To:	5
1st Value:	
2nd Value:	
Value Percent:	5.000
Continuous Index:	
Within 8" of Joint:	YES
Remarks:

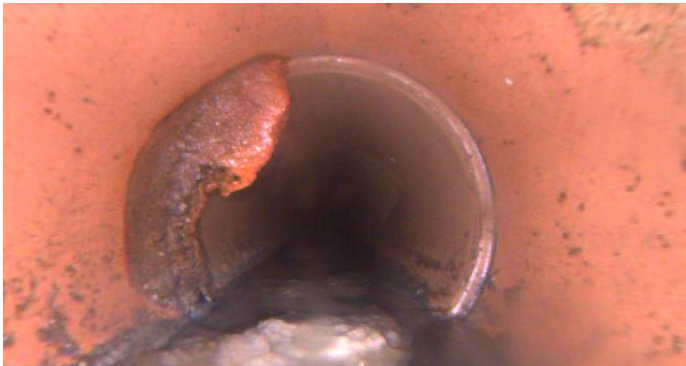
Code:	DAZ
Description:	Deposits Attached Other
Distance (ft):	140.9
Structural Grade:	0
O&M Grade:	2
Clock Start/From:	7
Clock To:	11
1st Value:	
2nd Value:	
Value Percent:	5.000
Continuous Index:	
Within 8" of Joint:	YES
Remarks:

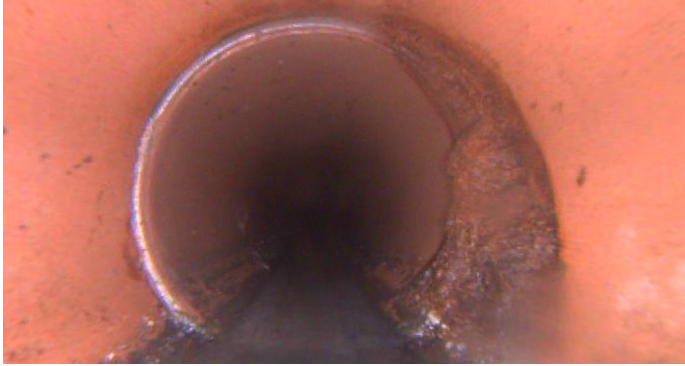
Code: **DAZ**
Description: **Deposits Attached Other**

Distance (ft): **156.5**
Structural Grade: **0**
O&M Grade: **2**
Clock Start/From: **1**
Clock To: **5**
1st Value:
2nd Value:
Value Percent: **5.000**
Continuous Index:
Within 8" of Joint: **YES**
Remarks:

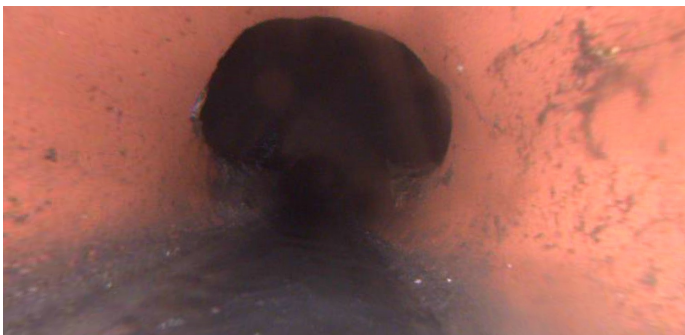
Code: **IW**
Description: **Infil Weeper**

Distance (ft): **204.5**
Structural Grade: **0**
O&M Grade: **2**
Clock Start/From: **8**
Clock To: **4**
1st Value:
2nd Value:
Value Percent:
Continuous Index: **F02**
Within 8" of Joint: **YES**
Remarks:

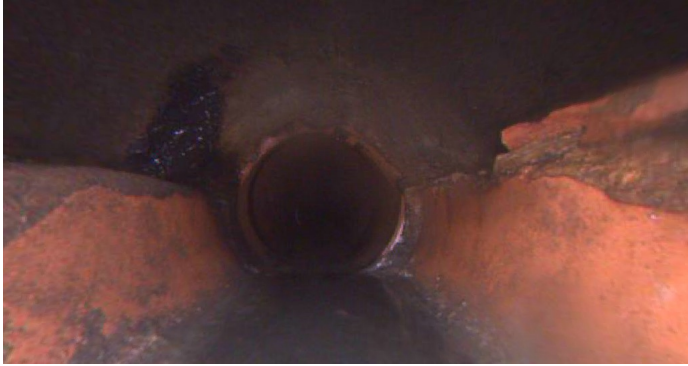
Code:	AMH
Description:	Manhole
Distance (ft):	207.2
Structural Grade:	0
O&M Grade:	0
Clock Start/From:	
Clock To:	
1st Value:	
2nd Value:	
Value Percent:	
Continuous Index:	
Within 8" of Joint:	NO
Remarks:	M-503-040
