Profile/Photo Observation Report

Date:	09/30/2018	Weather:		Coding:	PACP 6.0
Pipe Length (ft):	197.0	Owner:	NA	Pre Clean:	Not Known
P.O.#:		Surveyor:	Selasie Honu	PSR:	P-503-040-041
Customer:		Clean Date:	01/01/1900	Shape:	C

Street:	PENNSYLVANIA ST & N CAVENDER S	Flow Control:	Not Controlled
City:	Hobart, IN	Year Renewed:	
Location:	Light Highway	Tape/Media #:	
Purpose:	Routine Assessment	Dia/Height:	10"
Use:	Sanitary	Material:	VCP
Drain Area:	NA	Lining:	
Category:	NA		
Comment:			
Location Details:		Direction of Survey:	Downstream
US MH:	M-503-041	DS MH:	M-503-040
		Total Length Surveyed (ft):	192.7

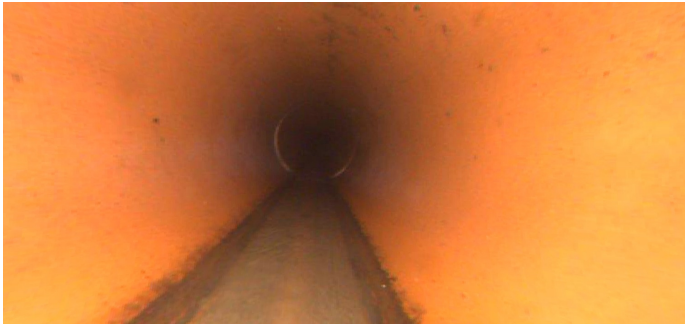
Code: **AMH**
Description: **Manhole**

Distance (ft): **.0**
Structural Grade: **0**
O&M Grade: **0**
Clock Start/From:
Clock To:
1st Value:
2nd Value:
Value Percent:
Continuous Index:
Within 8" of Joint: **NO**
Remarks: **M-503-041**

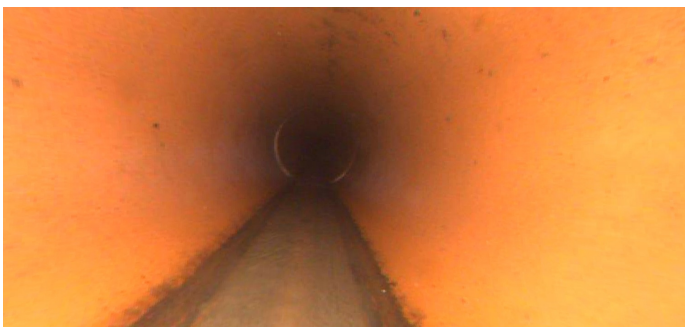
Code: **MWL**
Description: **Water Level**

Distance (ft): **.0**
Structural Grade: **0**
O&M Grade: **0**
Clock Start/From:
Clock To:
1st Value:
2nd Value:
Value Percent: **5.000**
Continuous Index:
Within 8" of Joint: **NO**
Remarks:

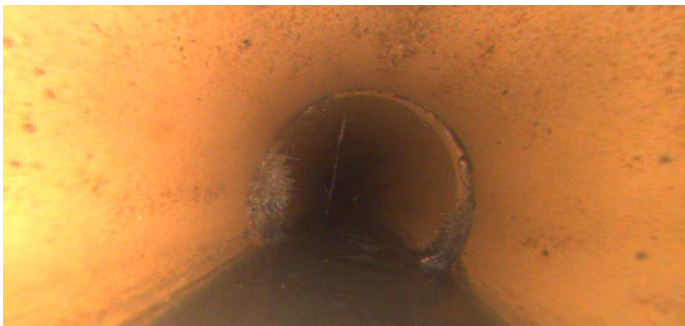
Code: **RFJ**
Description: **Roots Fine Joint**

Distance (ft): **57.1**
Structural Grade: **0**
O&M Grade: **1**
Clock Start/From: **8**
Clock To: **4**
1st Value:
2nd Value:
Value Percent:
Continuous Index:
Within 8" of Joint: **YES**
Remarks:

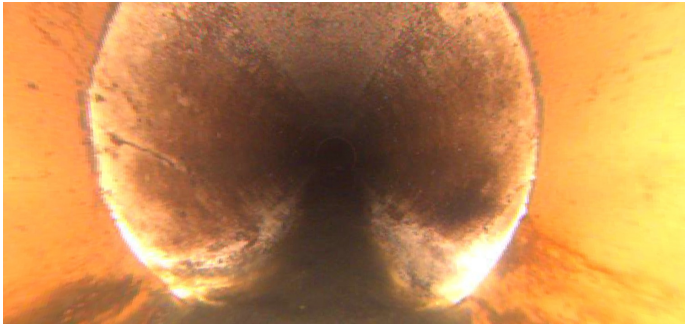
Code: **FL**
Description: **Fracture Longitudinal**

Distance (ft): **62.5**
Structural Grade: **3**
O&M Grade: **0**
Clock Start/From: **9**
Clock To:
1st Value:
2nd Value:
Value Percent:
Continuous Index:
Within 8" of Joint: **YES**
Remarks:

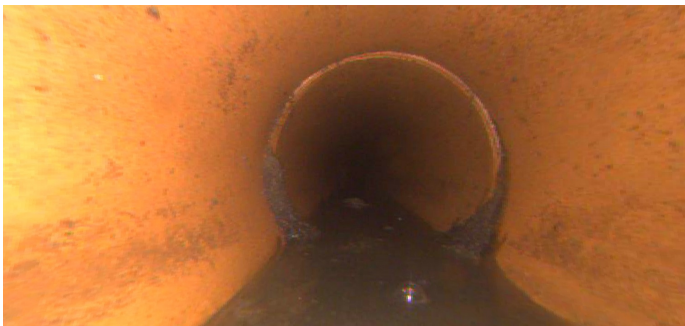
Code: **RFJ**
Description: **Roots Fine Joint**

Distance (ft): **72.0**
Structural Grade: **0**
O&M Grade: **1**
Clock Start/From: **8**
Clock To: **4**
1st Value:
2nd Value:
Value Percent:
Continuous Index:
Within 8" of Joint: **YES**
Remarks:

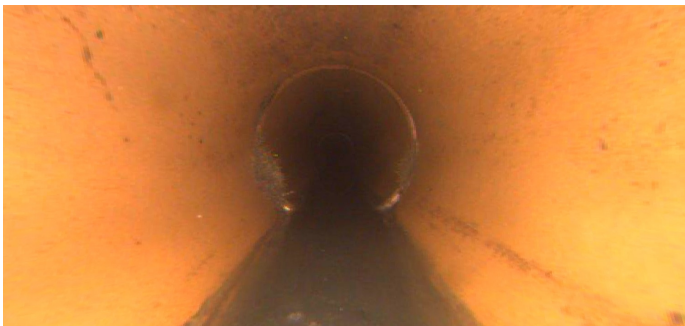
Code: **RFJ**
Description: **Roots Fine Joint**

Distance (ft): **81.5**
Structural Grade: **0**
O&M Grade: **1**
Clock Start/From: **8**
Clock To: **4**
1st Value:
2nd Value:
Value Percent:
Continuous Index:
Within 8" of Joint: **YES**
Remarks:

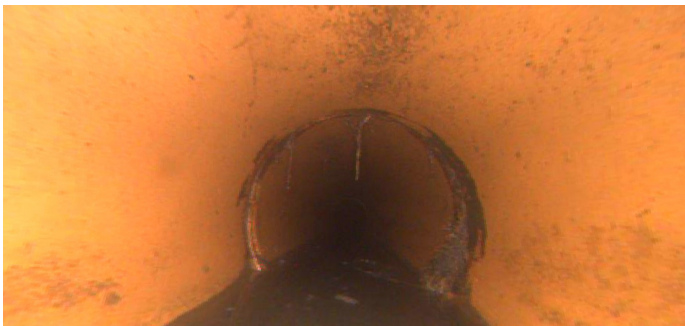
Code: **RFJ**
Description: **Roots Fine Joint**

Distance (ft): **91.7**
Structural Grade: **0**
O&M Grade: **1**
Clock Start/From: **8**
Clock To: **4**
1st Value:
2nd Value:
Value Percent:
Continuous Index:
Within 8" of Joint: **YES**
Remarks:

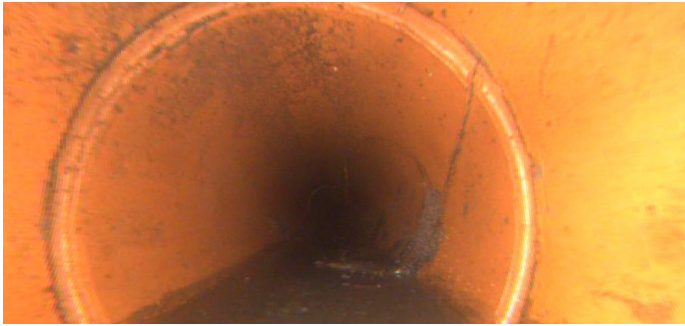
Code: **RFJ**
Description: **Roots Fine Joint**

Distance (ft): **97.1**
Structural Grade: **0**
O&M Grade: **1**
Clock Start/From: **2**
Clock To:
1st Value:
2nd Value:
Value Percent:
Continuous Index:
Within 8" of Joint: **YES**
Remarks:

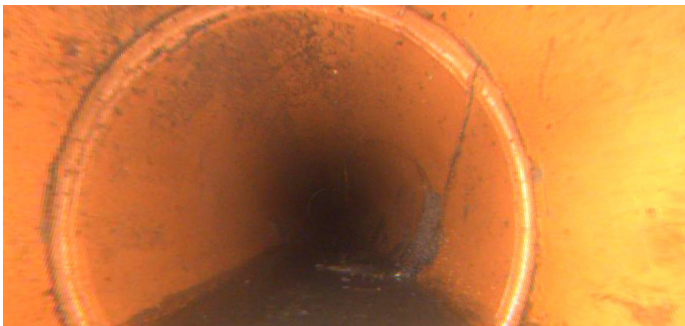
Code: **RFB**
Description: **Roots Fine Barrel**

Distance (ft): **97.1**
Structural Grade: **0**
O&M Grade: **2**
Clock Start/From: **2**
Clock To: **5**
1st Value:
2nd Value:
Value Percent:
Continuous Index:
Within 8" of Joint: **NO**
Remarks:

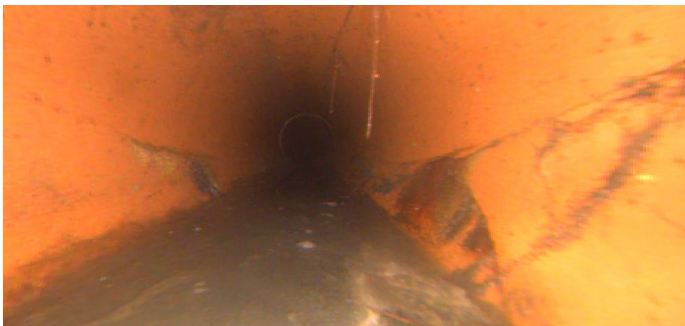
Code: **FL**
Description: **Fracture Longitudinal**

Distance (ft): **98.5**
Structural Grade: **3**
O&M Grade: **0**
Clock Start/From: **9**
Clock To:
1st Value:
2nd Value:
Value Percent:
Continuous Index:
Within 8" of Joint:
Remarks:

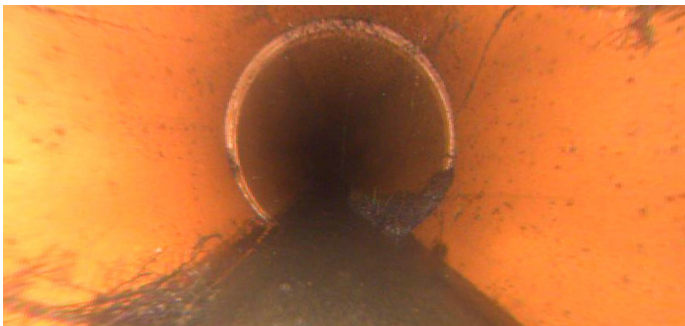
Code: **RFJ**
Description: **Roots Fine Joint**

Distance (ft): **101.6**
Structural Grade: **0**
O&M Grade: **1**
Clock Start/From: **7**
Clock To: **5**
1st Value:
2nd Value:
Value Percent:
Continuous Index:
Within 8" of Joint: **YES**
Remarks:

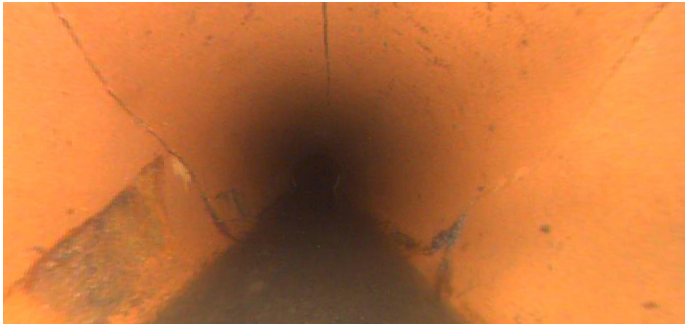
Code: **RFJ**
Description: **Roots Fine Joint**

Distance (ft): **122.2**
Structural Grade: **0**
O&M Grade: **1**
Clock Start/From: **7**
Clock To: **5**
1st Value:
2nd Value:
Value Percent:
Continuous Index:
Within 8" of Joint: **YES**
Remarks:

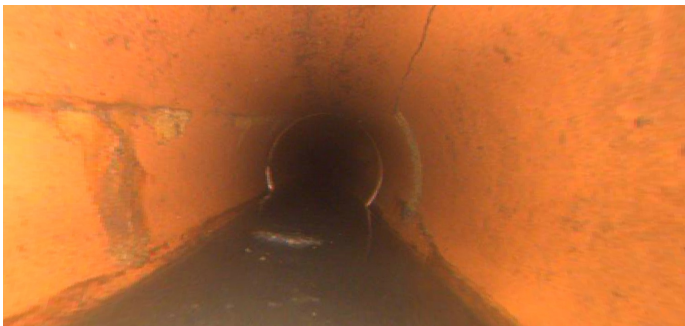
Code: **IS**
Description: **Infil Stain**

Distance (ft): **125.2**
Structural Grade: **0**
O&M Grade: **0**
Clock Start/From: **8**
Clock To: **4**
1st Value:
2nd Value:
Value Percent:
Continuous Index:
Within 8" of Joint:
Remarks:

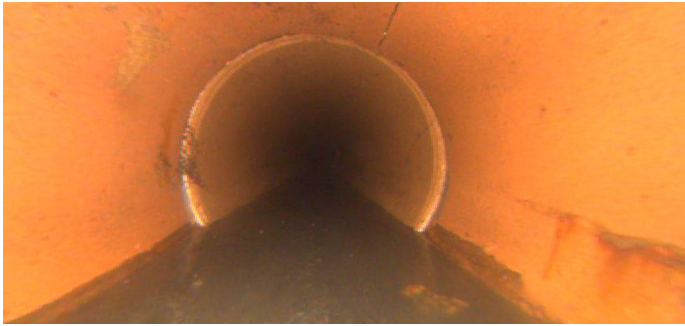
Code: **RFJ**
Description: **Roots Fine Joint**

Distance (ft): **126.4**
Structural Grade: **0**
O&M Grade: **1**
Clock Start/From: **9**
Clock To:
1st Value:
2nd Value:
Value Percent:
Continuous Index:
Within 8" of Joint: **YES**
Remarks:

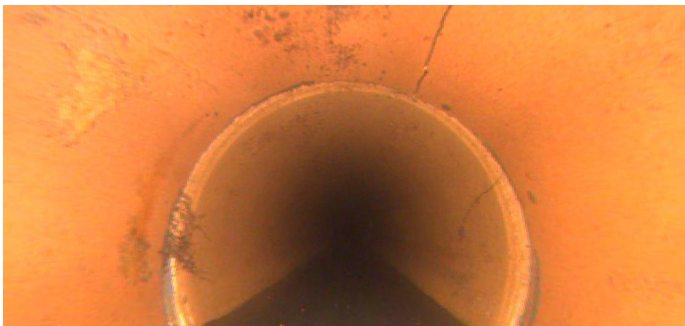
Code: **FL**
Description: **Fracture Longitudinal**

Distance (ft): **126.6**
Structural Grade: **3**
O&M Grade: **0**
Clock Start/From: **1**
Clock To:
1st Value:
2nd Value:
Value Percent:
Continuous Index:
Within 8" of Joint: **YES**
Remarks:

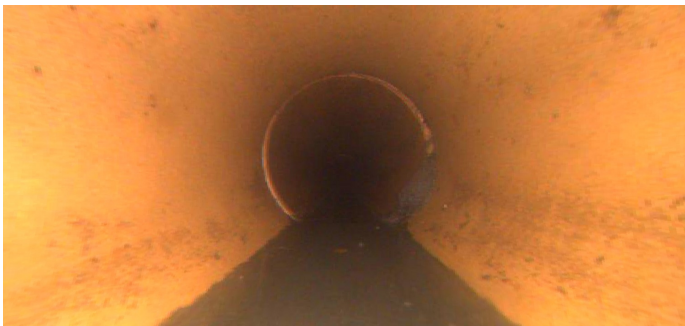
Code: **RFJ**
Description: **Roots Fine Joint**

Distance (ft): **130.8**
Structural Grade: **0**
O&M Grade: **1**
Clock Start/From: **7**
Clock To: **5**
1st Value:
2nd Value:
Value Percent:
Continuous Index:
Within 8" of Joint: **YES**
Remarks:

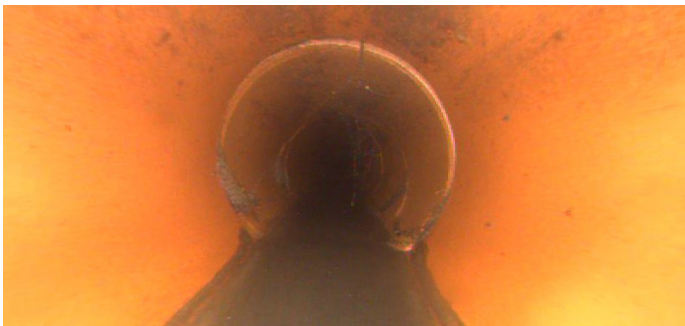
Code: **RFJ**
Description: **Roots Fine Joint**

Distance (ft): **136.2**
Structural Grade: **0**
O&M Grade: **1**
Clock Start/From: **7**
Clock To: **5**
1st Value:
2nd Value:
Value Percent:
Continuous Index:
Within 8" of Joint: **YES**
Remarks:

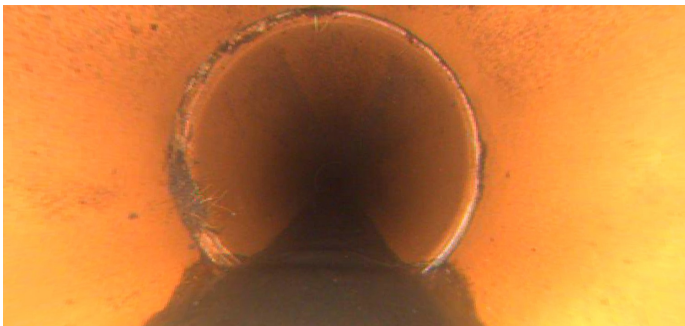
Code: **RFJ**
Description: **Roots Fine Joint**

Distance (ft): **141.3**
Structural Grade: **0**
O&M Grade: **1**
Clock Start/From: **7**
Clock To: **5**
1st Value:
2nd Value:
Value Percent:
Continuous Index:
Within 8" of Joint: **YES**
Remarks:

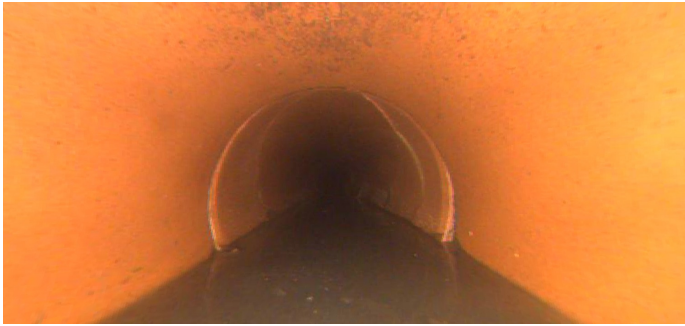
Code: **FM**
Description: **Fracture Multiple**

Distance (ft): **155.9**
Structural Grade: **4**
O&M Grade: **0**
Clock Start/From: **8**
Clock To: **4**
1st Value:
2nd Value:
Value Percent:
Continuous Index:
Within 8" of Joint: **YES**
Remarks:

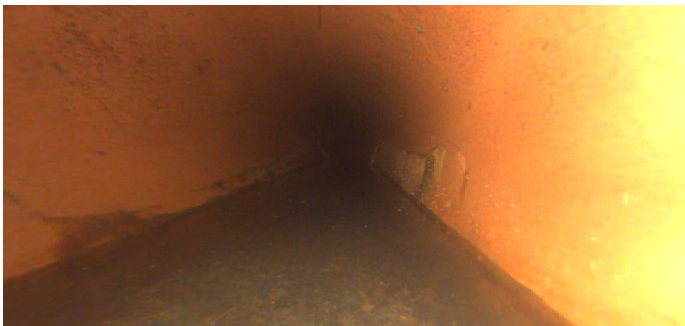
Code: **RFB**
Description: **Roots Fine Barrel**

Distance (ft): **157.1**
Structural Grade: **0**
O&M Grade: **2**
Clock Start/From: **8**
Clock To: **9**
1st Value:
2nd Value:
Value Percent:
Continuous Index:
Within 8" of Joint: **NO**
Remarks:

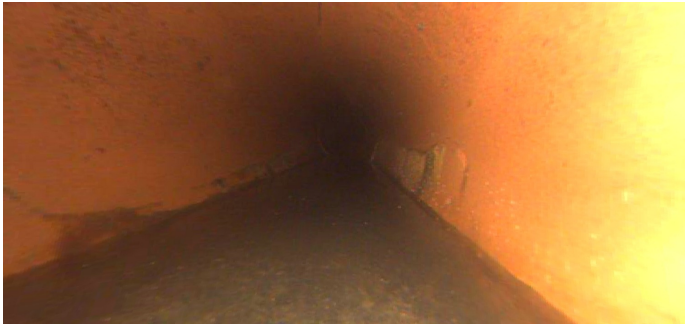
Code: **RFB**
Description: **Roots Fine Barrel**

Distance (ft): **157.1**
Structural Grade: **0**
O&M Grade: **2**
Clock Start/From: **3**
Clock To: **4**
1st Value:
2nd Value:
Value Percent:
Continuous Index:
Within 8" of Joint: **NO**
Remarks:

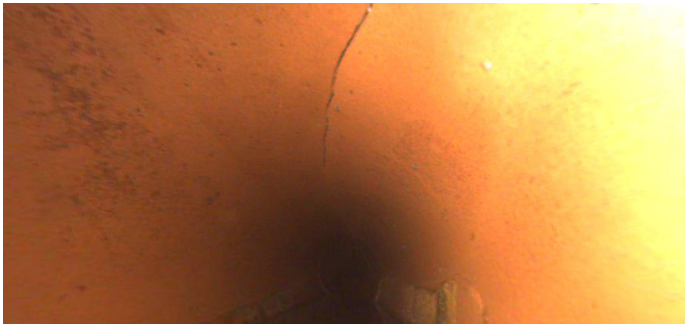
Code: **FL**
Description: **Fracture Longitudinal**

Distance (ft): **157.1**
Structural Grade: **3**
O&M Grade: **0**
Clock Start/From: **12**
Clock To:
1st Value:
2nd Value:
Value Percent:
Continuous Index:
Within 8" of Joint:
Remarks:

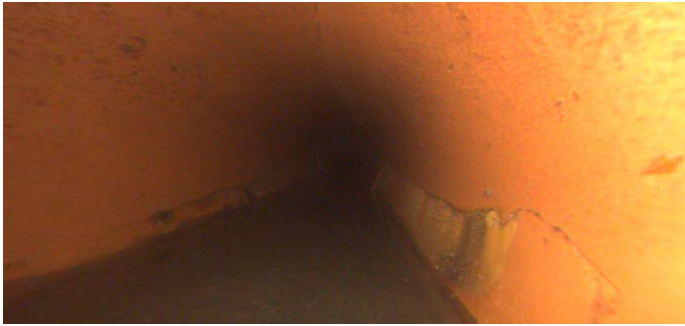
Code: **FL**
Description: **Fracture Longitudinal**

Distance (ft): **157.5**
Structural Grade: **3**
O&M Grade: **0**
Clock Start/From: **3**
Clock To:
1st Value:
2nd Value:
Value Percent:
Continuous Index:
Within 8" of Joint:
Remarks:

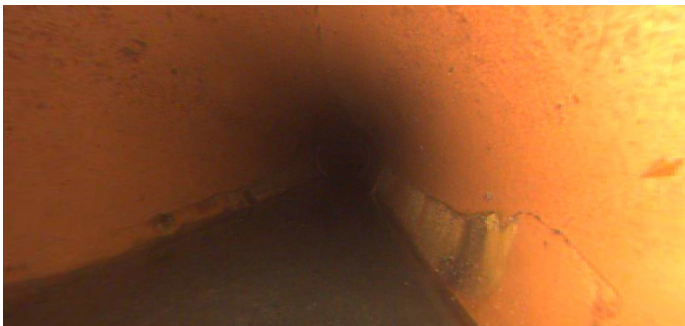
Code: **FL**
Description: **Fracture Longitudinal**

Distance (ft): **157.5**
Structural Grade: **3**
O&M Grade: **0**
Clock Start/From: **8**
Clock To:
1st Value:
2nd Value:
Value Percent:
Continuous Index:
Within 8" of Joint:
Remarks:

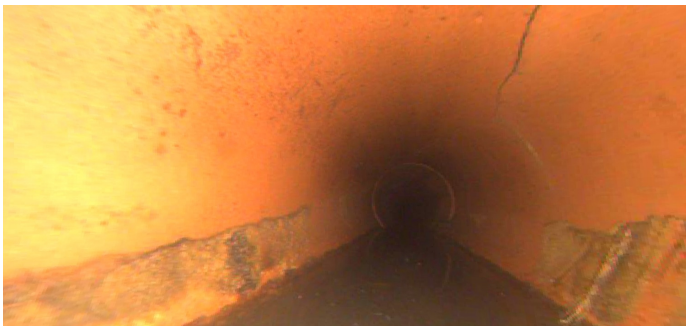
Code: **IS**
Description: **Infil Stain**

Distance (ft): **158.8**
Structural Grade: **0**
O&M Grade: **0**
Clock Start/From: **8**
Clock To: **9**
1st Value:
2nd Value:
Value Percent:
Continuous Index:
Within 8" of Joint:
Remarks:

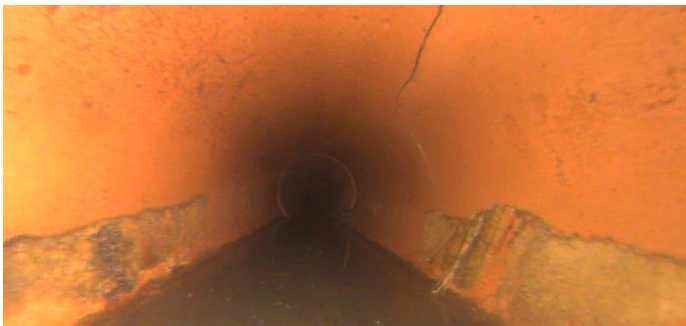
Code: **RFB**
Description: **Roots Fine Barrel**

Distance (ft): **158.8**
Structural Grade: **0**
O&M Grade: **2**
Clock Start/From: **3**
Clock To: **4**
1st Value:
2nd Value:
Value Percent:
Continuous Index:
Within 8" of Joint: **NO**
Remarks:

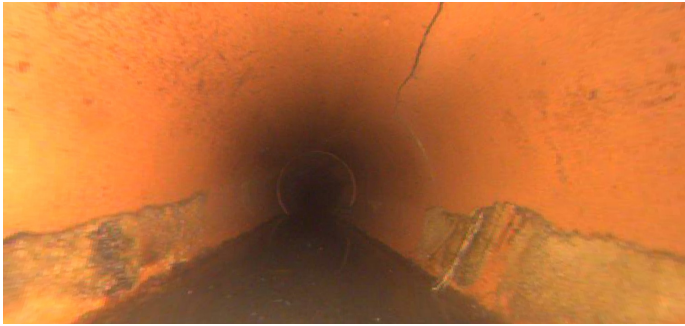
Code: **IS**
Description: **Infil Stain**

Distance (ft): **158.8**
Structural Grade: **0**
O&M Grade: **0**
Clock Start/From: **3**
Clock To: **4**
1st Value:
2nd Value:
Value Percent:
Continuous Index:
Within 8" of Joint:
Remarks:

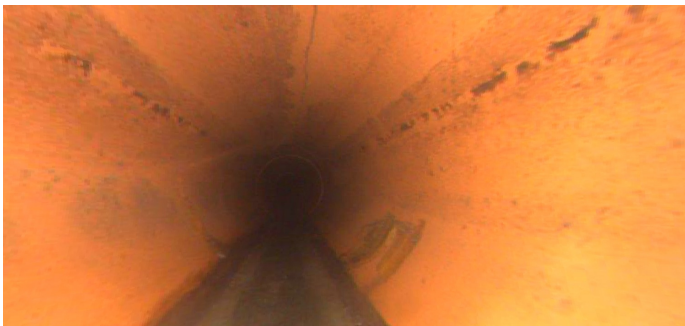
Code: **IS**
Description: **Infil Stain**

Distance (ft): **163.2**
Structural Grade: **0**
O&M Grade: **0**
Clock Start/From: **7**
Clock To: **5**
1st Value:
2nd Value:
Value Percent:
Continuous Index:
Within 8" of Joint:
Remarks:

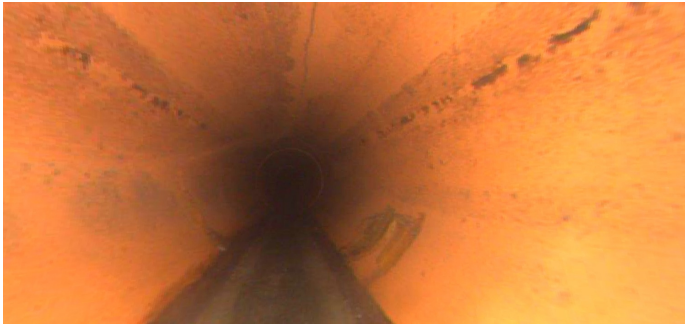
Code: **FL**
Description: **Fracture Longitudinal**

Distance (ft): **163.2**
Structural Grade: **3**
O&M Grade: **0**
Clock Start/From: **3**
Clock To:
1st Value:
2nd Value:
Value Percent:
Continuous Index:
Within 8" of Joint:
Remarks:

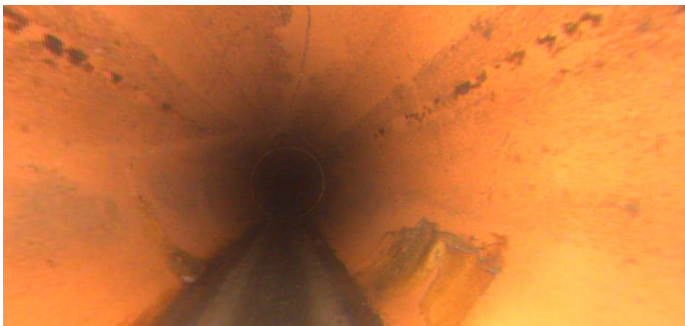
Code: **IS**
Description: **Infil Stain**

Distance (ft): **163.6**
Structural Grade: **0**
O&M Grade: **0**
Clock Start/From: **8**
Clock To: **10**
1st Value:
2nd Value:
Value Percent:
Continuous Index:
Within 8" of Joint:
Remarks:

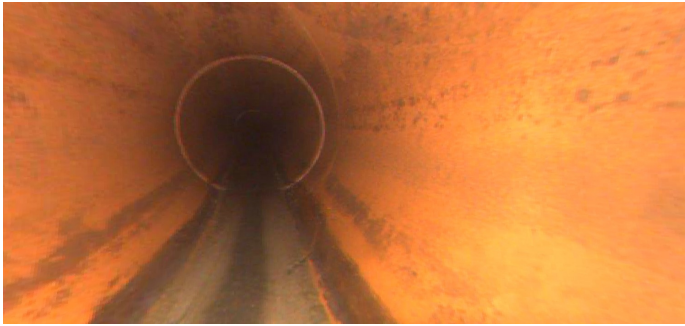
Code: **FC**
Description: **Fracture Circumferential**

Distance (ft): **165.0**
Structural Grade: **2**
O&M Grade: **0**
Clock Start/From: **12**
Clock To: **6**
1st Value:
2nd Value:
Value Percent:
Continuous Index:
Within 8" of Joint: **YES**
Remarks:

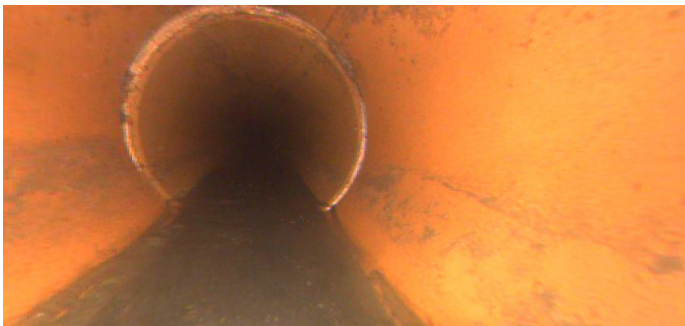
Code: **RFJ**
Description: **Roots Fine Joint**

Distance (ft): **170.6**
Structural Grade: **0**
O&M Grade: **1**
Clock Start/From: **8**
Clock To: **4**
1st Value:
2nd Value:
Value Percent:
Continuous Index:
Within 8" of Joint: **YES**
Remarks:

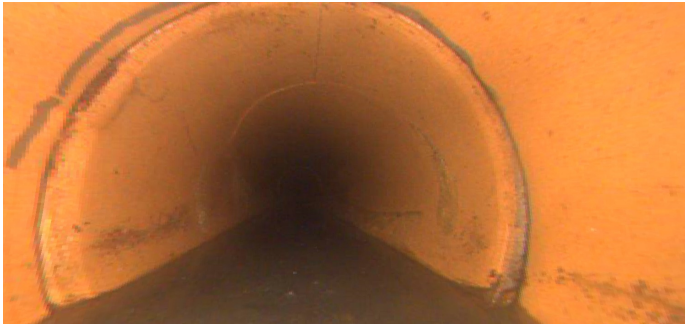
Code: **FM**
Description: **Fracture Multiple**

Distance (ft): **176.1**
Structural Grade: **4**
O&M Grade: **0**
Clock Start/From: **8**
Clock To: **4**
1st Value:
2nd Value:
Value Percent:
Continuous Index:
Within 8" of Joint: **YES**
Remarks:

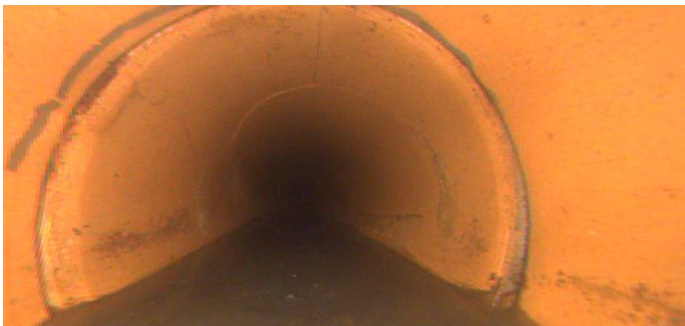
Code: **IS**
Description: **Infil Stain**

Distance (ft): **176.1**
Structural Grade: **0**
O&M Grade: **0**
Clock Start/From: **8**
Clock To: **4**
1st Value:
2nd Value:
Value Percent:
Continuous Index:
Within 8" of Joint:
Remarks:

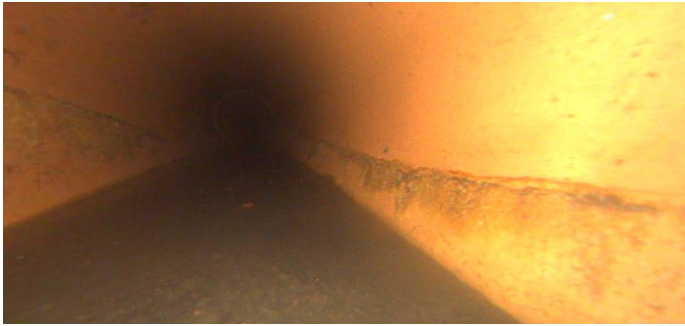
Code: **FL**
Description: **Fracture Longitudinal**

Distance (ft): **177.1**
Structural Grade: **3**
O&M Grade: **0**
Clock Start/From: **3**
Clock To:
1st Value:
2nd Value:
Value Percent:
Continuous Index:
Within 8" of Joint:
Remarks:

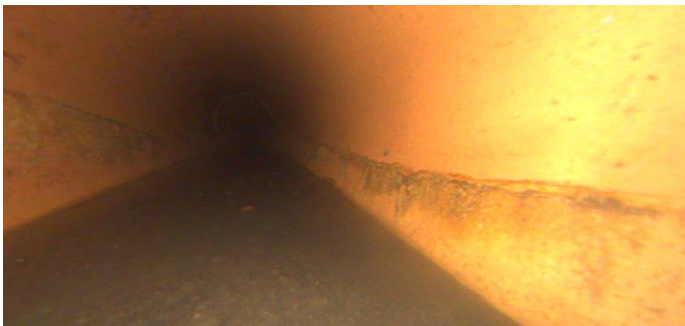
Code: **FL**
Description: **Fracture Longitudinal**

Distance (ft): **177.1**
Structural Grade: **3**
O&M Grade: **0**
Clock Start/From: **9**
Clock To:
1st Value:
2nd Value:
Value Percent:
Continuous Index:
Within 8" of Joint:
Remarks:

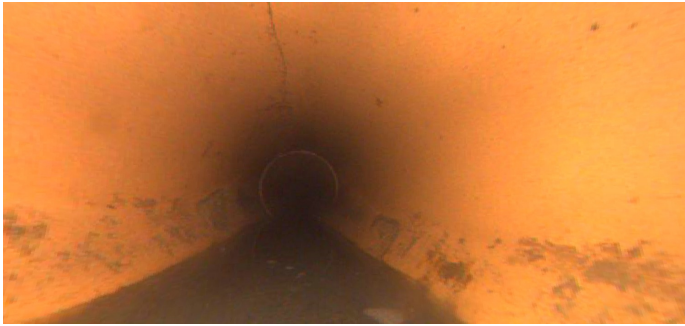
Code: **FL**
Description: **Fracture Longitudinal**

Distance (ft): **178.5**
Structural Grade: **3**
O&M Grade: **0**
Clock Start/From: **12**
Clock To:
1st Value:
2nd Value:
Value Percent:
Continuous Index:
Within 8" of Joint:
Remarks:

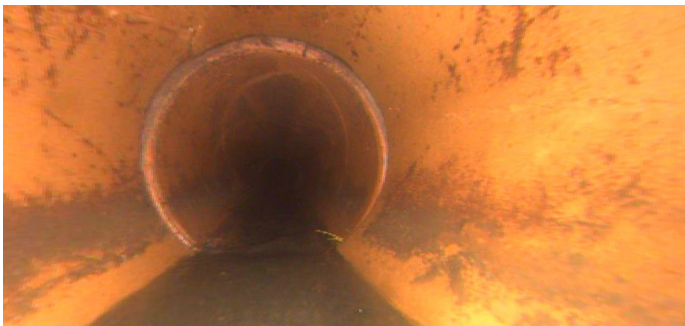
Code: **RFJ**
Description: **Roots Fine Joint**

Distance (ft): **180.5**
Structural Grade: **0**
O&M Grade: **1**
Clock Start/From: **11**
Clock To: **5**
1st Value:
2nd Value:
Value Percent:
Continuous Index:
Within 8" of Joint: **YES**
Remarks:

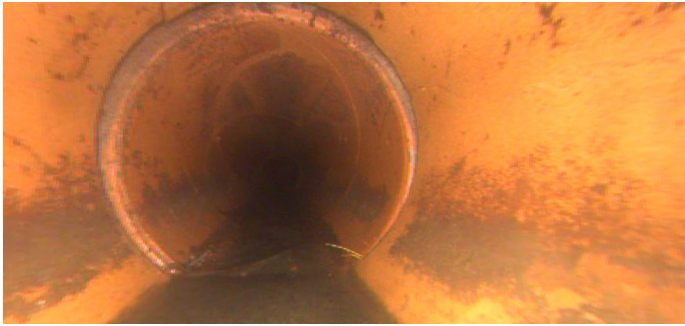
Code: **FM**
Description: **Fracture Multiple**

Distance (ft): **180.8**
Structural Grade: **4**
O&M Grade: **0**
Clock Start/From: **7**
Clock To: **5**
1st Value:
2nd Value:
Value Percent:
Continuous Index:
Within 8" of Joint:
Remarks:

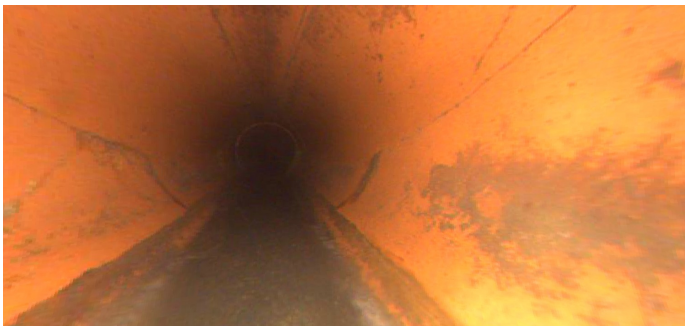
Code: **FM**
Description: **Fracture Multiple**

Distance (ft): **182.4**
Structural Grade: **4**
O&M Grade: **0**
Clock Start/From: **7**
Clock To: **5**
1st Value:
2nd Value:
Value Percent:
Continuous Index:
Within 8" of Joint:
Remarks:

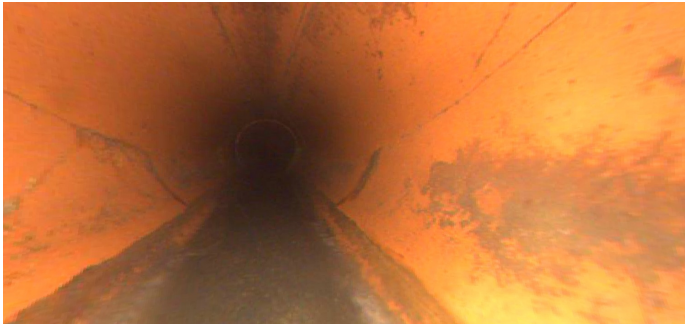
Code: **RFJ**
Description: **Roots Fine Joint**

Distance (ft): **182.4**
Structural Grade: **0**
O&M Grade: **1**
Clock Start/From: **3**
Clock To: **5**
1st Value:
2nd Value:
Value Percent:
Continuous Index:
Within 8" of Joint: **YES**
Remarks:

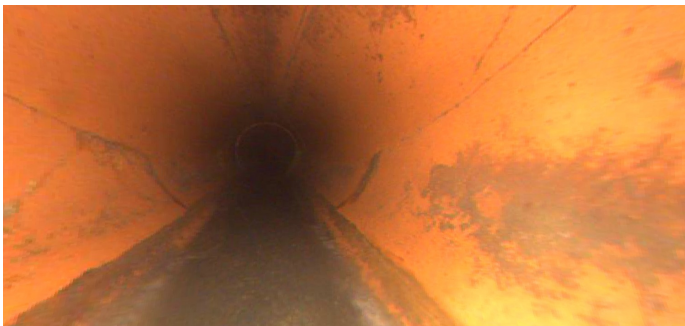
Code: **RFJ**
Description: **Roots Fine Joint**

Distance (ft): **182.4**
Structural Grade: **0**
O&M Grade: **1**
Clock Start/From: **7**
Clock To: **10**
1st Value:
2nd Value:
Value Percent:
Continuous Index:
Within 8" of Joint: **YES**
Remarks:

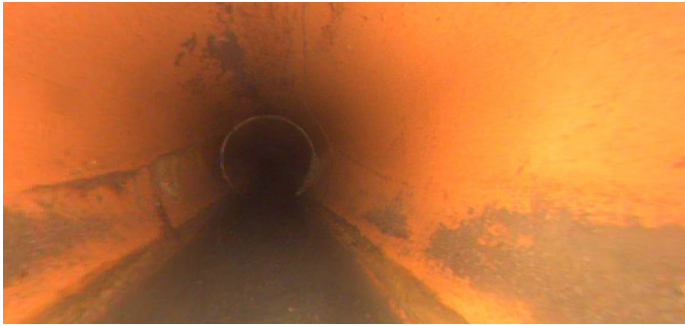
Code: **FL**
Description: **Fracture Longitudinal**

Distance (ft): **183.8**
Structural Grade: **3**
O&M Grade: **0**
Clock Start/From: **9**
Clock To:
1st Value:
2nd Value:
Value Percent:
Continuous Index:
Within 8" of Joint: **YES**
Remarks:

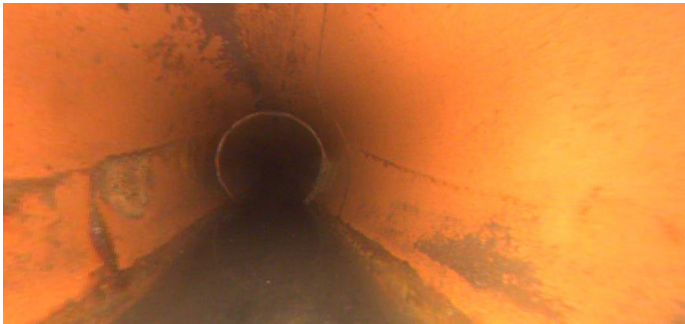
Code: **FC**
Description: **Fracture Circumferential**

Distance (ft): **184.1**
Structural Grade: **2**
O&M Grade: **0**
Clock Start/From: **1**
Clock To: **5**
1st Value:
2nd Value:
Value Percent:
Continuous Index:
Within 8" of Joint:
Remarks:

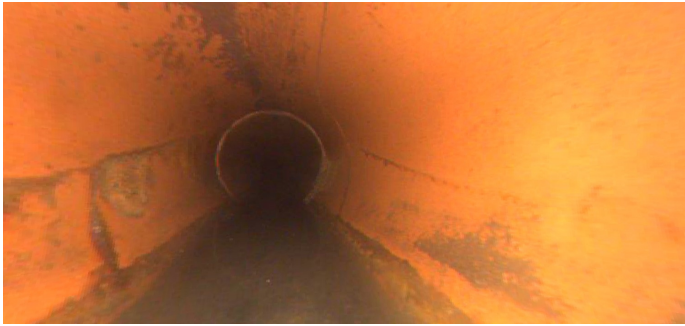
Code: **FL**
Description: **Fracture Longitudinal**

Distance (ft): **184.1**
Structural Grade: **3**
O&M Grade: **0**
Clock Start/From: **1**
Clock To:
1st Value:
2nd Value:
Value Percent:
Continuous Index:
Within 8" of Joint:
Remarks:

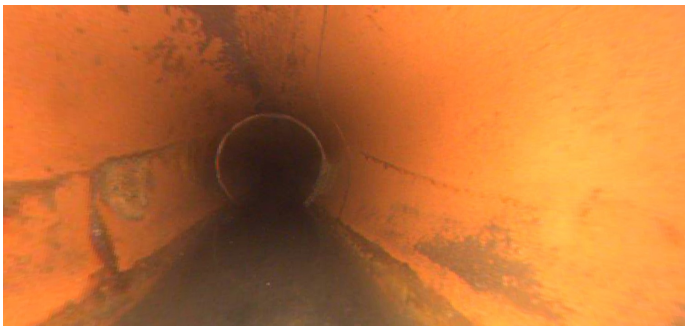
Code: **FL**
Description: **Fracture Longitudinal**

Distance (ft): **184.1**
Structural Grade: **3**
O&M Grade: **0**
Clock Start/From: **3**
Clock To:
1st Value:
2nd Value:
Value Percent:
Continuous Index:
Within 8" of Joint:
Remarks:

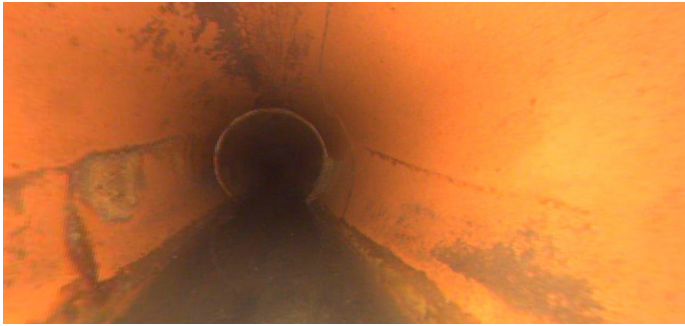
Code: **IS**
Description: **Infil Stain**

Distance (ft): **184.2**
Structural Grade: **0**
O&M Grade: **0**
Clock Start/From: **7**
Clock To: **9**
1st Value:
2nd Value:
Value Percent:
Continuous Index:
Within 8" of Joint: **YES**
Remarks:

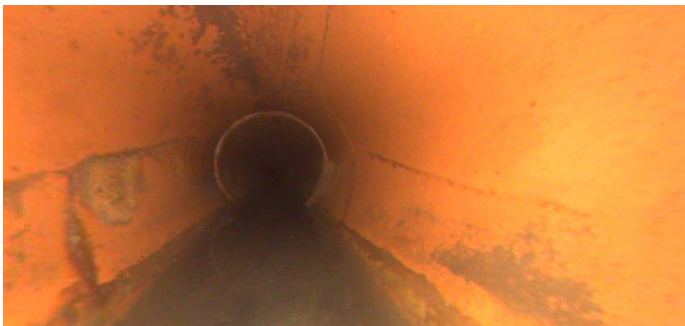
Code: **IS**
Description: **Infil Stain**

Distance (ft): **184.2**
Structural Grade: **0**
O&M Grade: **0**
Clock Start/From: **3**
Clock To: **5**
1st Value:
2nd Value:
Value Percent:
Continuous Index:
Within 8" of Joint: **YES**
Remarks:

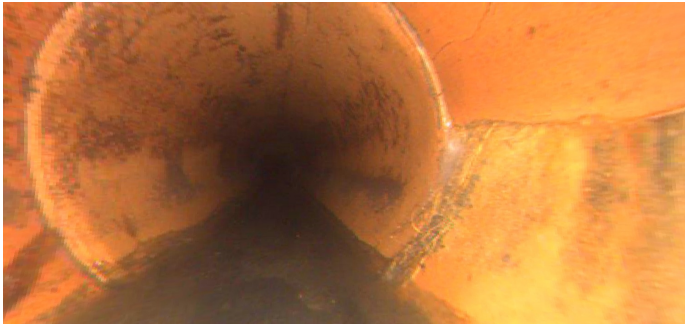
Code: **RFJ**
Description: **Roots Fine Joint**

Distance (ft): **185.8**
Structural Grade: **0**
O&M Grade: **1**
Clock Start/From: **3**
Clock To: **5**
1st Value:
2nd Value:
Value Percent:
Continuous Index:
Within 8" of Joint: **YES**
Remarks:

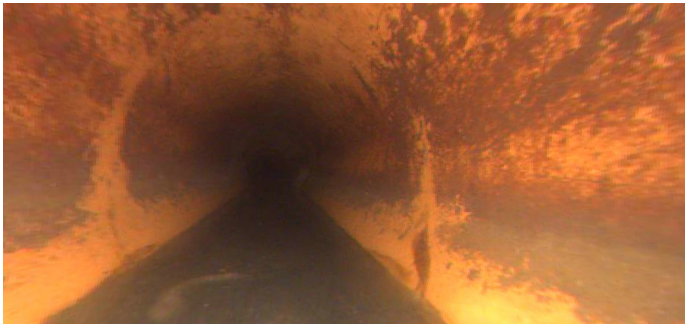
Code: **FC**
Description: **Fracture Circumferential**

Distance (ft): **187.6**
Structural Grade: **2**
O&M Grade: **0**
Clock Start/From: **8**
Clock To: **4**
1st Value:
2nd Value:
Value Percent:
Continuous Index:
Within 8" of Joint:
Remarks:

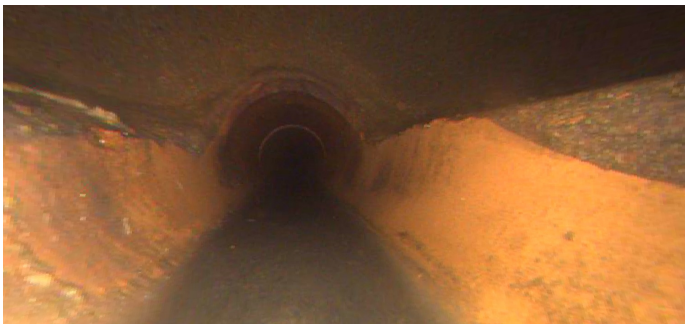
Code: **AMH**
Description: **Manhole**

Distance (ft): **192.7**
Structural Grade: **0**
O&M Grade: **0**
Clock Start/From:
Clock To:
1st Value:
2nd Value:
Value Percent:
Continuous Index:
Within 8" of Joint: **NO**
Remarks: **M-503-040**
