Profile/Photo Observation Report

Date:	09/30/2018	Weather:		Coding:	PACP 6.0
Pipe Length (ft):	197.0	Owner:	NA	Pre Clean:	Not Known
P.O.#:		Surveyor:	Selasie Honu	PSR:	P-503-040-041
Customer:		Clean Date:	01/01/1900	Shape:	C

Street:	Cavender St.	Flow Control:	Not Controlled
City:	Hobart, IN	Year Renewed:	
Location:	Light Highway	Tape/Media #:	
Purpose:	Routine Assessment	Dia/Height:	10"
Use:	Sanitary	Material:	VCP
Drain Area:	NA	Lining:	
Category:	NA		
Comment:			
Location Details:		Direction of Survey:	Downstream
US MH:	M-503-041	DS MH:	M-503-040
		Total Length Surveyed (ft):	192.7

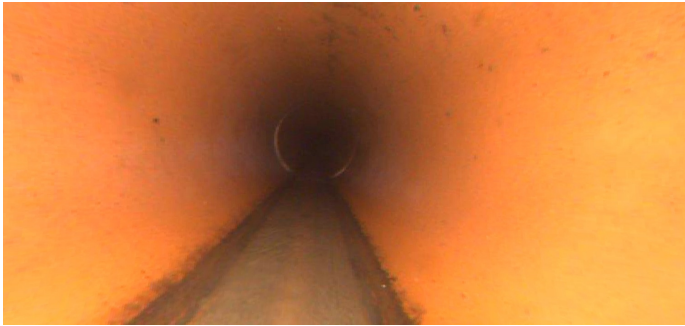
Code: **AMH**
Description: **Manhole**

Distance (ft): **.0**
Structural Grade: **0**
O&M Grade: **0**
Clock Start/From:
Clock To:
1st Value:
2nd Value:
Value Percent:
Continuous Index:
Within 8" of Joint: **NO**
Remarks: **M-503-041**

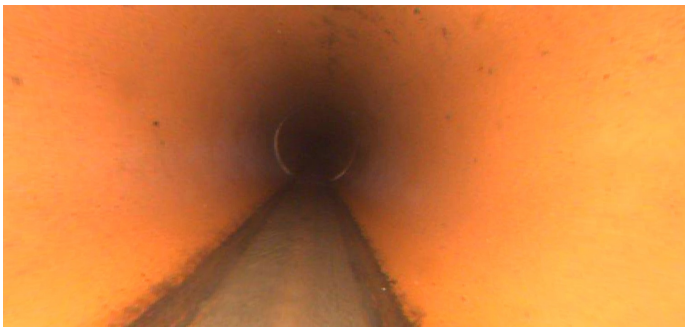
Code: **MWL**
Description: **Water Level**

Distance (ft): **.0**
Structural Grade: **0**
O&M Grade: **0**
Clock Start/From:
Clock To:
1st Value:
2nd Value:
Value Percent: **5.000**
Continuous Index:
Within 8" of Joint: **NO**
Remarks:

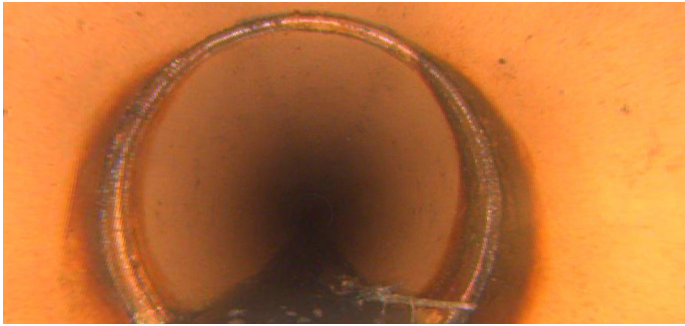
Code: **IS**
Description: **Infil Stain**

Distance (ft): **23.0**
Structural Grade: **0**
O&M Grade: **0**
Clock Start/From: **8**
Clock To: **4**
1st Value:
2nd Value:
Value Percent:
Continuous Index:
Within 8" of Joint: **YES**
Remarks:

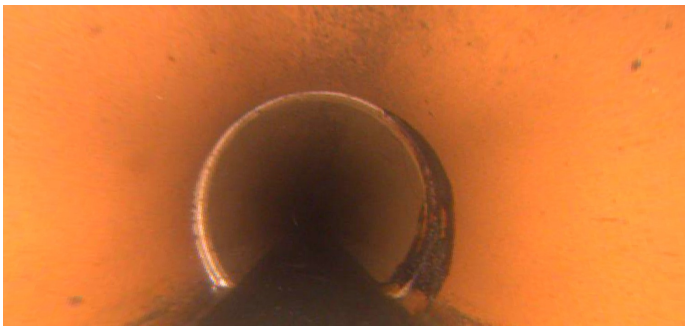
Code: **IS**
Description: **Infil Stain**

Distance (ft): **37.4**
Structural Grade: **0**
O&M Grade: **0**
Clock Start/From: **1**
Clock To: **4**
1st Value:
2nd Value:
Value Percent:
Continuous Index:
Within 8" of Joint: **YES**
Remarks:

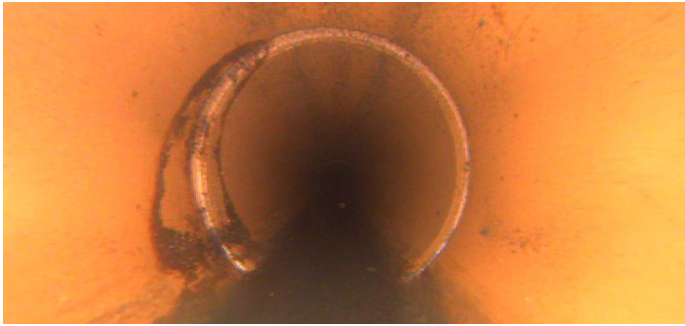
Code: **IS**
Description: **Infil Stain**

Distance (ft): **47.4**
Structural Grade: **0**
O&M Grade: **0**
Clock Start/From: **7**
Clock To: **11**
1st Value:
2nd Value:
Value Percent:
Continuous Index:
Within 8" of Joint: **YES**
Remarks:

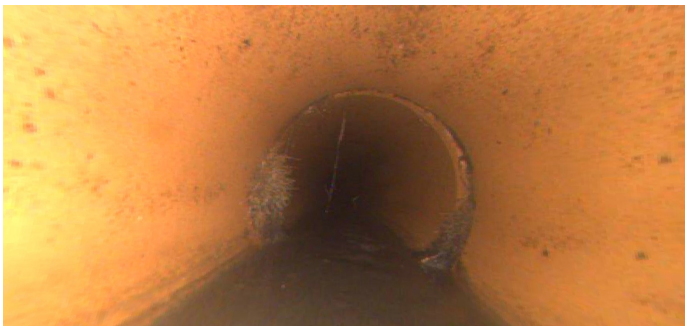
Code: **RFJ**
Description: **Roots Fine Joint**

Distance (ft): **57.1**
Structural Grade: **0**
O&M Grade: **1**
Clock Start/From: **8**
Clock To: **4**
1st Value:
2nd Value:
Value Percent:
Continuous Index:
Within 8" of Joint: **YES**
Remarks:

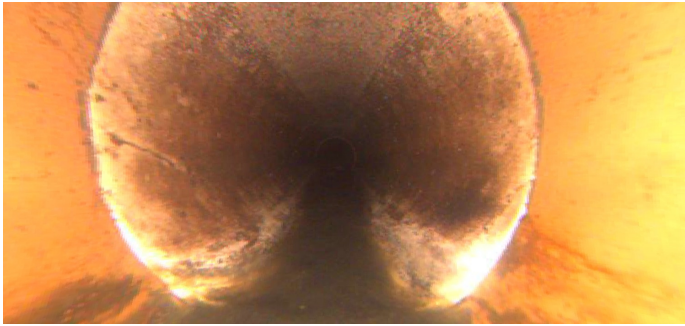
Code: **FL**
Description: **Fracture Longitudinal**

Distance (ft): **62.5**
Structural Grade: **3**
O&M Grade: **0**
Clock Start/From: **9**
Clock To:
1st Value:
2nd Value:
Value Percent:
Continuous Index:
Within 8" of Joint: **YES**
Remarks:

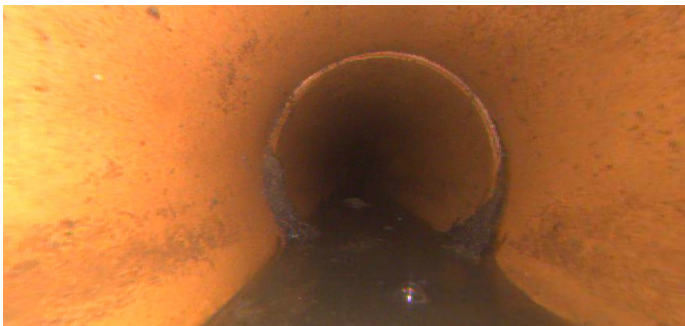
Code: **RFJ**
Description: **Roots Fine Joint**

Distance (ft): **72.0**
Structural Grade: **0**
O&M Grade: **1**
Clock Start/From: **8**
Clock To: **4**
1st Value:
2nd Value:
Value Percent:
Continuous Index:
Within 8" of Joint: **YES**
Remarks:

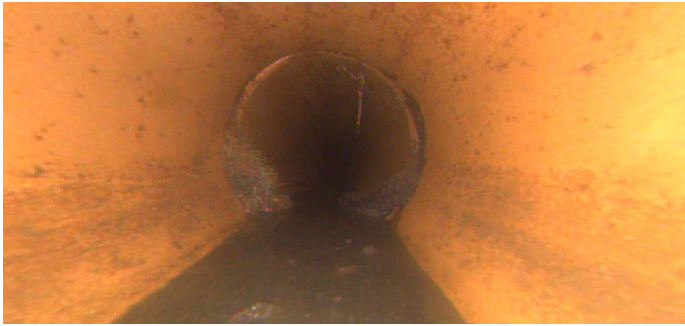
Code: **RFJ**
Description: **Roots Fine Joint**

Distance (ft): **76.8**
Structural Grade: **0**
O&M Grade: **1**
Clock Start/From: **8**
Clock To: **4**
1st Value:
2nd Value:
Value Percent:
Continuous Index:
Within 8" of Joint: **YES**
Remarks:

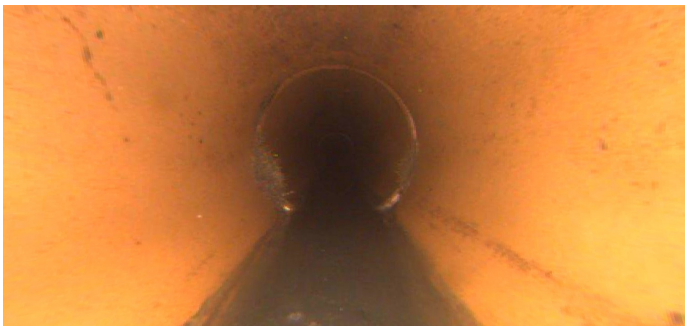
Code: **RFJ**
Description: **Roots Fine Joint**

Distance (ft): **81.5**
Structural Grade: **0**
O&M Grade: **1**
Clock Start/From: **8**
Clock To: **4**
1st Value:
2nd Value:
Value Percent:
Continuous Index:
Within 8" of Joint: **YES**
Remarks:

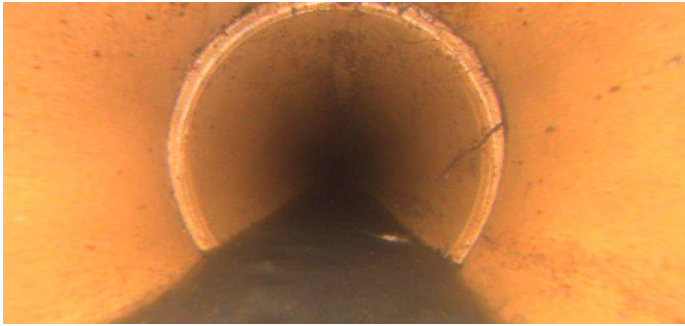
Code: **RFJ**
Description: **Roots Fine Joint**

Distance (ft): **87.1**
Structural Grade: **0**
O&M Grade: **1**
Clock Start/From: **8**
Clock To: **4**
1st Value:
2nd Value:
Value Percent:
Continuous Index:
Within 8" of Joint: **YES**
Remarks:

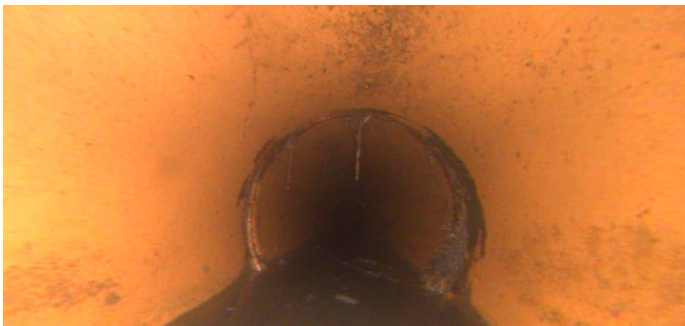
Code: **RFJ**
Description: **Roots Fine Joint**

Distance (ft): **91.7**
Structural Grade: **0**
O&M Grade: **1**
Clock Start/From: **8**
Clock To: **4**
1st Value:
2nd Value:
Value Percent:
Continuous Index:
Within 8" of Joint: **YES**
Remarks:

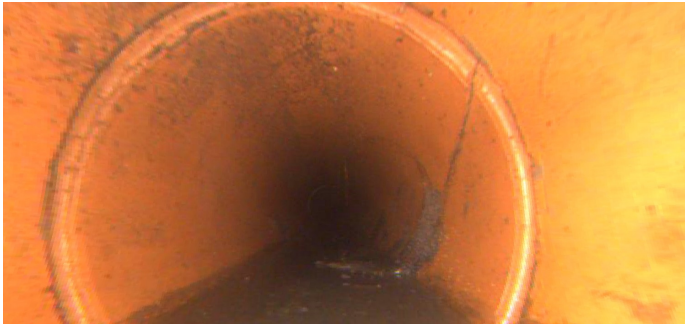
Code: **RFJ**
Description: **Roots Fine Joint**

Distance (ft): **97.1**
Structural Grade: **0**
O&M Grade: **1**
Clock Start/From: **2**
Clock To:
1st Value:
2nd Value:
Value Percent:
Continuous Index:
Within 8" of Joint: **YES**
Remarks:

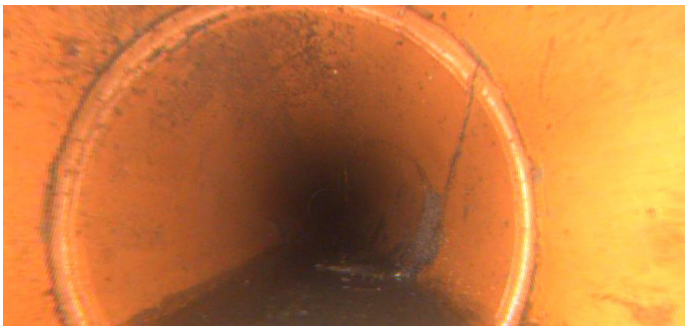
Code: **RFB**
Description: **Roots Fine Barrel**

Distance (ft): **97.1**
Structural Grade: **0**
O&M Grade: **2**
Clock Start/From: **2**
Clock To: **5**
1st Value:
2nd Value:
Value Percent:
Continuous Index:
Within 8" of Joint: **NO**
Remarks:

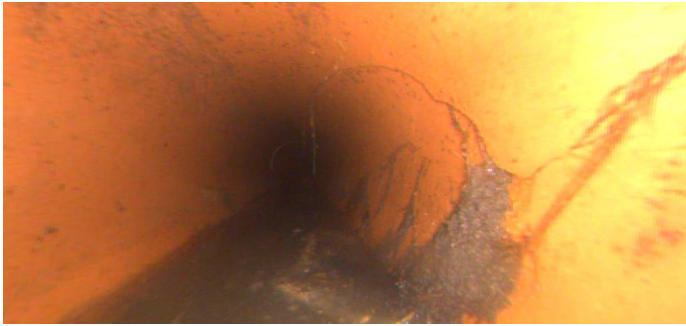
Code: **FC**
Description: **Fracture Circumferential**

Distance (ft): **97.7**
Structural Grade: **2**
O&M Grade: **0**
Clock Start/From: **12**
Clock To: **5**
1st Value:
2nd Value:
Value Percent:
Continuous Index:
Within 8" of Joint: **YES**
Remarks:

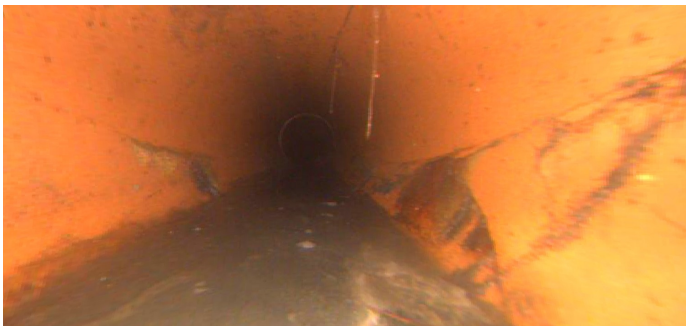
Code: **FL**
Description: **Fracture Longitudinal**

Distance (ft): **98.5**
Structural Grade: **3**
O&M Grade: **0**
Clock Start/From: **9**
Clock To:
1st Value:
2nd Value:
Value Percent:
Continuous Index:
Within 8" of Joint:
Remarks:

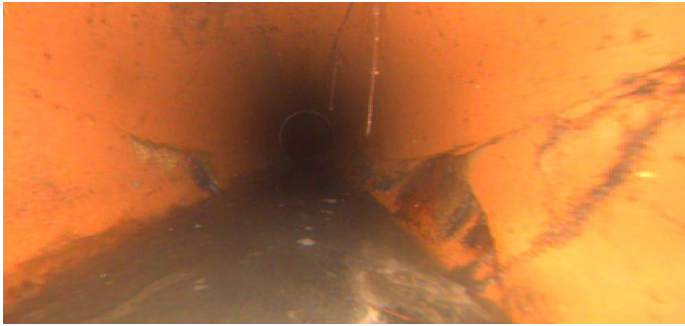
Code: **RFB**
Description: **Roots Fine Barrel**

Distance (ft): **98.5**
Structural Grade: **0**
O&M Grade: **2**
Clock Start/From: **8**
Clock To: **9**
1st Value:
2nd Value:
Value Percent:
Continuous Index:
Within 8" of Joint: **NO**
Remarks:

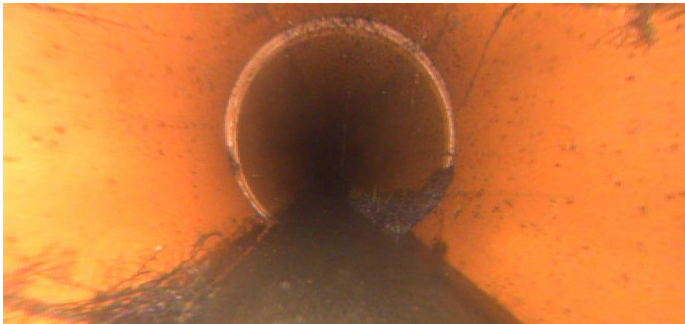
Code: **RFJ**
Description: **Roots Fine Joint**

Distance (ft): **101.6**
Structural Grade: **0**
O&M Grade: **1**
Clock Start/From: **7**
Clock To: **5**
1st Value:
2nd Value:
Value Percent:
Continuous Index:
Within 8" of Joint: **YES**
Remarks:

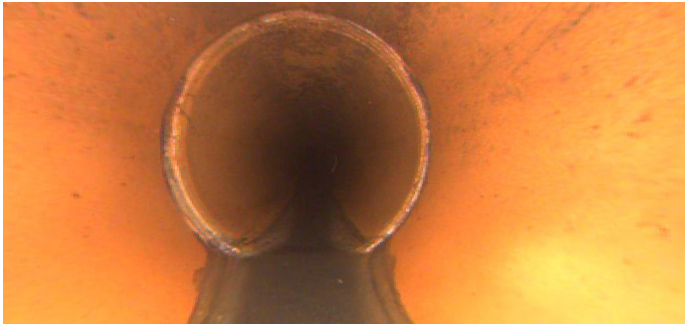
Code: **RFJ**
Description: **Roots Fine Joint**

Distance (ft): **106.6**
Structural Grade: **0**
O&M Grade: **1**
Clock Start/From: **7**
Clock To: **5**
1st Value:
2nd Value:
Value Percent:
Continuous Index:
Within 8" of Joint: **YES**
Remarks:

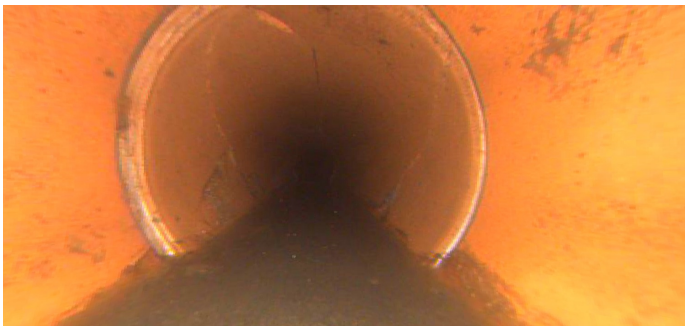
Code: **FM**
Description: **Fracture Multiple**

Distance (ft): **121.7**
Structural Grade: **4**
O&M Grade: **0**
Clock Start/From: **7**
Clock To: **5**
1st Value:
2nd Value:
Value Percent:
Continuous Index:
Within 8" of Joint: **YES**
Remarks:

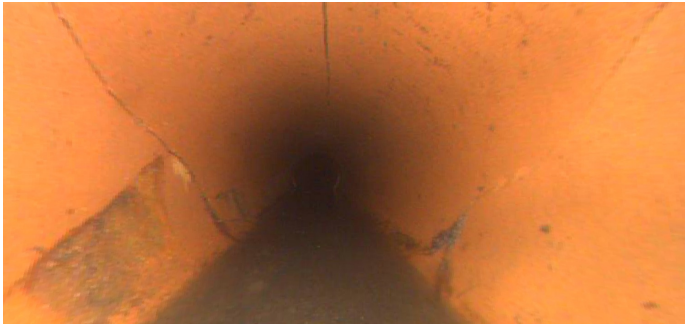
Code: **RFJ**
Description: **Roots Fine Joint**

Distance (ft): **122.2**
Structural Grade: **0**
O&M Grade: **1**
Clock Start/From: **7**
Clock To: **5**
1st Value:
2nd Value:
Value Percent:
Continuous Index:
Within 8" of Joint: **YES**
Remarks:

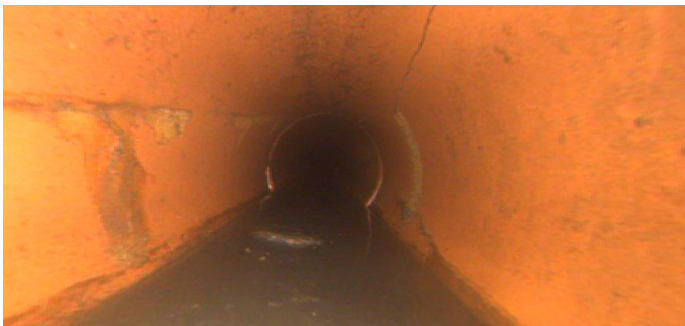
Code: **IS**
Description: **Infil Stain**

Distance (ft): **125.2**
Structural Grade: **0**
O&M Grade: **0**
Clock Start/From: **8**
Clock To: **4**
1st Value:
2nd Value:
Value Percent:
Continuous Index:
Within 8" of Joint:
Remarks:

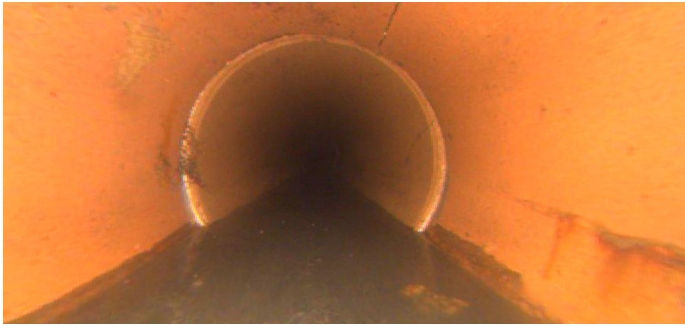
Code: **RFJ**
Description: **Roots Fine Joint**

Distance (ft): **126.4**
Structural Grade: **0**
O&M Grade: **1**
Clock Start/From: **9**
Clock To:
1st Value:
2nd Value:
Value Percent:
Continuous Index:
Within 8" of Joint: **YES**
Remarks:

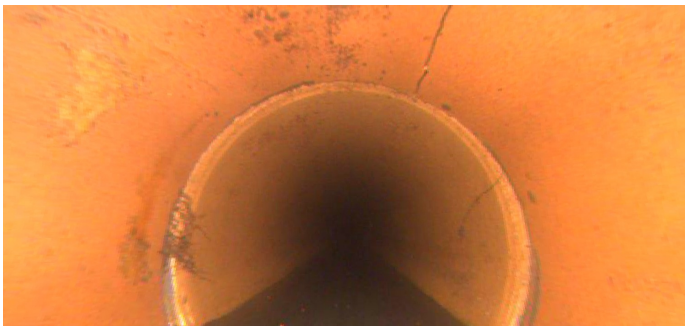
Code: **FL**
Description: **Fracture Longitudinal**

Distance (ft): **126.6**
Structural Grade: **3**
O&M Grade: **0**
Clock Start/From: **1**
Clock To:
1st Value:
2nd Value:
Value Percent:
Continuous Index:
Within 8" of Joint: **YES**
Remarks:

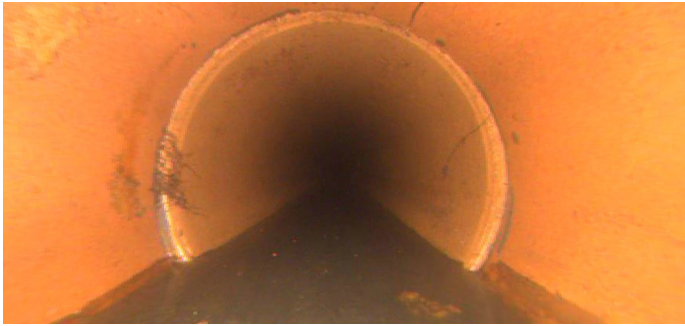
Code: **FC**
Description: **Fracture Circumferential**

Distance (ft): **126.6**
Structural Grade: **2**
O&M Grade: **0**
Clock Start/From: **2**
Clock To: **3**
1st Value:
2nd Value:
Value Percent:
Continuous Index:
Within 8" of Joint: **YES**
Remarks:

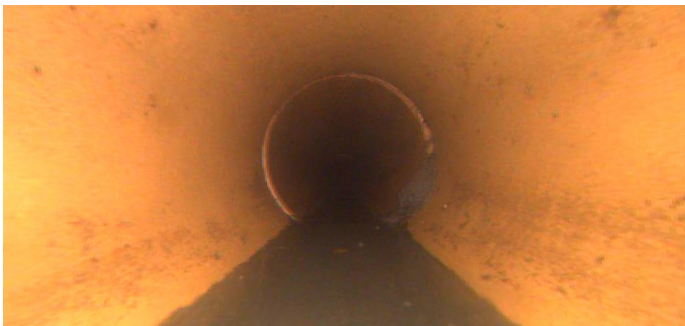
Code: **RFJ**
Description: **Roots Fine Joint**

Distance (ft): **130.8**
Structural Grade: **0**
O&M Grade: **1**
Clock Start/From: **7**
Clock To: **5**
1st Value:
2nd Value:
Value Percent:
Continuous Index:
Within 8" of Joint: **YES**
Remarks:

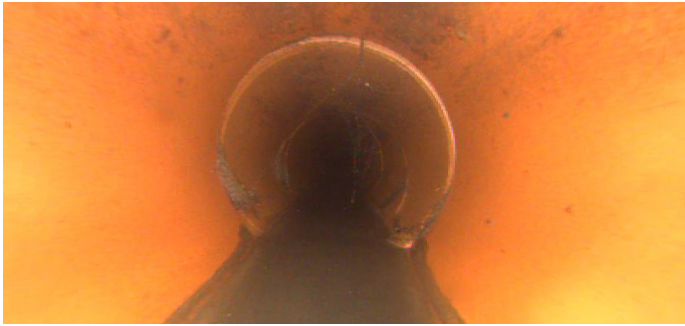
Code: **FM**
Description: **Fracture Multiple**

Distance (ft): **136.2**
Structural Grade: **4**
O&M Grade: **0**
Clock Start/From: **7**
Clock To: **5**
1st Value:
2nd Value:
Value Percent:
Continuous Index:
Within 8" of Joint: **YES**
Remarks:

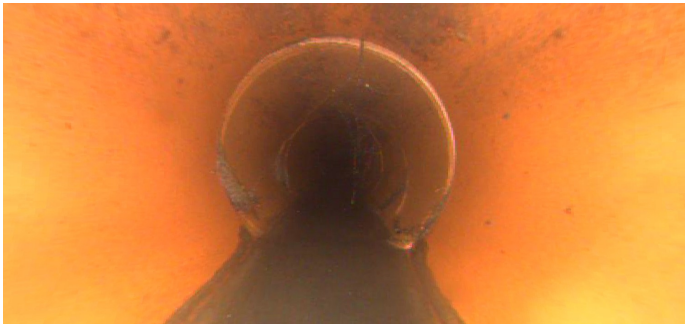
Code: **RFJ**
Description: **Roots Fine Joint**

Distance (ft): **136.2**
Structural Grade: **0**
O&M Grade: **1**
Clock Start/From: **7**
Clock To: **5**
1st Value:
2nd Value:
Value Percent:
Continuous Index:
Within 8" of Joint: **YES**
Remarks:

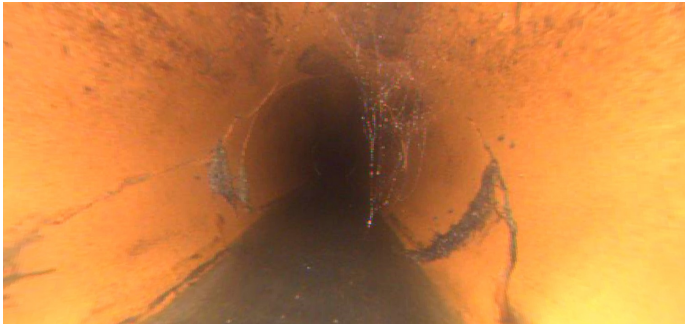
Code: **RFB**
Description: **Roots Fine Barrel**

Distance (ft): **137.0**
Structural Grade: **0**
O&M Grade: **2**
Clock Start/From: **7**
Clock To: **5**
1st Value:
2nd Value:
Value Percent:
Continuous Index:
Within 8" of Joint: **NO**
Remarks:

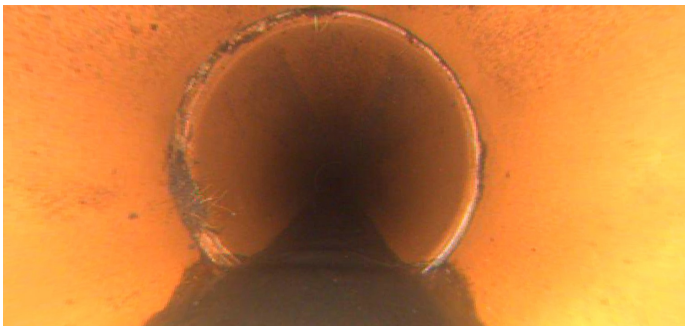
Code: **RFJ**
Description: **Roots Fine Joint**

Distance (ft): **141.3**
Structural Grade: **0**
O&M Grade: **1**
Clock Start/From: **7**
Clock To: **5**
1st Value:
2nd Value:
Value Percent:
Continuous Index:
Within 8" of Joint: **YES**
Remarks:

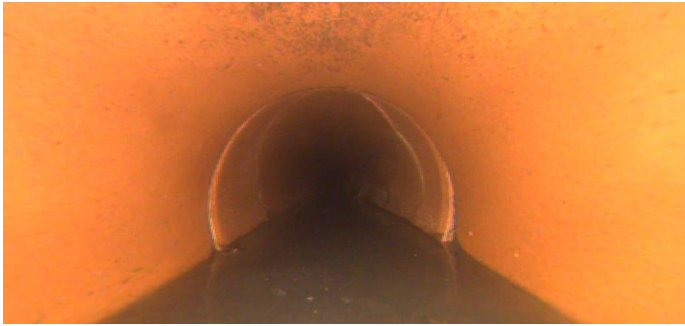
Code: **FM**
Description: **Fracture Multiple**

Distance (ft): **155.9**
Structural Grade: **4**
O&M Grade: **0**
Clock Start/From: **8**
Clock To: **4**
1st Value:
2nd Value:
Value Percent:
Continuous Index:
Within 8" of Joint: **YES**
Remarks:

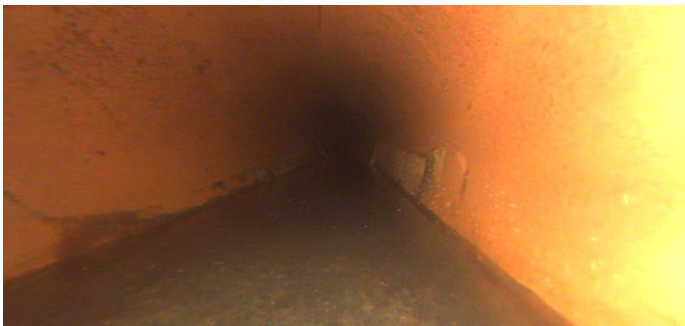
Code: **RFB**
Description: **Roots Fine Barrel**

Distance (ft): **157.1**
Structural Grade: **0**
O&M Grade: **2**
Clock Start/From: **8**
Clock To: **9**
1st Value:
2nd Value:
Value Percent:
Continuous Index:
Within 8" of Joint: **NO**
Remarks:

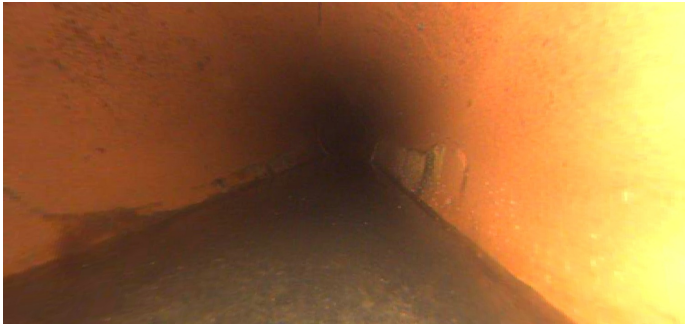
Code: **RFB**
Description: **Roots Fine Barrel**

Distance (ft): **157.1**
Structural Grade: **0**
O&M Grade: **2**
Clock Start/From: **3**
Clock To: **4**
1st Value:
2nd Value:
Value Percent:
Continuous Index:
Within 8" of Joint: **NO**
Remarks:

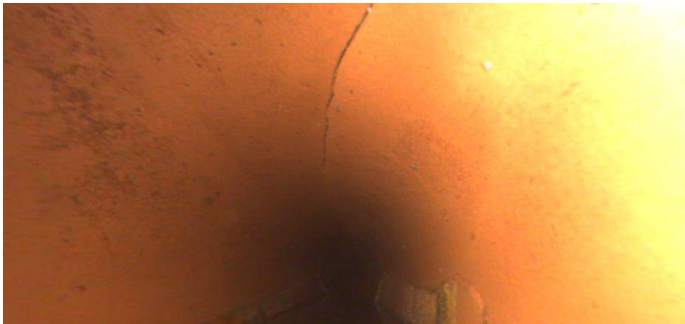
Code: **FL**
Description: **Fracture Longitudinal**

Distance (ft): **157.1**
Structural Grade: **3**
O&M Grade: **0**
Clock Start/From: **12**
Clock To:
1st Value:
2nd Value:
Value Percent:
Continuous Index:
Within 8" of Joint:
Remarks:

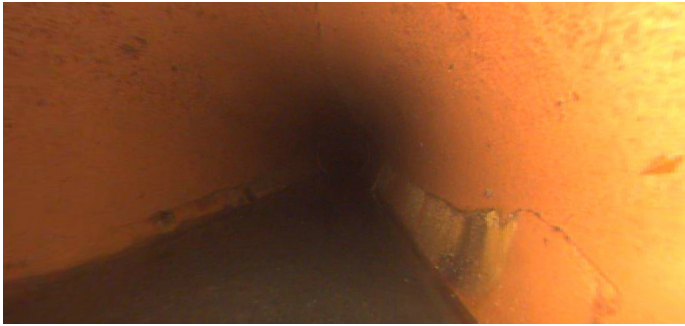
Code: **FL**
Description: **Fracture Longitudinal**

Distance (ft): **157.5**
Structural Grade: **3**
O&M Grade: **0**
Clock Start/From: **3**
Clock To:
1st Value:
2nd Value:
Value Percent:
Continuous Index:
Within 8" of Joint:
Remarks:

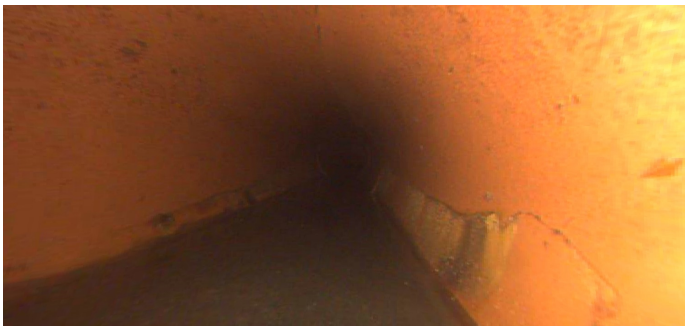
Code: **FL**
Description: **Fracture Longitudinal**

Distance (ft): **157.5**
Structural Grade: **3**
O&M Grade: **0**
Clock Start/From: **8**
Clock To:
1st Value:
2nd Value:
Value Percent:
Continuous Index:
Within 8" of Joint:
Remarks:

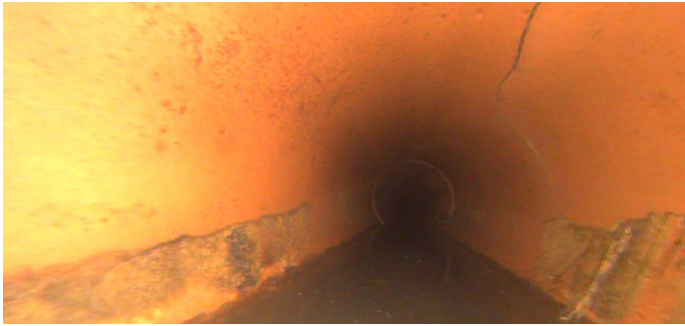
Code: **FM**
Description: **Fracture Multiple**

Distance (ft): **158.8**
Structural Grade: **4**
O&M Grade: **0**
Clock Start/From: **9**
Clock To: **3**
1st Value:
2nd Value:
Value Percent:
Continuous Index:
Within 8" of Joint:
Remarks:

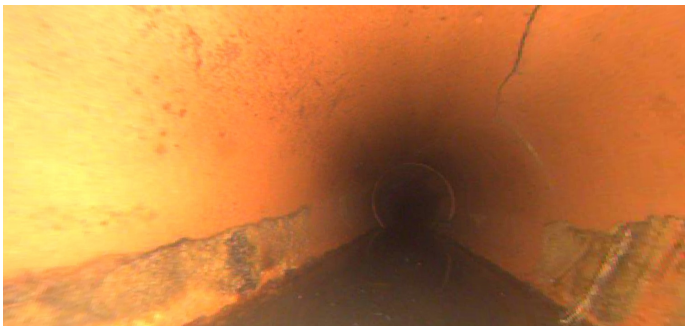
Code: **IS**
Description: **Infil Stain**

Distance (ft): **158.8**
Structural Grade: **0**
O&M Grade: **0**
Clock Start/From: **8**
Clock To: **9**
1st Value:
2nd Value:
Value Percent:
Continuous Index:
Within 8" of Joint:
Remarks:

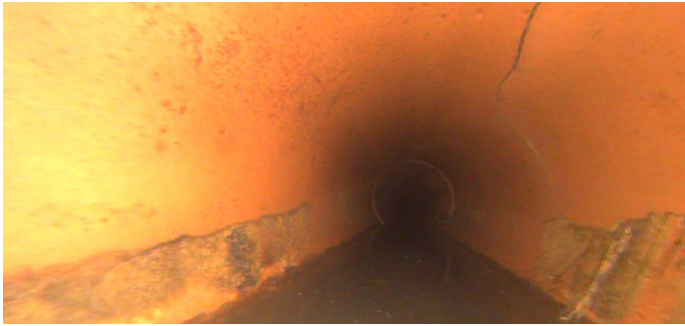
Code: **RFB**
Description: **Roots Fine Barrel**

Distance (ft): **158.8**
Structural Grade: **0**
O&M Grade: **2**
Clock Start/From: **8**
Clock To: **9**
1st Value:
2nd Value:
Value Percent:
Continuous Index:
Within 8" of Joint: **NO**
Remarks:

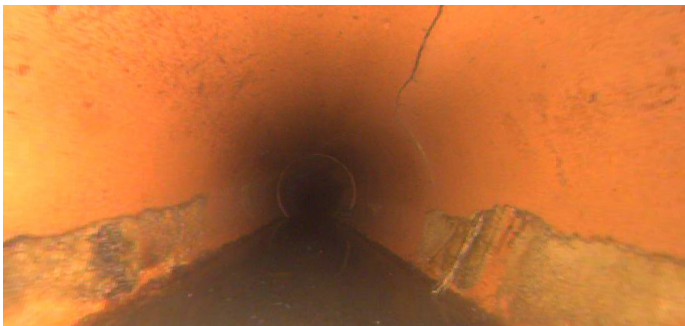
Code: **RFB**
Description: **Roots Fine Barrel**

Distance (ft): **158.8**
Structural Grade: **0**
O&M Grade: **2**
Clock Start/From: **3**
Clock To: **4**
1st Value:
2nd Value:
Value Percent:
Continuous Index:
Within 8" of Joint: **NO**
Remarks:

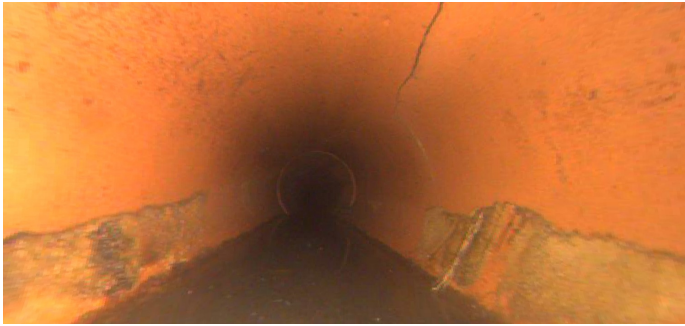
Code: **IS**
Description: **Infil Stain**

Distance (ft): **158.8**
Structural Grade: **0**
O&M Grade: **0**
Clock Start/From: **3**
Clock To: **4**
1st Value:
2nd Value:
Value Percent:
Continuous Index:
Within 8" of Joint:
Remarks:

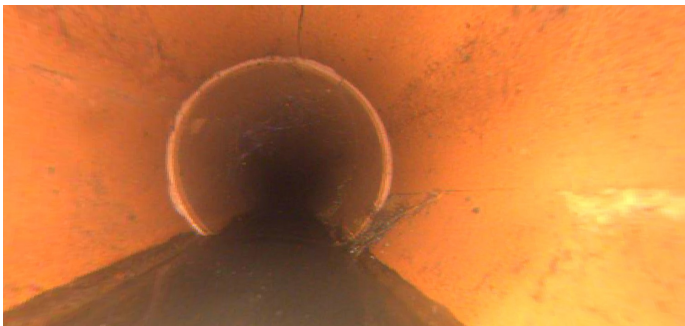
Code: **RFB**
Description: **Roots Fine Barrel**

Distance (ft): **160.7**
Structural Grade: **0**
O&M Grade: **2**
Clock Start/From: **3**
Clock To: **4**
1st Value:
2nd Value:
Value Percent:
Continuous Index:
Within 8" of Joint: **NO**
Remarks:

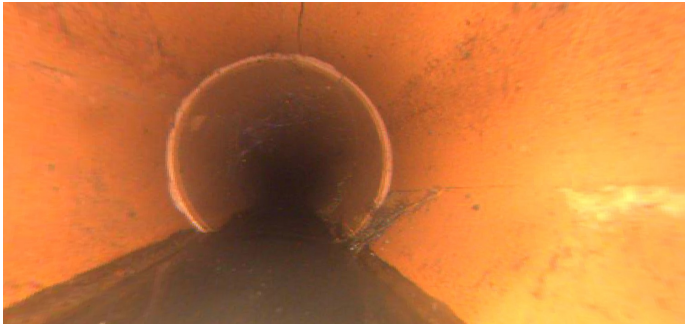
Code: **FL**
Description: **Fracture Longitudinal**

Distance (ft): **160.7**
Structural Grade: **3**
O&M Grade: **0**
Clock Start/From: **3**
Clock To:
1st Value:
2nd Value:
Value Percent:
Continuous Index:
Within 8" of Joint: **YES**
Remarks:

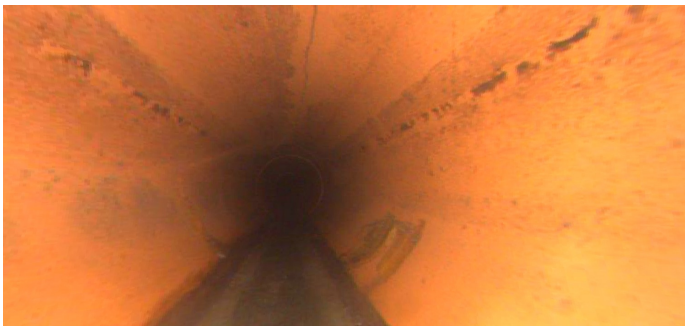
Code: **IS**
Description: **Infil Stain**

Distance (ft): **163.2**
Structural Grade: **0**
O&M Grade: **0**
Clock Start/From: **7**
Clock To: **5**
1st Value:
2nd Value:
Value Percent:
Continuous Index:
Within 8" of Joint:
Remarks:

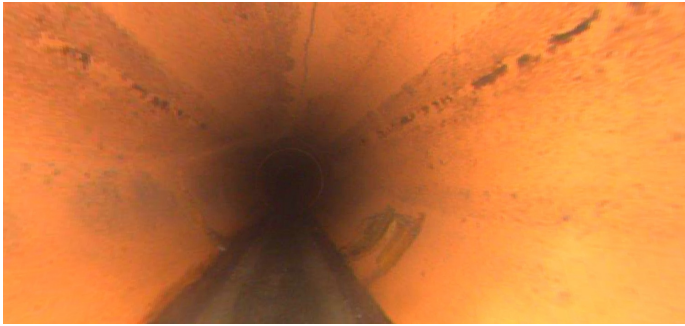
Code: **FL**
Description: **Fracture Longitudinal**

Distance (ft): **163.2**
Structural Grade: **3**
O&M Grade: **0**
Clock Start/From: **3**
Clock To:
1st Value:
2nd Value:
Value Percent:
Continuous Index:
Within 8" of Joint:
Remarks:

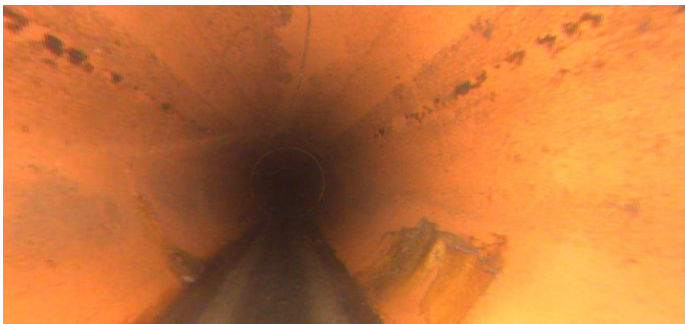
Code: **IS**
Description: **Infil Stain**

Distance (ft): **163.6**
Structural Grade: **0**
O&M Grade: **0**
Clock Start/From: **8**
Clock To: **10**
1st Value:
2nd Value:
Value Percent:
Continuous Index:
Within 8" of Joint:
Remarks:

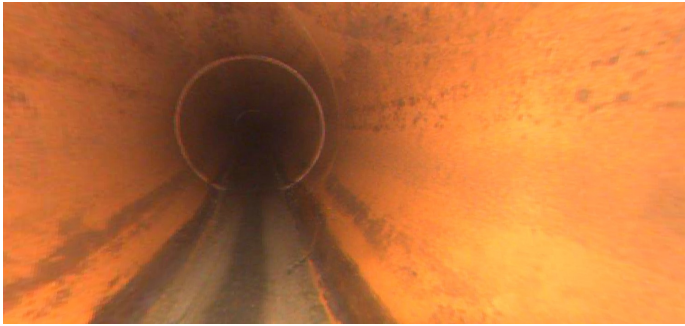
Code: **FC**
Description: **Fracture Circumferential**

Distance (ft): **165.0**
Structural Grade: **2**
O&M Grade: **0**
Clock Start/From: **12**
Clock To: **6**
1st Value:
2nd Value:
Value Percent:
Continuous Index:
Within 8" of Joint: **YES**
Remarks:

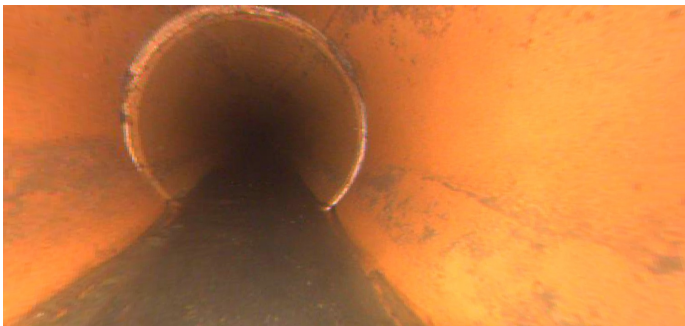
Code: **RFJ**
Description: **Roots Fine Joint**

Distance (ft): **170.6**
Structural Grade: **0**
O&M Grade: **1**
Clock Start/From: **8**
Clock To: **4**
1st Value:
2nd Value:
Value Percent:
Continuous Index:
Within 8" of Joint: **YES**
Remarks:

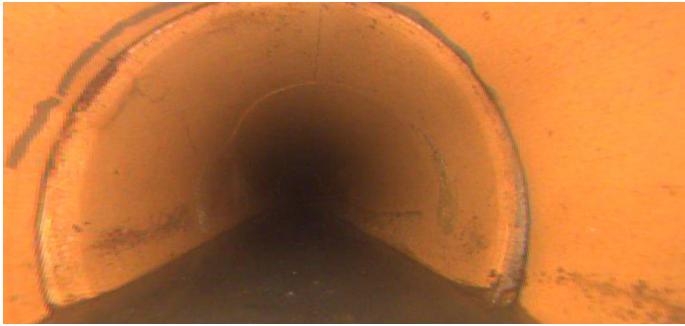
Code: **FM**
Description: **Fracture Multiple**

Distance (ft): **176.1**
Structural Grade: **4**
O&M Grade: **0**
Clock Start/From: **8**
Clock To: **4**
1st Value:
2nd Value:
Value Percent:
Continuous Index:
Within 8" of Joint: **YES**
Remarks:

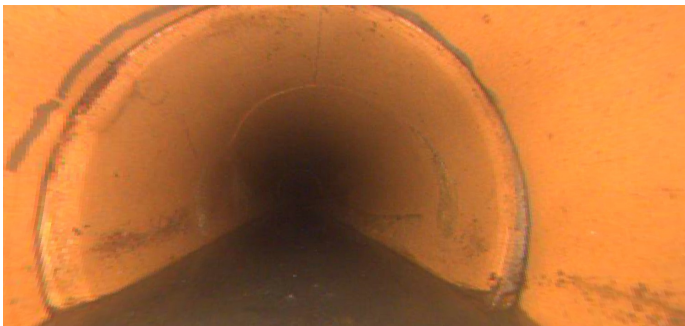
Code: **IS**
Description: **Infil Stain**

Distance (ft): **176.1**
Structural Grade: **0**
O&M Grade: **0**
Clock Start/From: **8**
Clock To: **4**
1st Value:
2nd Value:
Value Percent:
Continuous Index:
Within 8" of Joint:
Remarks:

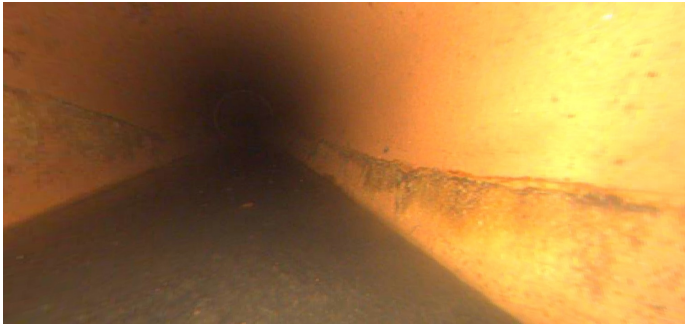
Code: **FL**
Description: **Fracture Longitudinal**

Distance (ft): **177.1**
Structural Grade: **3**
O&M Grade: **0**
Clock Start/From: **3**
Clock To:
1st Value:
2nd Value:
Value Percent:
Continuous Index:
Within 8" of Joint:
Remarks:

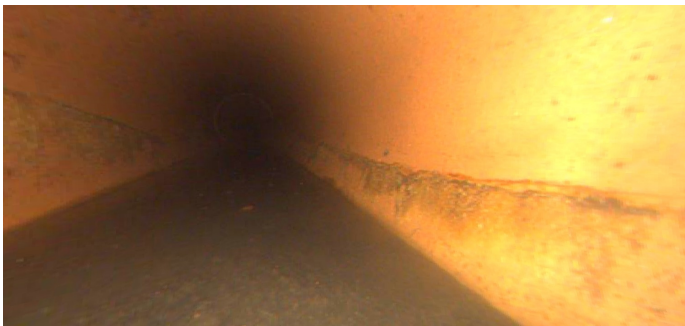
Code: **FL**
Description: **Fracture Longitudinal**

Distance (ft): **177.1**
Structural Grade: **3**
O&M Grade: **0**
Clock Start/From: **9**
Clock To:
1st Value:
2nd Value:
Value Percent:
Continuous Index:
Within 8" of Joint:
Remarks:

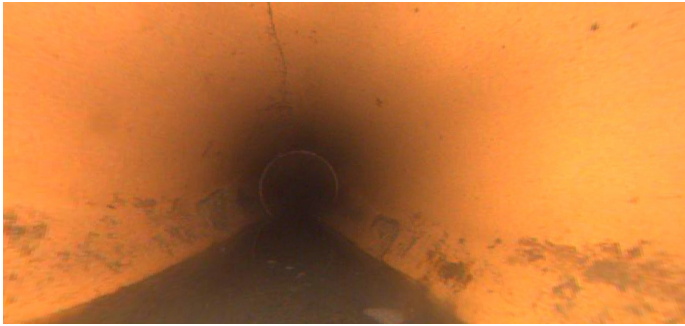
Code: **FL**
Description: **Fracture Longitudinal**

Distance (ft): **178.5**
Structural Grade: **3**
O&M Grade: **0**
Clock Start/From: **12**
Clock To:
1st Value:
2nd Value:
Value Percent:
Continuous Index:
Within 8" of Joint:
Remarks:

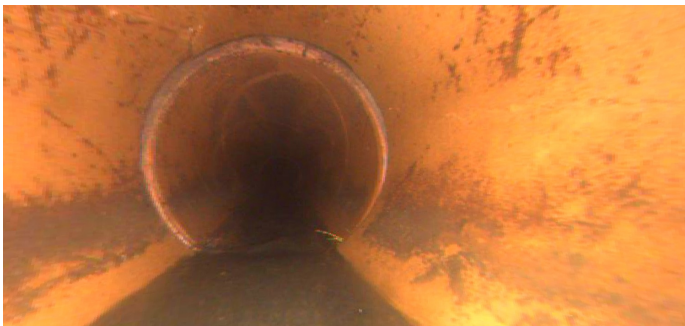
Code: **RFJ**
Description: **Roots Fine Joint**

Distance (ft): **180.5**
Structural Grade: **0**
O&M Grade: **1**
Clock Start/From: **11**
Clock To: **5**
1st Value:
2nd Value:
Value Percent:
Continuous Index:
Within 8" of Joint: **YES**
Remarks:

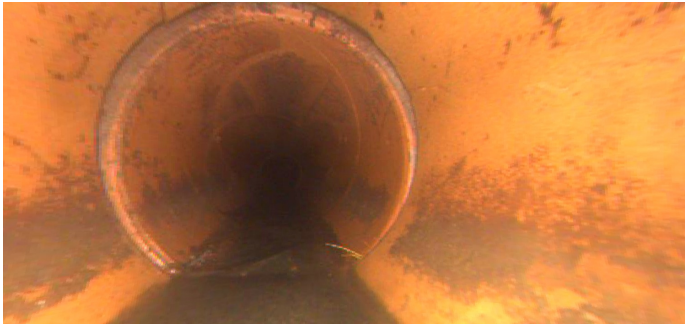
Code: **FM**
Description: **Fracture Multiple**

Distance (ft): **180.8**
Structural Grade: **4**
O&M Grade: **0**
Clock Start/From: **7**
Clock To: **5**
1st Value:
2nd Value:
Value Percent:
Continuous Index:
Within 8" of Joint:
Remarks:

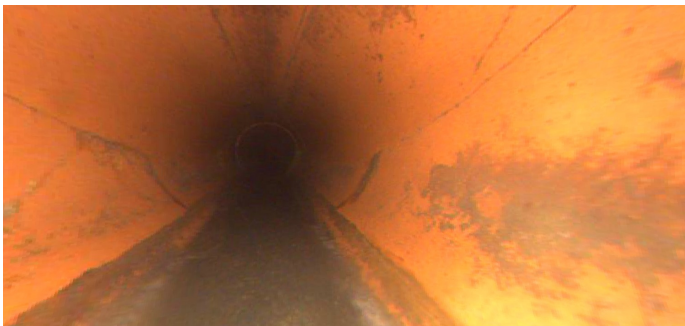
Code: **FM**
Description: **Fracture Multiple**

Distance (ft): **182.4**
Structural Grade: **4**
O&M Grade: **0**
Clock Start/From: **7**
Clock To: **5**
1st Value:
2nd Value:
Value Percent:
Continuous Index:
Within 8" of Joint:
Remarks:

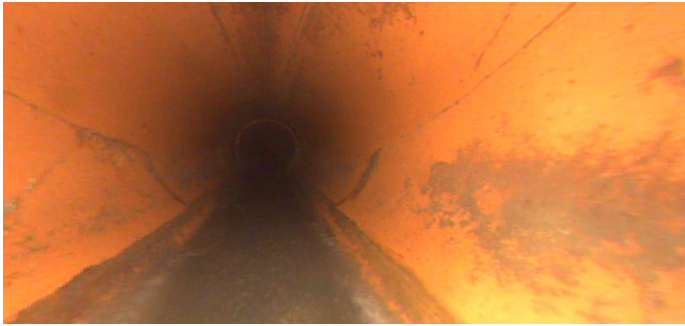
Code: **RFJ**
Description: **Roots Fine Joint**

Distance (ft): **182.4**
Structural Grade: **0**
O&M Grade: **1**
Clock Start/From: **3**
Clock To: **5**
1st Value:
2nd Value:
Value Percent:
Continuous Index:
Within 8" of Joint: **YES**
Remarks:

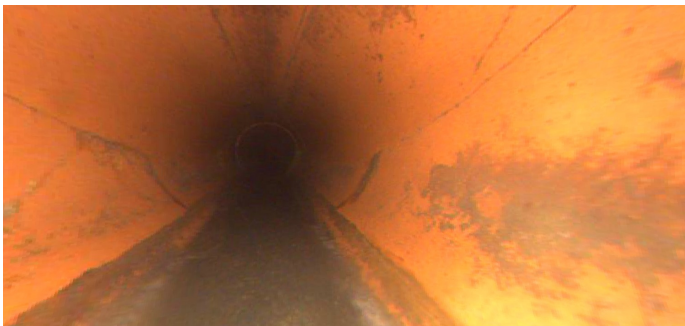
Code: **RFJ**
Description: **Roots Fine Joint**

Distance (ft): **182.4**
Structural Grade: **0**
O&M Grade: **1**
Clock Start/From: **7**
Clock To: **10**
1st Value:
2nd Value:
Value Percent:
Continuous Index:
Within 8" of Joint: **YES**
Remarks:

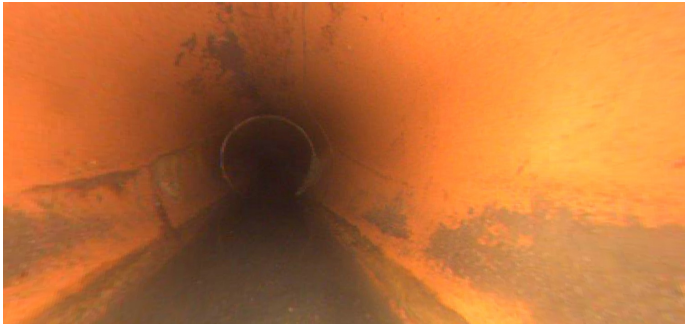
Code: **FL**
Description: **Fracture Longitudinal**

Distance (ft): **183.8**
Structural Grade: **3**
O&M Grade: **0**
Clock Start/From: **9**
Clock To:
1st Value:
2nd Value:
Value Percent:
Continuous Index:
Within 8" of Joint: **YES**
Remarks:

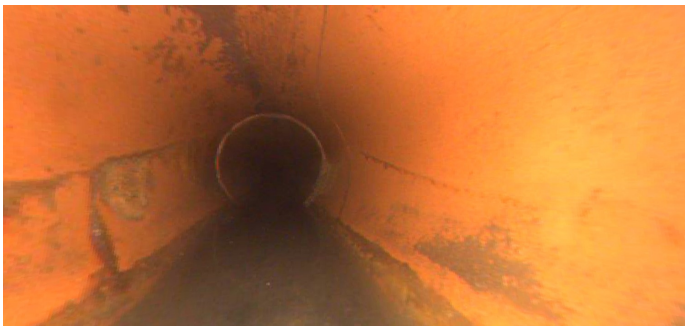
Code: **FC**
Description: **Fracture Circumferential**

Distance (ft): **184.1**
Structural Grade: **2**
O&M Grade: **0**
Clock Start/From: **1**
Clock To: **5**
1st Value:
2nd Value:
Value Percent:
Continuous Index:
Within 8" of Joint:
Remarks:

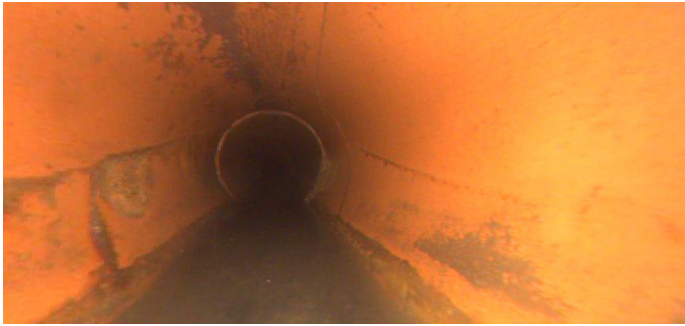
Code: **FL**
Description: **Fracture Longitudinal**

Distance (ft): **184.1**
Structural Grade: **3**
O&M Grade: **0**
Clock Start/From: **1**
Clock To:
1st Value:
2nd Value:
Value Percent:
Continuous Index:
Within 8" of Joint:
Remarks:

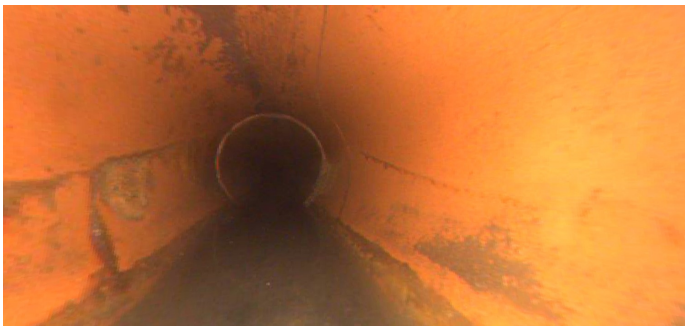
Code: **FL**
Description: **Fracture Longitudinal**

Distance (ft): **184.1**
Structural Grade: **3**
O&M Grade: **0**
Clock Start/From: **3**
Clock To:
1st Value:
2nd Value:
Value Percent:
Continuous Index:
Within 8" of Joint:
Remarks:

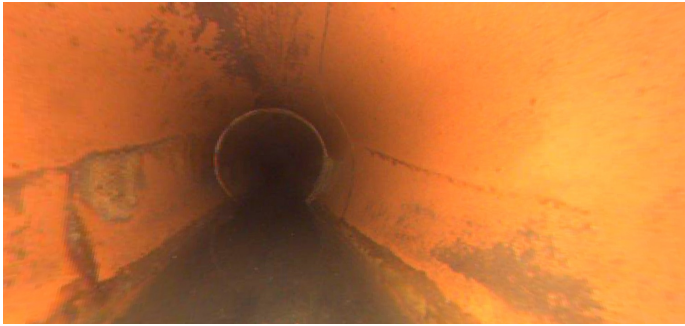
Code: **IS**
Description: **Infil Stain**

Distance (ft): **184.2**
Structural Grade: **0**
O&M Grade: **0**
Clock Start/From: **7**
Clock To: **9**
1st Value:
2nd Value:
Value Percent:
Continuous Index:
Within 8" of Joint: **YES**
Remarks:

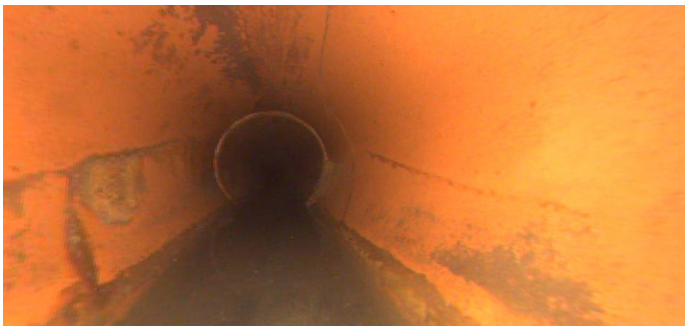
Code: **IS**
Description: **Infil Stain**

Distance (ft): **184.2**
Structural Grade: **0**
O&M Grade: **0**
Clock Start/From: **3**
Clock To: **5**
1st Value:
2nd Value:
Value Percent:
Continuous Index:
Within 8" of Joint: **YES**
Remarks:

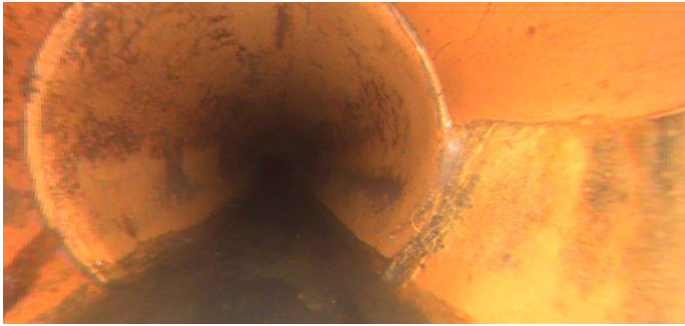
Code: **RFJ**
Description: **Roots Fine Joint**

Distance (ft): **185.8**
Structural Grade: **0**
O&M Grade: **1**
Clock Start/From: **3**
Clock To: **5**
1st Value:
2nd Value:
Value Percent:
Continuous Index:
Within 8" of Joint: **YES**
Remarks:

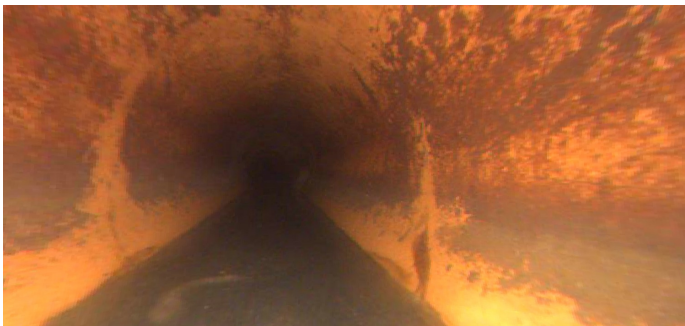
Code: **FC**
Description: **Fracture Circumferential**

Distance (ft): **187.6**
Structural Grade: **2**
O&M Grade: **0**
Clock Start/From: **8**
Clock To: **4**
1st Value:
2nd Value:
Value Percent:
Continuous Index:
Within 8" of Joint:
Remarks:

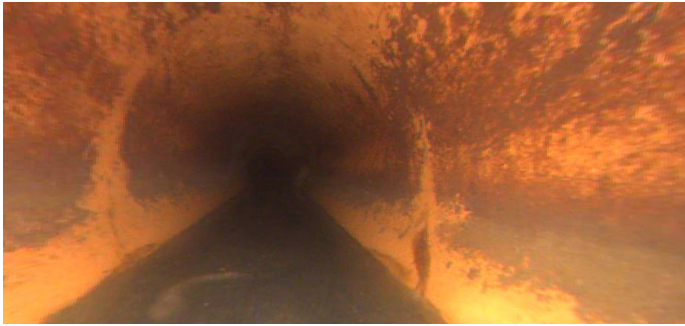
Code: **IS**
Description: **Infil Stain**

Distance (ft): **187.6**
Structural Grade: **0**
O&M Grade: **0**
Clock Start/From: **4**
Clock To:
1st Value:
2nd Value:
Value Percent:
Continuous Index:
Within 8" of Joint:
Remarks:

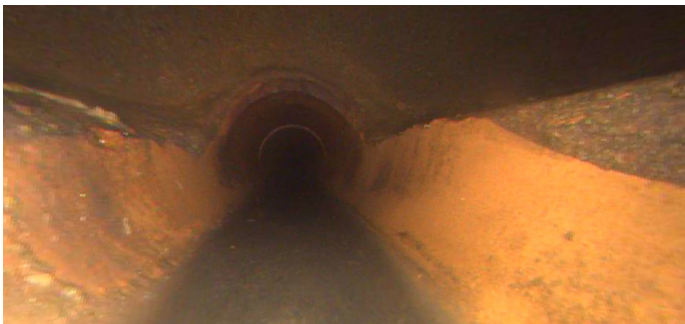
Code: **AMH**
Description: **Manhole**

Distance (ft): **192.7**
Structural Grade: **0**
O&M Grade: **0**
Clock Start/From:
Clock To:
1st Value:
2nd Value:
Value Percent:
Continuous Index:
Within 8" of Joint: **NO**
Remarks: **M-503-040**
