Profile/Photo Observation Report

Street:	W 40TH AVE	Flow Control:	Not Controlled
City:	Hobart, IN	Year Renewed:	
Location:	Other	Tape/Media #:	
Purpose:	Not Known	Dia/Height:	8"
Use:	Sanitary	Material:	PVC
Drain Area:	NA	Lining:	
Category:	NA		
Comment:

Location Details:		Direction of Survey:	Downstream
US MH:	M-503-042	DS MH:	M-503-088
		Total Length Surveyed (ft):	166.9

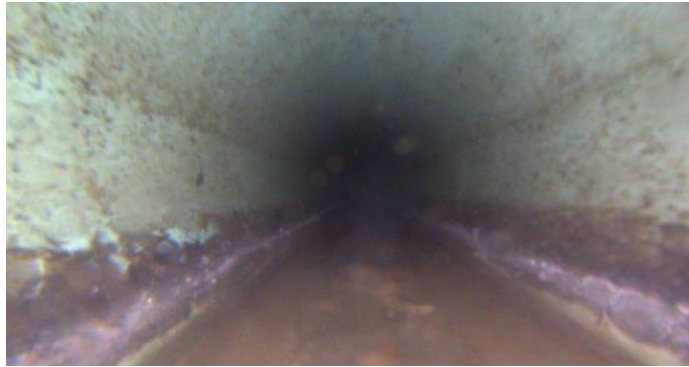
Code: **MWL**
Description: **Water Level**

Distance (ft): **.0**
Structural Grade: **0**
O&M Grade: **0**
Clock Start/From:
Clock To:
1st Value:
2nd Value:
Value Percent: **10.000**
Continuous Index:
Within 8" of Joint: **NO**
Remarks:

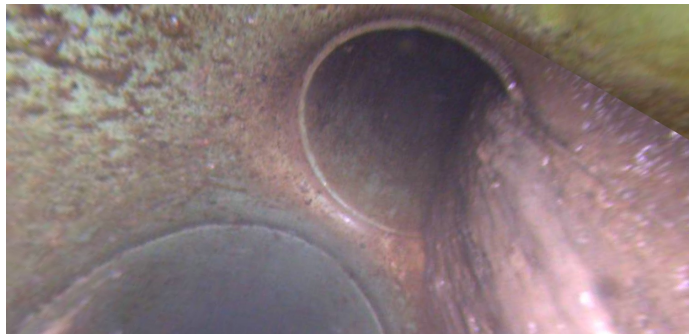
Code: **TFD**
Description: **Tap Factory Defective**

Distance (ft): **10.5**
Structural Grade: **0**
O&M Grade: **2**
Clock Start/From: **1**
Clock To:
1st Value: **4.000**
2nd Value:
Value Percent:
Continuous Index:
Within 8" of Joint:
Remarks: **dae**

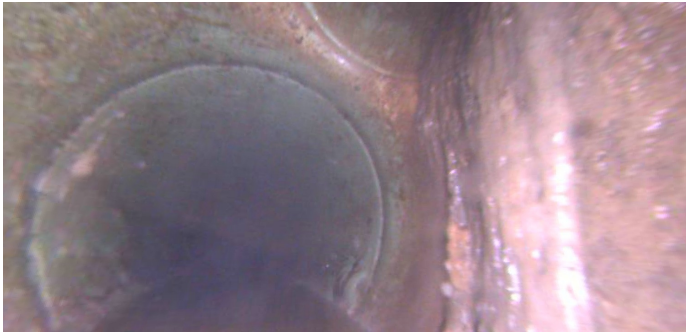
Code: **DAE**
Description: **Deposits Attached Encrustation**

Distance (ft): **10.5**
Structural Grade: **0**
O&M Grade: **2**
Clock Start/From: **1**
Clock To: **4**
1st Value:
2nd Value:
Value Percent: **5.000**
Continuous Index:
Within 8" of Joint: **NO**
Remarks:

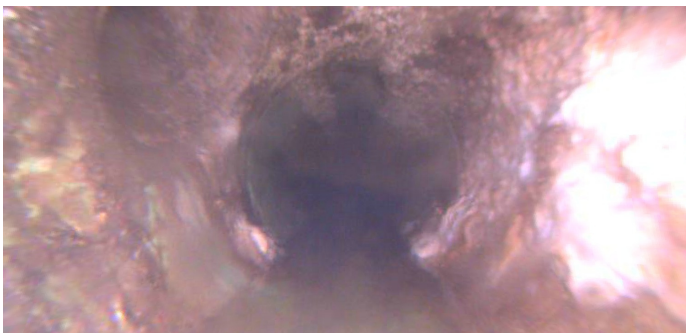
Code: **DAGS**
Description: **Deposits Attached Grease**

Distance (ft): **33.6**
Structural Grade: **0**
O&M Grade: **2**
Clock Start/From: **8**
Clock To: **4**
1st Value:
2nd Value:
Value Percent: **5.000**
Continuous Index:
Within 8" of Joint: **NO**
Remarks:

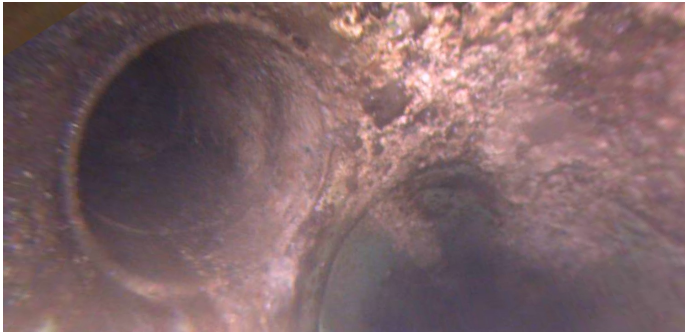
Code: **TF**
Description: **Tap Factory**

Distance (ft): **33.9**
Structural Grade: **0**
O&M Grade: **0**
Clock Start/From: **10**
Clock To:
1st Value: **4.000**
2nd Value:
Value Percent:
Continuous Index:
Within 8" of Joint:
Remarks:

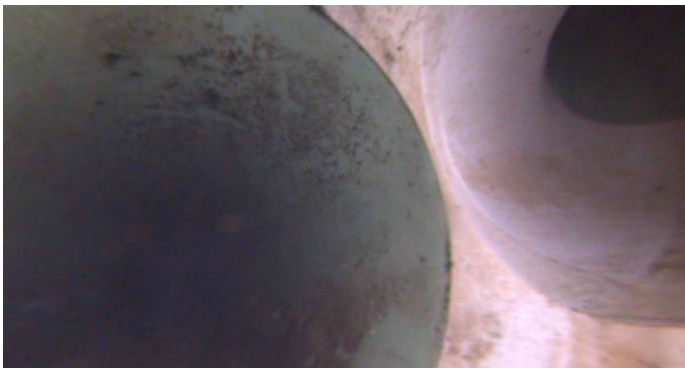
Code: **TF**
Description: **Tap Factory**

Distance (ft): **70.0**
Structural Grade: **0**
O&M Grade: **0**
Clock Start/From: **3**
Clock To:
1st Value: **4.000**
2nd Value:
Value Percent:
Continuous Index:
Within 8" of Joint:
Remarks:

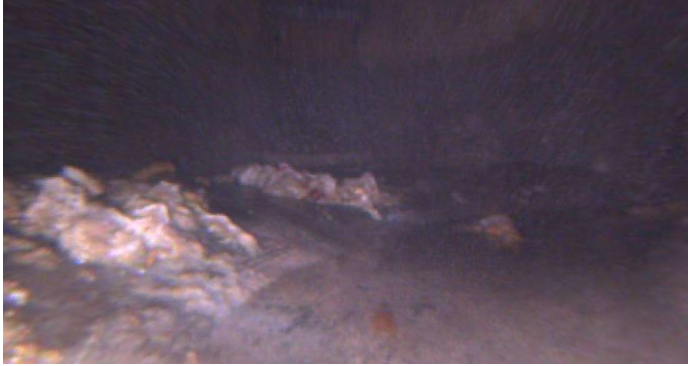
Code:	AMH
Description:	Manhole
Distance (ft):	166.9
Structural Grade:	0
O&M Grade:	0
Clock Start/From:	
Clock To:	
1st Value:	
2nd Value:	
Value Percent:	
Continuous Index:	
Within 8" of Joint:	NO
Remarks:	M-503-088
