Profile/Photo Observation Report

Street:	W 39TH AVE & W 38TH PL	Flow Control:	Not Controlled
City:	Hobart, IN	Year Renewed:	
Location:	Other	Tape/Media #:	
Purpose:	Not Known	Dia/Height:	10"
Use:	Sanitary	Material:	VCP
Drain Area:	NA	Lining:	
Category:	NA		
Comment:

Location Details:		Direction of Survey:	Downstream
US MH:	M-503-045	DS MH:	M-503-046
		Total Length Surveyed (ft):	168.0

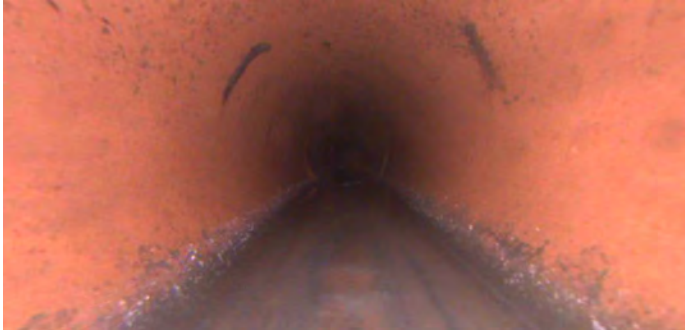
Code: **AMH**
Description: **Manhole**

Distance (ft): **.0**
Structural Grade: **0**
O&M Grade: **0**
Clock Start/From:
Clock To:
1st Value:
2nd Value:
Value Percent:
Continuous Index:
Within 8" of Joint: **NO**
Remarks: **M-503-045**

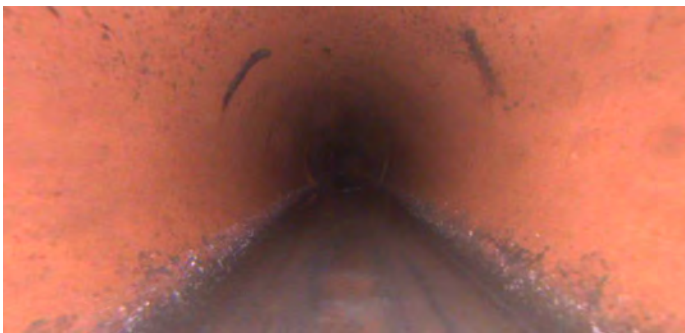
Code: **MWL**
Description: **Water Level**

Distance (ft): **.0**
Structural Grade: **0**
O&M Grade: **0**
Clock Start/From:
Clock To:
1st Value:
2nd Value:
Value Percent: **10.000**
Continuous Index:
Within 8" of Joint: **NO**
Remarks:

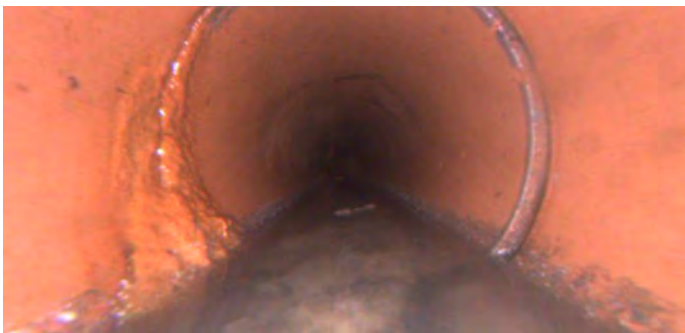
Code: **IW**
Description: **Infil Weeper**

Distance (ft): **3.5**
Structural Grade: **0**
O&M Grade: **2**
Clock Start/From: **8**
Clock To: **10**
1st Value:
2nd Value:
Value Percent:
Continuous Index:
Within 8" of Joint: **YES**
Remarks:

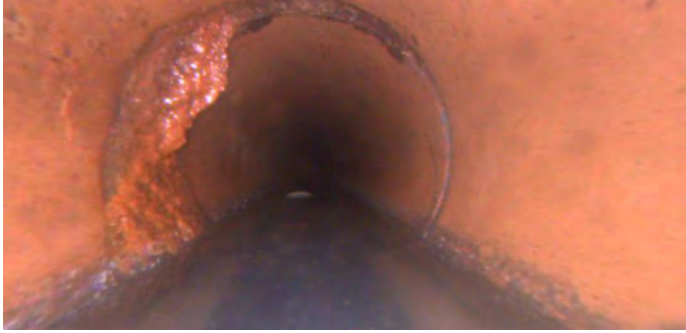
Code: **DAE**
Description: **Deposits Attached Encrustation**

Distance (ft): **8.0**
Structural Grade: **0**
O&M Grade: **2**
Clock Start/From: **7**
Clock To: **11**
1st Value:
2nd Value:
Value Percent: **10.000**
Continuous Index:
Within 8" of Joint: **YES**
Remarks:

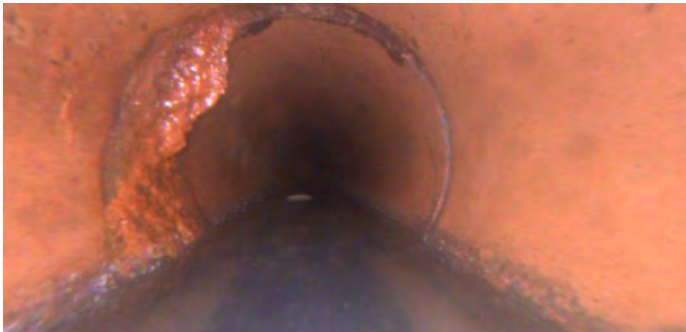
Code: **ID**
Description: **Infil Dripper**

Distance (ft): **8.0**
Structural Grade: **0**
O&M Grade: **3**
Clock Start/From: **11**
Clock To:
1st Value:
2nd Value:
Value Percent:
Continuous Index:
Within 8" of Joint: **YES**
Remarks:

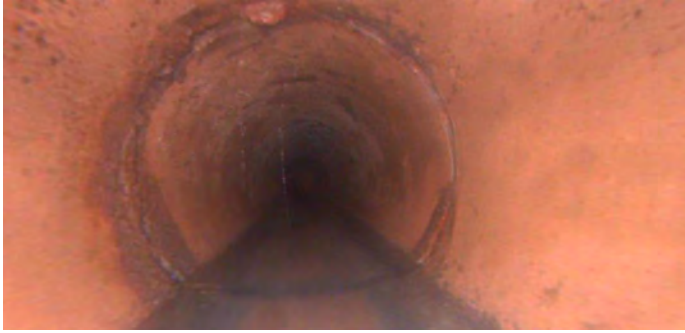
Code: **IW**
Description: **Infil Weeper**

Distance (ft): **18.1**
Structural Grade: **0**
O&M Grade: **2**
Clock Start/From: **8**
Clock To: **4**
1st Value:
2nd Value:
Value Percent:
Continuous Index:
Within 8" of Joint: **YES**
Remarks:

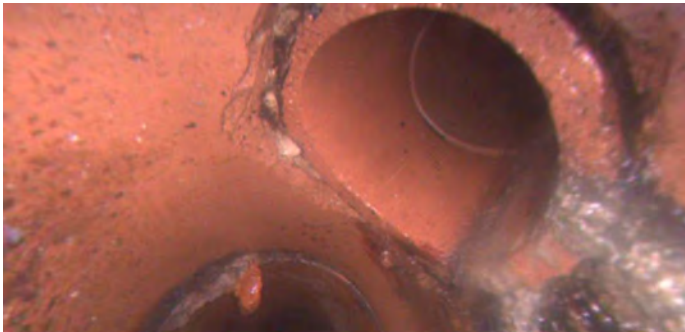
Code: **TB**
Description: **Tap Break-in**

Distance (ft): **45.3**
Structural Grade: **0**
O&M Grade: **0**
Clock Start/From: **1**
Clock To:
1st Value: **4.000**
2nd Value:
Value Percent:
Continuous Index:
Within 8" of Joint:
Remarks:

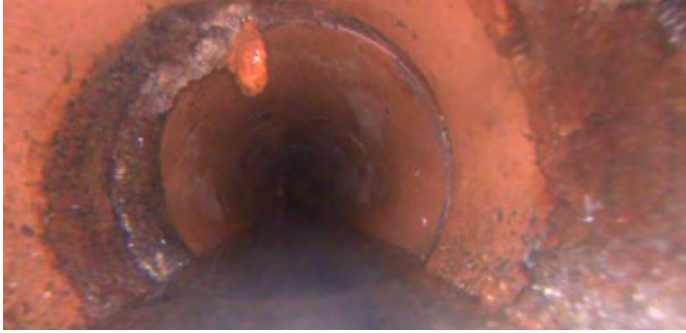
Code: **DAE**
Description: **Deposits Attached Encrustation**

Distance (ft): **45.9**
Structural Grade: **0**
O&M Grade: **2**
Clock Start/From: **8**
Clock To: **12**
1st Value:
2nd Value:
Value Percent: **5.000**
Continuous Index:
Within 8" of Joint: **YES**
Remarks:

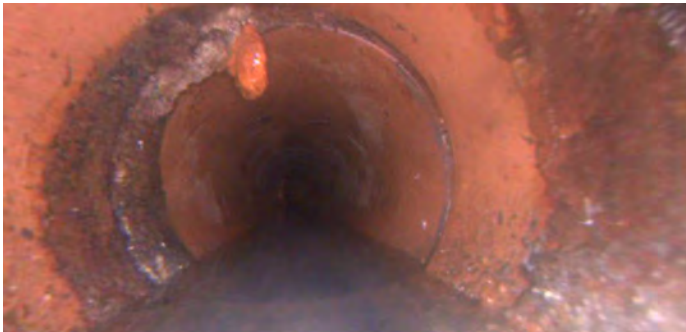
Code: **ID**
Description: **Infil Dripper**

Distance (ft): **45.9**
Structural Grade: **0**
O&M Grade: **3**
Clock Start/From: **12**
Clock To:
1st Value:
2nd Value:
Value Percent:
Continuous Index:
Within 8" of Joint: **YES**
Remarks:

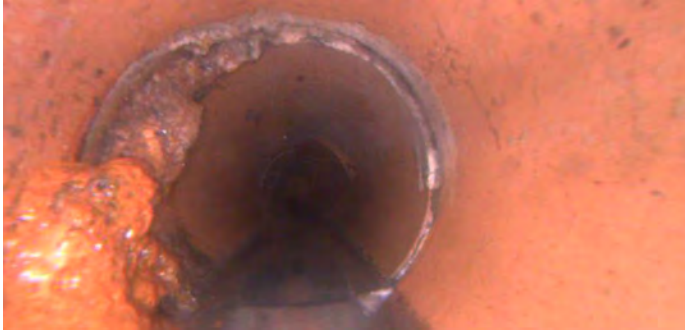
Code: **DAE**
Description: **Deposits Attached Encrustation**

Distance (ft): **50.9**
Structural Grade: **0**
O&M Grade: **2**
Clock Start/From: **7**
Clock To: **11**
1st Value:
2nd Value:
Value Percent: **10.000**
Continuous Index:
Within 8" of Joint: **YES**
Remarks:

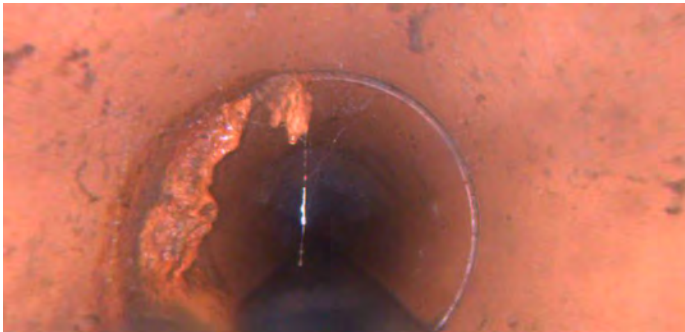
Code: **ID**
Description: **Infil Dripper**

Distance (ft): **58.2**
Structural Grade: **0**
O&M Grade: **3**
Clock Start/From: **12**
Clock To:
1st Value:
2nd Value:
Value Percent:
Continuous Index:
Within 8" of Joint: **YES**
Remarks:

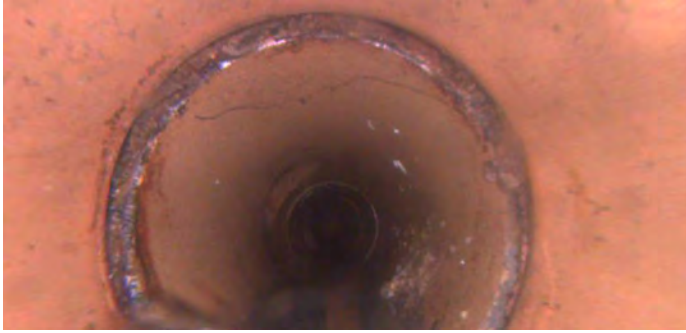
Code: **IW**
Description: **Infil Weeper**

Distance (ft): **94.2**
Structural Grade: **0**
O&M Grade: **2**
Clock Start/From: **8**
Clock To: **4**
1st Value:
2nd Value:
Value Percent:
Continuous Index:
Within 8" of Joint: **YES**
Remarks:

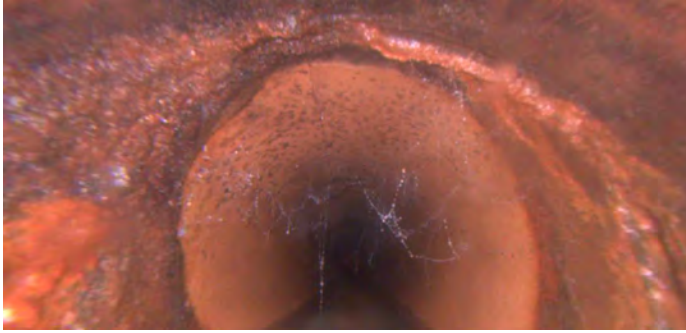
Code: **DAE**
Description: **Deposits Attached Encrustation**

Distance (ft): **114.0**
Structural Grade: **0**
O&M Grade: **2**
Clock Start/From: **8**
Clock To: **4**
1st Value:
2nd Value:
Value Percent: **10.000**
Continuous Index:
Within 8" of Joint: **YES**
Remarks:

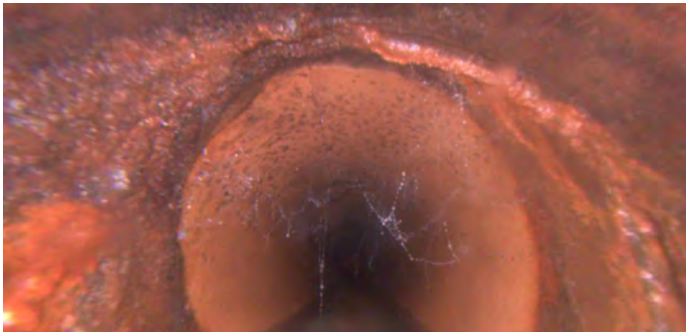
Code: **IW**
Description: **Infil Weeper**

Distance (ft): **114.0**
Structural Grade: **0**
O&M Grade: **2**
Clock Start/From: **8**
Clock To: **4**
1st Value:
2nd Value:
Value Percent:
Continuous Index:
Within 8" of Joint: **YES**
Remarks:

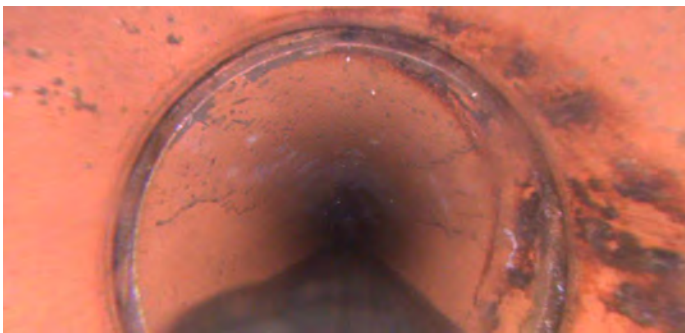
Code: **IS**
Description: **Infil Stain**

Distance (ft): **129.3**
Structural Grade: **0**
O&M Grade: **0**
Clock Start/From: **8**
Clock To: **4**
1st Value:
2nd Value:
Value Percent:
Continuous Index:
Within 8" of Joint: **YES**
Remarks:
