Profile/Photo Observation Report

Street:	W 40th ave	Flow Control:	Not Controlled
City:	Hobart, IN	Year Renewed:	
Location:	Other	Tape/Media #:	
Purpose:	Not Known	Dia/Height:	10"
Use:	Sanitary	Material:	VCP
Drain Area:	NA	Lining:	
Category:	NA		
Comment:

Location Details:		Direction of Survey:	Downstream
US MH:	M-503-045	DS MH:	M-503-046
		Total Length Surveyed (ft):	168.0

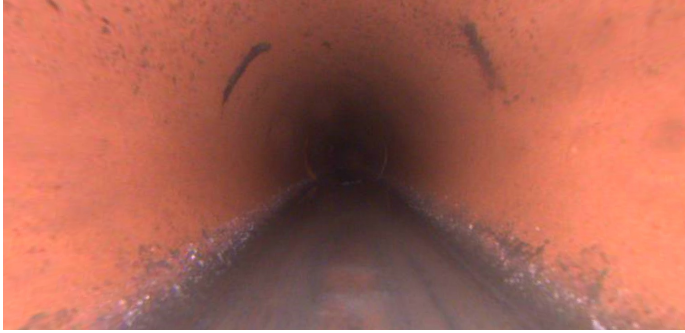
Code: **AMH**
Description: **Manhole**

Distance (ft): **.0**
Structural Grade: **0**
O&M Grade: **0**
Clock Start/From:
Clock To:
1st Value:
2nd Value:
Value Percent:
Continuous Index:
Within 8" of Joint: **NO**
Remarks: **M-503-045**

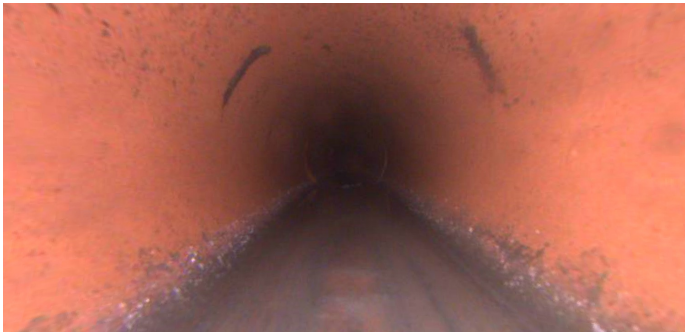
Code: **MWL**
Description: **Water Level**

Distance (ft): **.0**
Structural Grade: **0**
O&M Grade: **0**
Clock Start/From:
Clock To:
1st Value:
2nd Value:
Value Percent: **10.000**
Continuous Index:
Within 8" of Joint: **NO**
Remarks:

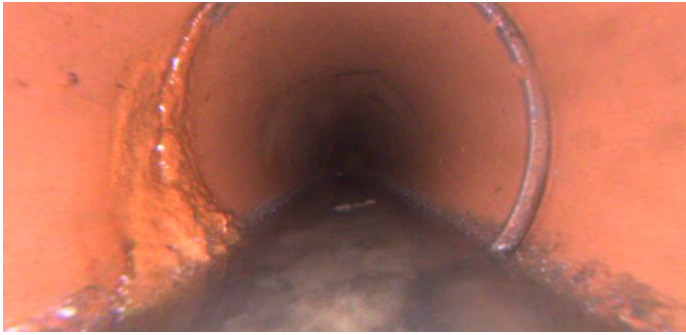
Code: **DAE**
Description: **Deposits Attached Encrustation**

Distance (ft): **3.5**
Structural Grade: **0**
O&M Grade: **2**
Clock Start/From: **8**
Clock To: **11**
1st Value:
2nd Value:
Value Percent: **5.000**
Continuous Index:
Within 8" of Joint: **YES**
Remarks:

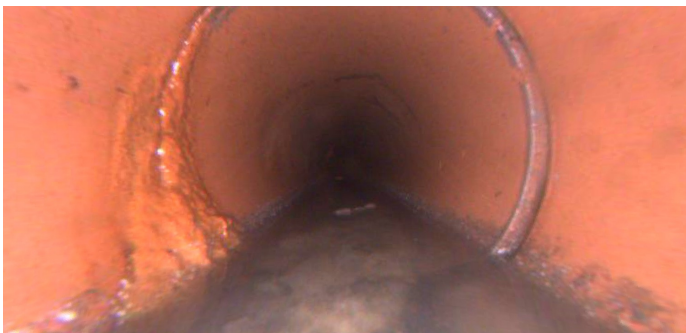
Code: **IW**
Description: **Infil Weeper**

Distance (ft): **3.5**
Structural Grade: **0**
O&M Grade: **2**
Clock Start/From: **8**
Clock To: **10**
1st Value:
2nd Value:
Value Percent:
Continuous Index:
Within 8" of Joint: **YES**
Remarks:

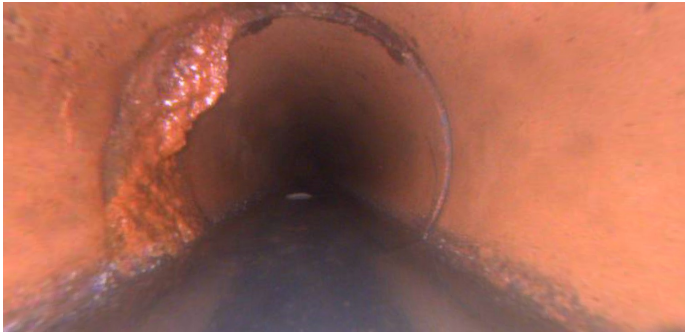
Code: **DAE**
Description: **Deposits Attached Encrustation**

Distance (ft): **8.0**
Structural Grade: **0**
O&M Grade: **2**
Clock Start/From: **7**
Clock To: **11**
1st Value:
2nd Value:
Value Percent: **10.000**
Continuous Index:
Within 8" of Joint: **YES**
Remarks:

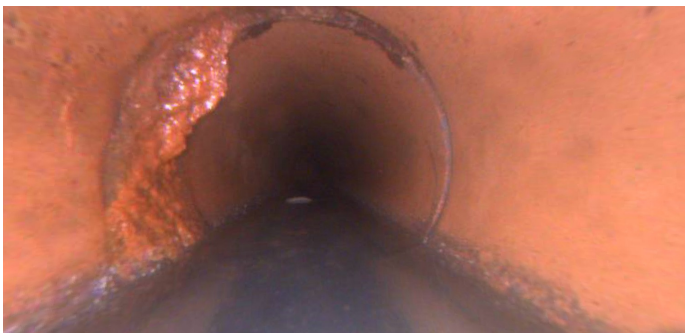
Code: **ID**
Description: **Infil Dripper**

Distance (ft): **8.0**
Structural Grade: **0**
O&M Grade: **3**
Clock Start/From: **11**
Clock To:
1st Value:
2nd Value:
Value Percent:
Continuous Index:
Within 8" of Joint: **YES**
Remarks:

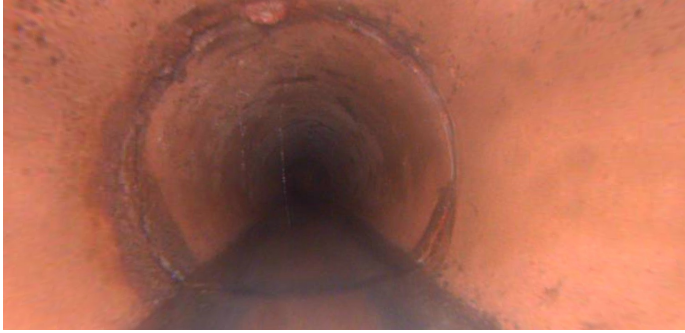
Code: **IW**
Description: **Infil Weeper**

Distance (ft): **18.1**
Structural Grade: **0**
O&M Grade: **2**
Clock Start/From: **8**
Clock To: **4**
1st Value:
2nd Value:
Value Percent:
Continuous Index:
Within 8" of Joint: **YES**
Remarks:

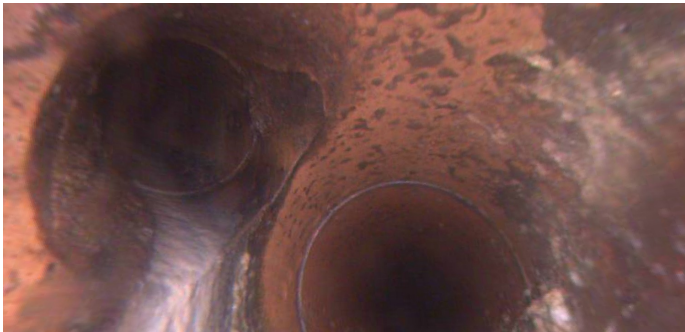
Code: **TF**
Description: **Tap Factory**

Distance (ft): **30.0**
Structural Grade: **0**
O&M Grade: **0**
Clock Start/From: **10**
Clock To:
1st Value: **4.000**
2nd Value:
Value Percent:
Continuous Index:
Within 8" of Joint:
Remarks:

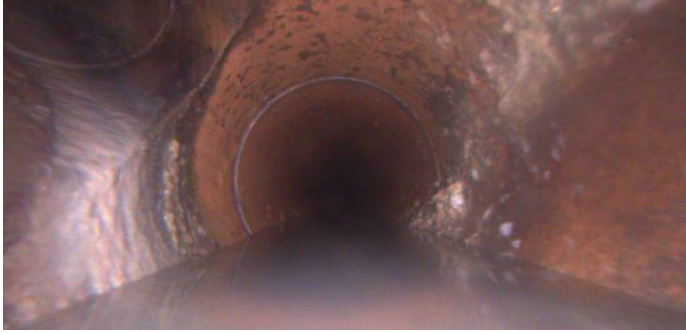
Code: **DAGS**
Description: **Deposits Attached Grease**

Distance (ft): **30.0**
Structural Grade: **0**
O&M Grade: **2**
Clock Start/From: **8**
Clock To: **4**
1st Value:
2nd Value:
Value Percent: **5.000**
Continuous Index:
Within 8" of Joint: **NO**
Remarks:

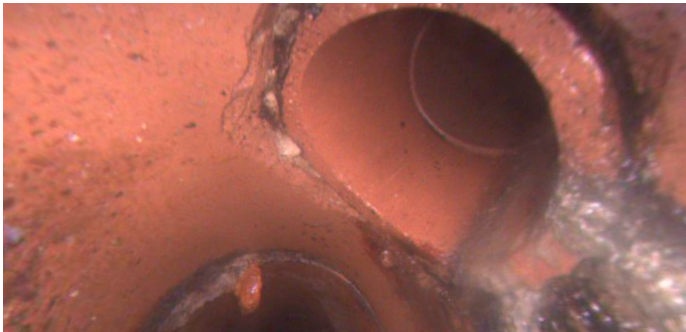
Code: **TB**
Description: **Tap Break-in**

Distance (ft): **45.3**
Structural Grade: **0**
O&M Grade: **0**
Clock Start/From: **1**
Clock To:
1st Value: **4.000**
2nd Value:
Value Percent:
Continuous Index:
Within 8" of Joint:
Remarks:

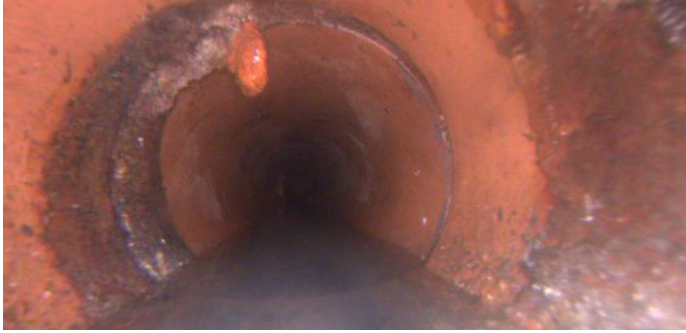
Code: **DAE**
Description: **Deposits Attached Encrustation**

Distance (ft): **45.9**
Structural Grade: **0**
O&M Grade: **2**
Clock Start/From: **8**
Clock To: **12**
1st Value:
2nd Value:
Value Percent: **5.000**
Continuous Index:
Within 8" of Joint: **YES**
Remarks:

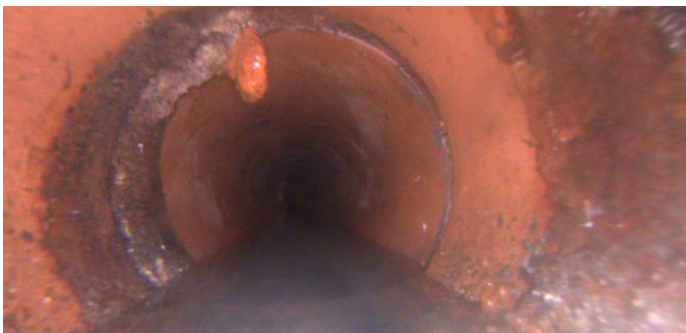
Code: **ID**
Description: **Infil Dripper**

Distance (ft): **45.9**
Structural Grade: **0**
O&M Grade: **3**
Clock Start/From: **12**
Clock To:
1st Value:
2nd Value:
Value Percent:
Continuous Index:
Within 8" of Joint: **YES**
Remarks:

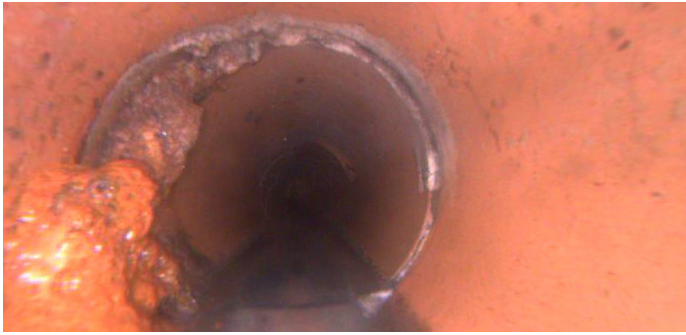
Code: **DAE**
Description: **Deposits Attached Encrustation**

Distance (ft): **50.9**
Structural Grade: **0**
O&M Grade: **2**
Clock Start/From: **7**
Clock To: **11**
1st Value:
2nd Value:
Value Percent: **10.000**
Continuous Index:
Within 8" of Joint: **YES**
Remarks:

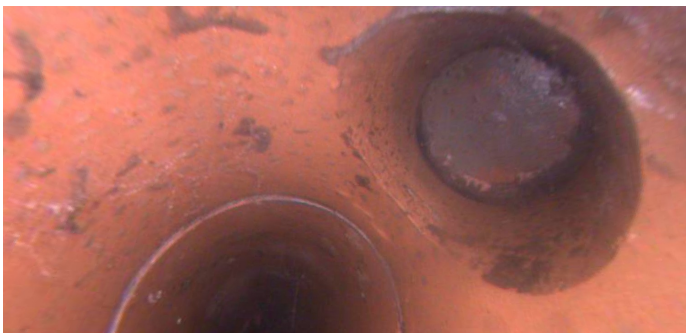
Code: **TFC**
Description: **Tap Factory Capped**

Distance (ft): **52.8**
Structural Grade: **0**
O&M Grade: **0**
Clock Start/From: **2**
Clock To:
1st Value: **4.000**
2nd Value:
Value Percent:
Continuous Index:
Within 8" of Joint:
Remarks:

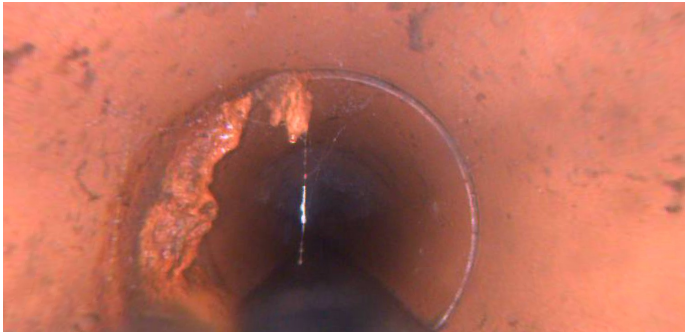
Code: **DAE**
Description: **Deposits Attached Encrustation**

Distance (ft): **58.2**
Structural Grade: **0**
O&M Grade: **2**
Clock Start/From: **7**
Clock To: **11**
1st Value:
2nd Value:
Value Percent: **10.000**
Continuous Index:
Within 8" of Joint: **YES**
Remarks:

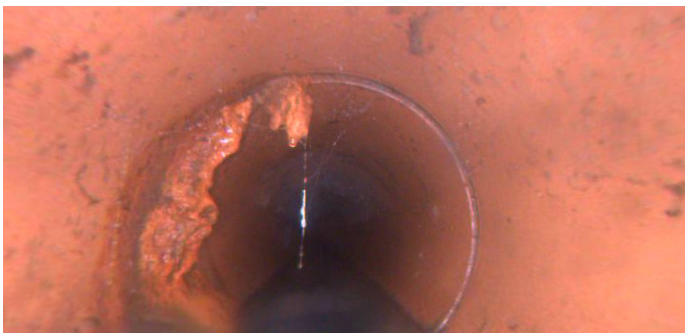
Code: **ID**
Description: **Infil Dripper**

Distance (ft): **58.2**
Structural Grade: **0**
O&M Grade: **3**
Clock Start/From: **12**
Clock To:
1st Value:
2nd Value:
Value Percent:
Continuous Index:
Within 8" of Joint: **YES**
Remarks:

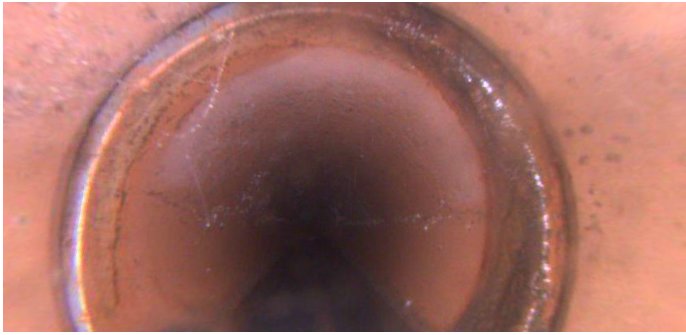
Code: **IW**
Description: **Infil Weeper**

Distance (ft): **73.9**
Structural Grade: **0**
O&M Grade: **2**
Clock Start/From: **12**
Clock To: **4**
1st Value:
2nd Value:
Value Percent:
Continuous Index:
Within 8" of Joint: **YES**
Remarks:

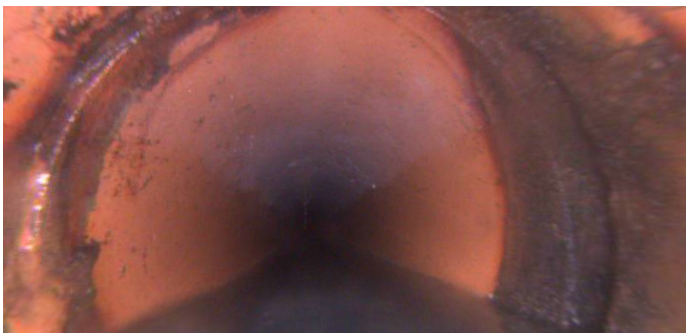
Code: **IW**
Description: **Infil Weeper**

Distance (ft): **84.1**
Structural Grade: **0**
O&M Grade: **2**
Clock Start/From: **8**
Clock To: **4**
1st Value:
2nd Value:
Value Percent:
Continuous Index:
Within 8" of Joint: **YES**
Remarks:

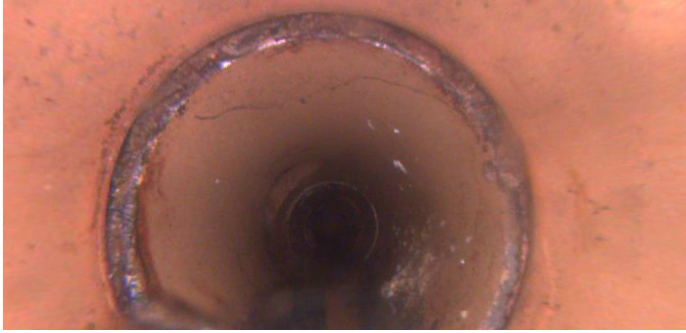
Code: **IW**
Description: **Infil Weeper**

Distance (ft): **94.2**
Structural Grade: **0**
O&M Grade: **2**
Clock Start/From: **8**
Clock To: **4**
1st Value:
2nd Value:
Value Percent:
Continuous Index:
Within 8" of Joint: **YES**
Remarks:

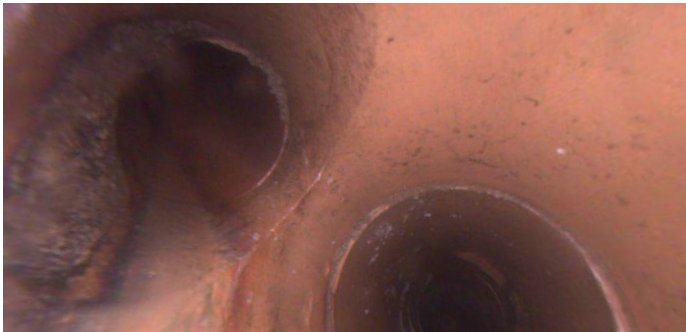
Code: **TF**
Description: **Tap Factory**

Distance (ft): **95.9**
Structural Grade: **0**
O&M Grade: **0**
Clock Start/From: **10**
Clock To:
1st Value: **4.000**
2nd Value:
Value Percent:
Continuous Index:
Within 8" of Joint:
Remarks:

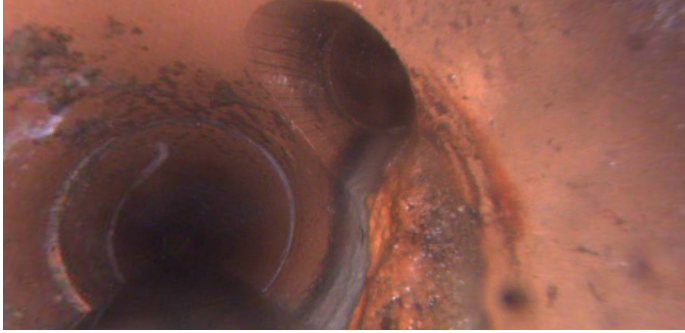
Code: **TF**
Description: **Tap Factory**

Distance (ft): **97.7**
Structural Grade: **0**
O&M Grade: **0**
Clock Start/From: **2**
Clock To:
1st Value: **4.000**
2nd Value:
Value Percent:
Continuous Index:
Within 8" of Joint:
Remarks:

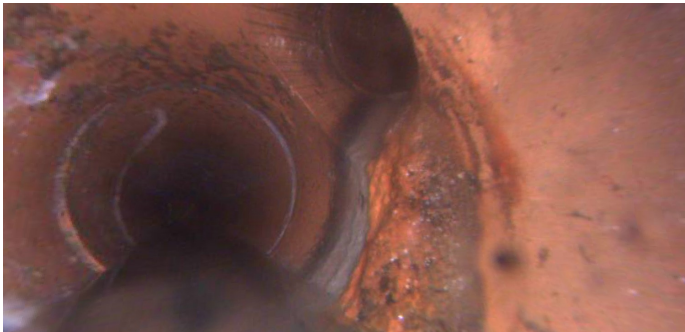
Code: **DAE**
Description: **Deposits Attached Encrustation**

Distance (ft): **97.7**
Structural Grade: **0**
O&M Grade: **2**
Clock Start/From: **2**
Clock To: **4**
1st Value:
2nd Value:
Value Percent: **5.000**
Continuous Index:
Within 8" of Joint: **NO**
Remarks:

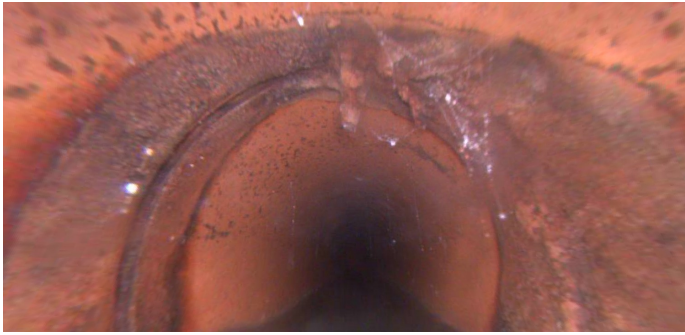
Code: **DAE**
Description: **Deposits Attached Encrustation**

Distance (ft): **103.6**
Structural Grade: **0**
O&M Grade: **2**
Clock Start/From: **8**
Clock To: **4**
1st Value:
2nd Value:
Value Percent: **5.000**
Continuous Index:
Within 8" of Joint: **YES**
Remarks:

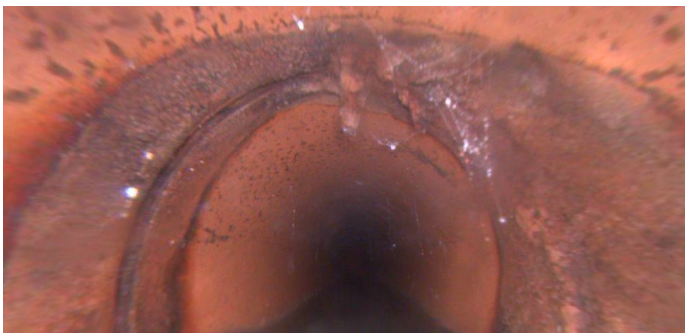
Code: **ID**
Description: **Infil Dripper**

Distance (ft): **103.6**
Structural Grade: **0**
O&M Grade: **3**
Clock Start/From: **12**
Clock To:
1st Value:
2nd Value:
Value Percent:
Continuous Index:
Within 8" of Joint: **YES**
Remarks:

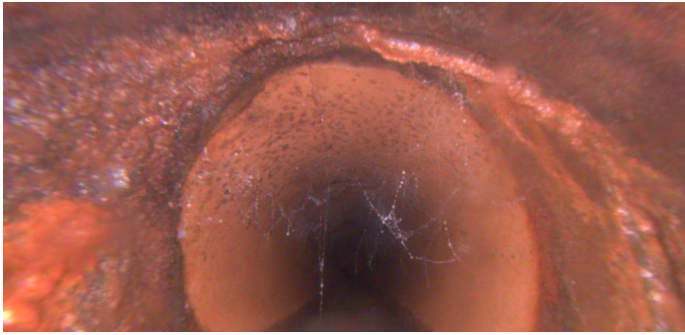
Code: **DAE**
Description: **Deposits Attached Encrustation**

Distance (ft): **114.0**
Structural Grade: **0**
O&M Grade: **2**
Clock Start/From: **8**
Clock To: **4**
1st Value:
2nd Value:
Value Percent: **10.000**
Continuous Index:
Within 8" of Joint: **YES**
Remarks:

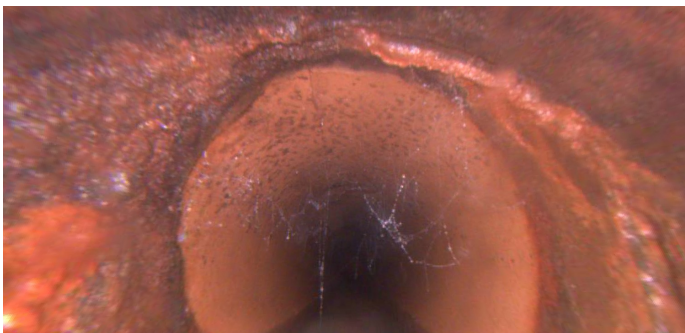
Code: **IW**
Description: **Infil Weeper**

Distance (ft): **114.0**
Structural Grade: **0**
O&M Grade: **2**
Clock Start/From: **8**
Clock To: **4**
1st Value:
2nd Value:
Value Percent:
Continuous Index:
Within 8" of Joint: **YES**
Remarks:

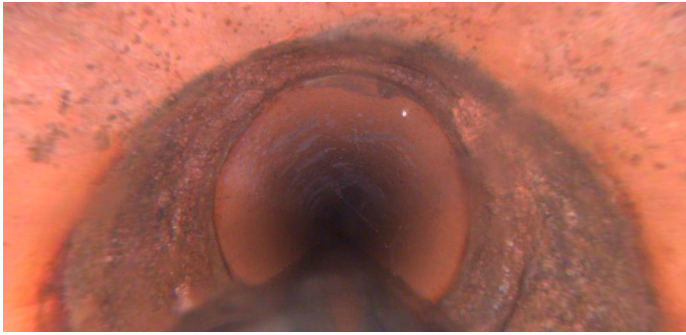
Code: **DAE**
Description: **Deposits Attached Encrustation**

Distance (ft): **124.1**
Structural Grade: **0**
O&M Grade: **2**
Clock Start/From: **8**
Clock To: **4**
1st Value:
2nd Value:
Value Percent: **5.000**
Continuous Index:
Within 8" of Joint: **YES**
Remarks:

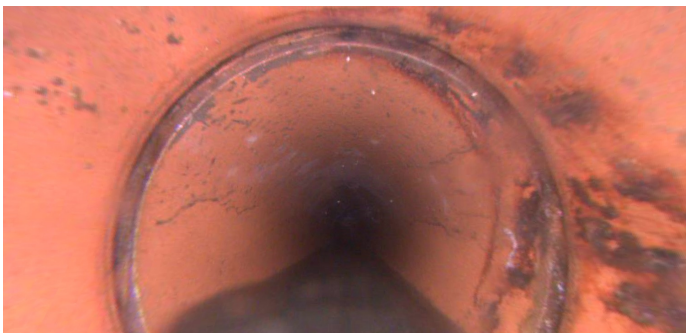
Code: **IS**
Description: **Infil Stain**

Distance (ft): **129.3**
Structural Grade: **0**
O&M Grade: **0**
Clock Start/From: **8**
Clock To: **4**
1st Value:
2nd Value:
Value Percent:
Continuous Index:
Within 8" of Joint: **YES**
Remarks:

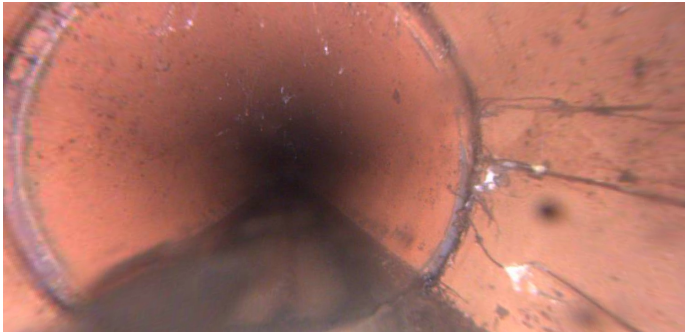
Code: **RFJ**
Description: **Roots Fine Joint**

Distance (ft): **160.1**
Structural Grade: **0**
O&M Grade: **1**
Clock Start/From: **12**
Clock To: **4**
1st Value:
2nd Value:
Value Percent:
Continuous Index:
Within 8" of Joint: **YES**
Remarks:

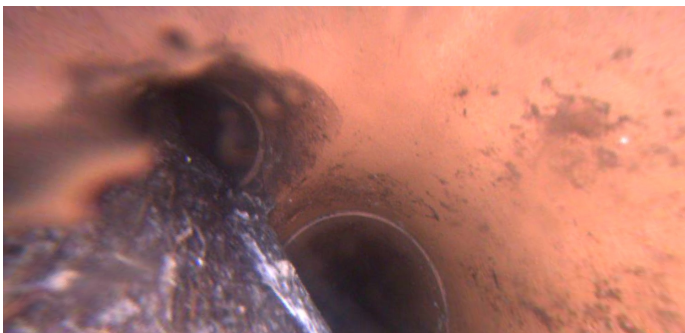
Code: **TFD**
Description: **Tap Factory Defective**

Distance (ft): **166.7**
Structural Grade: **0**
O&M Grade: **2**
Clock Start/From: **10**
Clock To:
1st Value: **4.000**
2nd Value:
Value Percent:
Continuous Index:
Within 8" of Joint:
Remarks: **ROOTS**

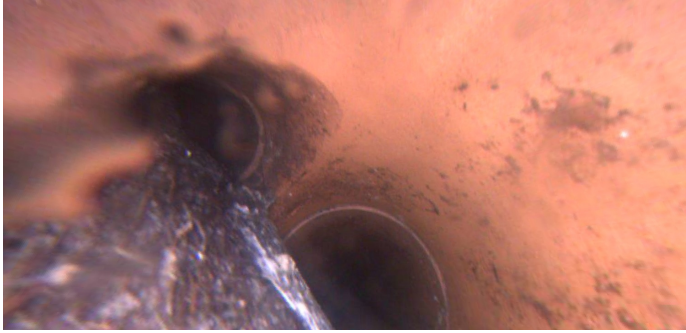
Code: **RML**
Description: **Roots Medium Lateral**

Distance (ft): **166.7**
Structural Grade: **0**
O&M Grade: **3**
Clock Start/From: **6**
Clock To: **10**
1st Value:
2nd Value:
Value Percent: **40.000**
Continuous Index:
Within 8" of Joint: **NO**
Remarks:

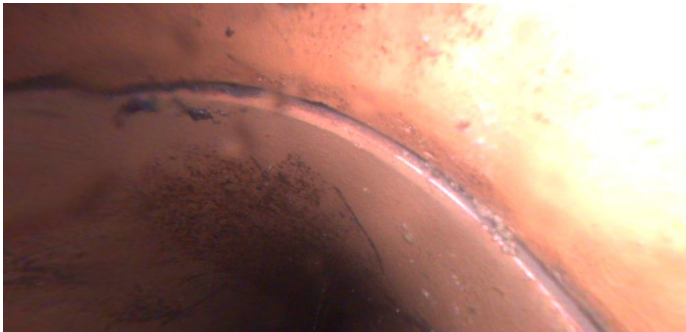
Code: **MSA**
Description: **Abandoned Survey**

Distance (ft): **168.0**
Structural Grade: **0**
O&M Grade: **0**
Clock Start/From:
Clock To:
1st Value:
2nd Value:
Value Percent:
Continuous Index:
Within 8" of Joint: **NO**
Remarks: **ROOTS**
